Clark Fork River Plains Reach Assessment & Restoration Prioritization

May 14, 2014

**CLARK FORK RIVER
PLAINS REACH ASSESSMENT
AND
RESTORATION PRIORITIZATION**

RESPEC

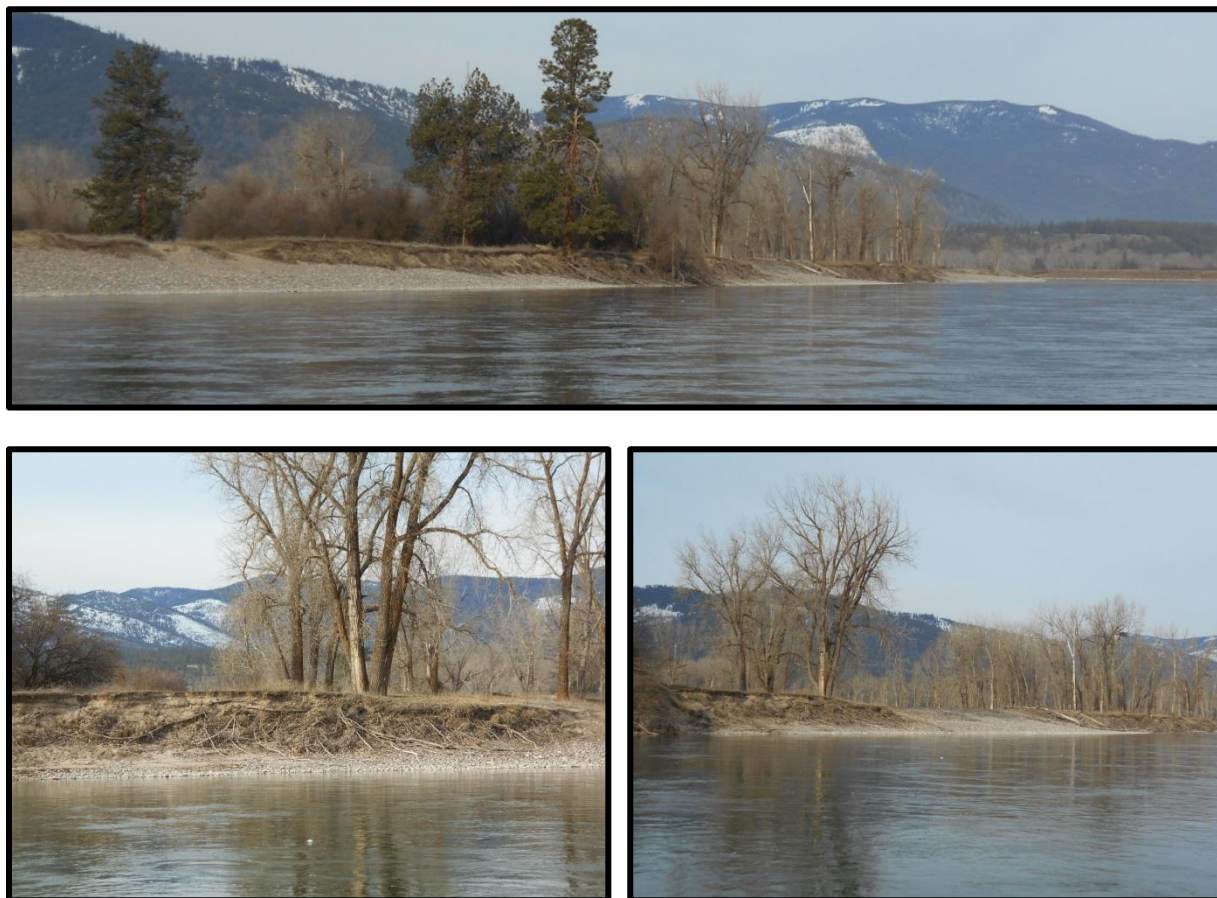
Bank 4 is 1,334 feet long and is located on river left downstream of the Sanders County Fairgrounds. Bank 4 extends downstream from the end of the rock riprap placed along the fairgrounds by the Army Corps of Engineers, which covered the fairgrounds under approximately four feet of water (Randy Garrison, personal communication, 2/4/14). Riprap extends nearly 1,600 feet above the start of bank 4. Bank 4 is partially vegetated with ponderosa pine and cottonwoods and bisected by two overflow channels that lead into Big Eddy (**Figures 5-10 and 5-11**). Between 1995 and 2013, bank 4 has eroded an average of 81 feet, with a mean annual retreat rate of 4.5 feet. Portions of the bank occupied by the overflow channels are comprised of gravel and cobble, while vegetated areas have fine grained material throughout the bank with gravel and cobble in the toe. The primary factors influencing erosion of bank 4 are upstream channel constriction by the 5th Avenue South Bridge and the growth of the gravel bar on the opposite side of the channel. The gravel bar has developed downstream of the 5th Avenue South Bridge and likely formed in response to the placement and alignment of the bridge, which was originally constructed in 1911. A review of aerial imagery dating back to 1955 indicates this gravel bar has become larger and more vegetated over the past 58 years, which has directed the river towards bank 4. Compounding factors influencing erosion along bank 4 include upstream channelization on river right along the town of Plains which has effectively restricted lateral migration of the river upstream of the bridge over the past 100 years.

Figure 5-10. Bank 4, March 2014

Bank 4 has retreated an average of 81 feet over the past 18 years, though this retreat rate is not excessive for a river of this size and no stabilization is recommended at this time. However, the gravel bar across the channel has expanded over the past 18 years and additional growth of this gravel bar, along with the accompanying development of riparian vegetation, may lead to increased stream power along bank 4. If bank erosion becomes accelerated in the future, bioengineering techniques could be applied to work with the existing vegetation. Since this bank is bisected by two primary overflow channels, stabilization will likely increase the amount of stream power directed towards the next meander bend downstream (bank 5), which is partially stabilized by rock riprap. As an alternative to bank stabilization, the overflow channels that bisect bank 4 could be enhanced and additional water directed across the low floodplain that leads into Big Eddy (Figure 6-11). This may help alleviate stream power along bank 5 while also creating convergent flows as it rejoins the main channel above the bedrock outcrop, which could potentially deflect stream energy currently directed at bank 6 and River Road West. However, increased stream flows in Combest Creek along River Road West upstream of the bedrock outcrop should be further evaluated prior to overflow channel enhancement. Additional overflow channels could also potentially be developed in the gravel bar across the channel from bank 4.

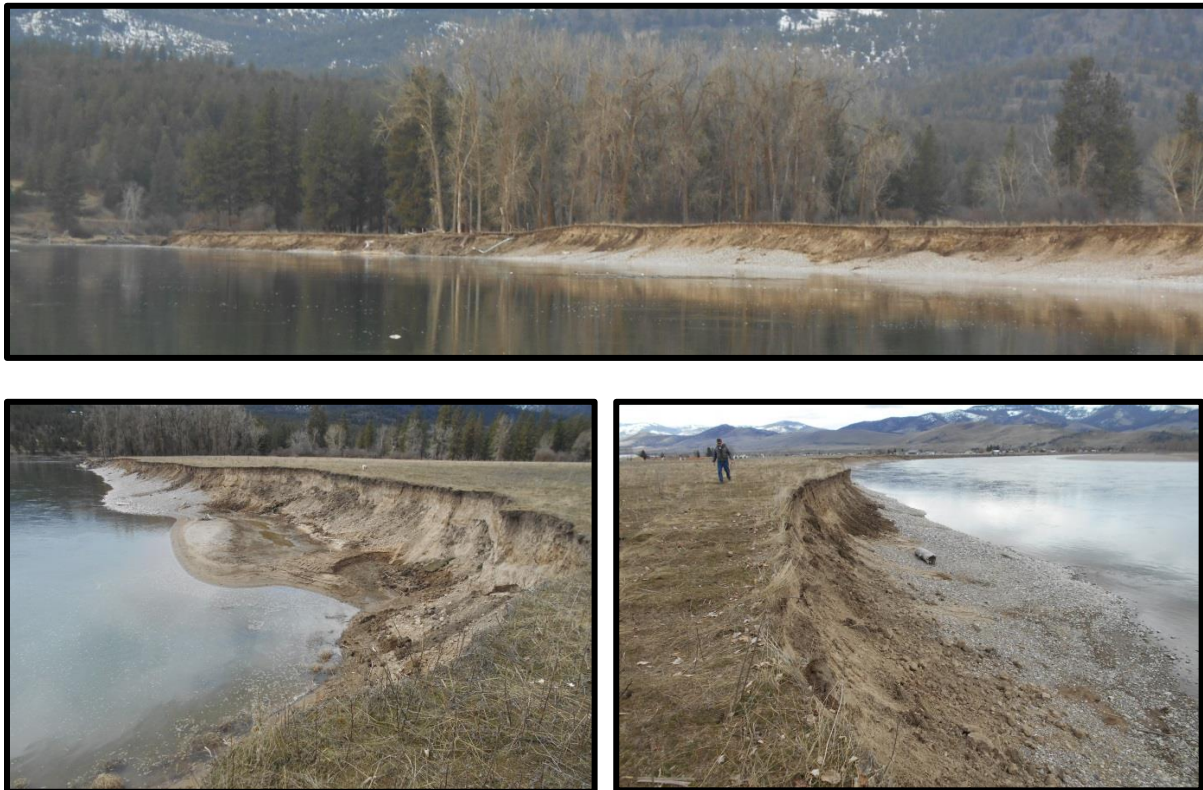
Bank 5 is 2,515 feet long and located on river right at the outside of a meander bend that is naturally experiencing lateral retreat and has been partially stabilized with rock riprap. Erosion along bank 5 extends downstream from a section of riprap placed by the Army Corps of Engineers that was reinforced in 2011 as water was overtopping the bank. The newly placed riprap extends approximately 900 feet upstream from the upper end of bank 5, while the historic riprap extends approximately 600 additional feet, leading to approximately 1,500 feet of bank stabilization upstream of bank 5. Prior to 2011, active retreat was observed along the 900 feet of bank that was reinforced with riprap in 2011. The majority of bank 5 is actively eroding into an agricultural field currently used for livestock grazing, though a stand of cottonwoods and a stand of ponderosa pines reduce the retreat rate at the downstream end (**Figures 5-12 and 5-13**). The majority of bank 5 is comprised of gravel in the toe that often extends up into the lower third of the bank, with fine grained material in the upper two thirds. A 150 foot section of bank 5 is comprised entirely of fine grain material and is eroding at an accelerated rate. Between 1995 and 2013, bank 5 has eroded an average of 322 feet, with a mean annual retreat rate of 17.8 feet. The primary factors influencing erosion of bank 5 are its location at the outside of meander bend and the lack of deep rooted riparian vegetation along the top of the bank. Compounding factors include upstream bank stabilization along the fairgrounds, channel constriction under the 5th Avenue South Bridge, and upstream channel confinement by the levee along River Road East that restricts higher flows from accessing the floodplain in the South Plains area. Material eroded from bank 5 has been deposited on the next point bar downstream where a young stand of cottonwoods is becoming established (**Figures 5-14 and 5-15**).

Figure 5-12. Bank 5, March 2014

Floodplain revegetation is highly recommended at this site since water was actively overtopping bank 5 during the 2011 flood event and flowing into a series of overflow channels, including one that flows behind the Town of Plains WWTP. This area was identified as a potential avulsion hazard during the Channel Migration Zone analysis and presents a hazard to the long term maintenance of the WWTP. To help stabilize the floodplain surrounding the WWTP, the existing floodplain topography could be enhanced and floodplain vegetation could be re-established on 61 acres along bank 5 and an additional 32 acres along bank 9. A total of 33 acres were identified as primary floodplain planting areas along bank 5, with an additional 28 acres identified as a secondary priority along bank 5 (**Figures 6-12 and 6-13**). Floodplain planting strategies along bank 5 account for erosion over the next 20 years, which is estimated at 358 feet, while floodplain plantings extend up to the base of the levee behind the existing riprap at the upstream end. In addition to the primary and secondary floodplain planting priorities identified in **Figure 6-12**, understory riparian shrubs could be planted in the area currently occupied by mature cottonwoods along the western edge of the primary floodplain planting area (**Figure 6-14**). If bank 5 is stabilized, then floodplain plantings could be extended to the edge of the stabilized channel or a 150 foot vegetated riparian buffer could be established.

Additional activities along bank 5 include the removal of an underwater obstruction formed by a concrete slab in the channel and removal of excess riprap residing at the downstream end of the riprap that can be seen in the 2013 NAIP aerial imagery extending over 100 feet into the channel (**Figures 6-15 and 6-16**). Riparian vegetation could also be added to the recently placed riprap as a mitigation measure.

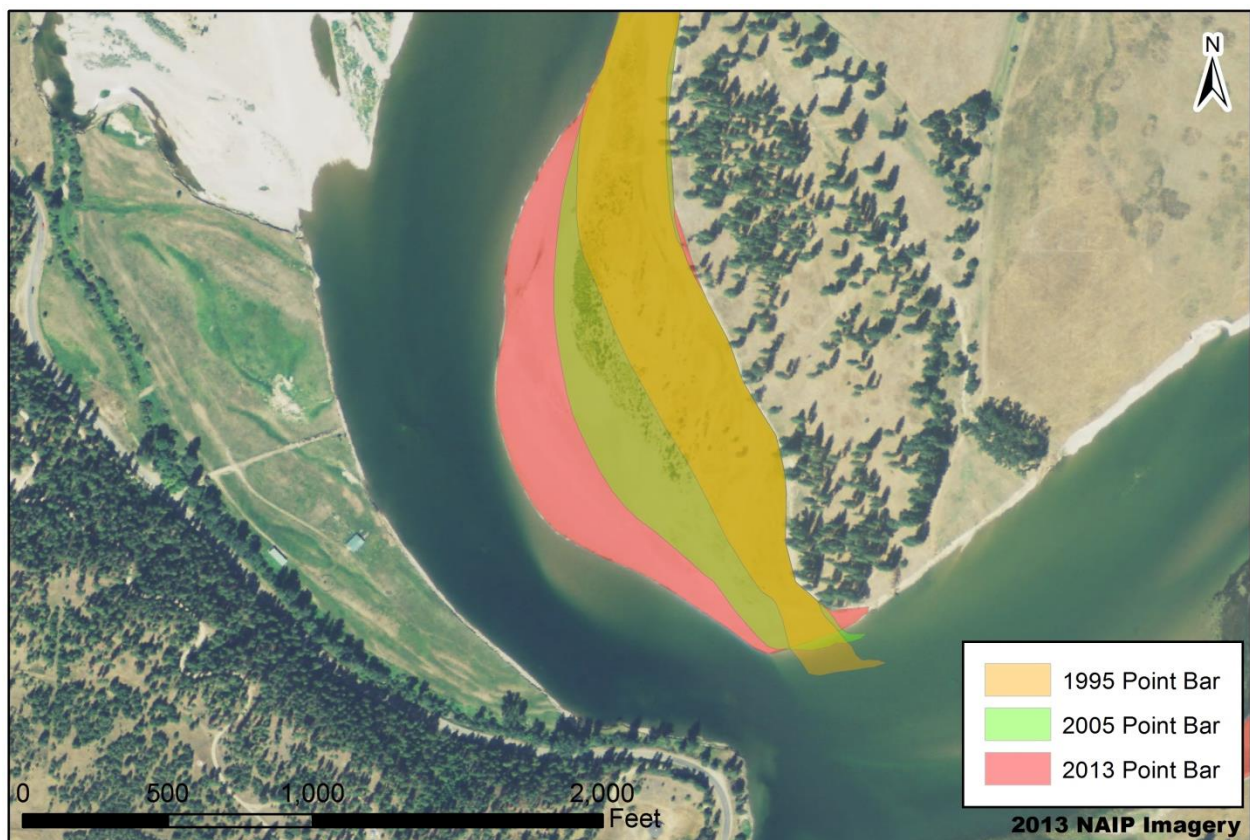
Figure 5-15. Sediment Deposition on Point Bar Downstream of Bank 5

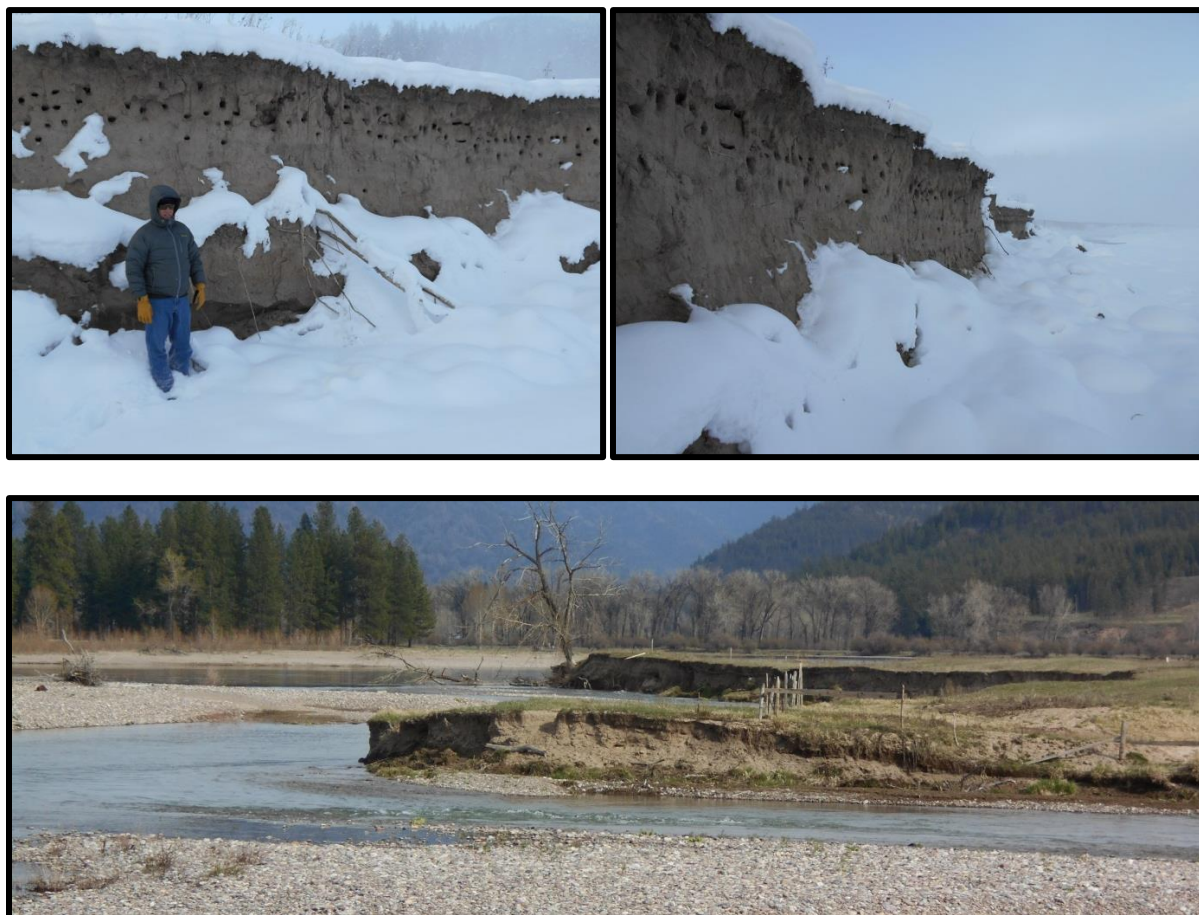
Bank 7 is 1,373 feet long and located on river left along the head of the west channel. Bank 7 is a vertical bank comprised of highly erosive fine grained material (**Figure 5-22**). A small pile of rocks placed on the floodplain that have fallen into the channel partially stabilize the downstream end of bank 6 and one cottonwood remains at a small point that separates the main channel along bank 6 from the west channel along bank 7. When combined, banks 6 and 7 total 3,762 feet. Between 1995 and 2013, bank 7 has eroded an average of 154 feet, with a mean annual retreat rate of 8.6 feet. In the 1995 aerial imagery, the west channel branches off the main channel further upstream and the majority of bank 7 is situated along a straight section of the west channel (**Figure 5-23**). The primary factors influencing erosion of bank 7 since 1995 are an extension of the processes influencing bank 6, including downstream channel migration and a lack of deep rooted riparian vegetation along the top of the bank. In addition, the accumulation of coarse grained material eroded from bank 6 at the head of the west channel has led to channel aggradation and over-widening, which has directed more of the flow toward bank 7 along the river left channel margin (**Figure 5-24**). Coarse grained material from the toe of bank 7 likely remains at the head of the west channel, while fine grained material eroded from bank 7 has been deposited throughout the west channel, with an increase in fine grained material observed at the downstream end of the west channel (Karen Thorson, personal communication, 3/26/14).

Figure 5-22. Bank 7

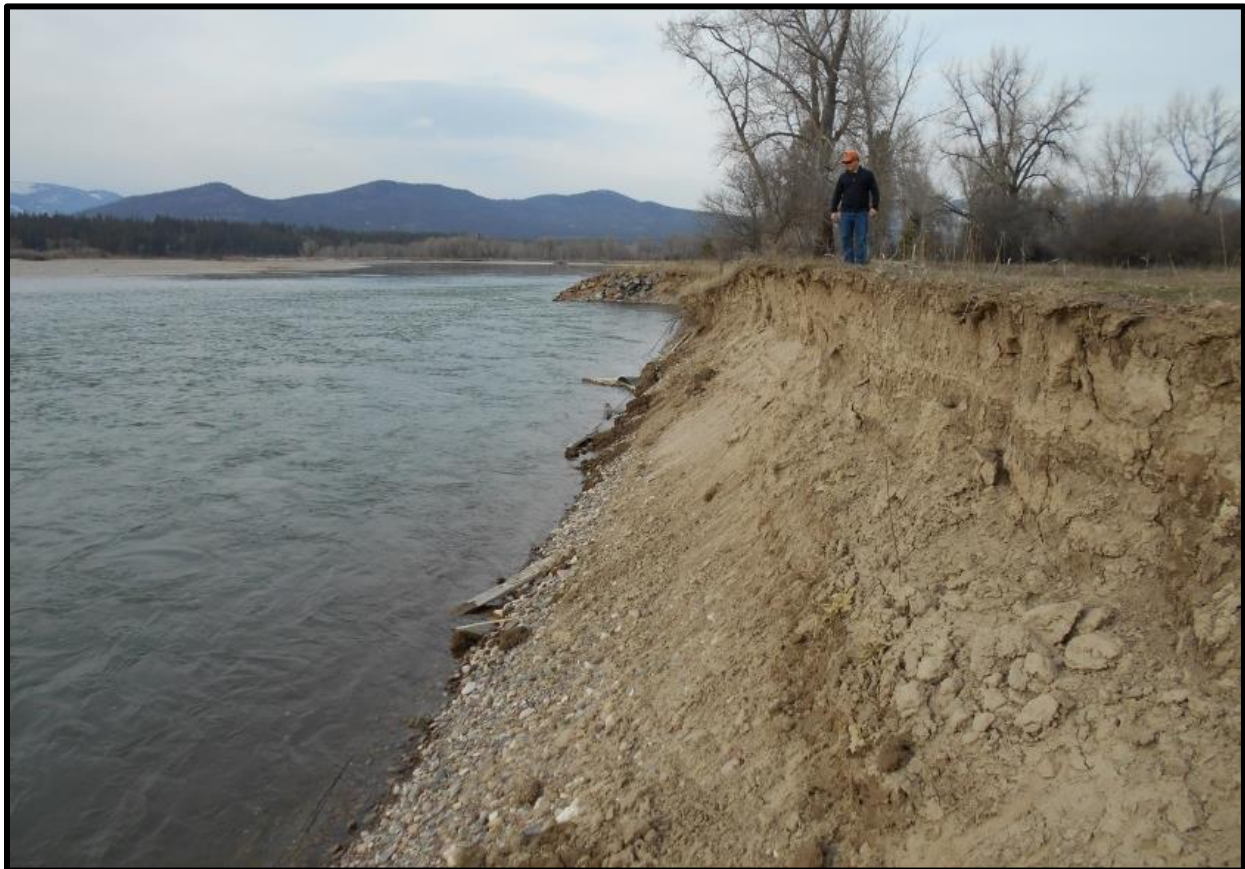
Bank 9 is 715 feet long and is located along river right upstream of the Town of Plains WWTP outfall. Bank 9 is separated from bank 10 by approximately 137 feet of rock riprap placed at the outfall of the WWTP prior to runoff in 2010. Bank 9 is comprised of fine grained material with gravel and cobble in the toe at the lower end (**Figure 5-27**). Wind transport of the fine grained material in bank 9 was observed during a site visit in March 2014. Gravel and cobble comprise a greater portion of the bank at the upper end where the bank merges with the downstream end of a point bar. This bank is slowly eroding into an area currently used for livestock grazing. Between 1995 and 2013, bank 9 has eroded an average of 22 feet, with a mean annual retreat rate of 1.2 feet. During a site visit in March 2014, fence posts formerly lining the top of the bank were observed along the toe of the bank. Since 2010, erosion has primarily occurred immediately upstream of the riprap, creating a scallop approximately 100 feet long that is prone to future erosion (**Figure 5-26**). The top of the bank in the 100 feet upstream of the riprap is also approximately three feet lower than the top of the bank immediately upstream. The primary factors influencing erosion of bank 9 are downstream channel migration, increased stream power due to reduced access to the west channel, the lack of deep rooted riparian vegetation along the top of the bank, and the hydrologic impacts induced by the placement of the rock riprap at the Town of Plains WWTP outfall. Material eroded from bank 9 is likely deposited on the next mid-channel bar downstream, which is rapidly expanding and directing additional stream power towards the lower portion of bank 10.

Figure 5-27. Bank 9 Looking Downstream toward Riprap at WWTP Outfall, March 2014

Floodplain revegetation is highly recommended at this site to help provide long term stabilization along bank 9 and the associated floodplain directly upstream of the Town of Plains WWTP. To help stabilize the floodplain surrounding the WWTP, the existing floodplain topography could be enhanced and floodplain vegetation could be re-established on 32 acres along bank 9 (**Figure 6-29 and 6-12**). In addition, understory shrubs could be planted in the area currently occupied by mature cottonwoods along the southern edge of the primary floodplain planting area (**Figure 6-14**).

Additional activities along bank 9 include upgrades to the culvert on the WWTP access road crossing an overflow channel that flows behind the WWTP when water overtops bank 5 (**Figure 6-30**).

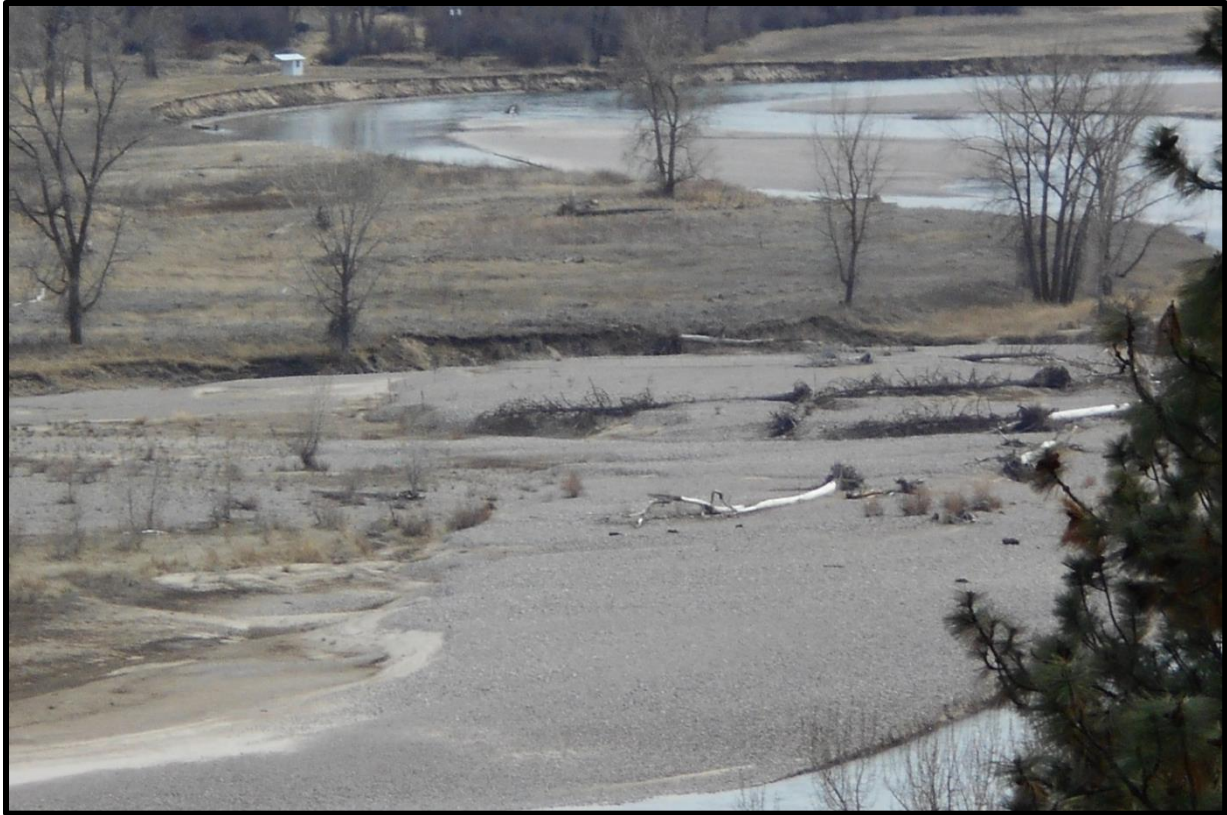
Figure 5-32. Bank 10 with Mid-channel Bar and Sediment Deposition at the Head of the East Channel

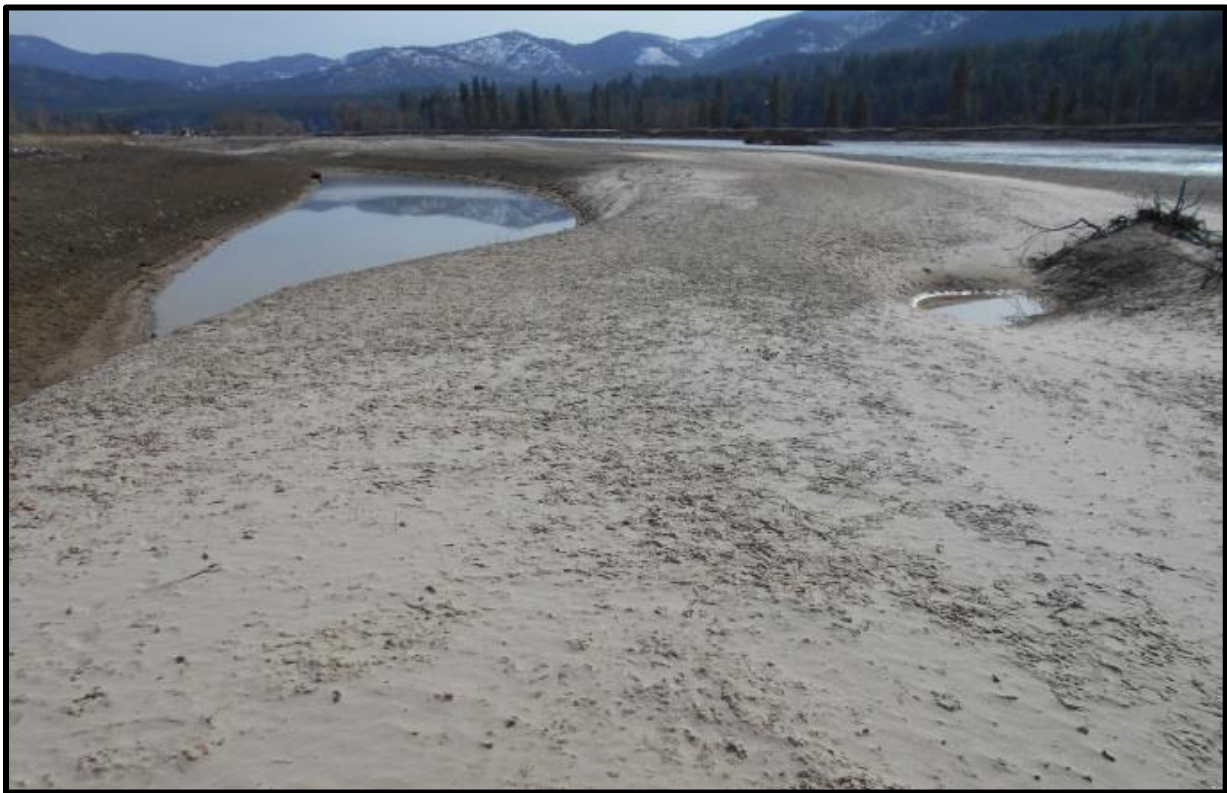
Figure 5-33. Sediment Deposition Downstream of Bank 10

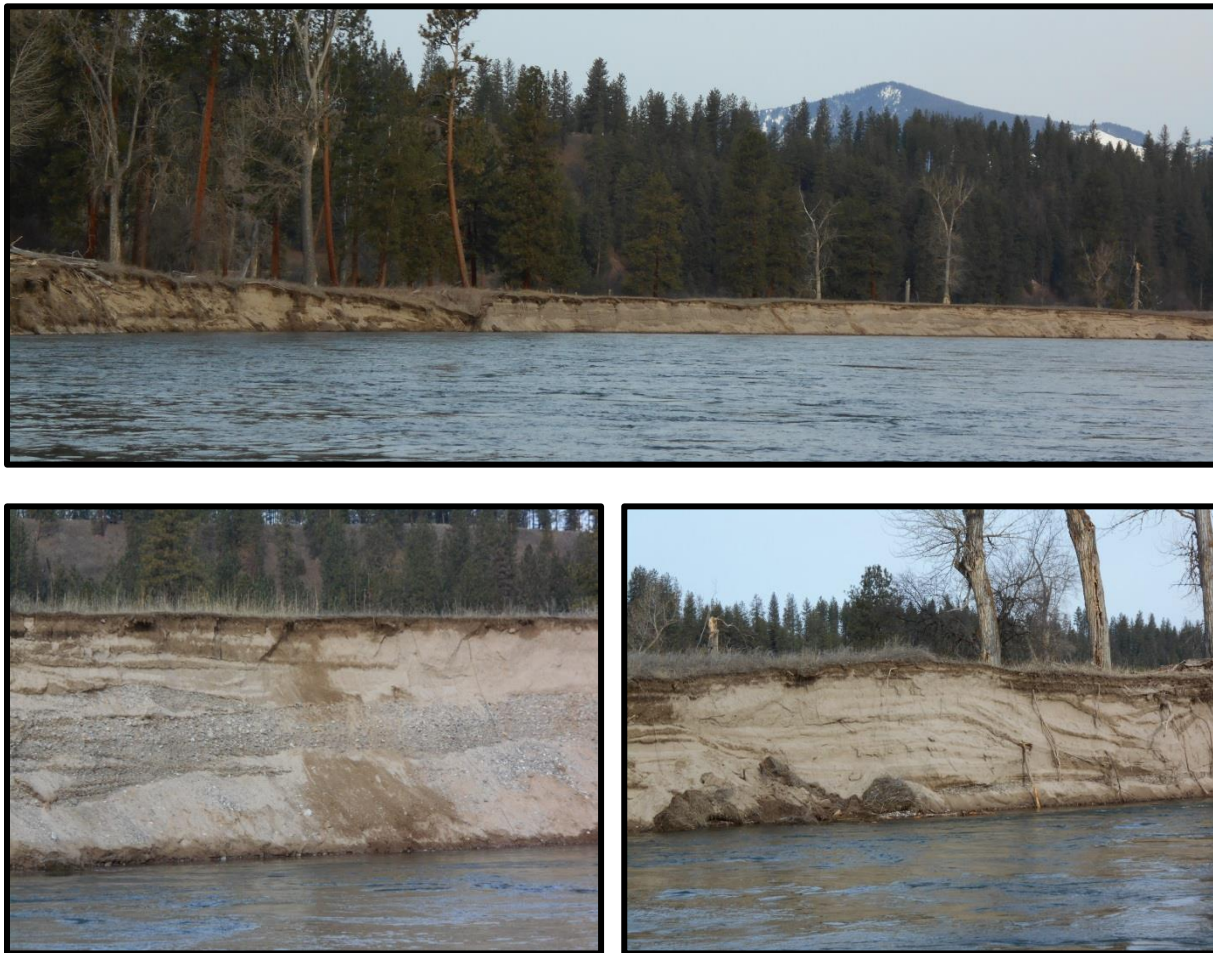
Bank 11 is 3,925 feet long and located at the downstream end of the island that separates the west channel from the main channel and is along the river left margin of the main channel across from Lawyer Nursery. Bank 11 is comprised primarily of fine grained material with periodic bands of gravel (**Figure 5-34**). Between 1995 and 2013, bank 11 has eroded an average of 196 feet, with a mean annual retreat rate of 10.9 feet (**Figure 5-35**). The primary factor influencing erosion of bank 11 is the large mid-channel bar that directs water towards the channel margin, along with reduced flows in the east channel due to the deposition of material eroded from bank 10, which influences the erosion along the lower end of bank 11. Decreased flows in the east channel are also indicated by more exposed gravel observed in the 1995 aerial imagery than in the 2013 aerial imagery (**Figure 5-35**). If the head of the east channel continues to aggrade and the current rate of erosion along bank 11 continues, the lower 1,500 feet of the island that separates the west channel from the main channel could become completely eroded away.

Figure 5-34. Bank 11, March 2014

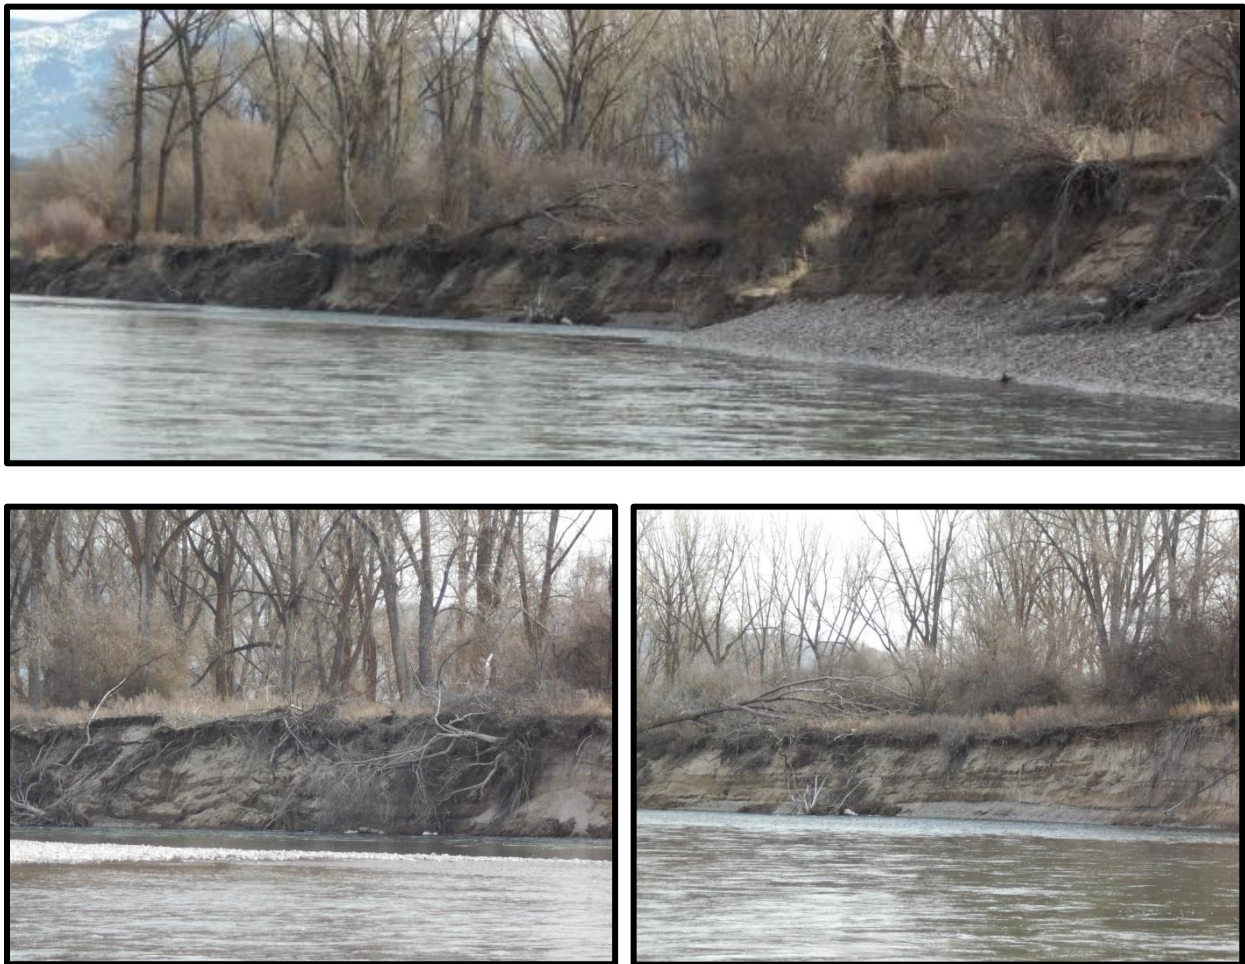
Bank 14 is 1,261 feet long and is located along the river right bank upstream of the confluence with Lynch Creek. Bank 14 is comprised of fine grained material with gravel in the toe that periodically extends higher into the bank (**Figure 5-38**). Between 1995 and 2013, bank 14 has eroded an average of 69 feet, with a mean annual retreat rate of 3.8 feet. This area contains undisturbed riparian vegetation and represents natural rates of streambank erosion expected in situations where there are mid-channel bars directing the flow towards the channel margins (**Figure 5-39**). However, decreased flows in the east channel, along with increased sediment deposition on the mid-channel bar from upstream bank erosion, may also influence erosion rates along this bank.

Figure 5-38. Bank 14, March 2014

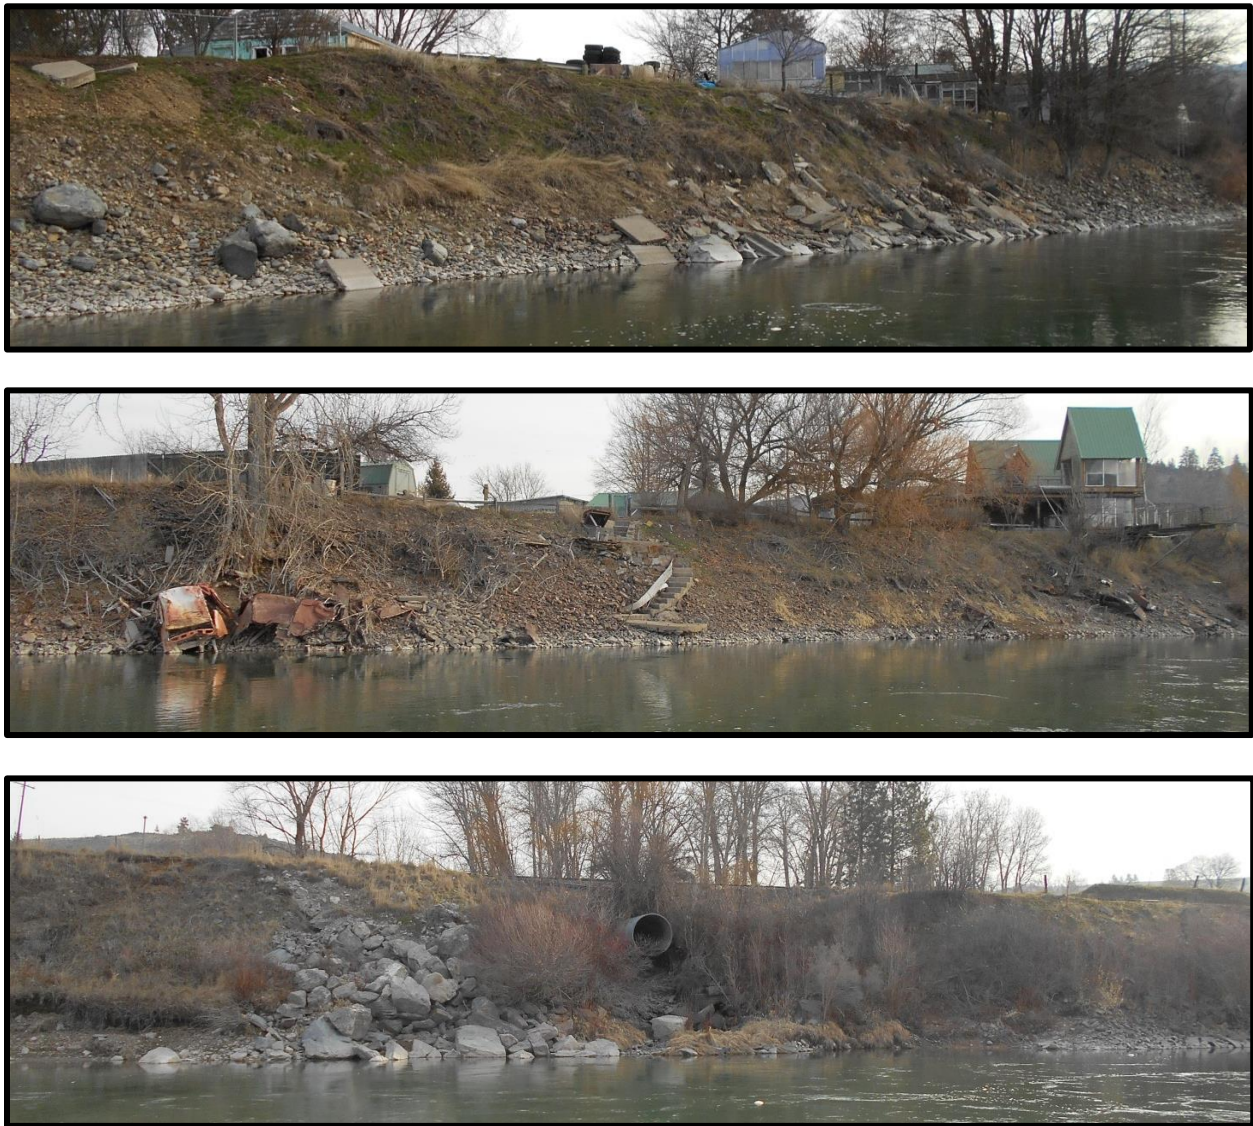
Over the past 100 years, various items have been used to stabilize the river right bank along the town of Plains upstream of the 5th Avenue South Bridge, including old cars, concrete blocks, wooden poles, sheet metal, and native rock material, many of which date back to the time when the lumber mill was in operation (**Figure 6-8**). While some of this material provides important stabilization to the streambank, places where unnecessary material exists could be identified and the items removed. Without some level of streambank protection, much of the bank along town would likely resemble bank 3 (**Figure 6-9**).

Figure 6-8. Various Bank Stabilization Treatments Found along the Town of Plains

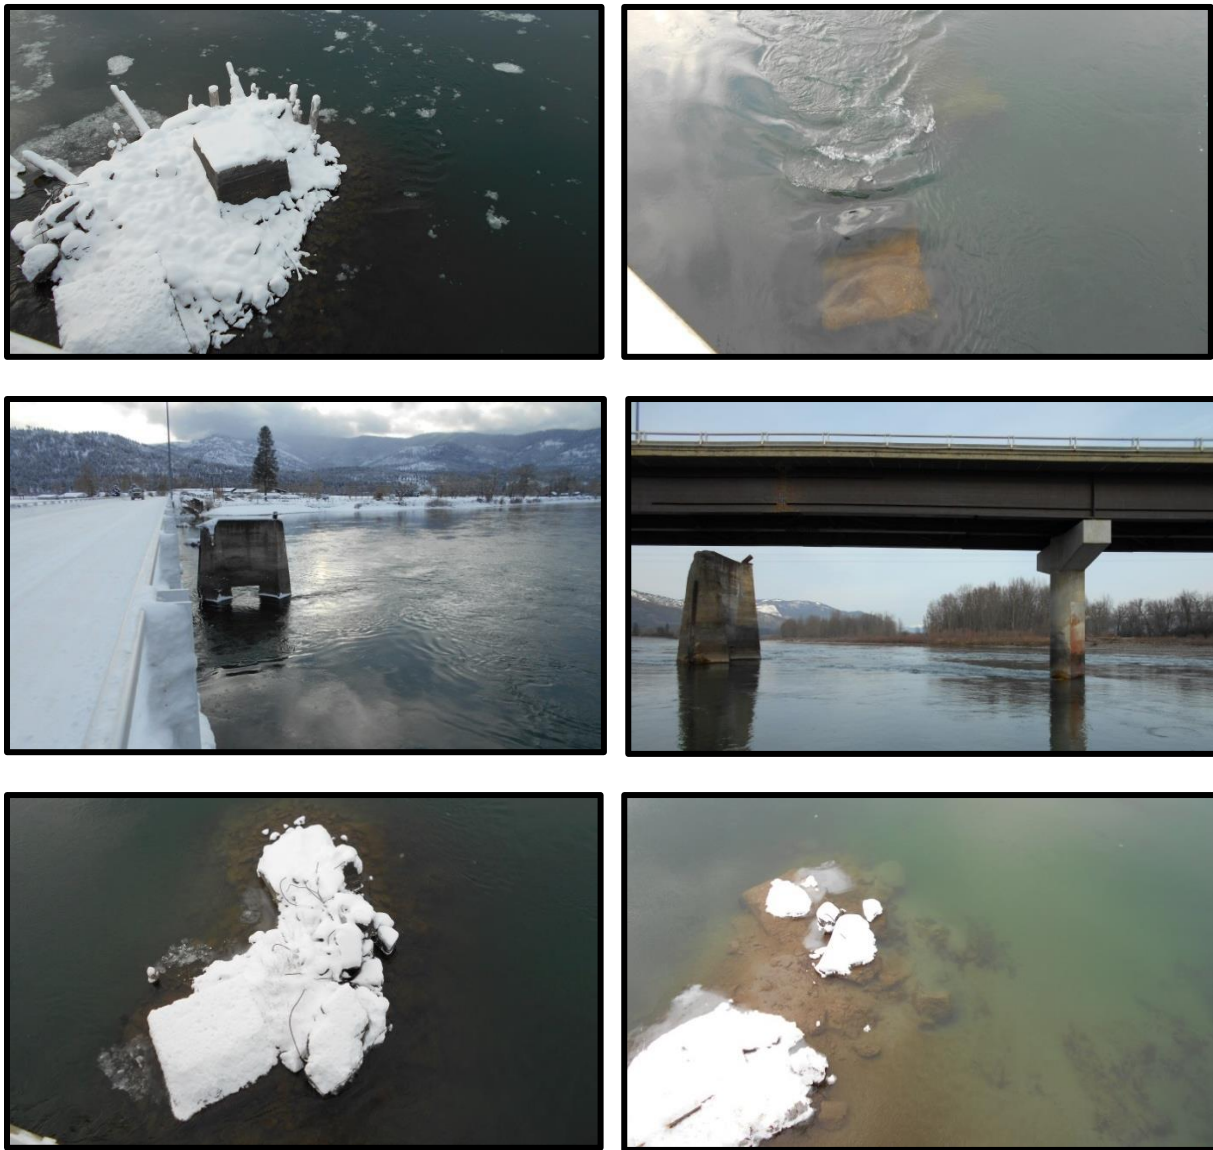
A total of five pylons remain in the channel from the original bridge, with three foundations, one toppled pylon/foundation, and one fully intact and upright pylon (**Figure 6-10**). The bridge constricts the river by at least 17% at bankfull flows, which leads to an increase in stream power as water passes under the bridge. Removal of the historic bridge pylons is recommended to reduce the amount of constriction at the bridge and decrease the turbulence created as the river flows under the bridge.

Figure 6-10. Historic 5th Avenue South Bridge Pylons

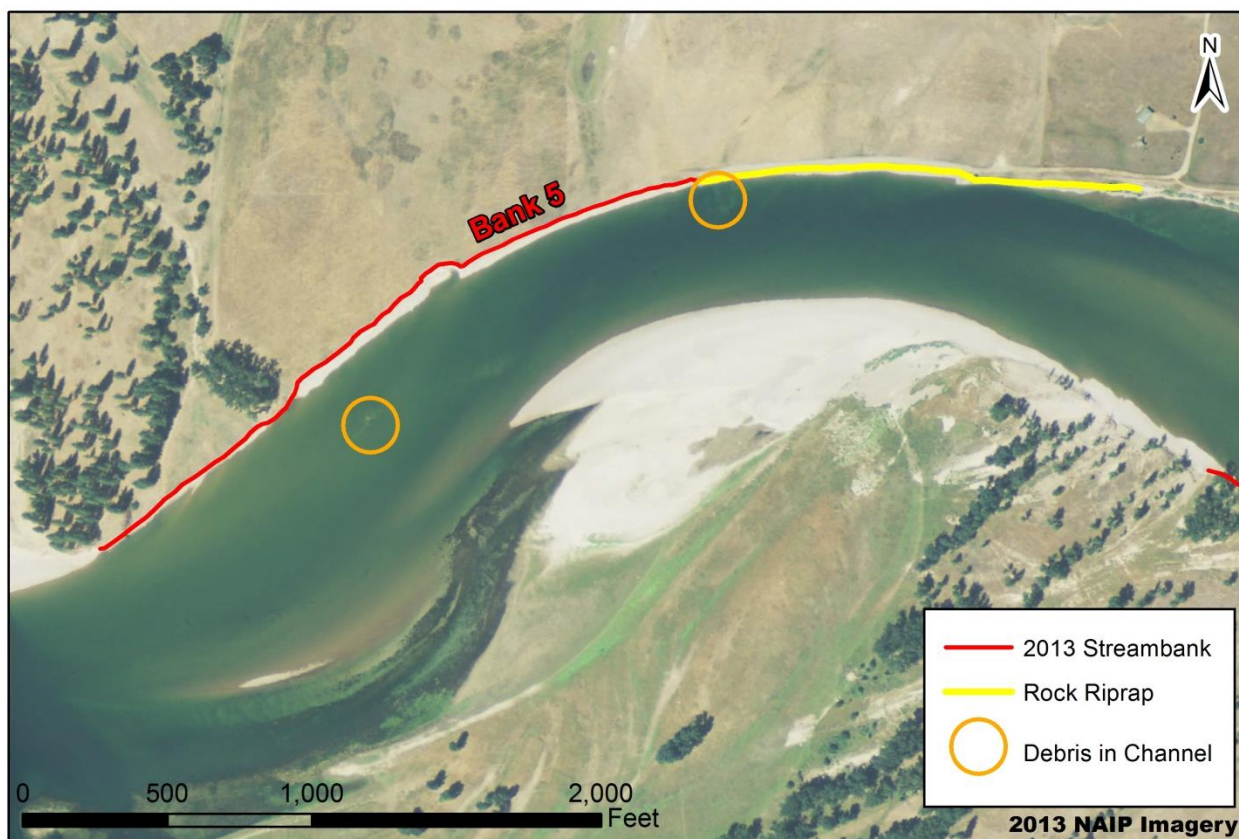
Figure 6-16. Concrete and Rock Riprap Debris in Channel along Bank 5

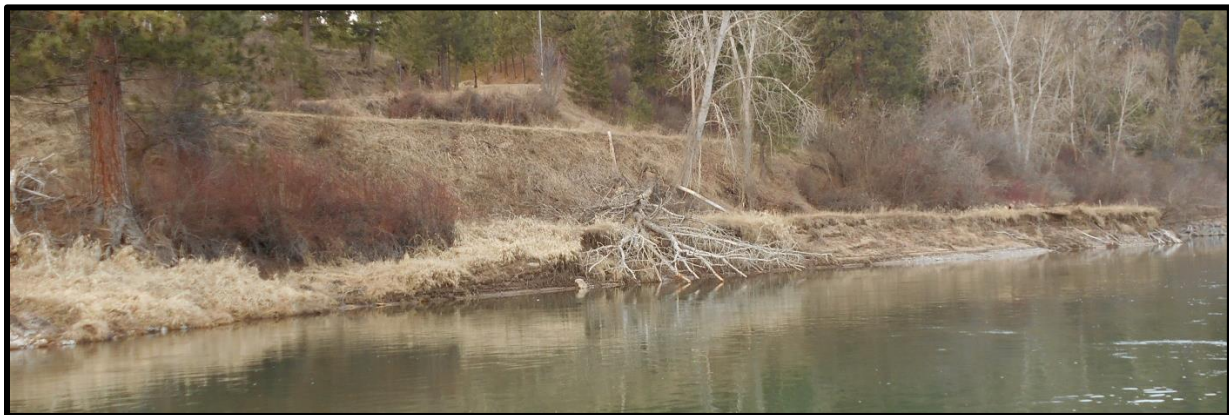
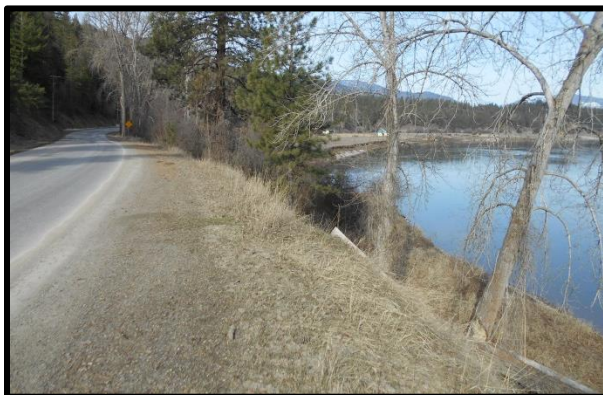
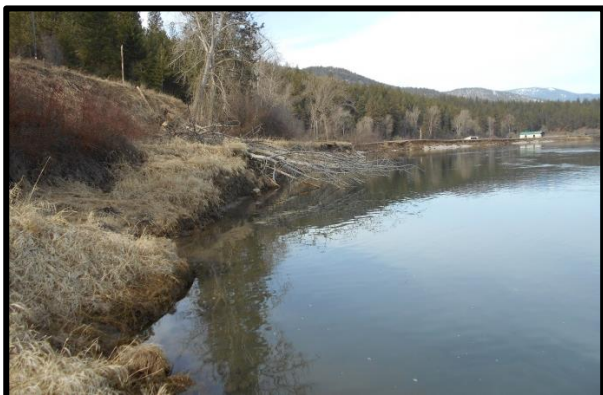
While a small floodplain bench currently remains at the toe of the fillslope, additional erosion in upcoming years may necessitate stabilization along River Road West. Since the channel is relatively deep here along the outside of a developing meander bend and has a high amount of stream power, stabilization of River Road West will likely require the use of rock riprap. Additional erosion along Bank 6 will likely expose an even greater length of the road to erosion potential in the future. Assuming the bank retreat rates observed over the past 18 years continue, it is estimated that 400 additional feet of River Road West will become adjacent to the main channel within the next 20 years. In addition, an overflow channel runs along the base of the road. If flows increase in this channel, a longer portion of the road's fillslope may quickly become exposed to scour during high flow events. The small floodplain bench at the toe of the road's fillslope currently provides an opportunity to perform stabilization before the channel erodes additional material and exposes the toe of the fillslope to erosion.

Figure 6-20. River Road West downstream of the Bedrock Outcrop at Big Eddy

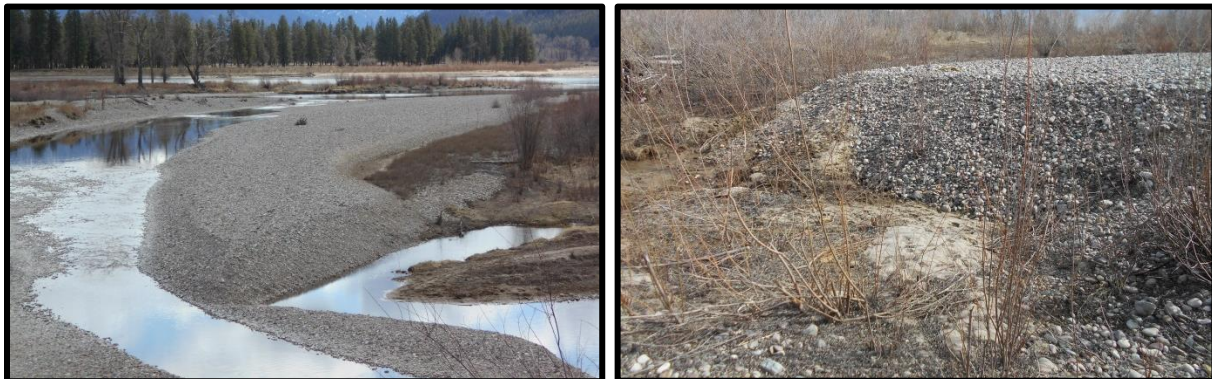
Figure 6-22. Sediment Deposition at the Head of the West Channel

Removal of sediment from the head of the west channel could enhance flows within the west channel during lower flows, while also alleviating stream power along bank 9 and bank 10 during high flow events. However, while bank 6 and bank 7 remain sources of sediment, any sediment removed from the head of the west channel will likely be replaced by sediment eroded from these banks. Alternatively, continued erosion along bank 6 and downstream channel migration may allow the river to naturally flush sediment out of the head of the west channel, potentially sending more water down the west channel. In addition, the point of the island that separates the west channel from the main channel has eroded and retreated downstream, reducing its ability to deflect flows into the west channel. The river has also become much wider at the head of the west channel, leading to decreased stream power and sediment transport capacity. The addition of woody debris to the point of the island through the construction of an engineered log jam could help stabilize the point of the island and direct additional flow towards the west channel. Engineered log jams mimic natural large woody debris accumulations often found at the heads of islands and are observed within the Plains Reach (**Figure 6-23**).

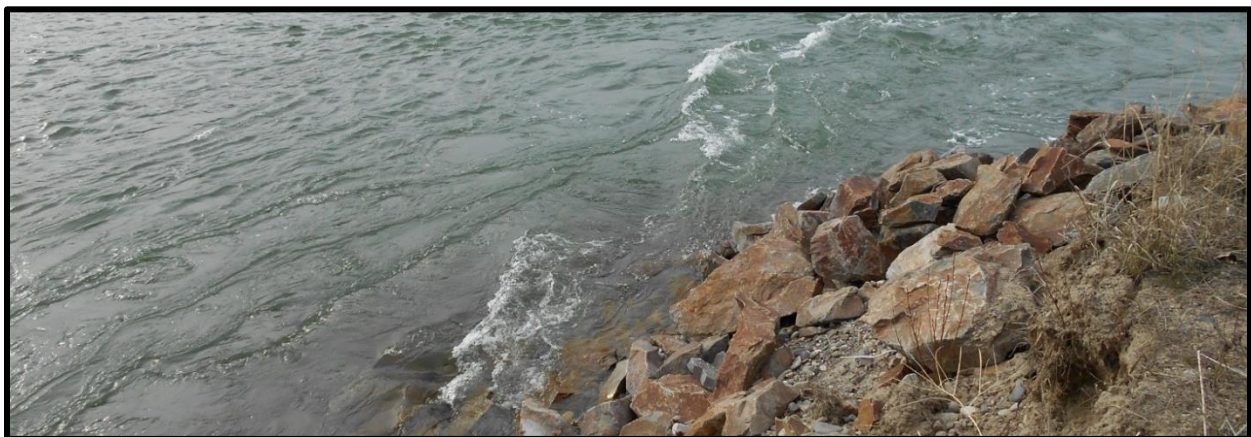
Figure 6-25. Turbulence along the WWTP Riprap (13,500 cfs)

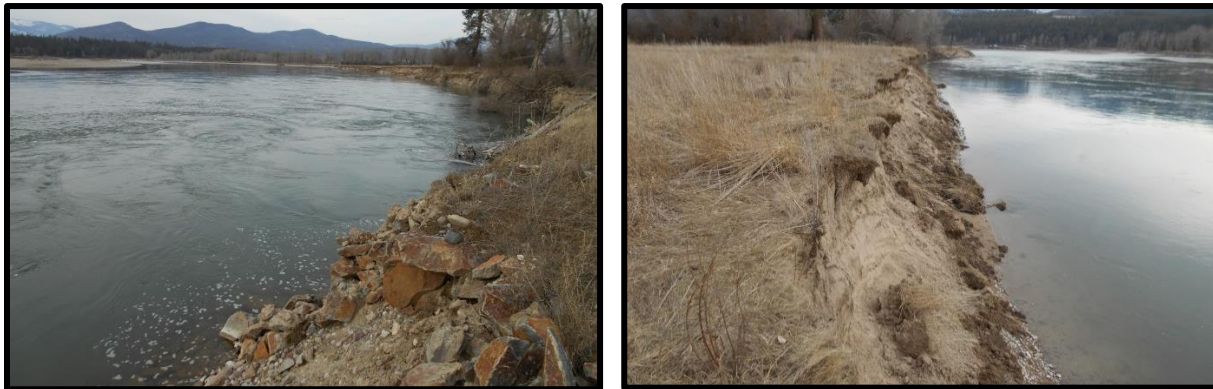
Bank 10 exhibits two distinct characteristics progressing from upstream to downstream, with a vertical bank at the upstream end transitioning to a lower angled bank at the downstream end. The upper portion of bank 10 is located downstream of the riprap at the Town of Plains WWTP outfall where the thalweg is along the channel margin (**Figure 6-31**). Stabilization at the upstream end may require extending the rock riprap downstream of the existing riprap at the WWTP outfall downstream. In April of 2014, a large eddy was observed off the downstream of the rock riprap and was recirculating from approximately 300 feet downstream at a flow of approximately 31,000 cfs. Recirculating water in this large eddy is leading to accelerated bank erosion at the head of an overflow channel. At the tail end of this eddy, plumes of sediment were observed washing from the streambank, which contained a high amount of sandy material (**Figure 6-32**). As the channel becomes shallower along bank 10 in the vicinity of the mid-channel bar and the bank height decreases, bioengineering techniques may be appropriate. However, flow deflection from the mid-channel bar may increase the relative stream power along this portion of the bank and partial dredging to remove sediment from this mid-channel bar may help reduce stream power along bank 10. Also, the influence of mill waste material within the bank at the downstream end should be considered when developing a restoration strategy for bank 10. A potential option would be to remove a portion of the area with the mill waste, thereby opening up additional flow

Figure 6-31. Bank Erosion at the Upstream End of Bank 10 Downstream of Riprap at WWTP Outfall

Establishment of riparian vegetation on the floodplain downstream of the Town of Plains WWTP and within the historic side channel along Lawyer Nursery is recommended to slow the rate of lateral channel migration and to help protect this area which was identified as a potential avulsion risk during the Channel Migration Zone analysis due to the presence of overflow channels across the floodplain (**Figures 6-33 and 6-34**). The floodplain area downstream of the Town of Plains WWTP resembles floodplain areas used for grazing along banks 5, 6, and 9, while the overflow channel along Lawyer Nursery is vegetated with native and introduced grass species (**Figures 6-35 and 6-36**). Signs of beaver activity were observed on the cottonwood trees along the channel margin at this site and protection from beaver would help maintain the existing vegetation.

Additional activities along bank 10 include upgrades to four identified culverts on roads crossing the overflow channel that starts downstream of the WWTP and outlets into the east channel, along with re-location of an irrigation pump and ground water well that is approximately 65 feet from the edge of bank 10 (**Figure 6-37**). Culverts on abandoned access roads could be removed, while culverts on roads that continue to be used could be replaced (**Figure 6-38 and 6-39**). In addition, a power pole located along bank 10 is precipitously close to the bank near the existing pump house.

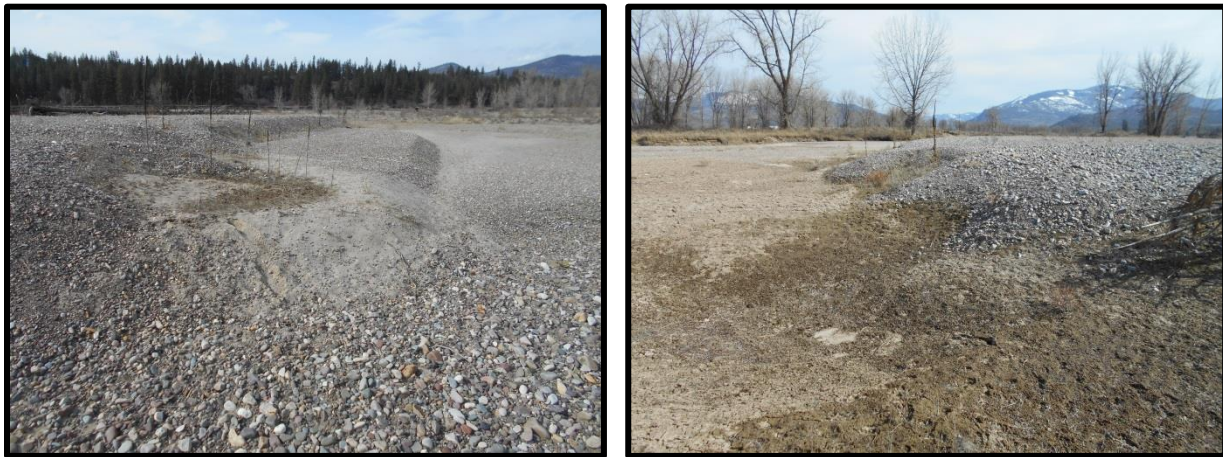
Figure 6-40. Sediment Deposition at the Head of the East Channel

Removal of sediment from the head of the east channel could enhance flows within the east channel during lower flows, while also alleviating stream power along bank 11 during high flow events. However, while bank 10 remains a source of sediment, any sediment removed from the head of the east channel will likely be replaced by sediment eroded bank 10. While not as extensive as the sediment deposition in the west channel, sediment deposition at the head of the east channel and decreased stream flows during high water directs additional flow towards bank 11, which is on the island that separates the west channel from the main channel. The estimated 20 year erosion zone for bank 11 indicates that the lower 1,500 feet of the island may become completely washed away if bank erosion continues at the rate of erosion observed over the past 18 years (**Figures 6-41** and **5-35**).
