PLSS Corner Collection System Data Sheet

Meridian: <u>PMM</u> Tier: <u>5N</u> Range: <u>5E</u> Section(s): <u>31</u> County: <u>Gallatin</u>

GCDB Point ID: MT200050N0050E0 100100

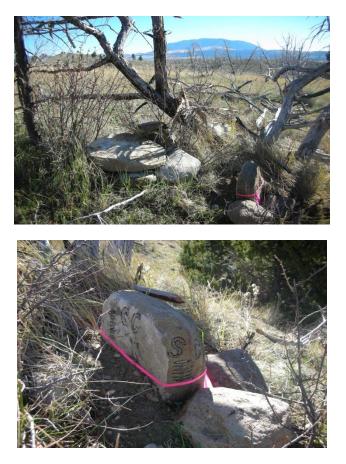
Found: Original sandstone, 17x14x6, lying flat. Monument appears in original position and fell west. Therefore I reset in place with 'CC' on east face with 6 grooves, 'SC' on north face with 6 notches and 6 notches in south edge. Found scattered mound of stone along east side of monument (as called for in notes). Monument is situated at intersection of a dilapidated fence extending north and a dilapidated fence extending east. I re-raised a mound of stone east of corner.
