January 2021

FINAL

Bighorn River Channel Migration Zone Mapping

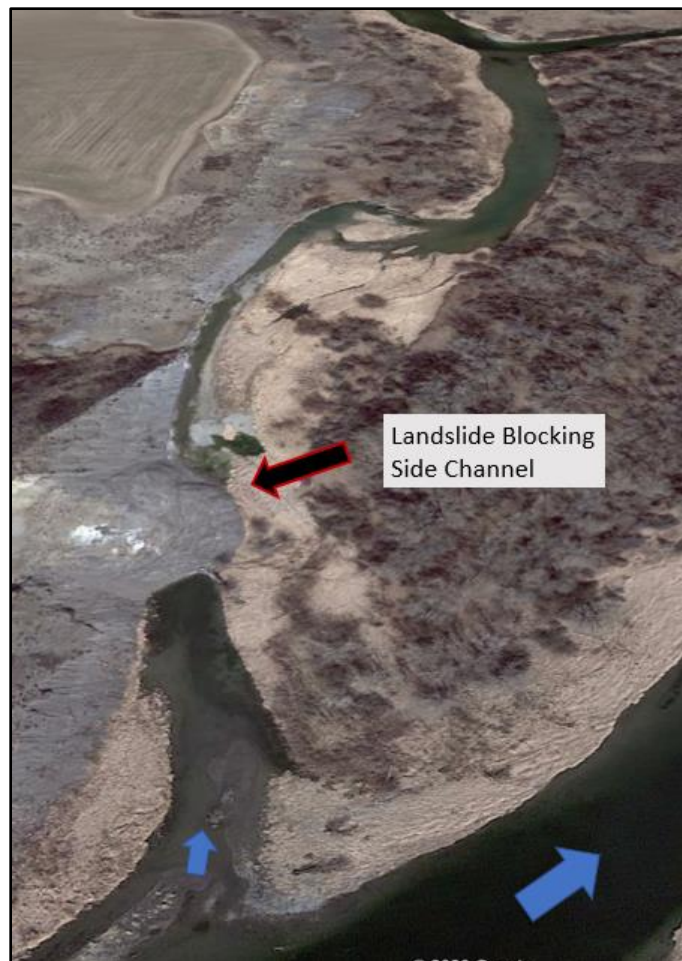
Figure 9. Google Earth (2016) image showing side channel blocked by landslide at RM 56.7.

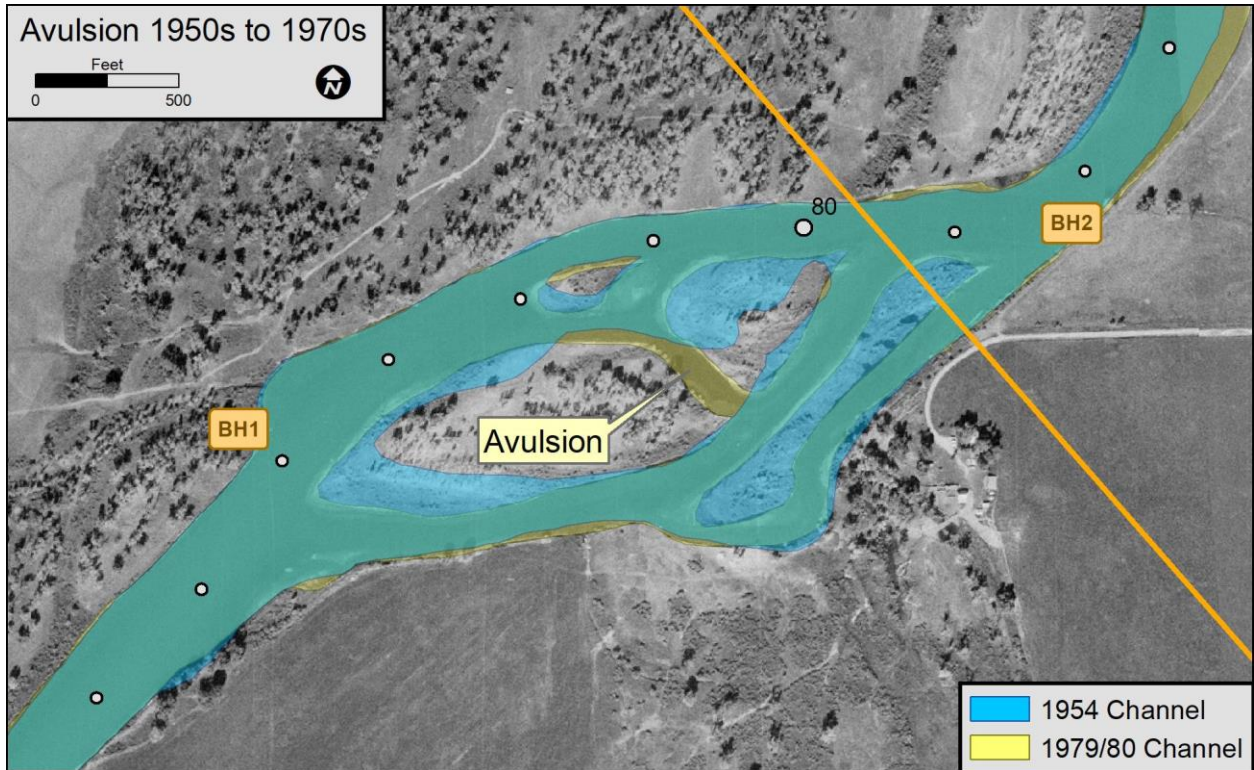
Figure 42. Avulsion upstream of Three mile access.

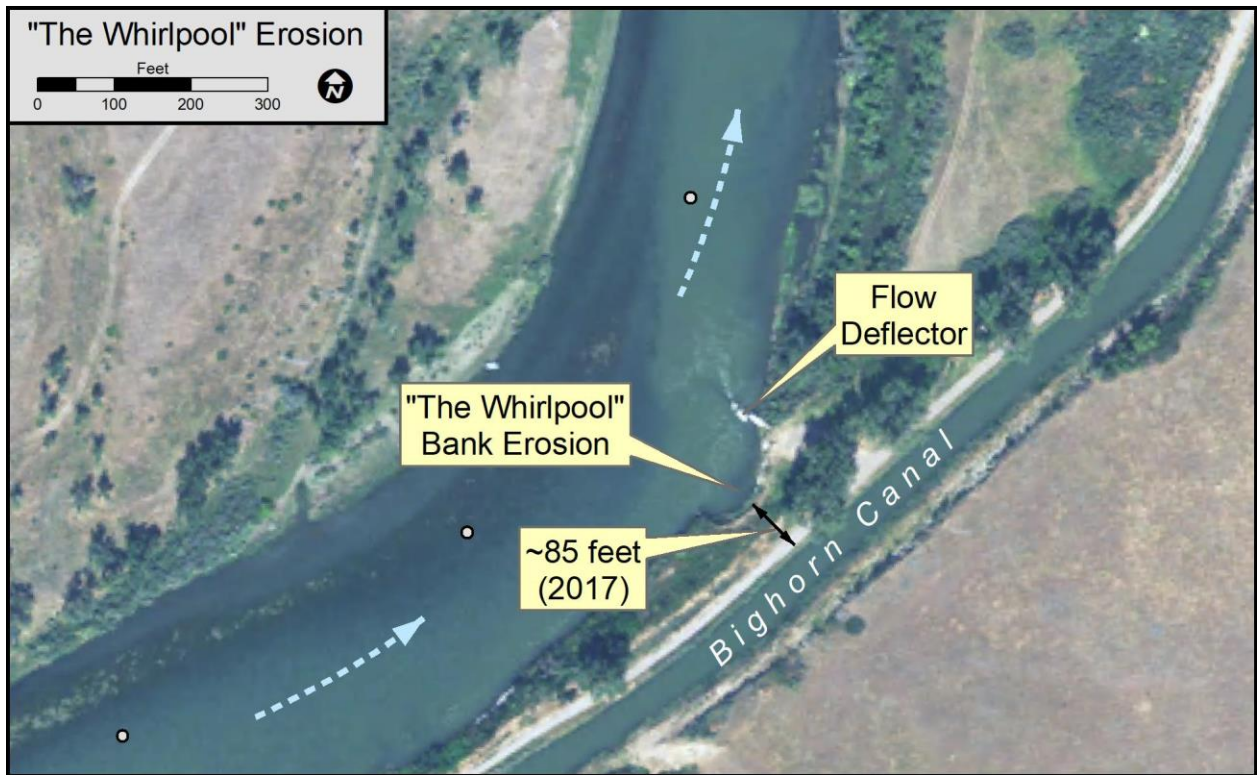
Figure 43. 2017 air photo showing scour upstream of flow deflector; back eddy has eroded the bank towards Bighorn Canal.

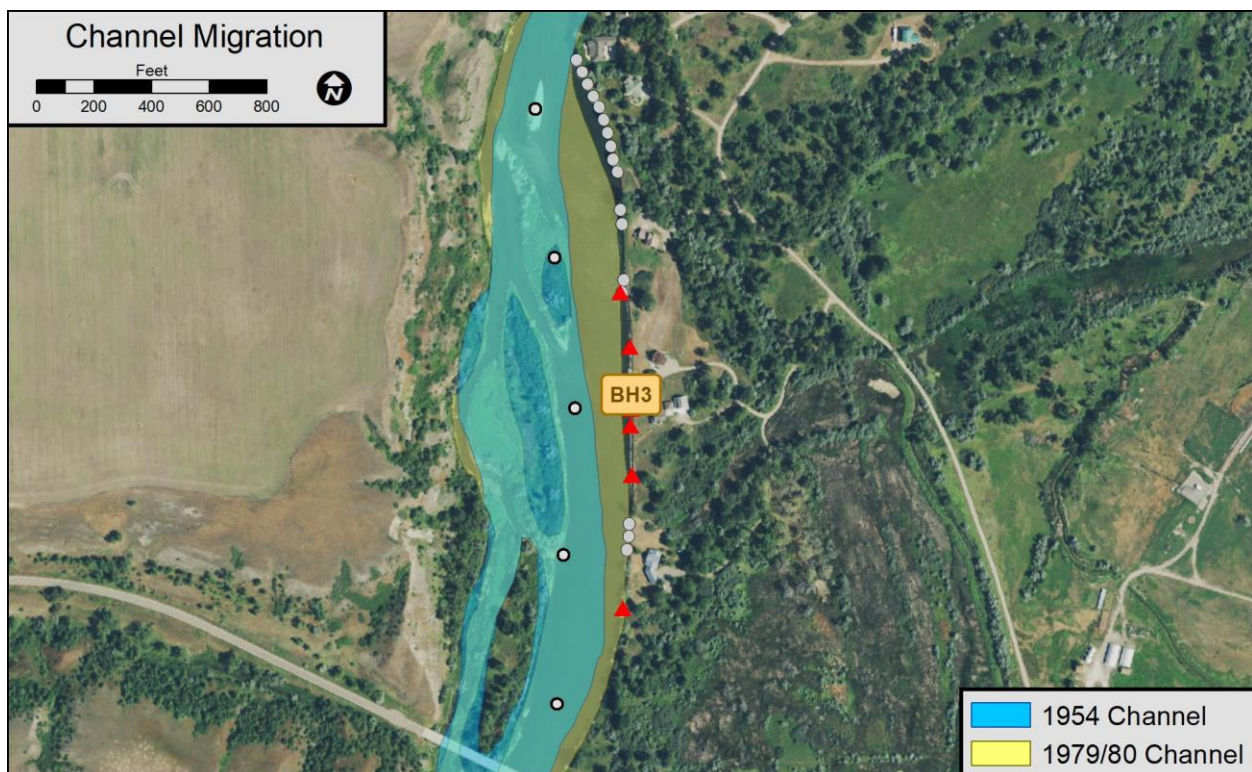
Figure 53. Right bank erosion threatening homes below St. Xavier Bridge.

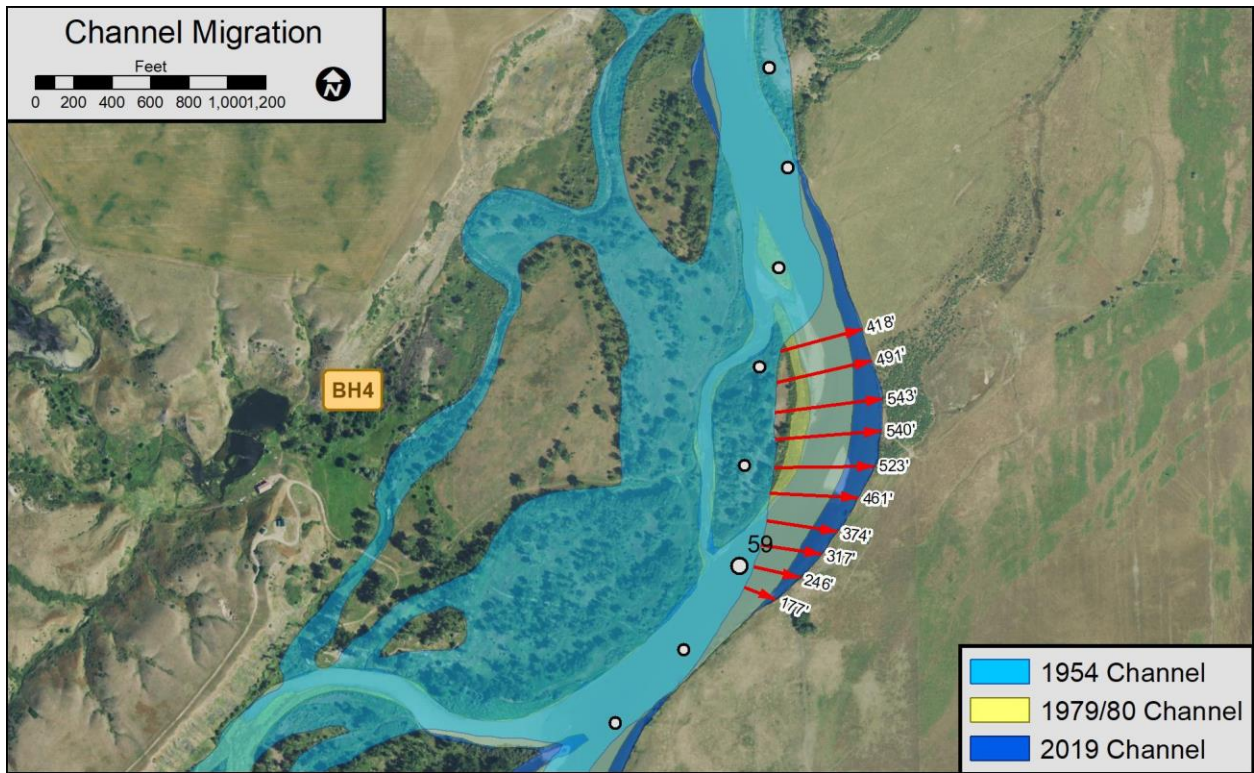
Figure 57. Right bank meander migration into unvegetated bankline, RM 58.9.

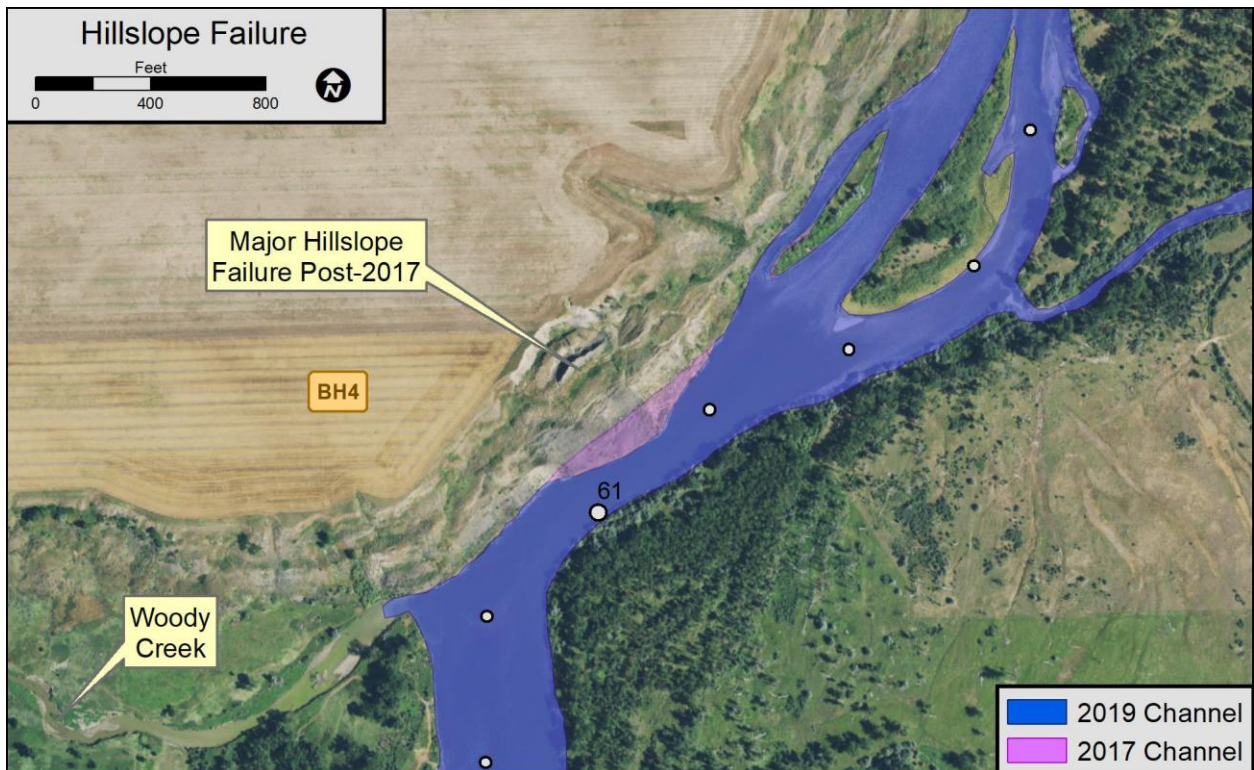
Figure 58. Recent landslide just below Woody Creek RM 61.

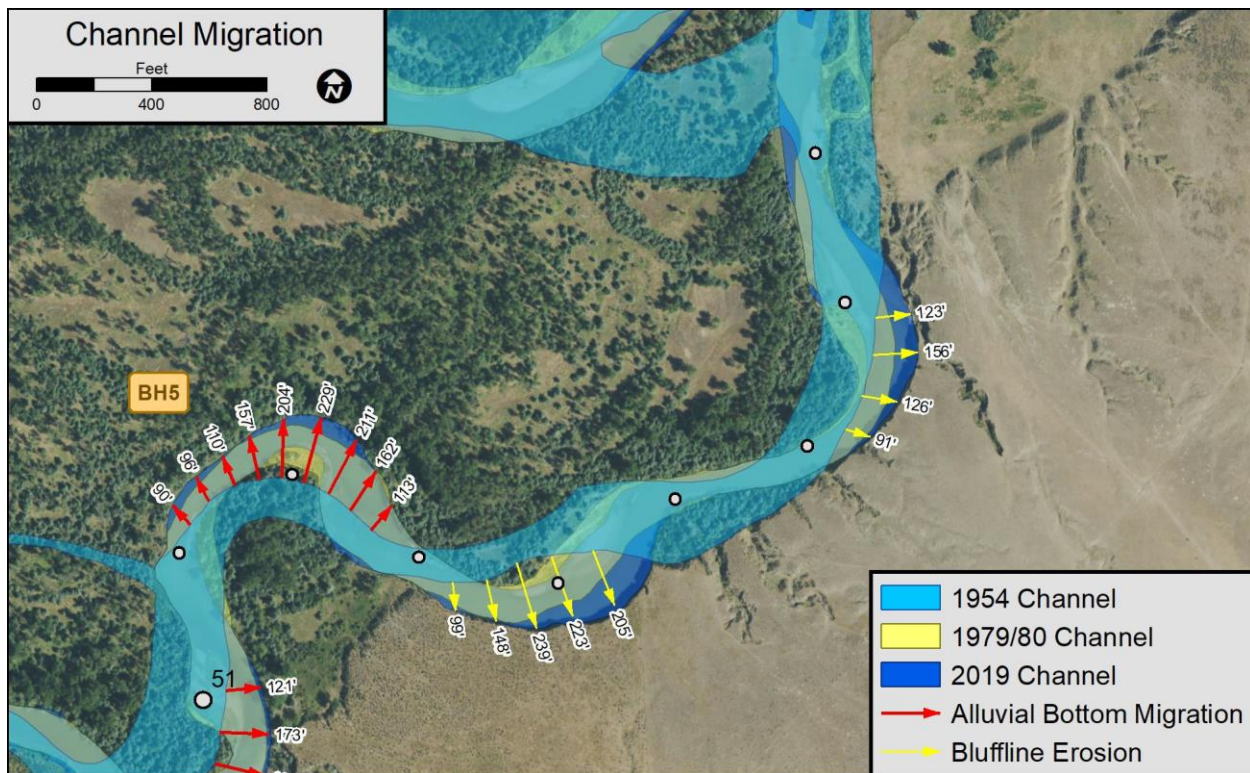
Figure 59. Terrace erosion at RM 50.6.

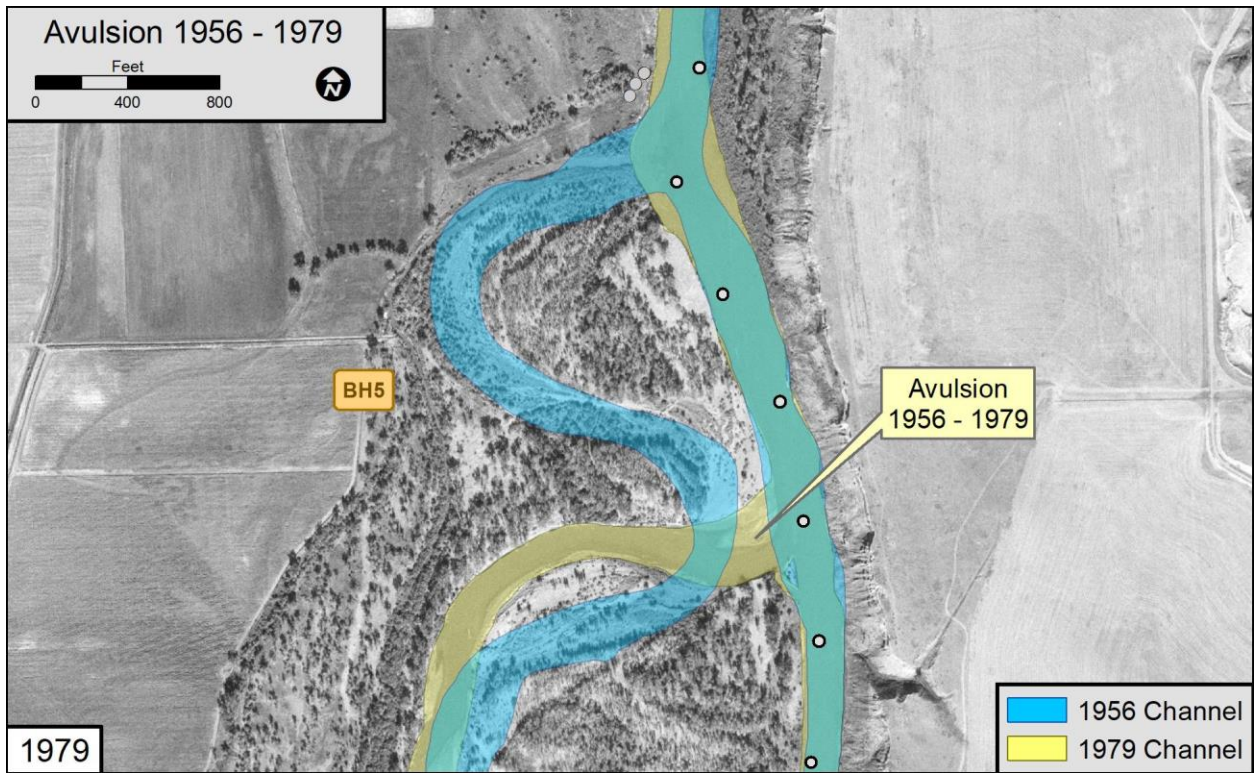
Figure 61. Avulsion at RM 43.5 that abandoned almost 3,000 feet of channel.

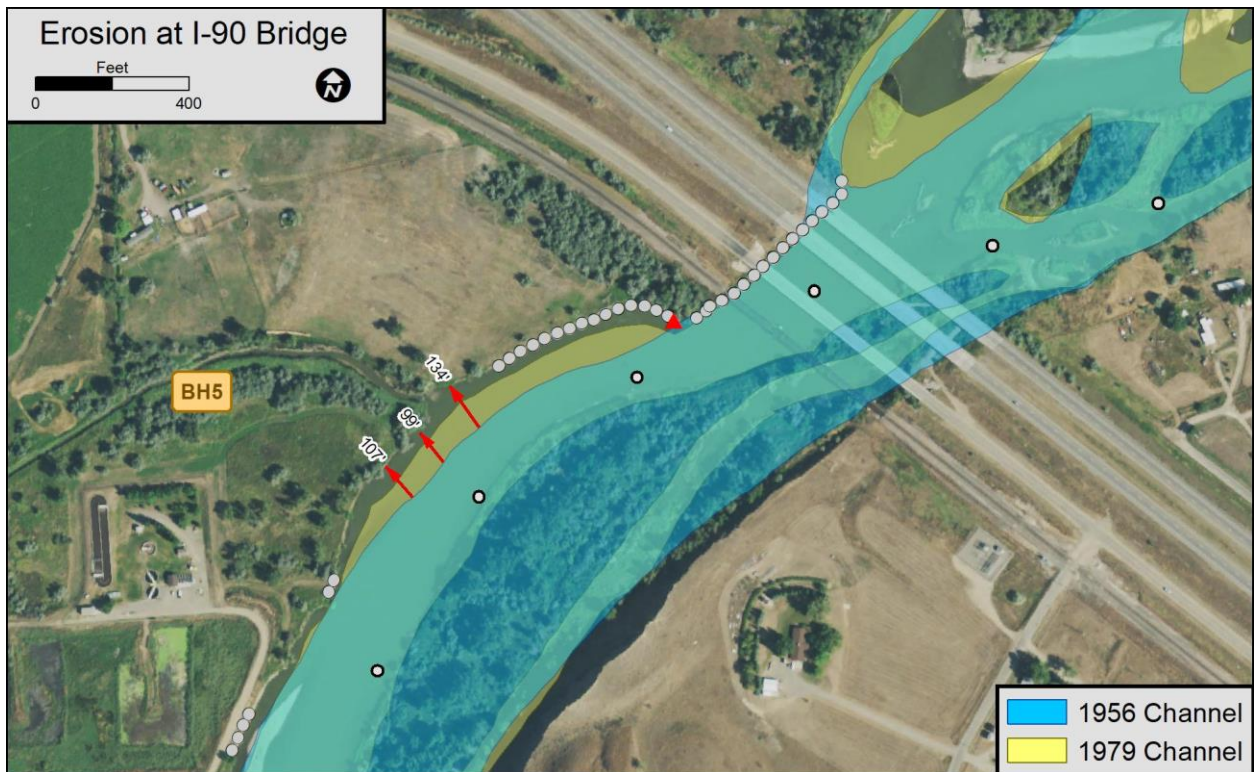
Figure 62. Left bank erosion above interstate bridge that appears to be flanking bank armor.

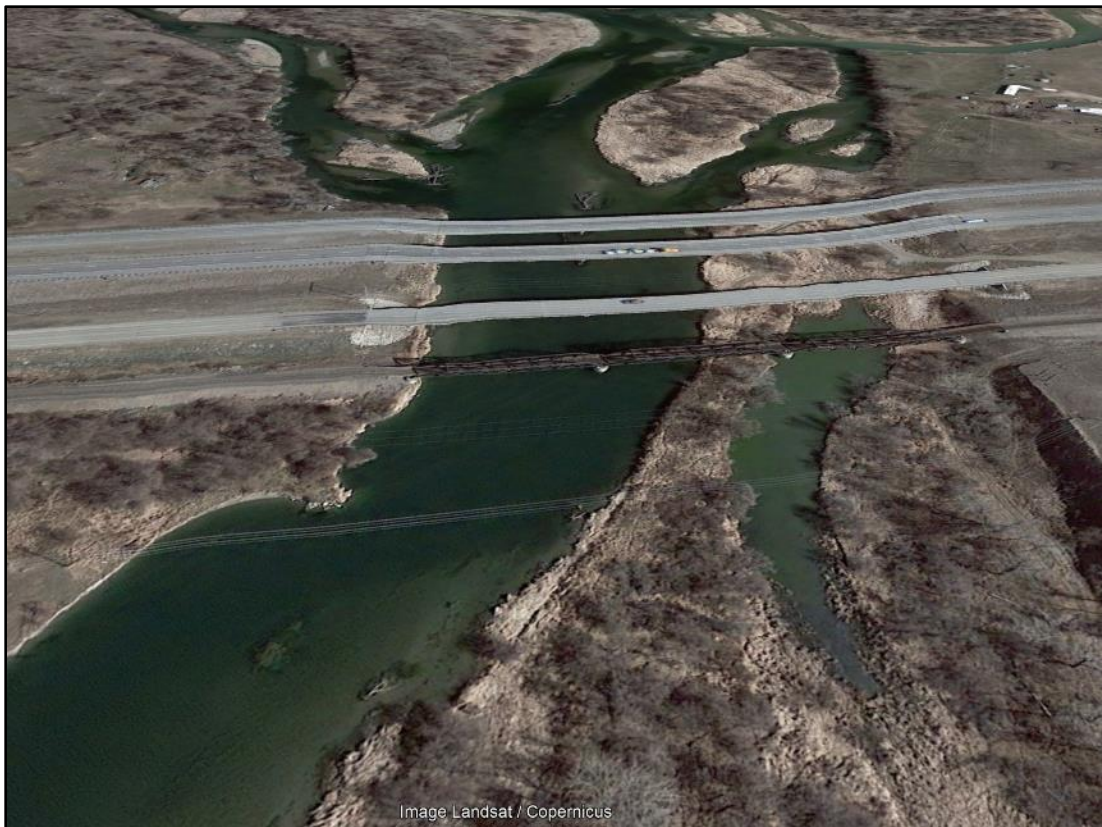
Figure 63. Google Earth image showing flanking of left bank armor above Interstate Bridge.

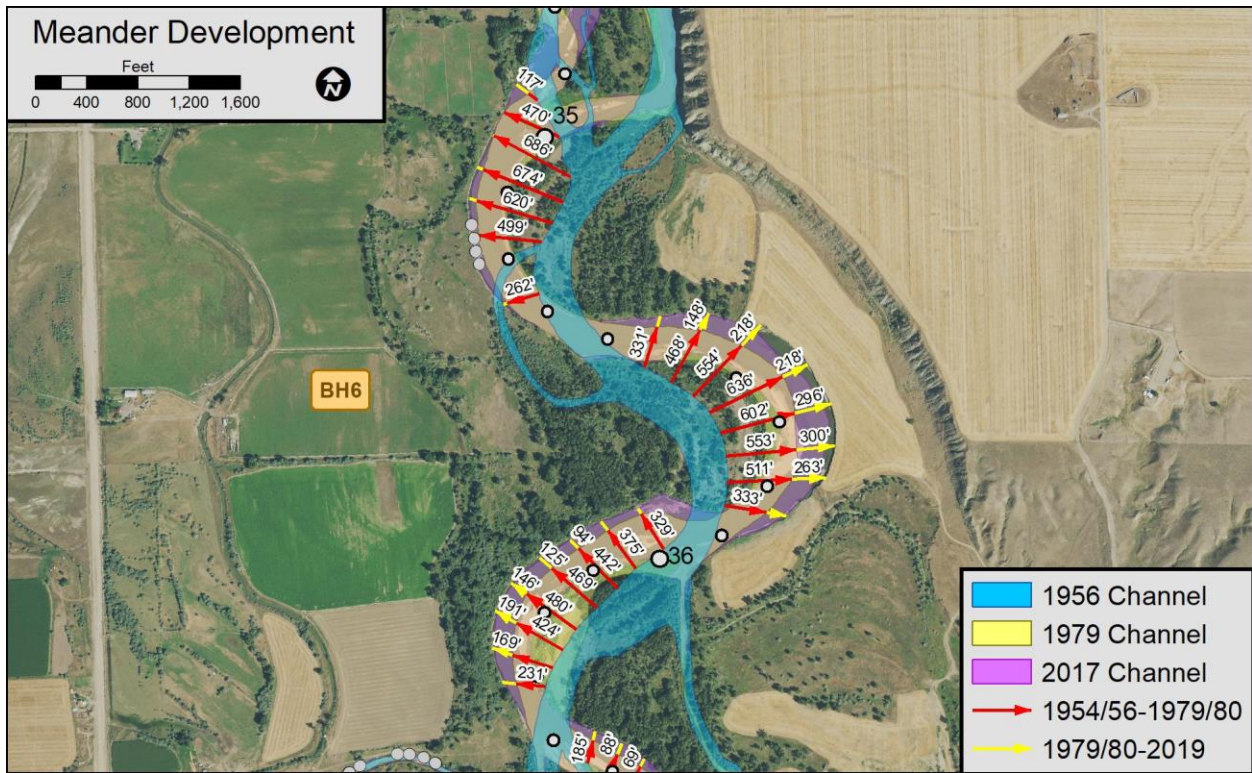
Figure 65. Large meander migration across floodplain causing field erosion, RM 35.7.

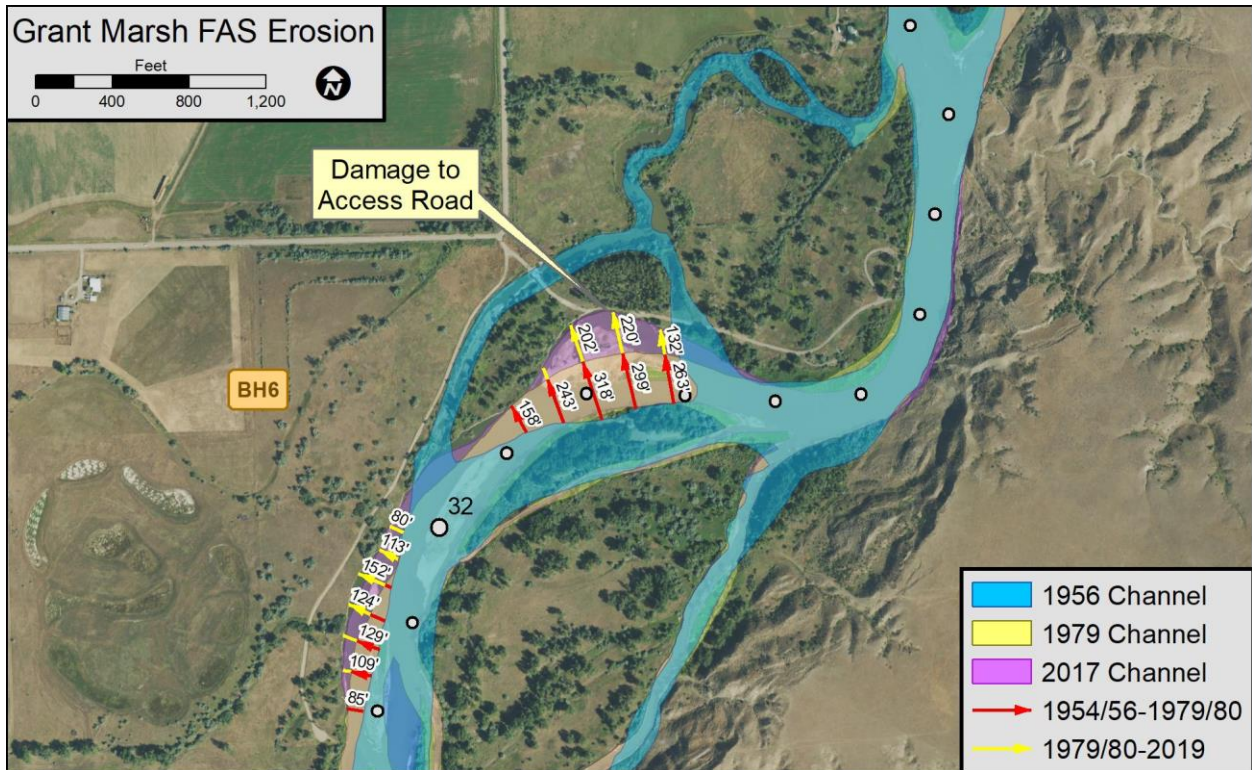
Figure 66. Northward channel migration into Grand Marsh FAS.

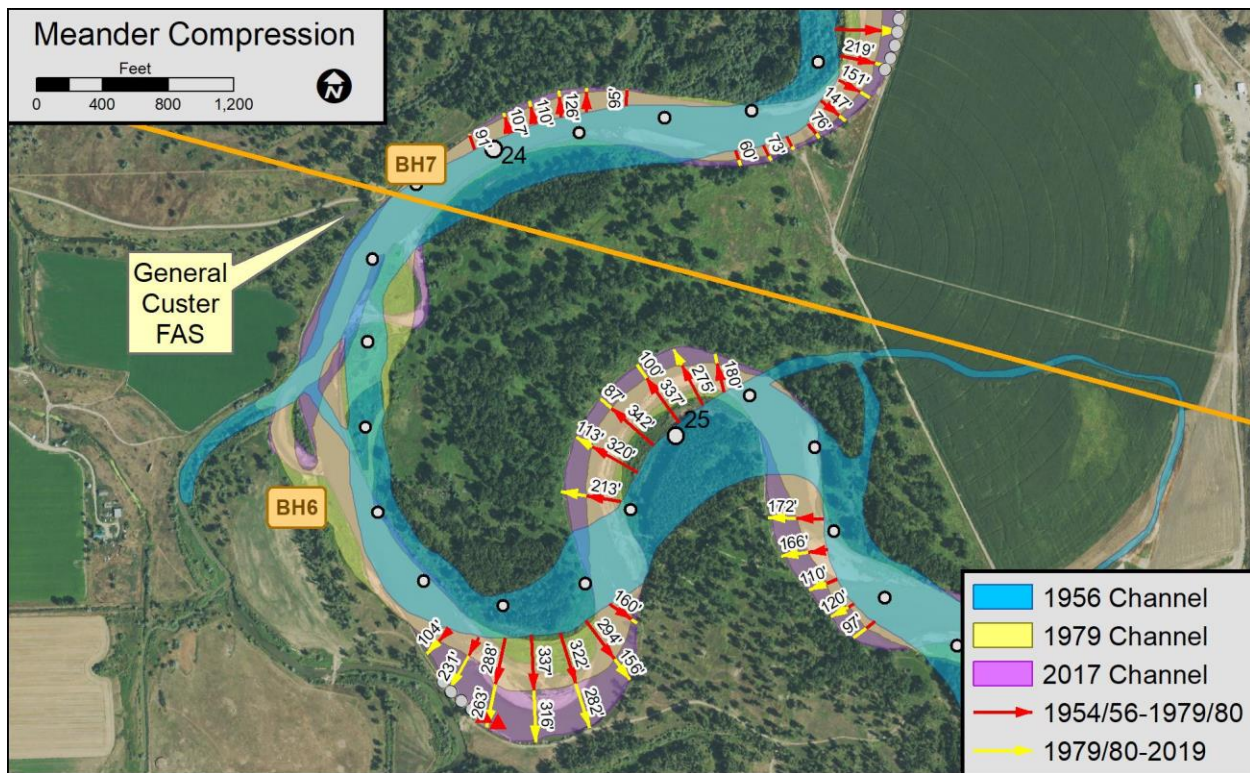
The George Custer FAS at the lower end of Reach BH6 is on a large, lengthening bendway that is prone to cutoff incoming decades. Depending on how a cutoff manifests, the changes could result in the Bighorn River abandoning the access site (Figure 67).

Figure 67. Meander compression at General Custer FAS; an avulsion across the meander core would abandon the site.

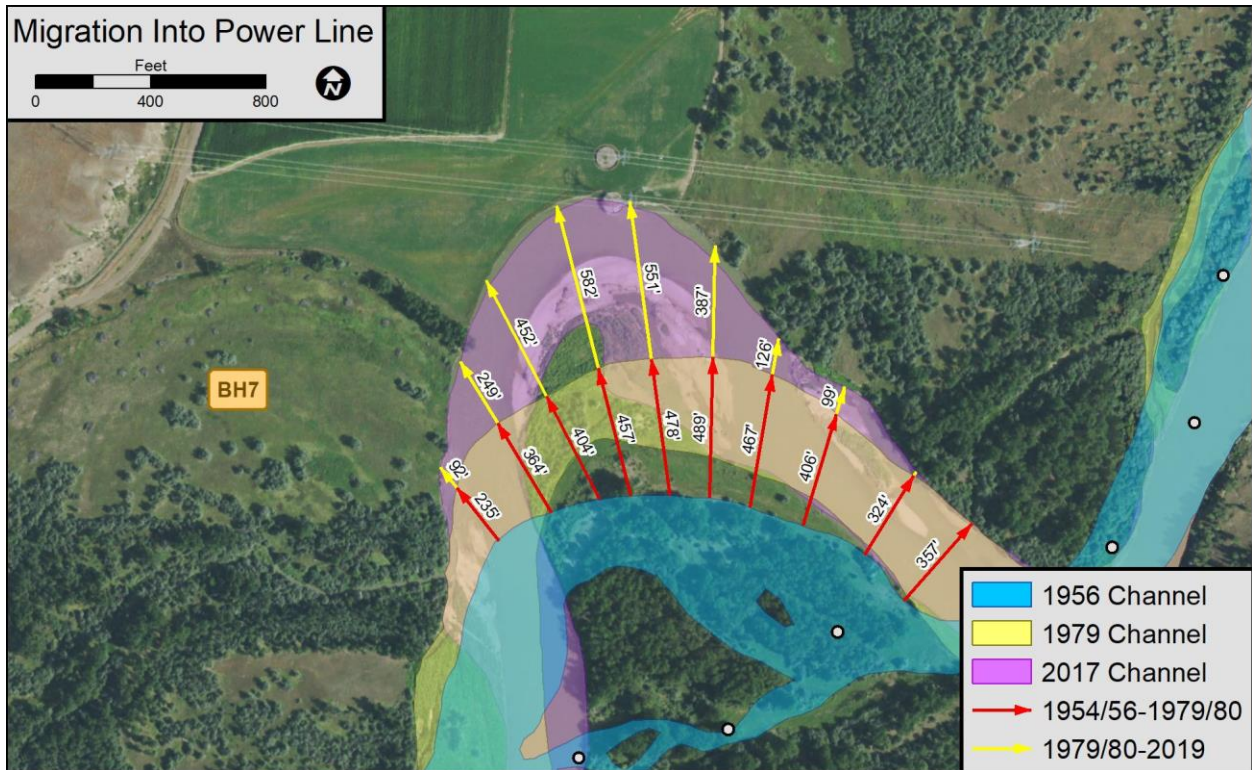
Figure 70. Migration into power line tower at RM 18.7.

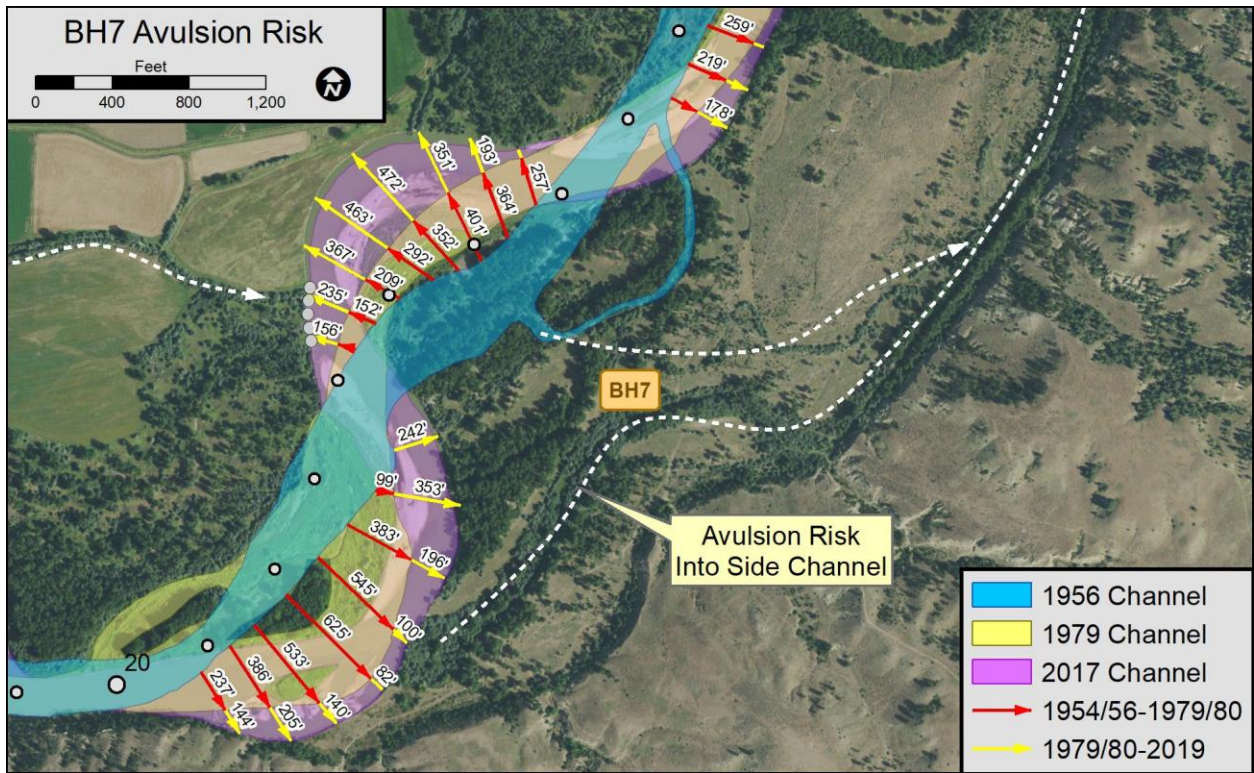
Figure 71. Migration into a long side channel at RM 20.8 creating a heightened risk of avulsion.
