December 31, 2017

Upper Missouri Headwaters River Channel Migration Mapping Summary Report

Tony Thatcher
DTM Consulting, Inc.
211 N Grand Ave, Suite J
Bozeman, MT 59715

Karin Boyd
Applied Geomorphology, Inc.
211 N Grand Ave, Suite C
Bozeman, MT 59715

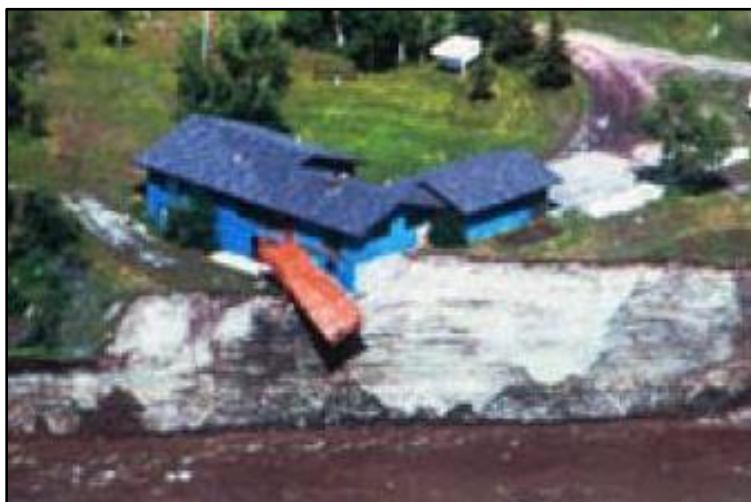
Figure 4 shows a property on the Yellowstone River in Park County that was progressively undermined during the 1996-1997 floods, prompting the owner to burn it down to prevent any liability associated with the structure falling into the river. This has been a chronic problem in river management, as landowners assume that if their home is beyond the mapped floodplain margin, it is removed from all river hazards.

Figure 4. Yellowstone River home on high glacial terrace that was burned down in 1997 to prevent its undermining by the river.

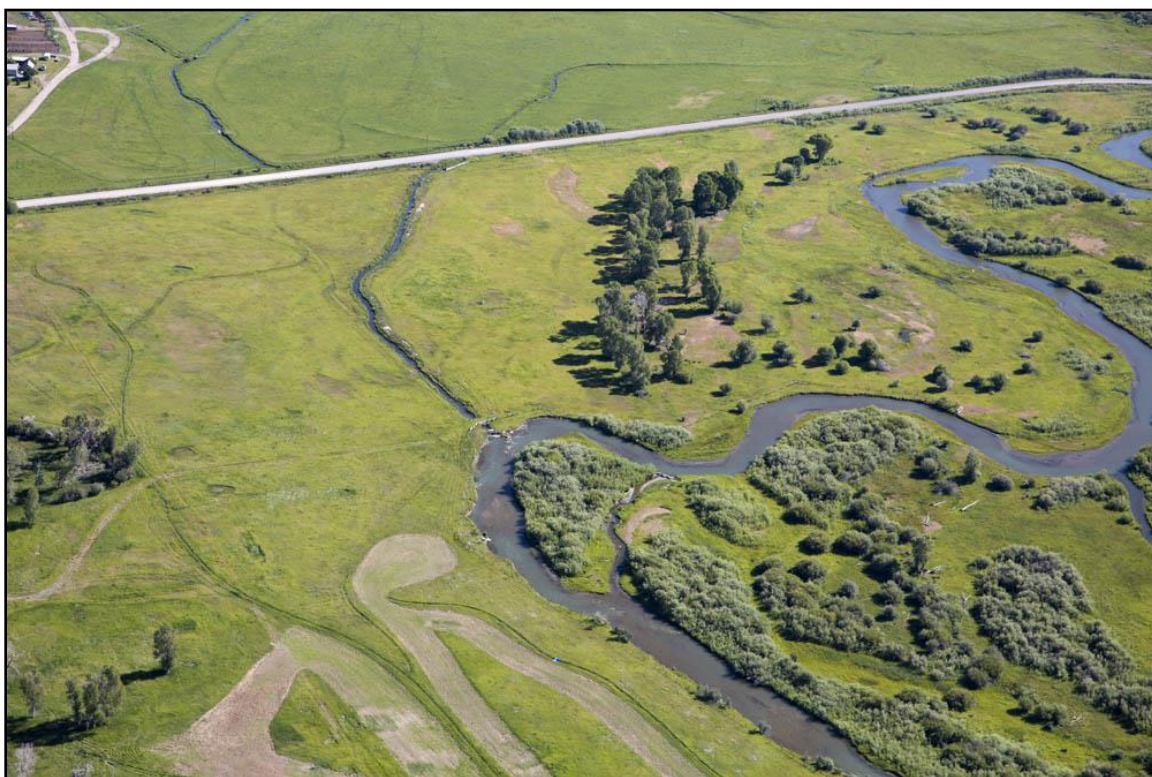
Figure 18. View downstream near Dillon showing diversion structure at risk of abandonment by bendway cutoff (Kestrel).

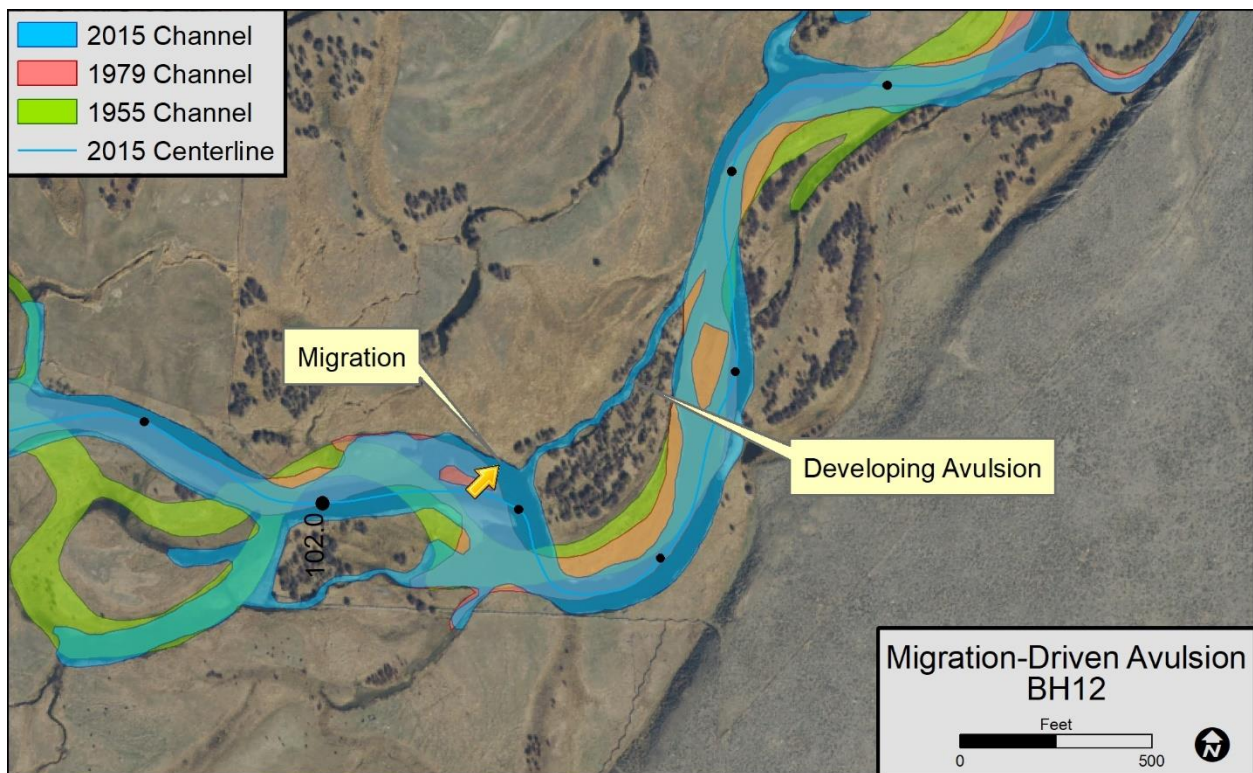
Figure 20. Big Hole River at RM 102 showing northeastward migration into floodplain swale driving bendway cutoff/avulsion.

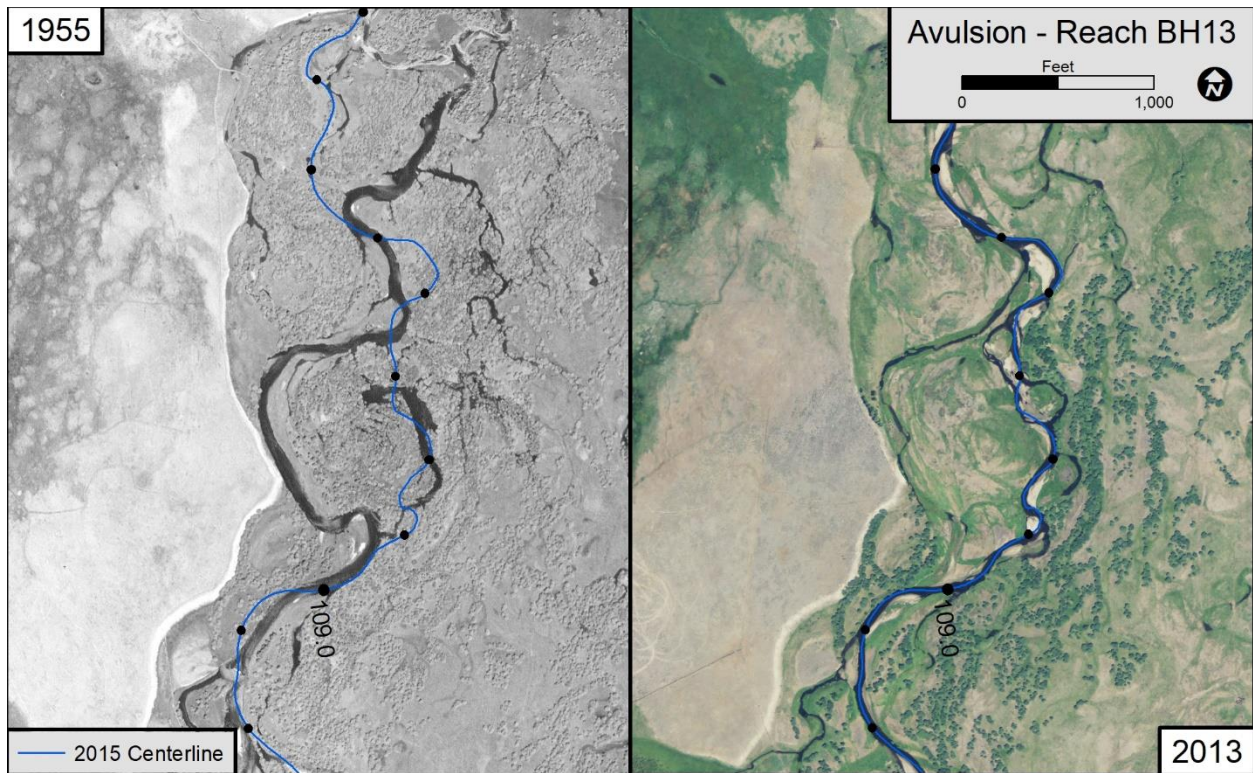
Figure 22. Reach BH13 showing 1,700 foot long avulsion since 1955; note loss of open water and riparian vegetation density.

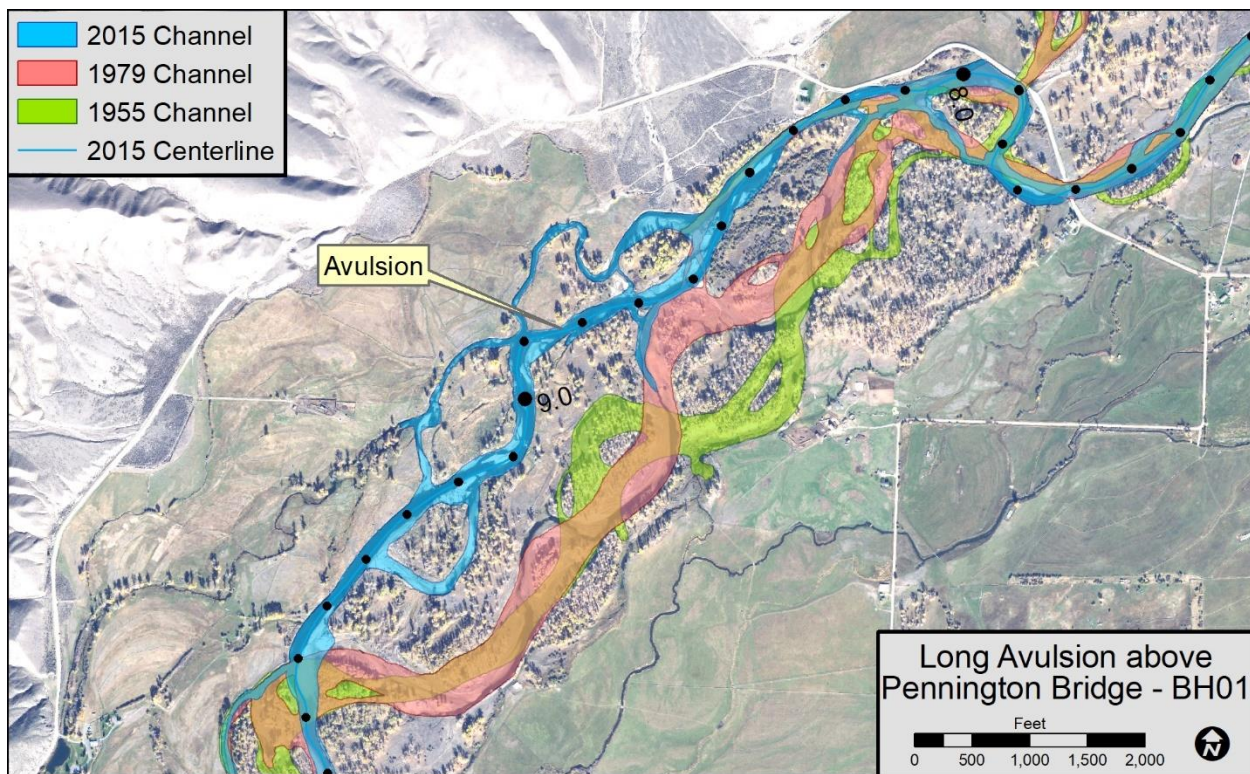
Figure 27. 2015 image of Reach BH1 above Pennington Bridge showing 1.6 mile long avulsion site.

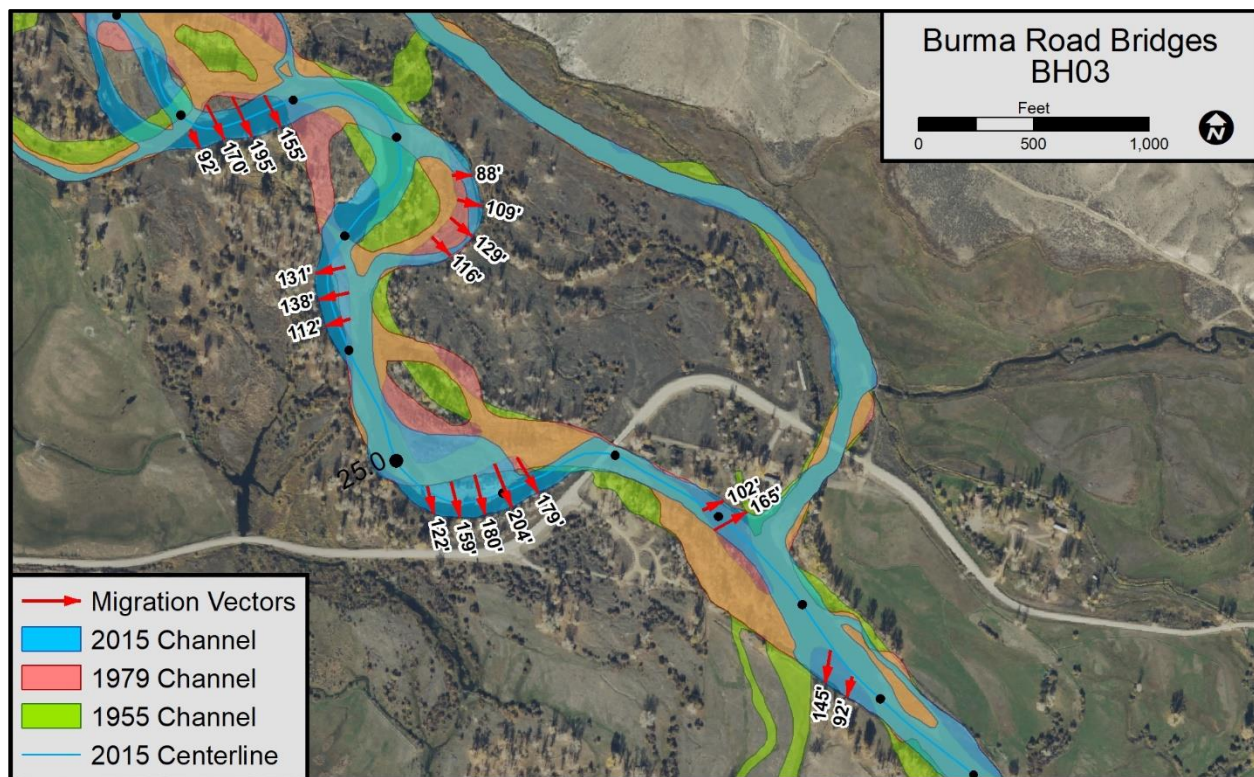
Figure 28. Big Hole River at Burma Road Bridge crossing showing progressive decay of river approach to west bridge structure.

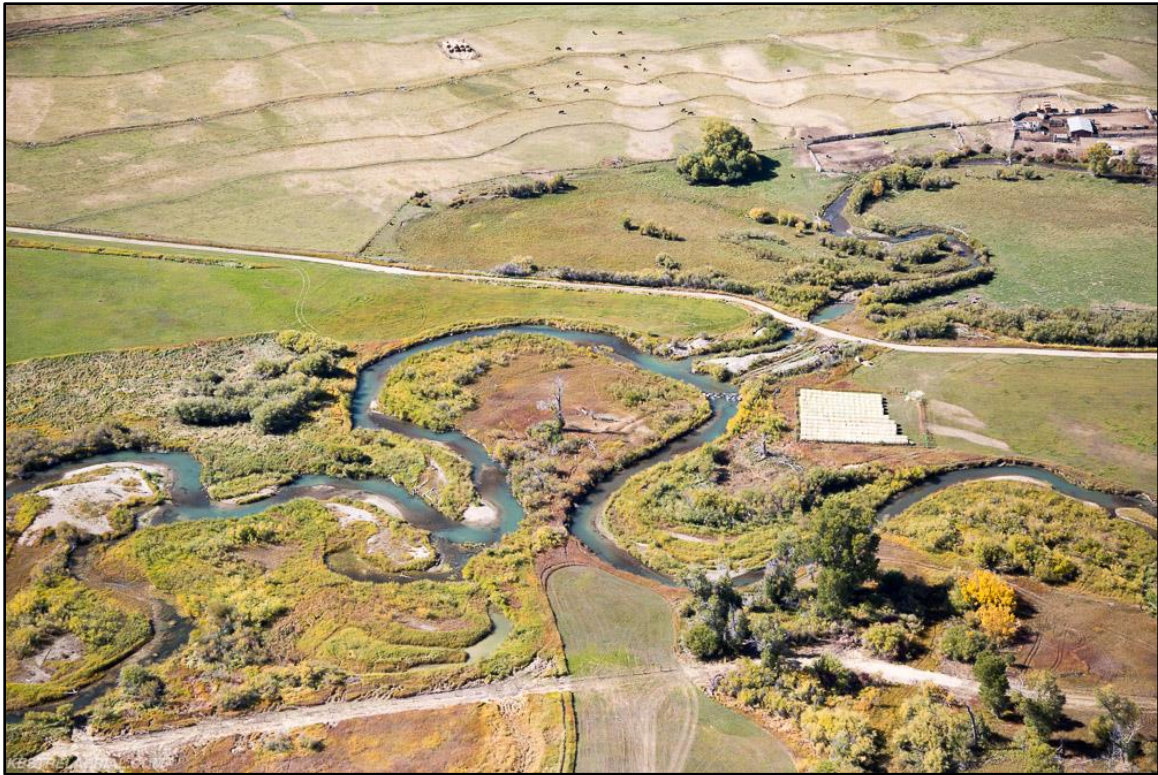
Figure 33. View west showing Clear Creek Diversion through culvert under road; note meander cutoff potential in center of photo (Kestrel).

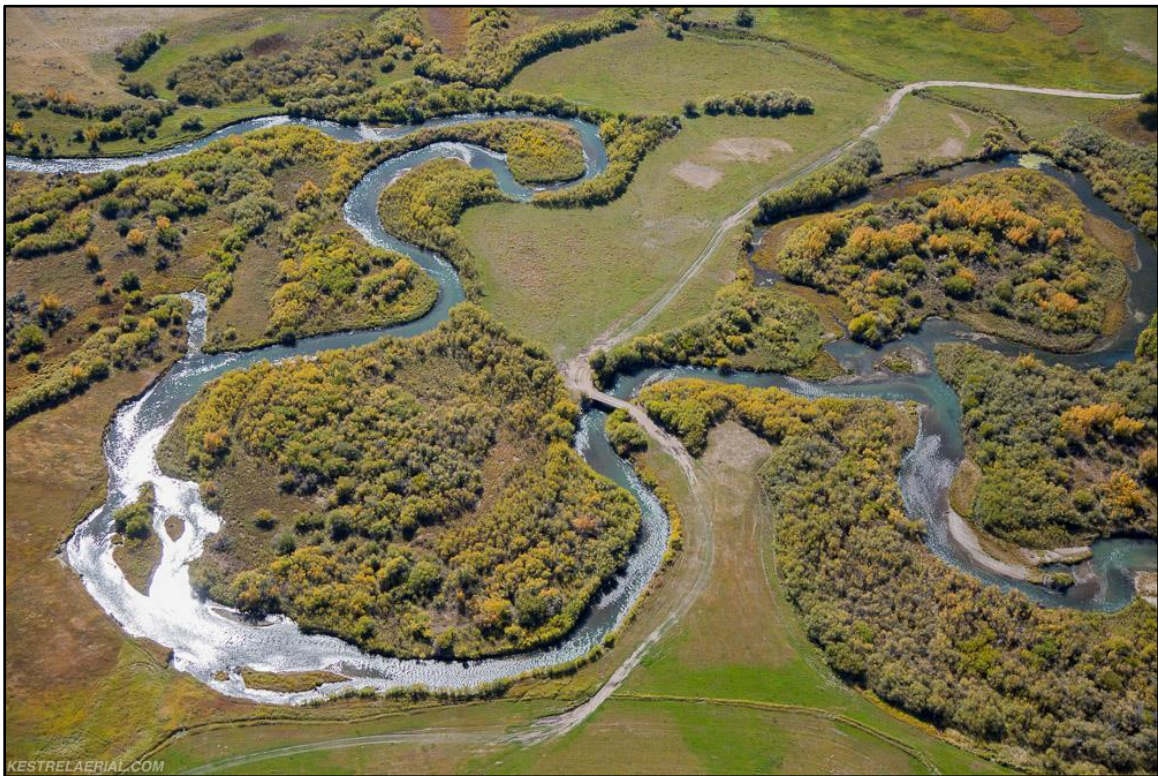
Figure 34. View west showing 2011 avulsion on Ruby River (upper right corner of photo) (Kestrel)

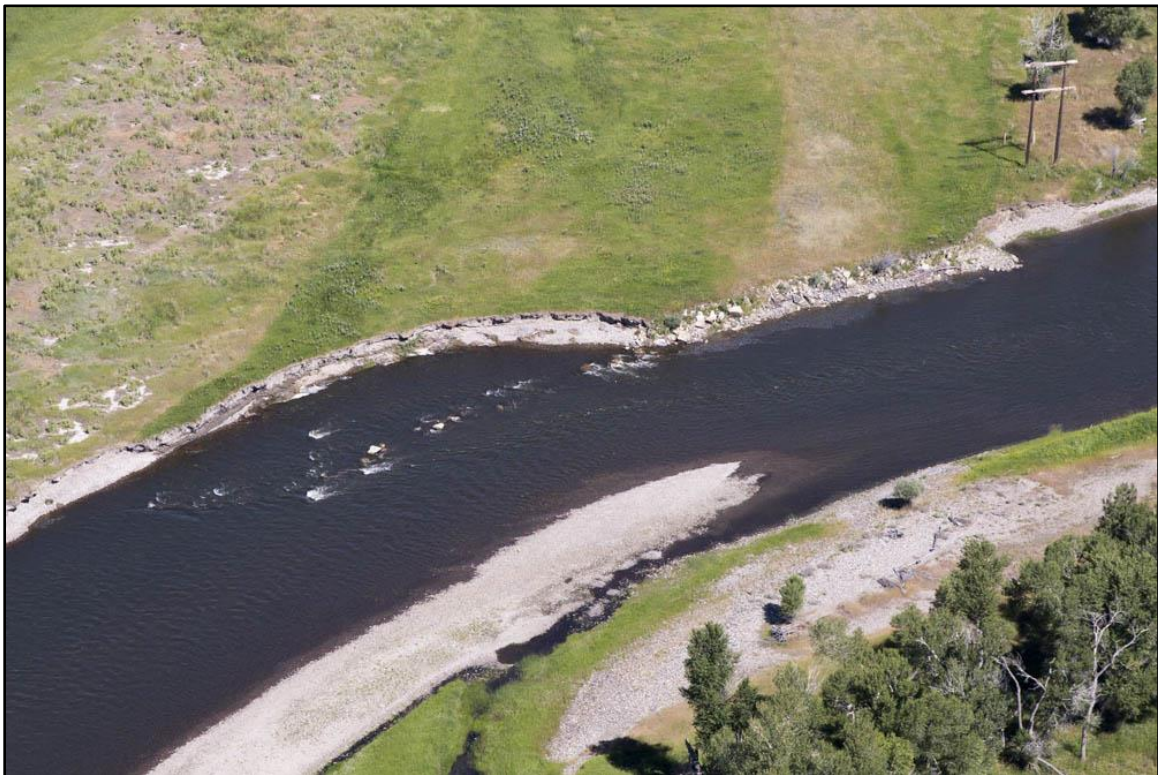
Figure 38. Flanked left bank riprap in channel, RM 71.8L (Kestrel).

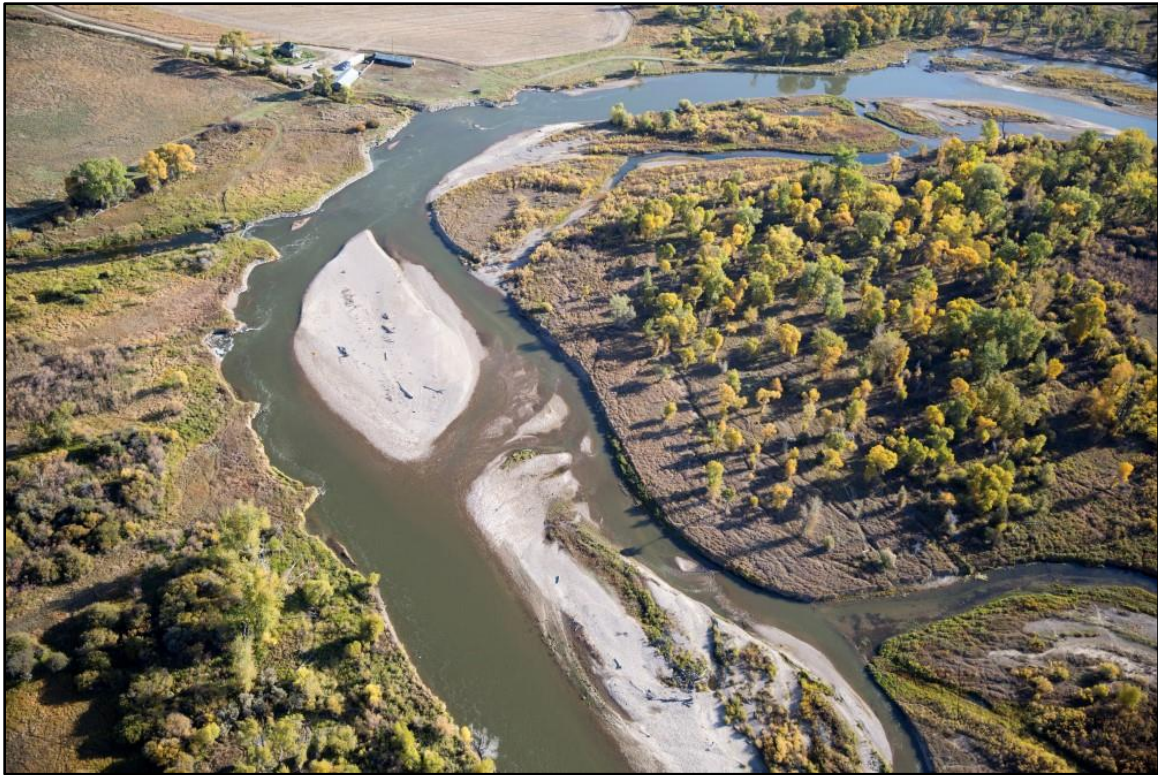
Figure 43. View downstream showing left bank barbs with erosion between structures (Kestrel).

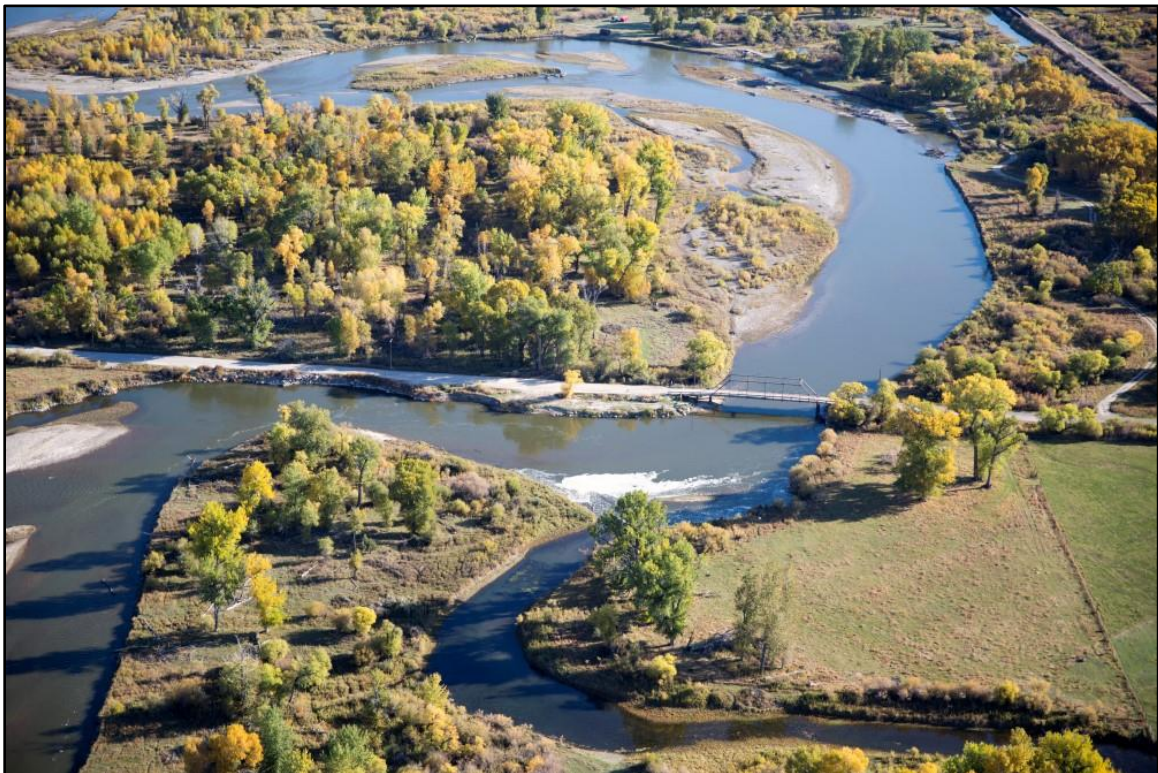
Figure 44. View downstream showing poor river alignment and bank armoring at Old Town Road Bridge over Jefferson River (Kestrel)..

- c. Old Town Road: Poor alignment caused by a severe dogleg at the bridge has threatened the road.

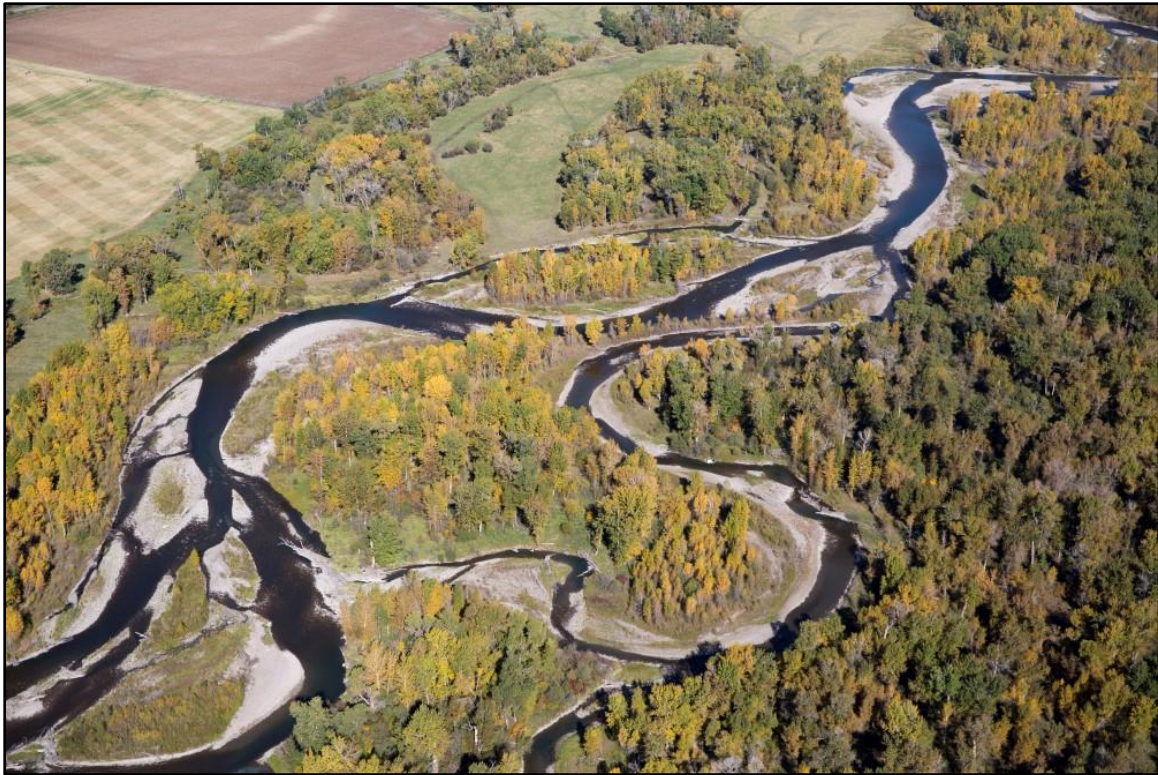
Figure 59. View downstream below Norris Road; bendway in left foreground has migrated 392 feet since 1965 (Kestrel).

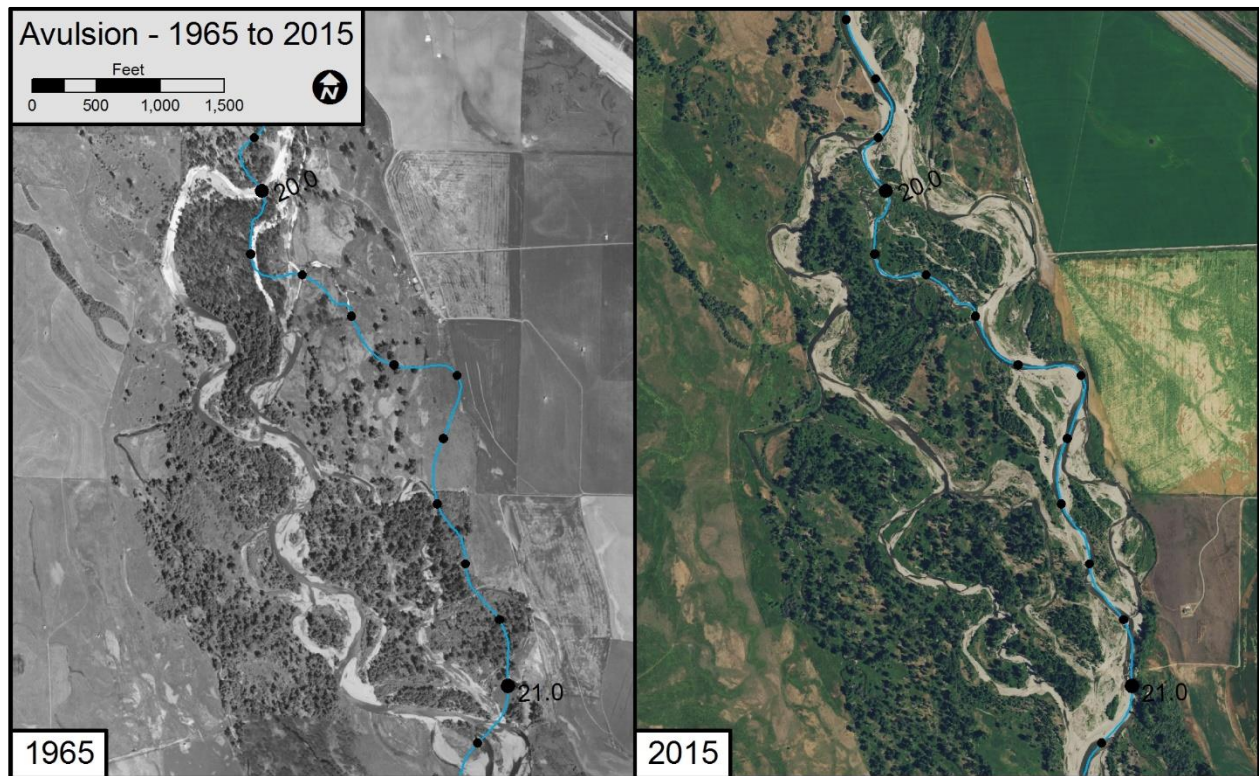
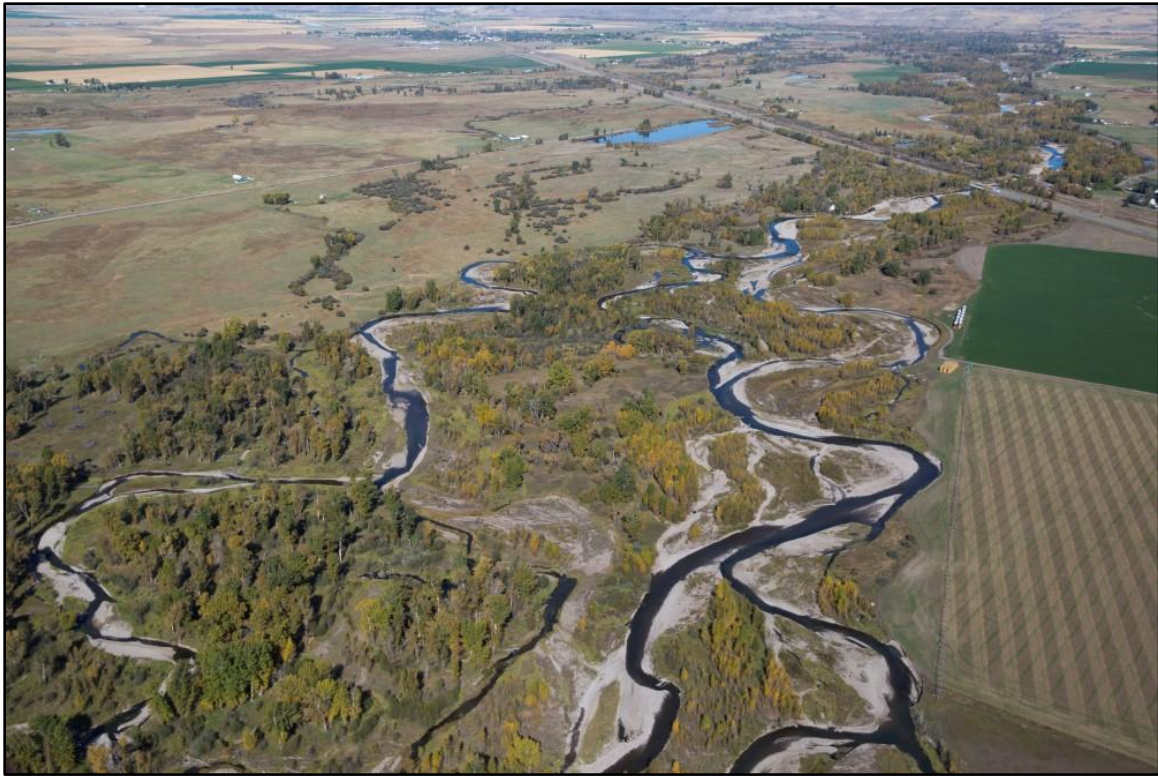
Figure 60. Major avulsion at RM 20.4 between 1965 (left) and 2015 (right).

Figure 61. View downstream of ~1.1 mile long avulsion shown in Figure 60; I-90 Bridge crossing is in distance (Kestrel).

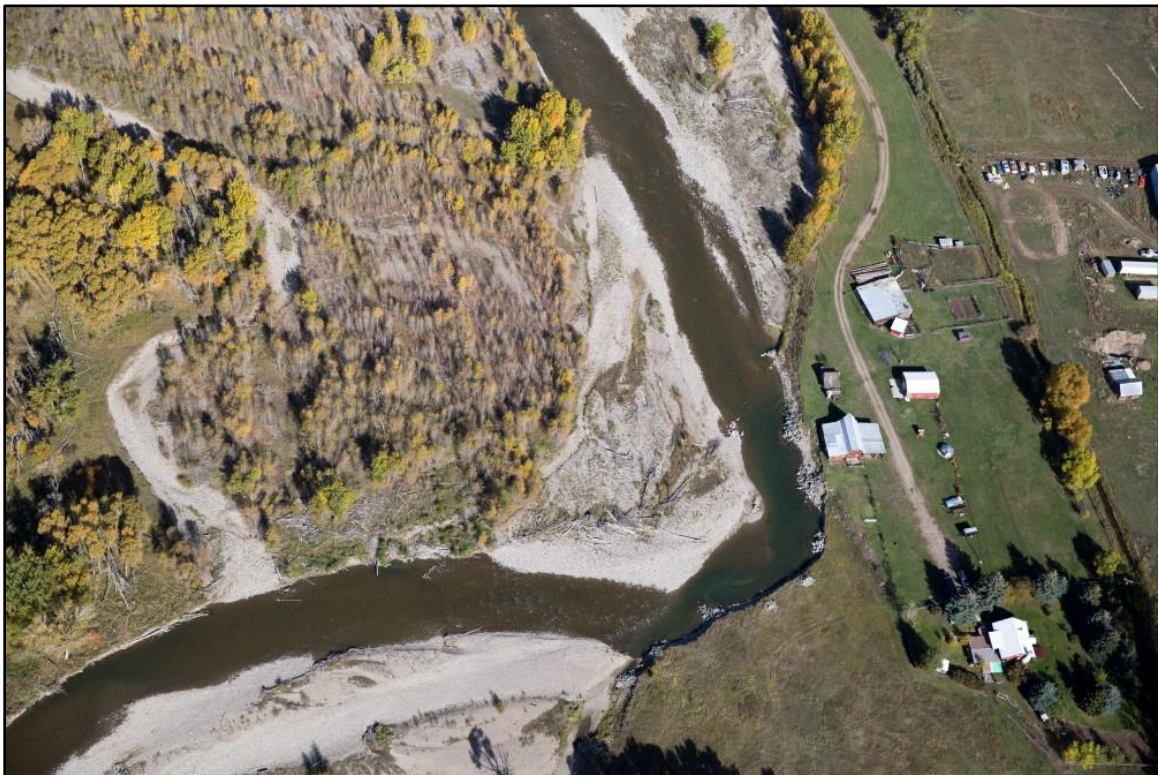
Figure 62. Barn on right bank where river has migrated 216 feet since 1965, RM 23.2 (Kestrel).

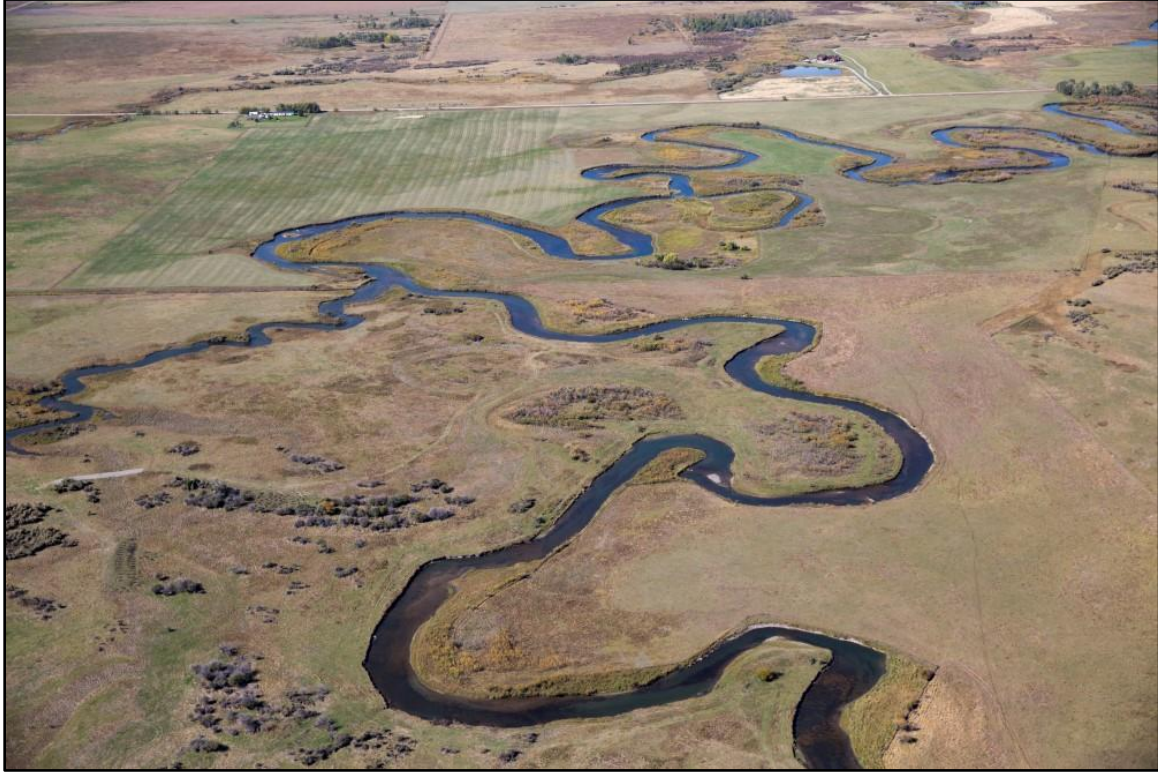
Figure 67. View downstream showing lack of woody vegetation on banklines and floodplain (Kestrel).

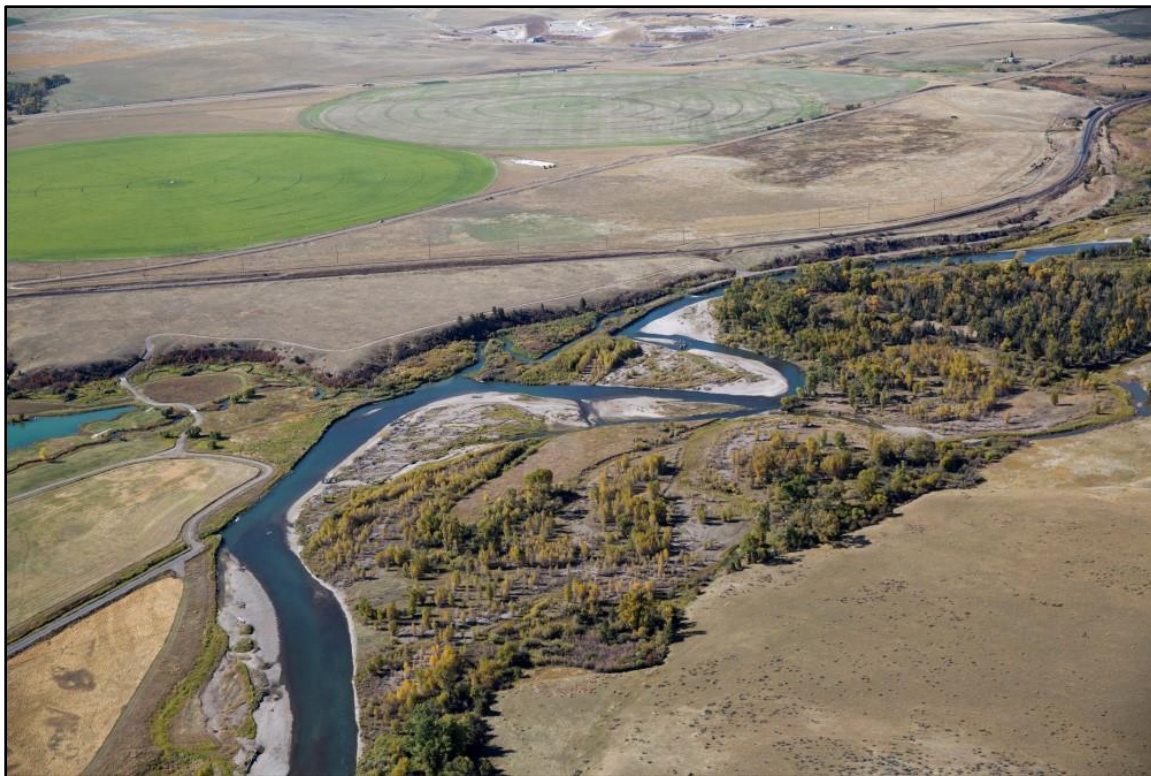
Figure 78. View downstream of Gallatin River near Logan showing breached rail line embankment (left) and re-routed road (Kestrel).

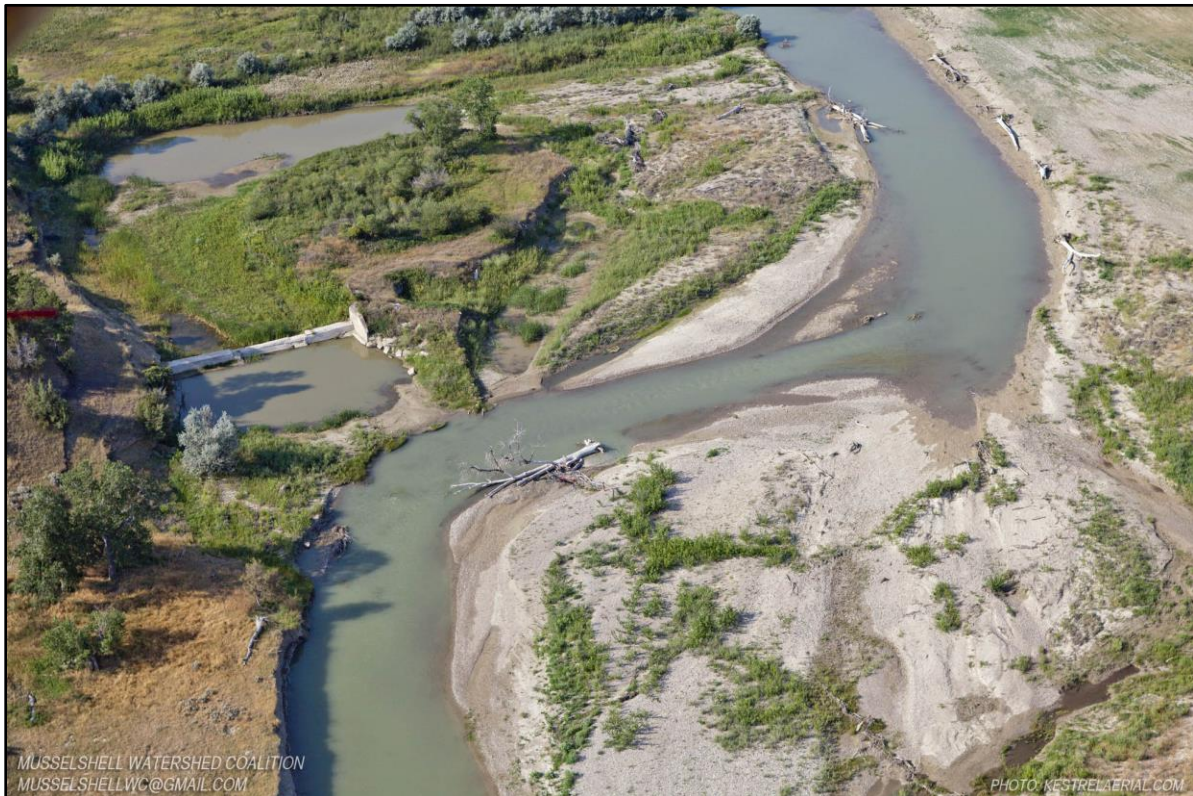
Figure 80. Flanking and abandonment of a diversion dam on the Musselshell River during the 2011 flood (Kestrel).

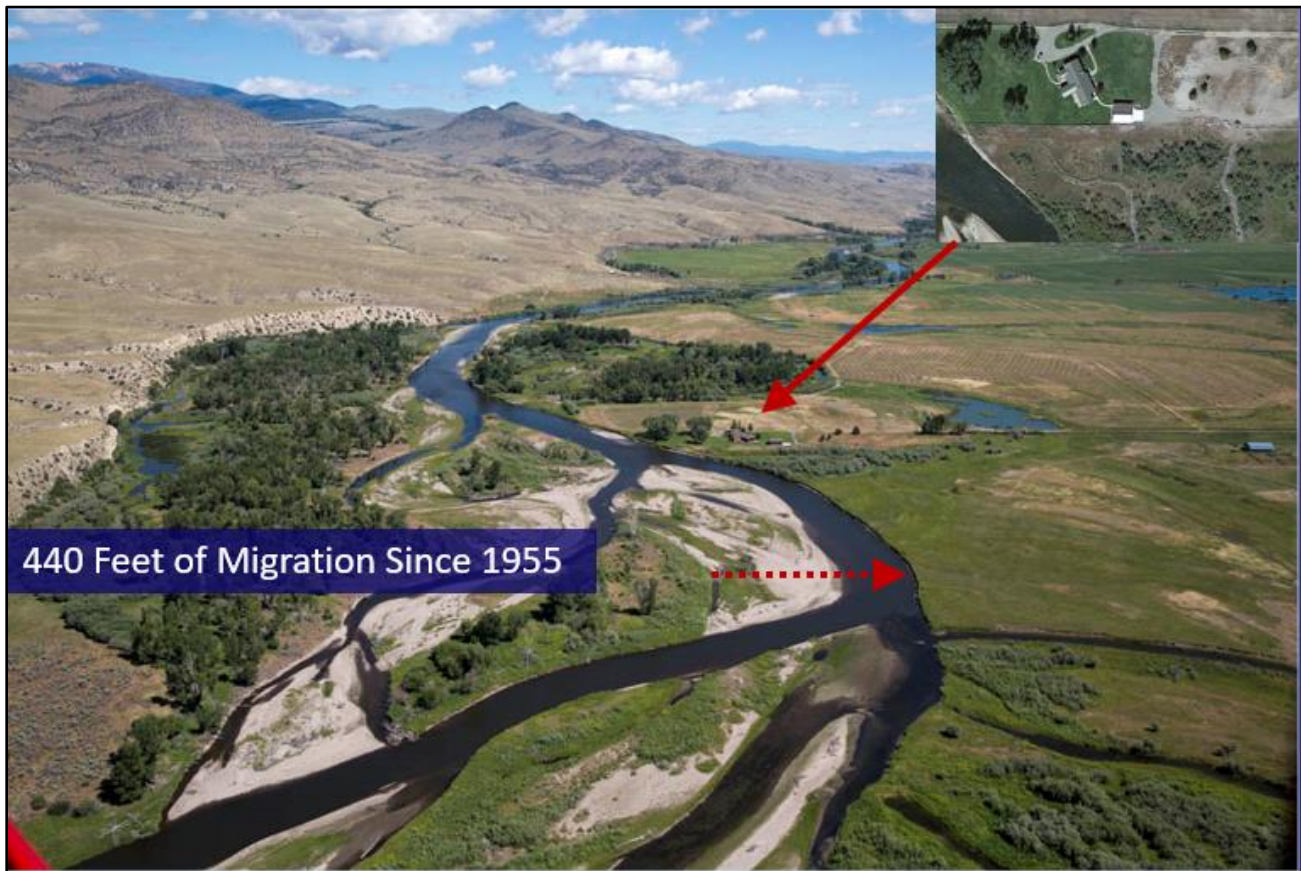
Figure 83. View downstream of upper Jefferson River bendway where eastward migration of 440 feet since 1955 threatens a home site (Kestrel).
