# Final Report

January 14, 2011

## Prickly Pear / Tenmile Creeks Channel Migration Zone Mapping

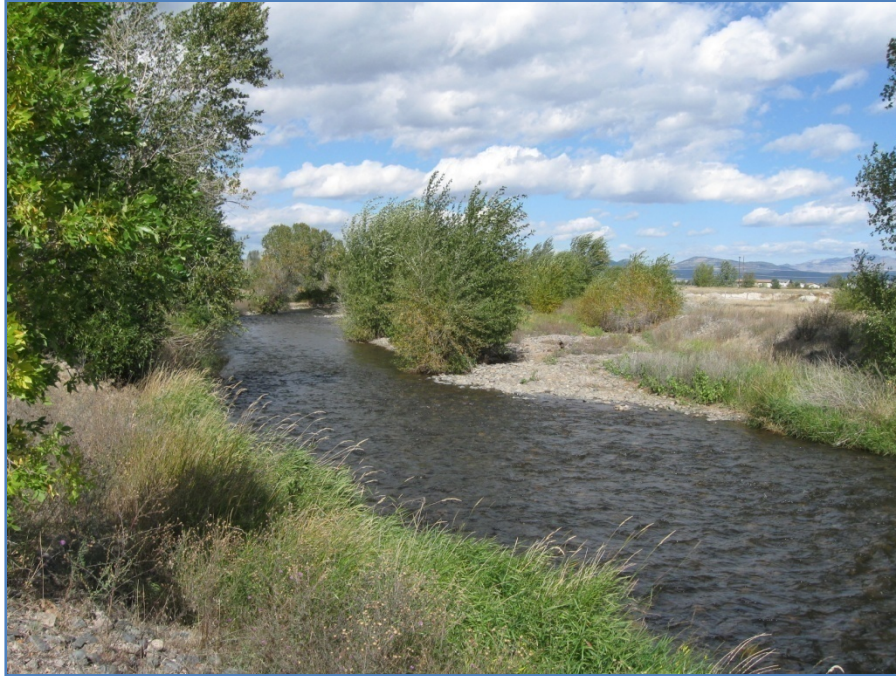
**Figure 1. Bar formation, wood recruitment, and riparian vegetation succession, Prickly Pear Creek.**

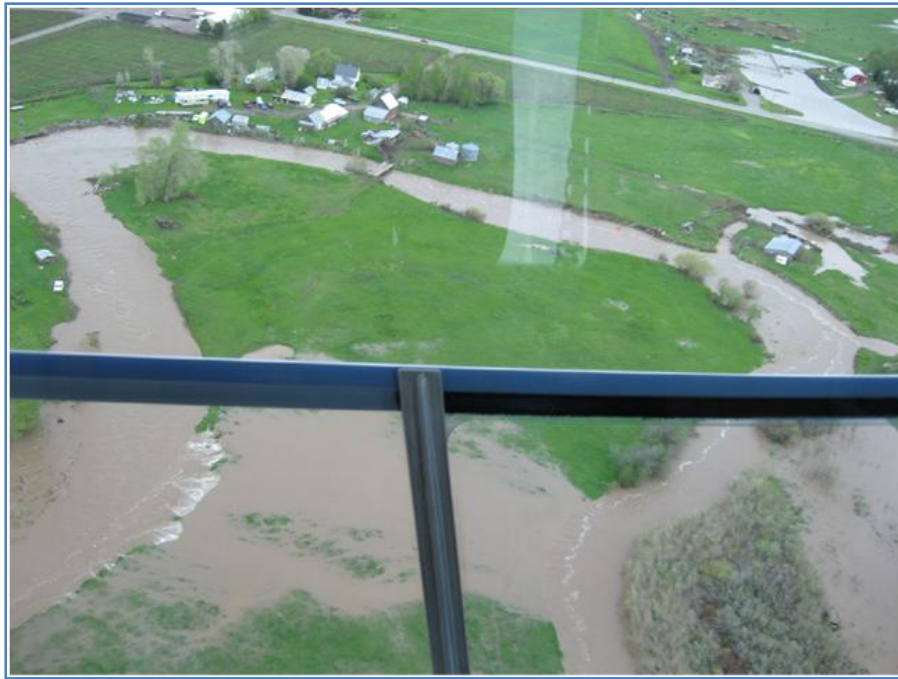
**Figure 5. Example of the avulsion process, East Gallatin River, May 2008 (DNRC).**

The photo shown in Figure 5 was taken from a helicopter by DNRC staff during the 2008 flood on the East Gallatin River near Bozeman, Montana. The photo shows a typical bendway on the East Gallatin, with floodwaters flowing over the core of the bend. On the downstream end of the bend (left side of photo), the overflows re-enter the main channel over a steep bank edge, creating a headcut. If the flood is large enough, or of long enough duration, the headcut will migrate up-valley through the core of the bend and excavate a cutoff channel. On this particular bend, the flood dissipated before cutoff occurred, resulting in a “failed avulsion”.

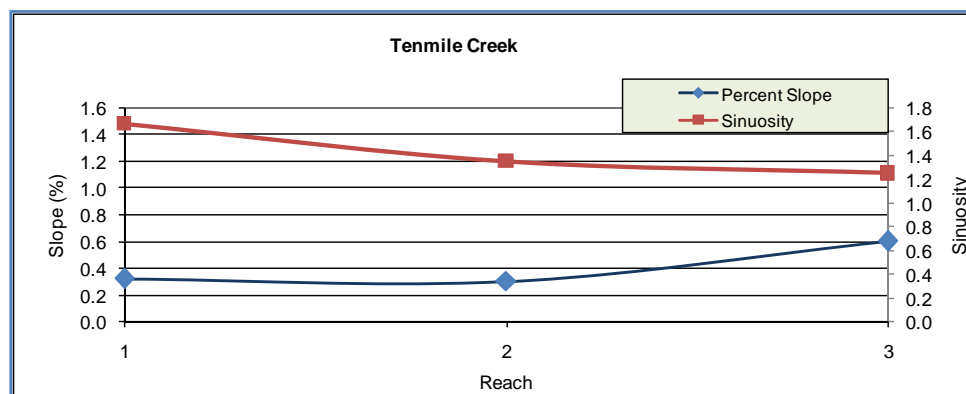
**Figure 15. Channel sinuosity and slope, Temmile Creek project reaches.**

On Tenmile Creek, slope is more consistent through the project reach relative to Tenmile Creek (Figure 14). Sinuosity increases slightly in the downstream direction between I-15 and the confluence with Prickly Pear Creek (Figure 15).

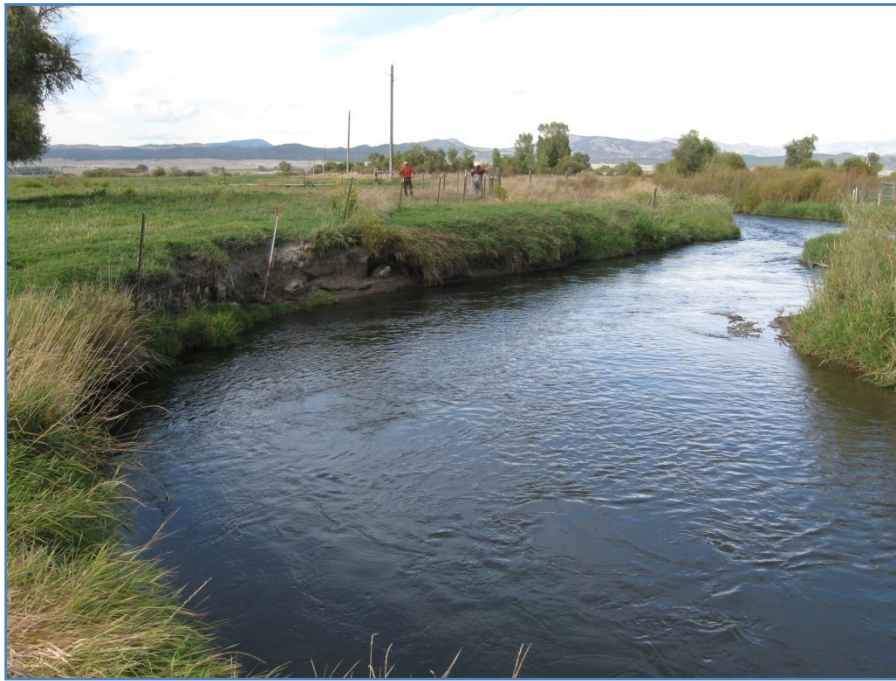
**Figure 16. View downstream of left bank erosion on Prickly Pear Creek, Reach PP3 (RM 3.0).**

Reach PP3 extends from the Tenmile Confluence up to Sierra Road (Appendix A). Within this reach, the creek is sinuous and laterally dynamic. The channel is characterized by locally high eroding banks and an inset floodplain surface which suggests that the reach has incised (Figure 16). The willow corridor is locally dense, and observed bank materials are fine grained silts and sands.

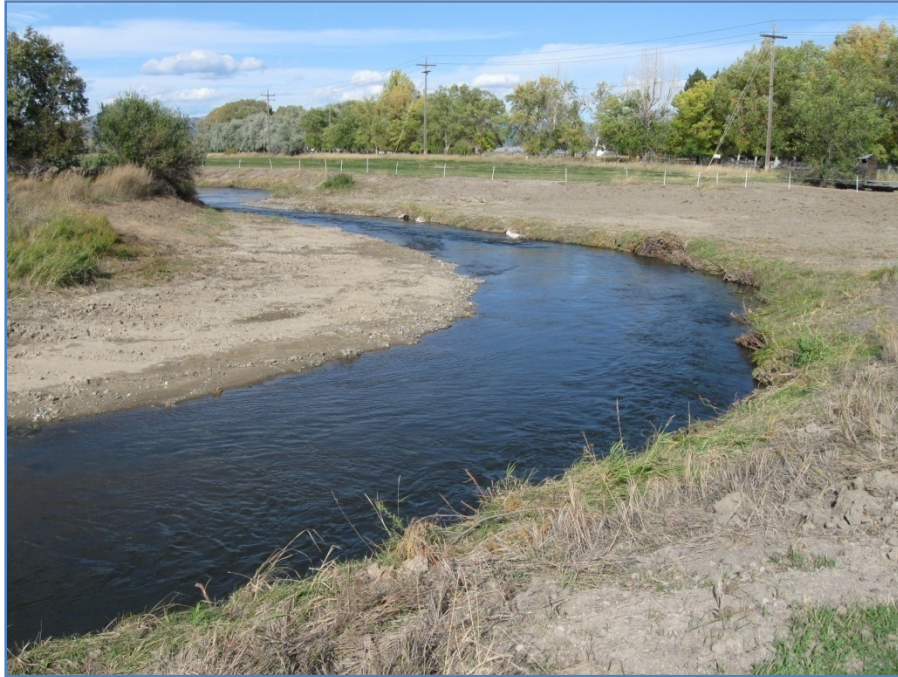
**Figure 17. View downstream in Reach PP4 showing recently completed restoration project to reduce bank height and create an inset floodplain surface (RM 5.2).**

Reach PP4 extends from Sierra Road upstream to an old dike/embankment at River Mile 7.0, just upstream of the confluence of the City of Helena wastewater treatment effluent ditch with Prickly Pear Creek. Within this reach, Prickly Pear Creek has a sinuosity (channel length to valley length ratio) of 2.16. The reach is incised, and has developed an inset floodplain surface, primarily on meander cores. Restoration activities in Reach 4 (Figure 17) have included bank lowering and inset floodplain development. The D3 drain enters Prickly Pear Creek in Reach 4 at approximately RM 4.9.

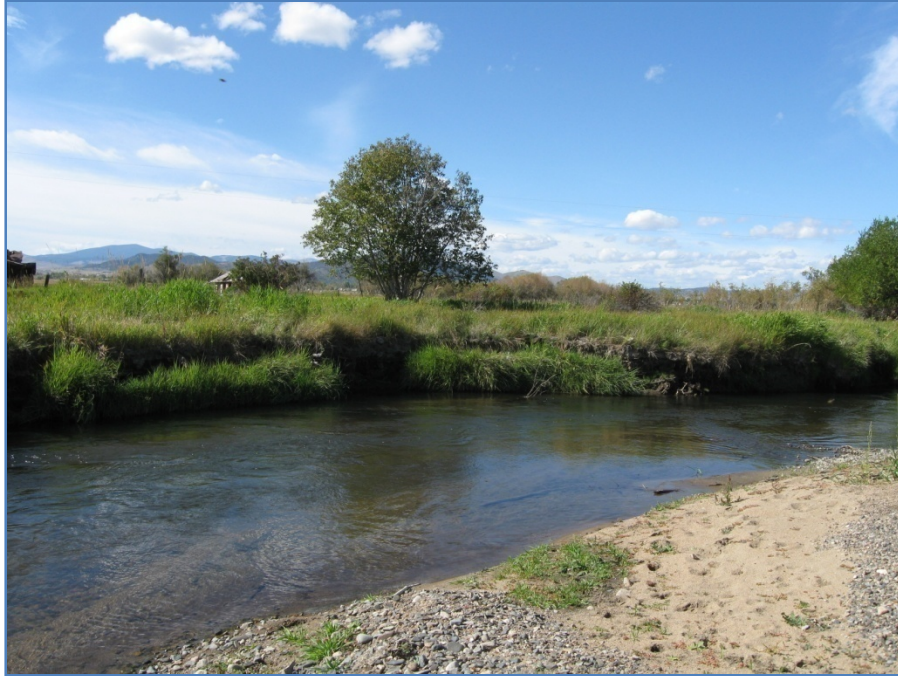
**Figure 18. View downstream on Prickly Pear Creek of bank undercutting and topple failure, Reach PP5 (RM 7.8).**

Reach 5 is approximately 1.3 miles long, extending from RM 7.0 to RM 8.3, which is just downstream from York Road (Appendix A). This reach has a moderate sinuosity and slope. Reach 5 marks a notable reduction in channel slope relative to upstream reaches, and migration rates are relatively high. Observed bank erosion includes undercutting of fine grained banks and subsequent topple failure of the upper bank (Figure 18). At approximately RM 7.4, Prickly Pear has breached a dike that separates the stream from a constructed lake/wetland complex on the right floodplain (Figure 19).

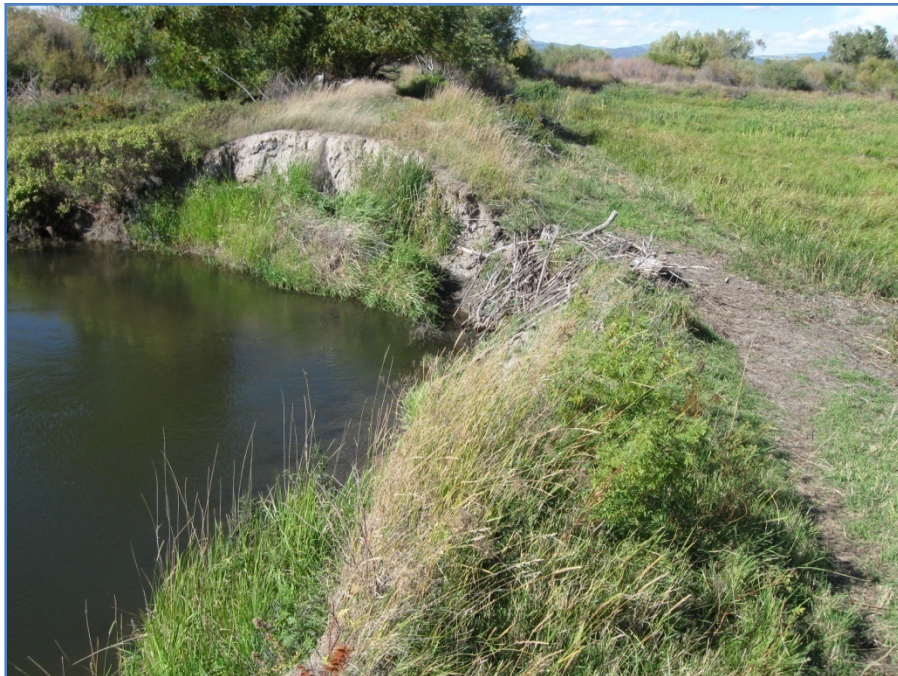
**Figure 19. View downstream on Prickly Pear Creek showing right bank migration through constructed dike, Reach PP5 (RM 7.4).**

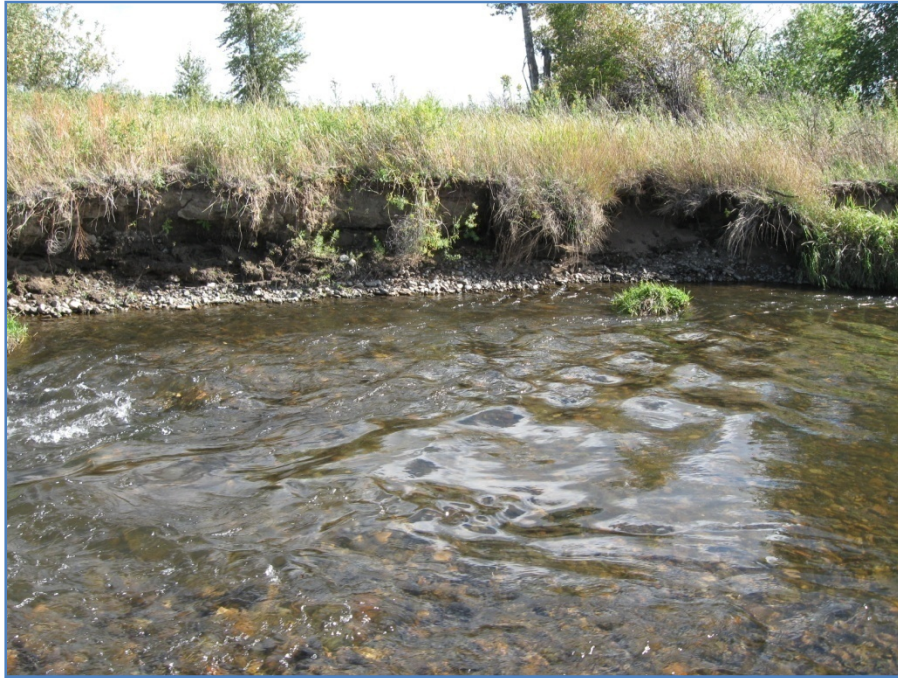
**Figure 20. Right bank erosion in Reach PP6 showing undercutting on gravel bank toe (RM 9.1).**

Reach PP6 extends from just below York Road upstream to Canyon Ferry Road. Within this reach, Prickly Pear Creek flows through a transition from the relatively steep primary fan area, to the lower slope distal fan area downstream. Field observations of coarse sediment deposition and severe bank erosion suggest that this reach is aggradational due to a reduction in sediment transport capacities on the fan surface relative to upstream. Coarse gravels and cobbles are commonly exposed in the lower banks of Reach PP6 (Figure 20).

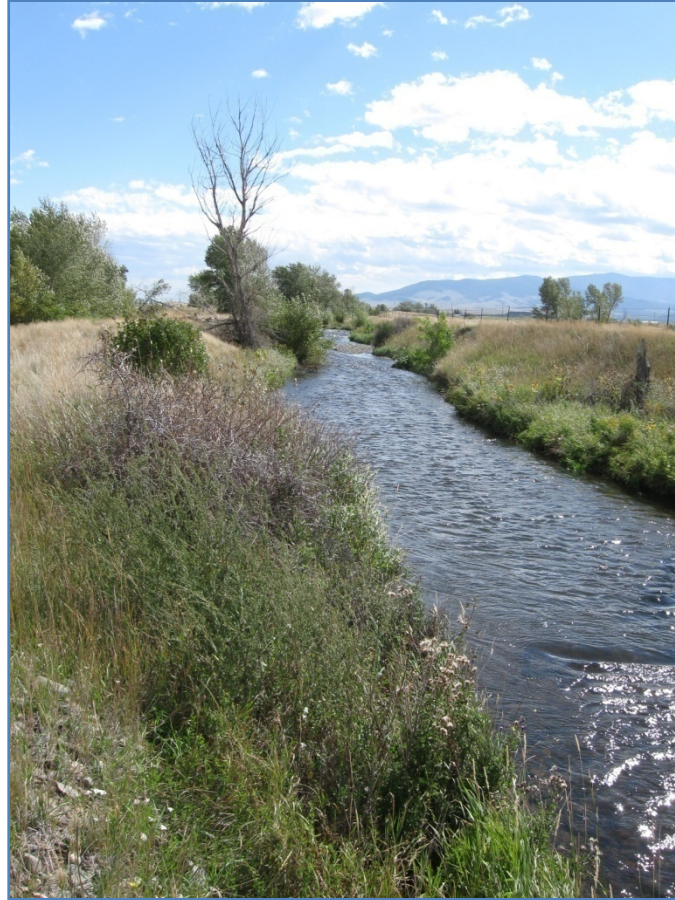
**Figure 21. View upstream of channelized segment between the gravel pits (left) and abandoned gravel pit lake (right), Reach PP7 (RM 10.7).**

Reach PP7 extends from York Road upstream to the Helena Valley Canal siphon. Within this reach, Prickly Pear Creek has been channelized and encroached upon by a series of dikes that protect active and inactive gravel pits. Although the reach is channelized and diked (Figure 21), some bank migration was measured where point bars have formed, and old dike features have been flanked. This reach has been classified as a Forced Plane Bed channel type, indicating that the diking and channel straightening has converted the channel from a natural pool/riffle channel to a straight trapezoidal channel with little bedform diversity.

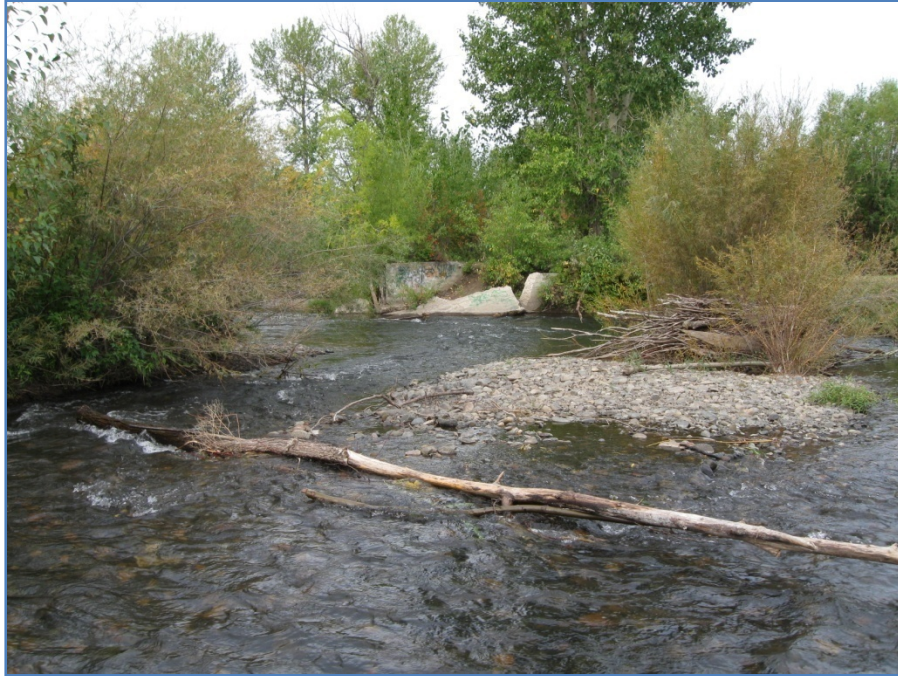
**Figure 22. View downstream at the start of Reach PP8 showing coarse bed material, woody debris, and concrete structure (RM 12.9).**

Reach 8 extends from East Helena downstream to the Helena Canal Siphon. This reach is relatively coarse grained, and has numerous functional and decrepit irrigation structures (Figure 22). Bed material reaches coarse cobble in size, and the primary geomorphic unit is a trapezoidal run. Due to the confinement associated with the irrigation structures in the reach, the reach has been classified as a Forced Plane Bed channel type, although some channel segments locally exhibit a pool/riffle morphology.

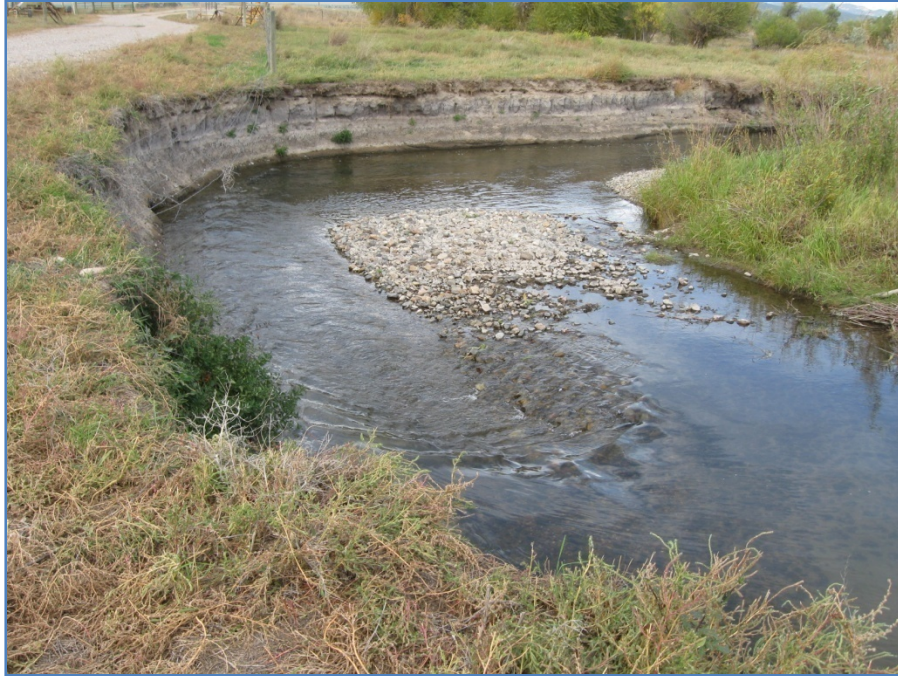
**Figure 23. View downstream of Reach TM1, Tenmile Creek (RM 0.9).**

The lowermost 0.95 miles of Tenmile Creek are moderately sinuous, and entrenched with high banks and active bank erosion. Bank materials are fine grained and horizontally bedded suggesting deposition in a slackwater environment (Figure 23).

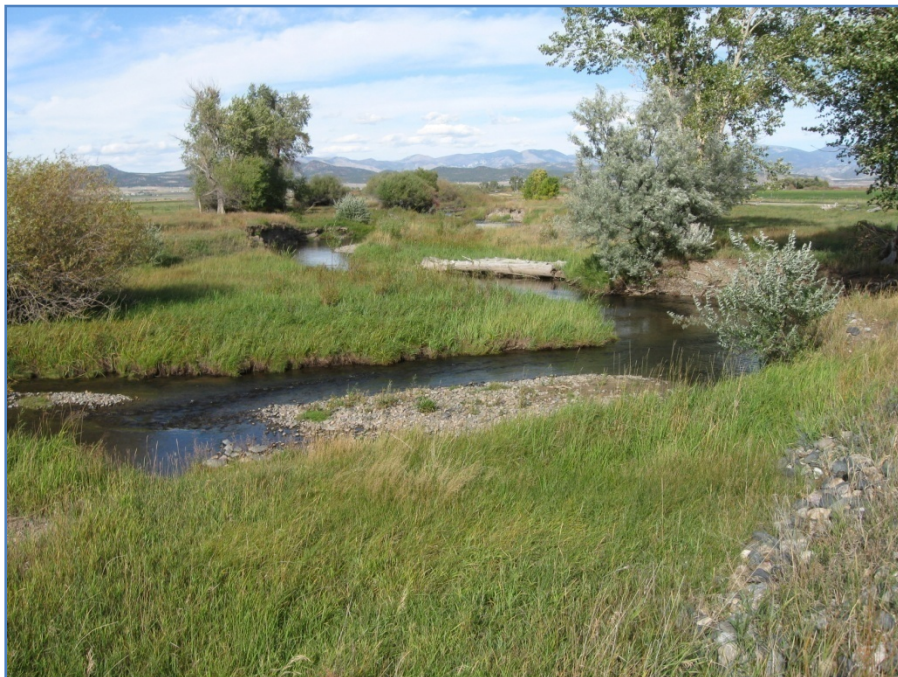
**Figure 24. View downstream showing natural inset floodplain development on meander cores, Reach TM2.**

Reach TM2 is 1.13 miles long, and consists of an entrenched channel cross section that shows active bar development and inset floodplain development (Figure 24). Lateral migration was measureable at numerous sites in this reach.

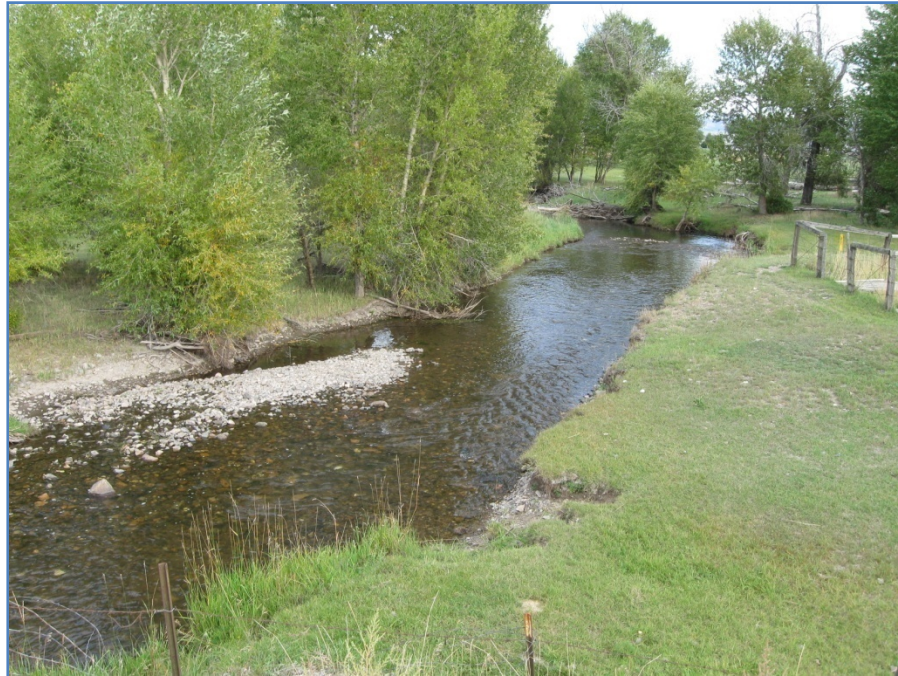
**Figure 25. View downstream from I-15 Frontage Road bridge at the upper end of Reach TM3 and Tenmile Creek Project Area (RM 3.4).**

Reach TM3 extends from River Mile 2.1 upstream to the Interstate 15 bridge at River Mile 3.4. The riparian corridor within this reach is relatively dense, and bed material consists of gravel to cobble sized material (Figure 25). The Tenmile Creek study area ends at the I-15 Frontage Road bridge. Of note in reach TM3 is a long moderate avulsion hazard running northeasterly, connecting with Prickly Pear Creek approximately 1.5 miles upstream of the current Tenmile/Prickly Pear confluence.

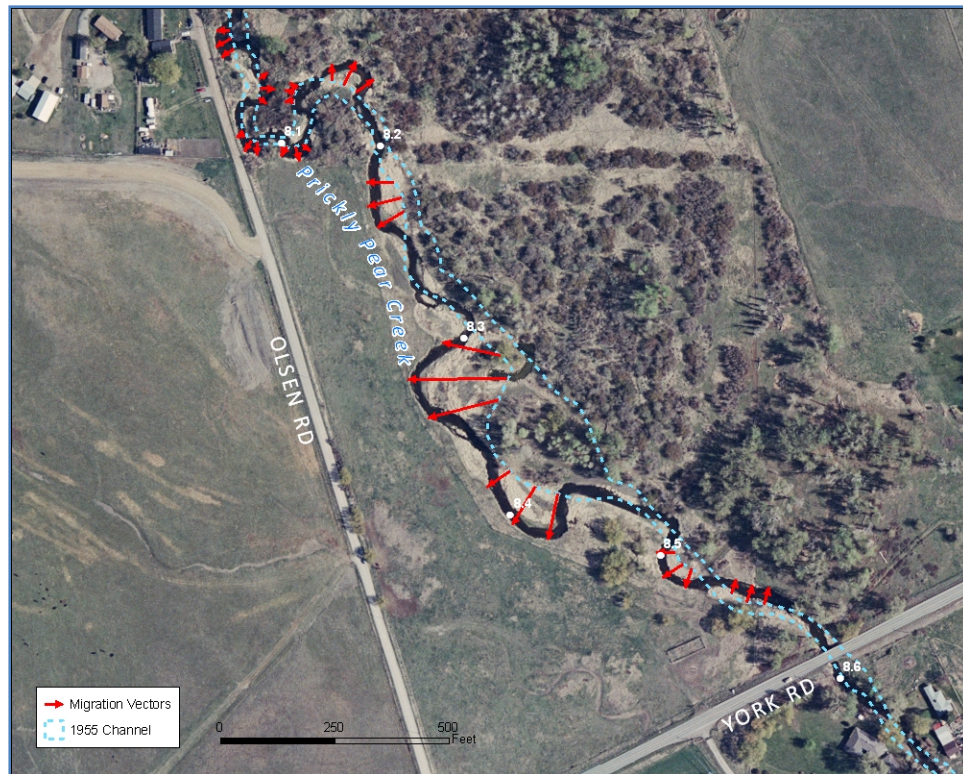
**Figure 26. Migration rate measurement vectors, Prickly Pear Creek (RM 8.0-8.6).**

identification, and line length. These measurements were then summarized by site and by reach to determine appropriate reach-specific buffer widths to accommodate future shifts in channel location.

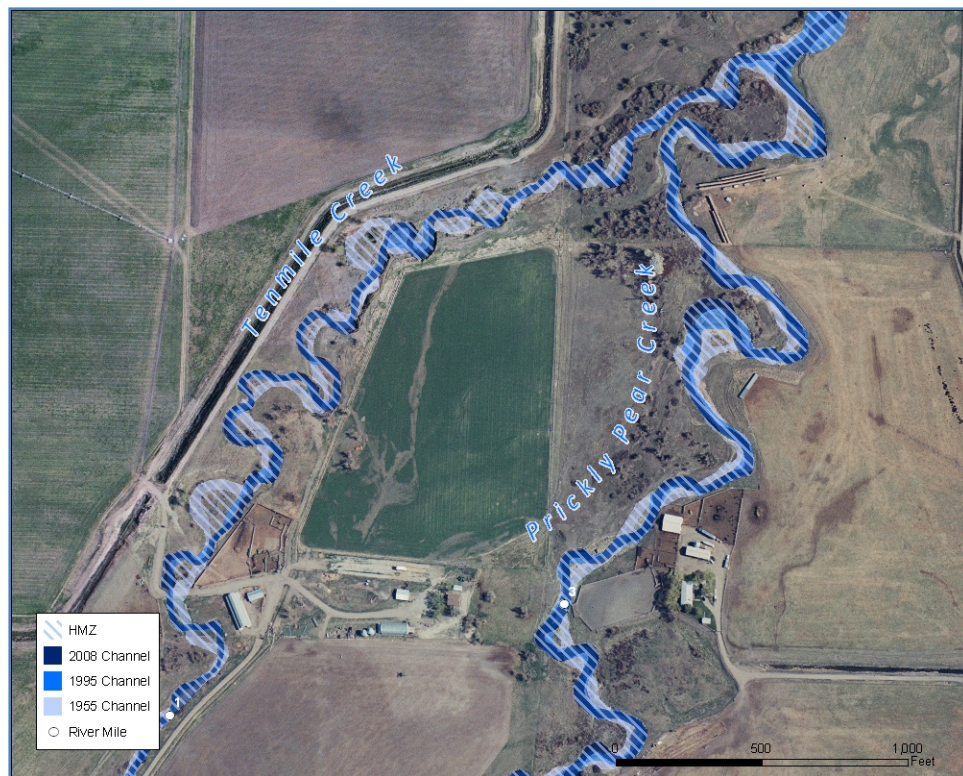
**Figure 28.** A section of Prickly Pear Creek and Tenmile Creek showing the Historic Migration Zone (HMZ), a composite of 1955, 1995/97, and 2008 channel locations.

The HMZ for the study area consists of the collective footprint created by the 1955, 1995/97, and 2008 bankfull channel polygons (Figure 28). All islands are included within the HMZ. Any future integration of additional intermediate air photo suites (e.g. 1978) may alter the footprint of the HMZ; however, it is most likely that these changes will be entirely masked by the overlying EHA (Section 4.2).

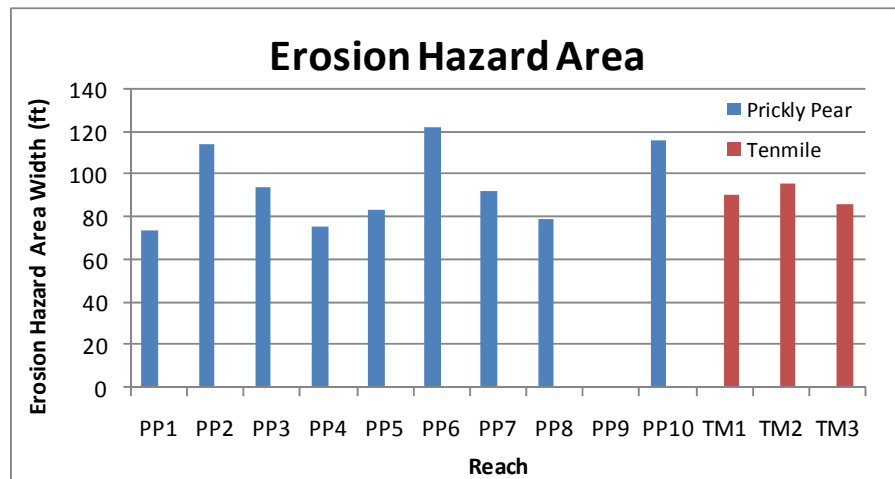
Figure 32. Erosion Hazard Area (EHA) buffers, Prickly Pear and Tenmile Creeks.

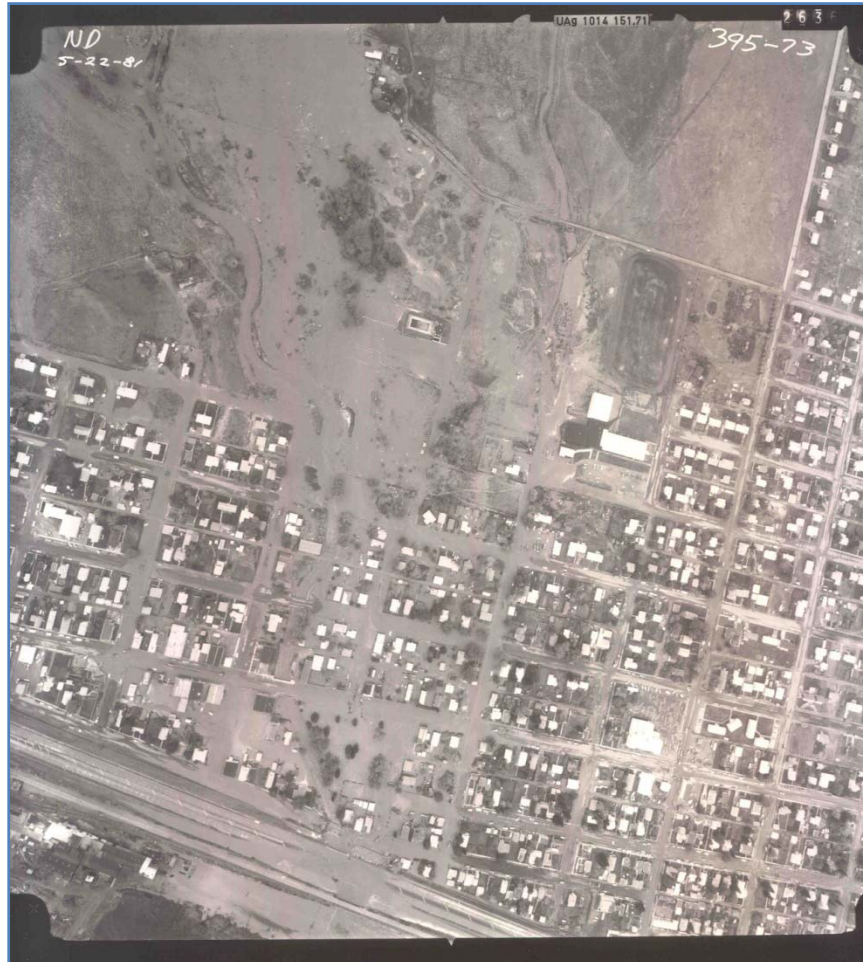
Figure 34. 1981 flood image showing flow spreading through and downstream of East Helena.

Avulsion hazards can be difficult to identify on broad floodplains, because an avulsion could occur virtually anywhere on the entire floodplain if the right conditions were to occur. Our approach to defining avulsion pathways is to develop criteria that identify a relatively high propensity for such an event. These criteria include bendway cores that are prone to cutoff, as well as relic floodplain channels that concentrate flow during floods. Flood photos, LiDAR data, and inundation modeling results were used to help identify floodplain channels (Figure 34 through Figure 36).

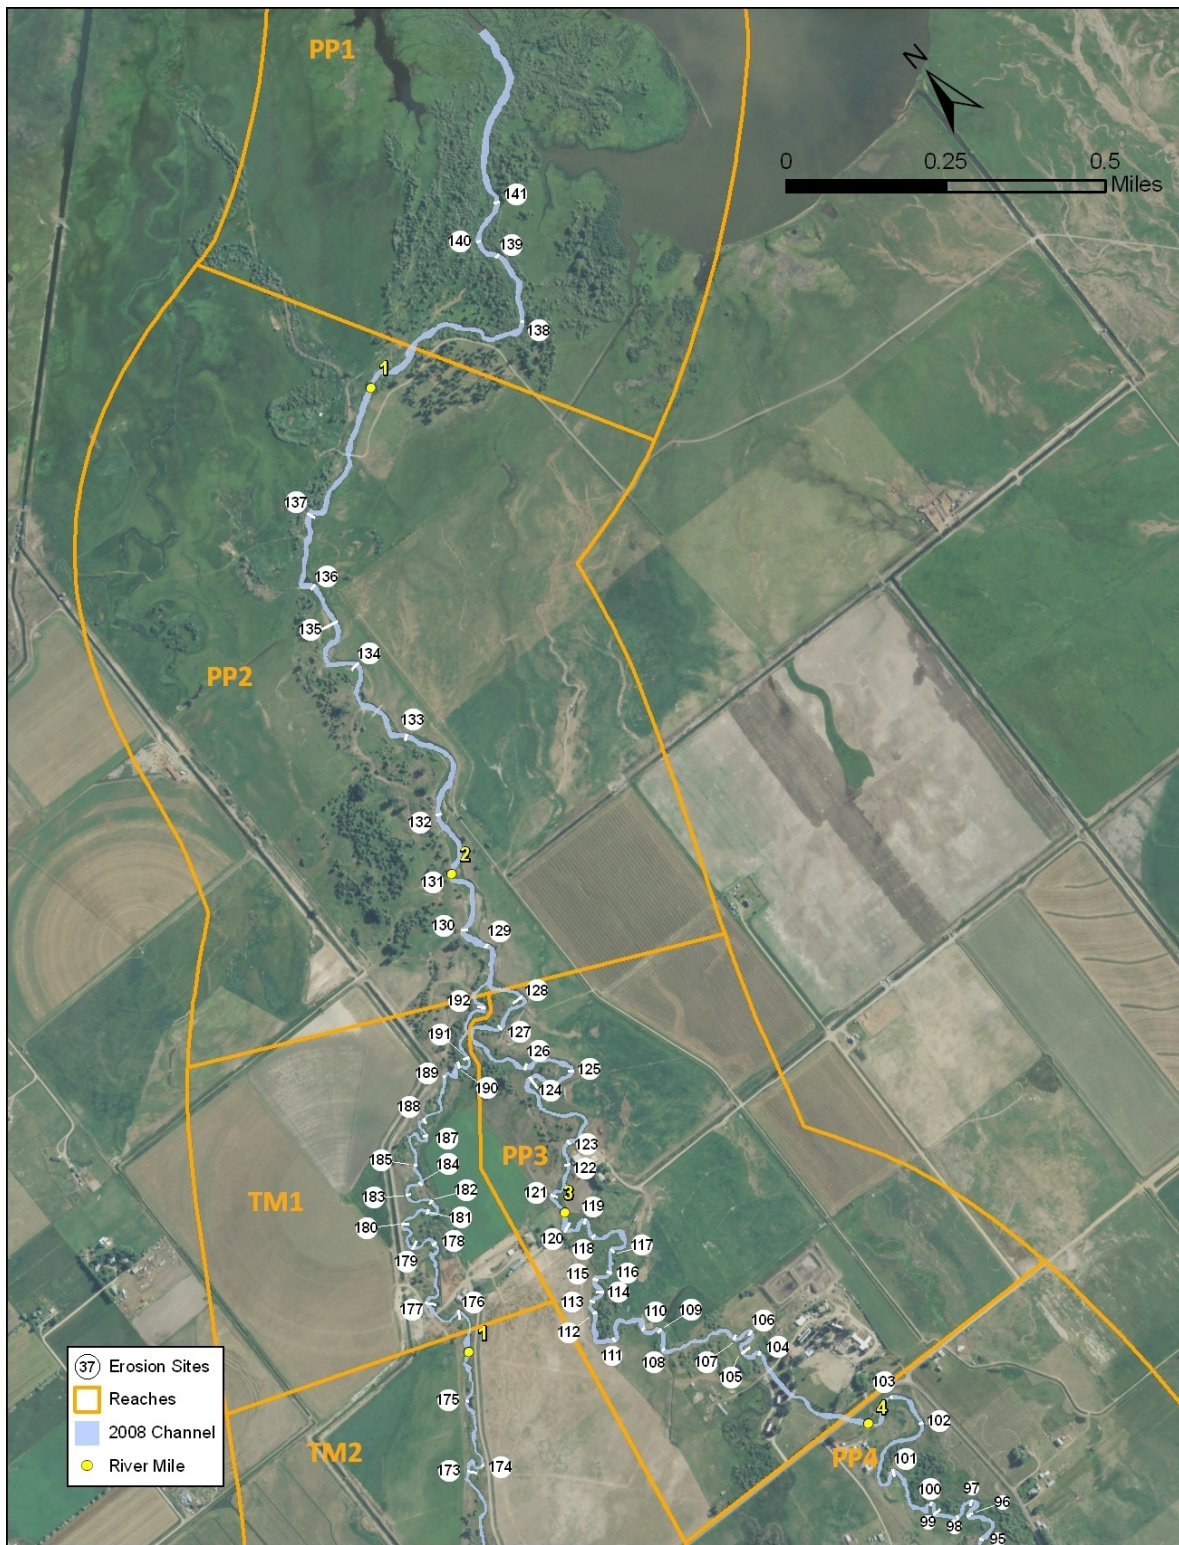
Figure 39. Reaches PP1-PP3. Note: site numbers are not sequential and relate to statistics in Appendix B.

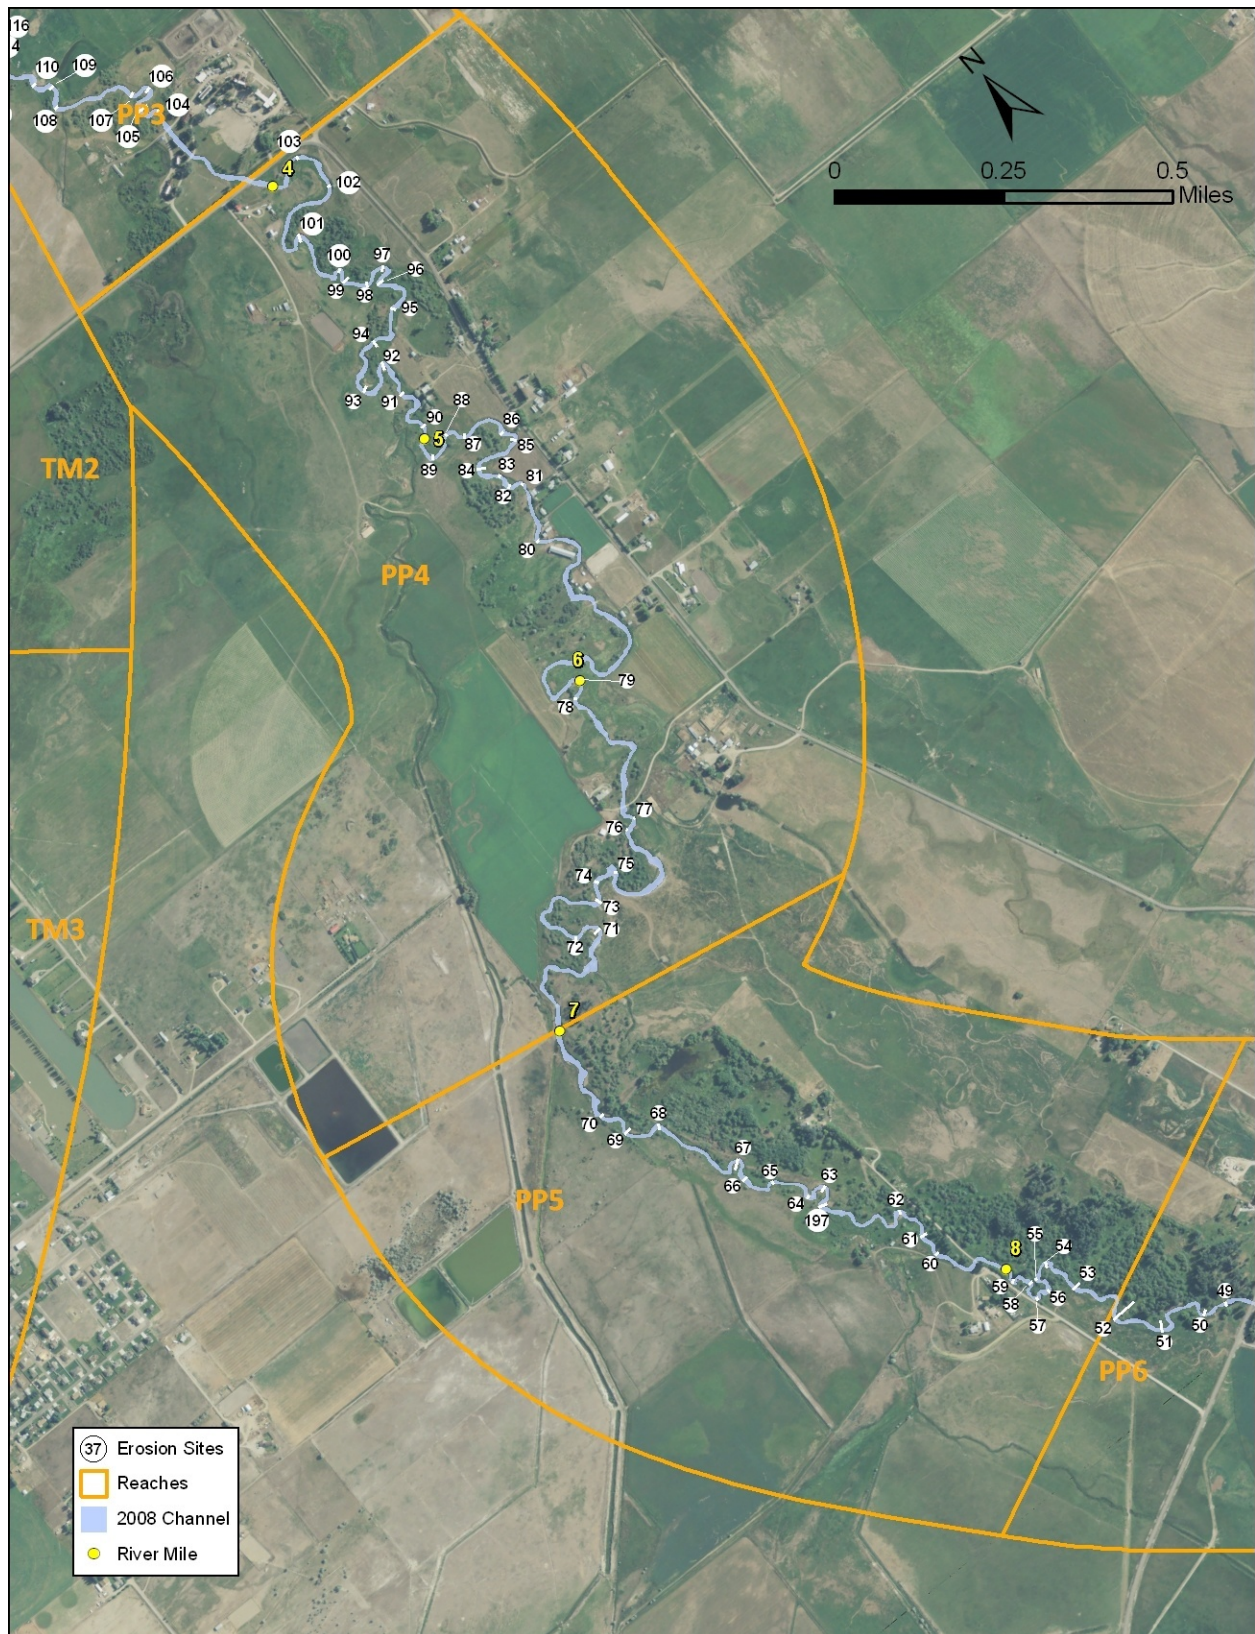
**Figure 40. Reaches PP4-PP5. Note: site numbers are not sequential and relate to statistics in Appendix B.**

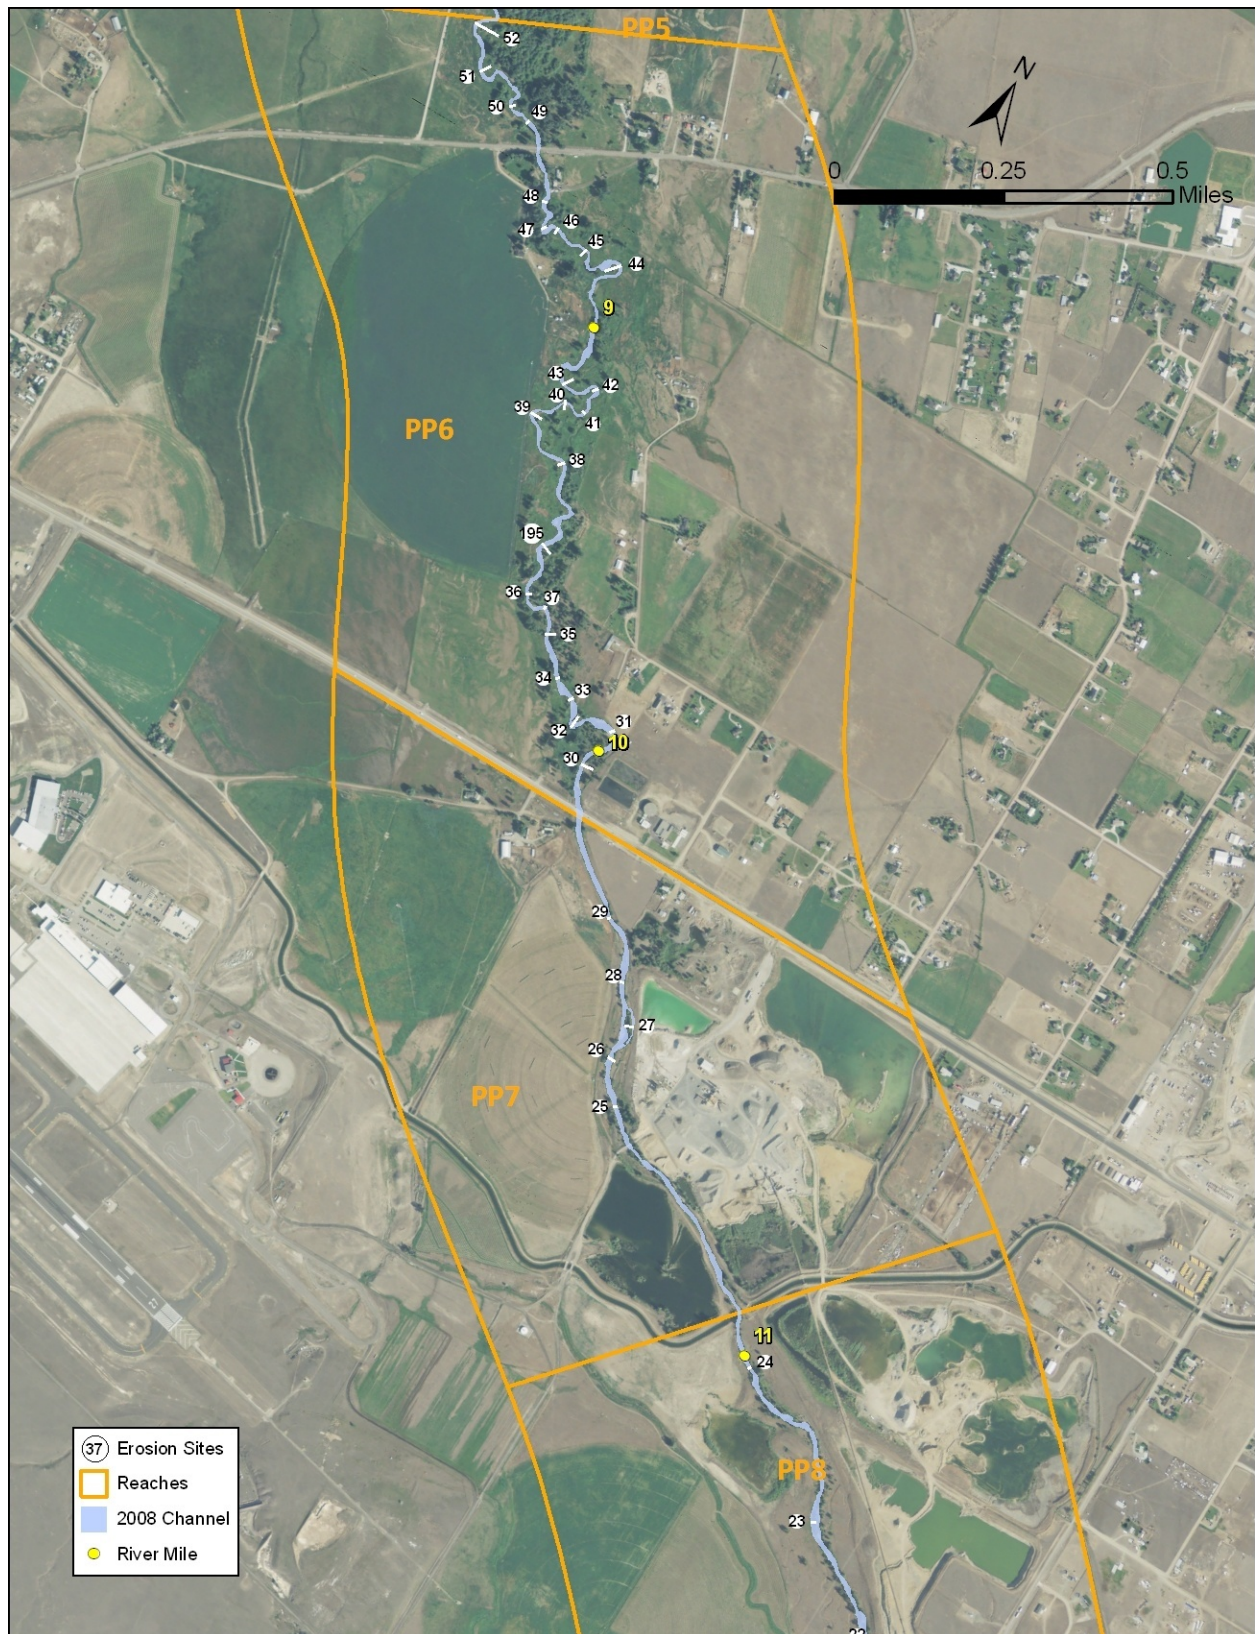
**Figure 41. Reaches PP6-PP8. Note: site numbers are not sequential and relate to statistics in Appendix B.**

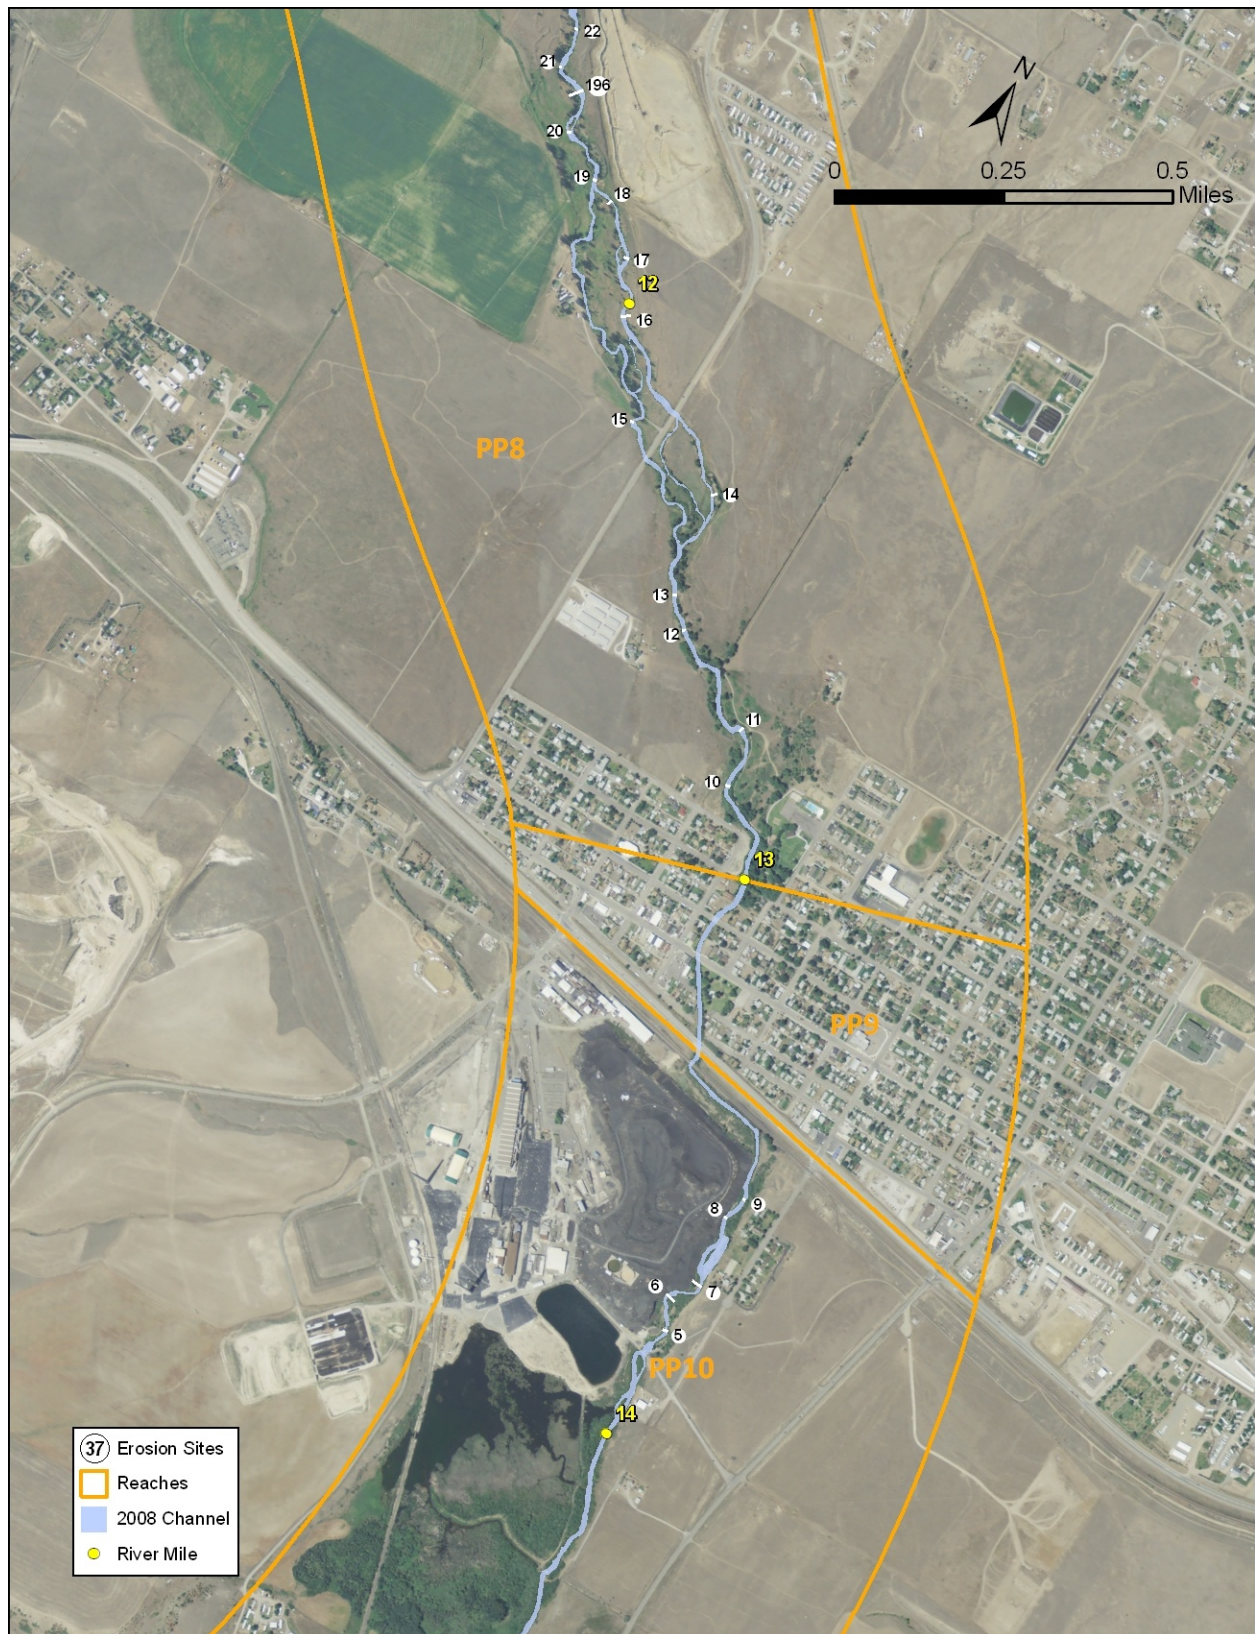
**Figure 42. Reaches PP8-PP10. Note: site numbers are not sequential and relate to statistics in Appendix B.**

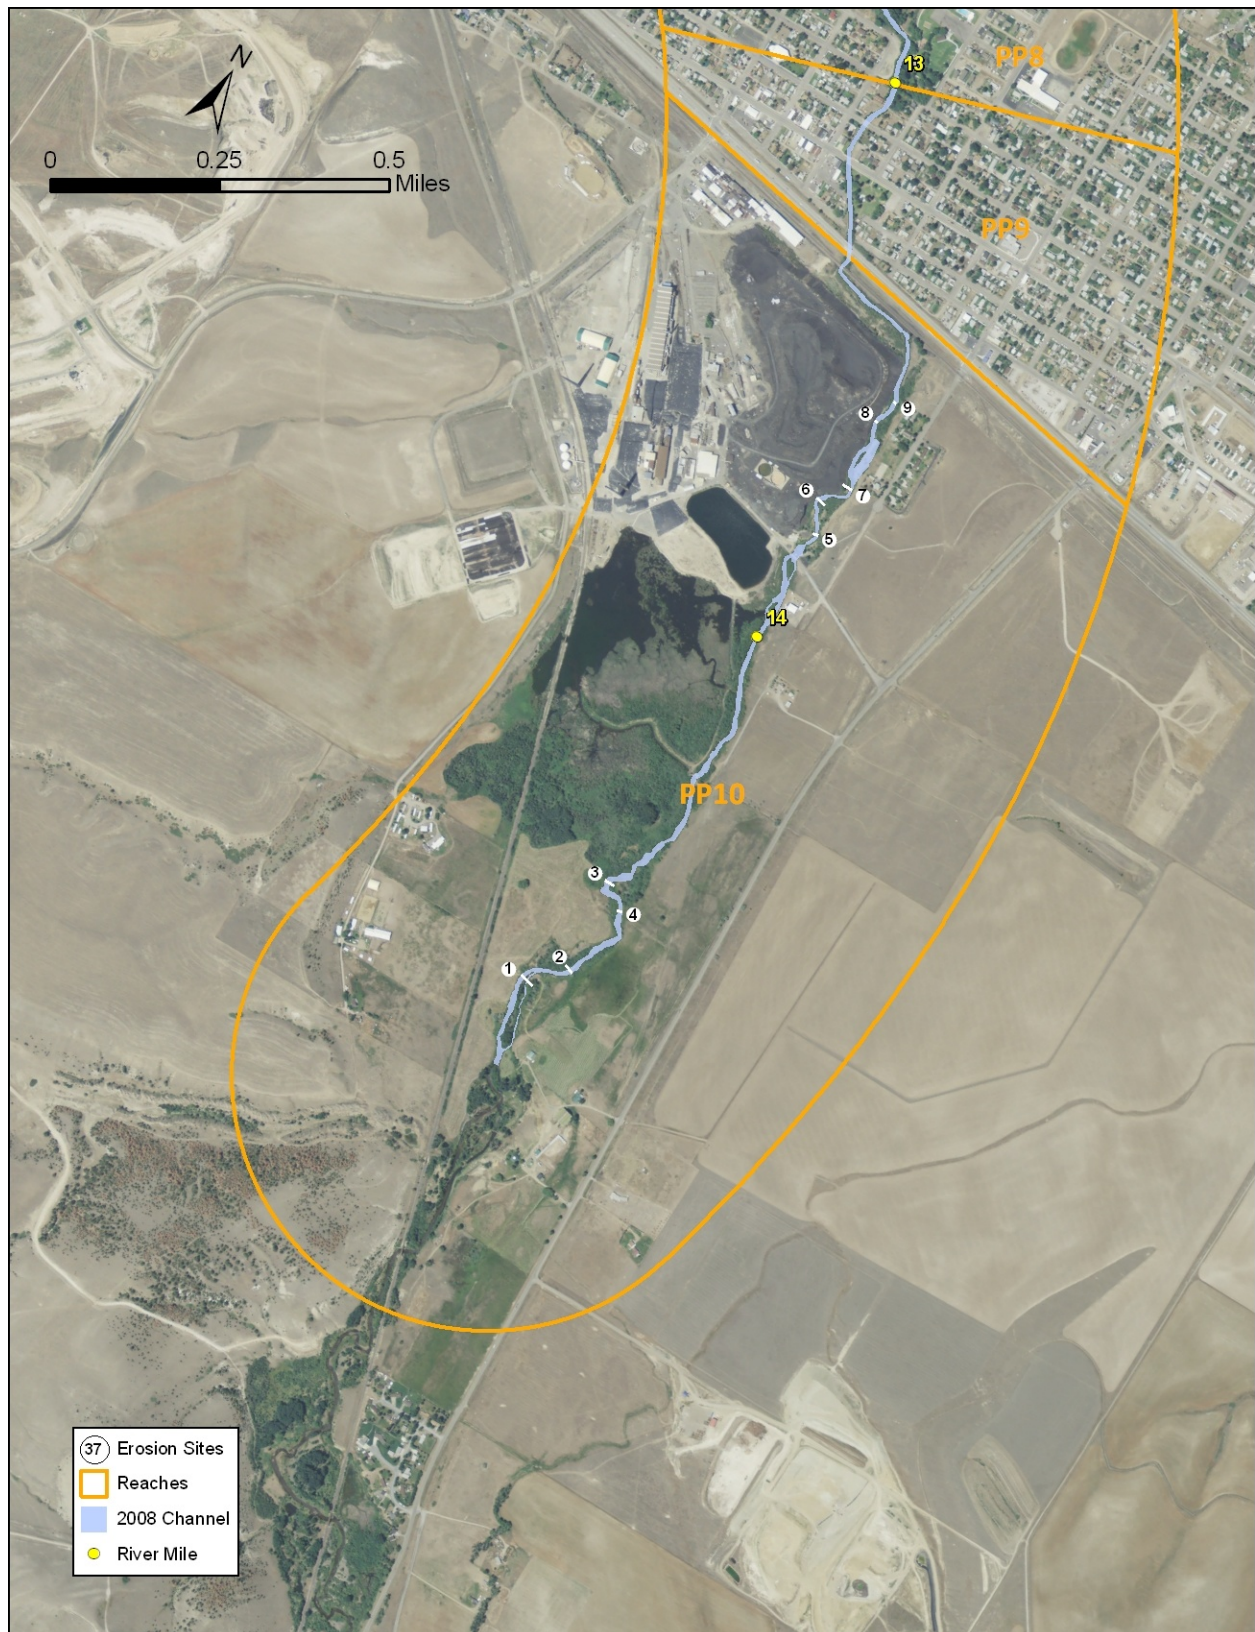
**Figure 43. Reaches PP9-PP10. Note: site numbers are not sequential and relate to statistics in Appendix B.**
