## Final Report

November 30, 2010\*

# Ruby River Channel Migration Zone Mapping

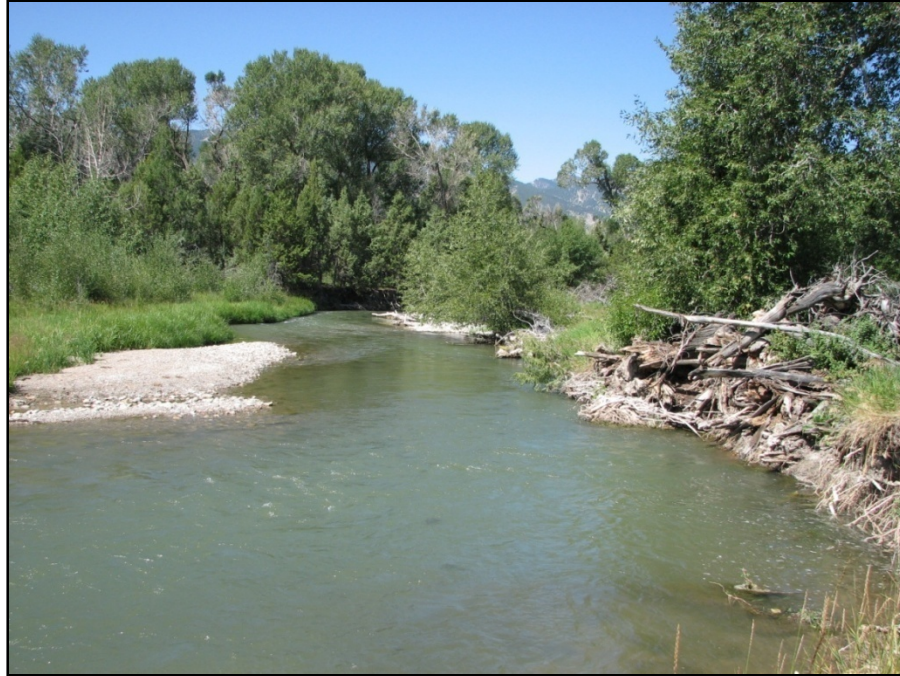
**Figure 1. Bar formation, wood recruitment, and riparian vegetation succession, Ruby River.**

The river tends to become finer-grained in the downstream direction. In the upper reaches, coarse gravel bars form discreet point bar features (Figure 1). The lower river is markedly finer grained, with a notable lack of point bars (Figure 15). An inventory of the Ruby River performed by the RVCD (Alvin, 1998) indicates that the system hosts coarse gravel deposits in the upper portions of the project area, and fines in the downstream direction below Alder (Figure 16).

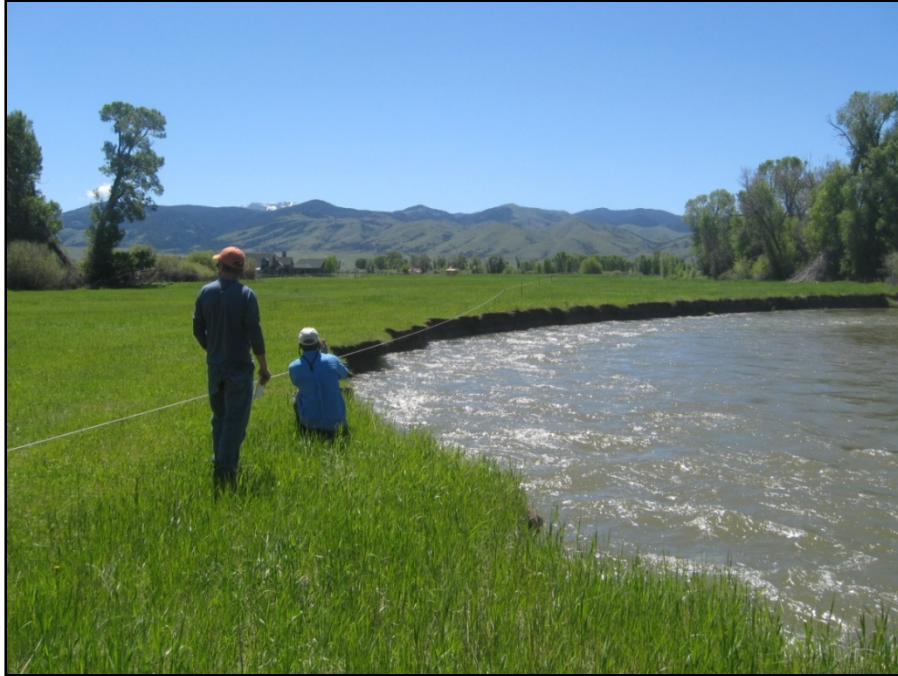
Figure 3. Active bank erosion and channel migration, Ruby River (Spring, 2010).

Over a given timeframe, the Ruby River occupies a corridor that extends beyond its current channel boundaries (Figure 2). The width of this corridor reflects rates of lateral migration. Some banklines migrate relatively slowly due to low stream energy or erosion-resistant perimeter materials. Conversely, some banks migrate rapidly where the stream energy and sediment loads are relatively high and the erosion resistance of the channel perimeter is low (Figure 3).

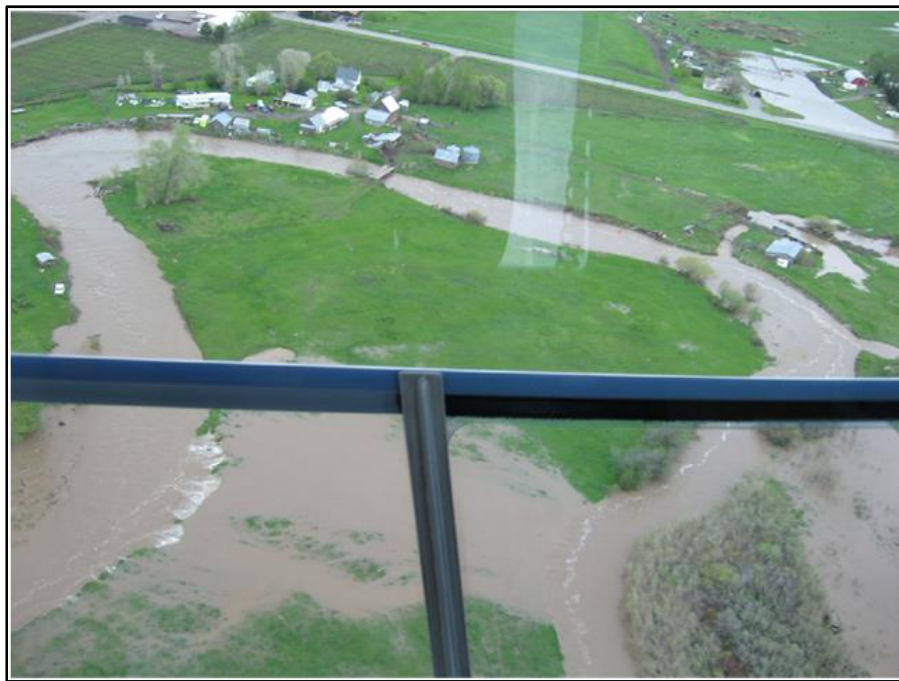
**Figure 5. Example of the avulsion process, East Gallatin River May 2008 (DNRC).**

The photo shown in Figure 5 was taken from a helicopter by DNRC staff during the 2008 flood on the East Gallatin River near Bozeman, Montana. The photo shows a typical bendway on the East Gallatin, with floodwaters flowing over the core of the bend. On the downstream end of the bend (left side of photo), the overflows re-enter the main channel over a steep bank edge, creating a headcut. If the flood is large enough, or of long enough duration, the headcut will migrate up-valley through the core of the bend and excavate a cutoff channel. On this particular bend, the flood dissipated before cutoff occurred, resulting in a “failed avulsion”. Numerous bendway cutoffs have occurred on the Ruby River since 1955 (Figure 6). During spring runoff of 2010, the Ruby River was out of bank for several weeks, creating avulsion hazards across the cores of bendways (Figure 7).

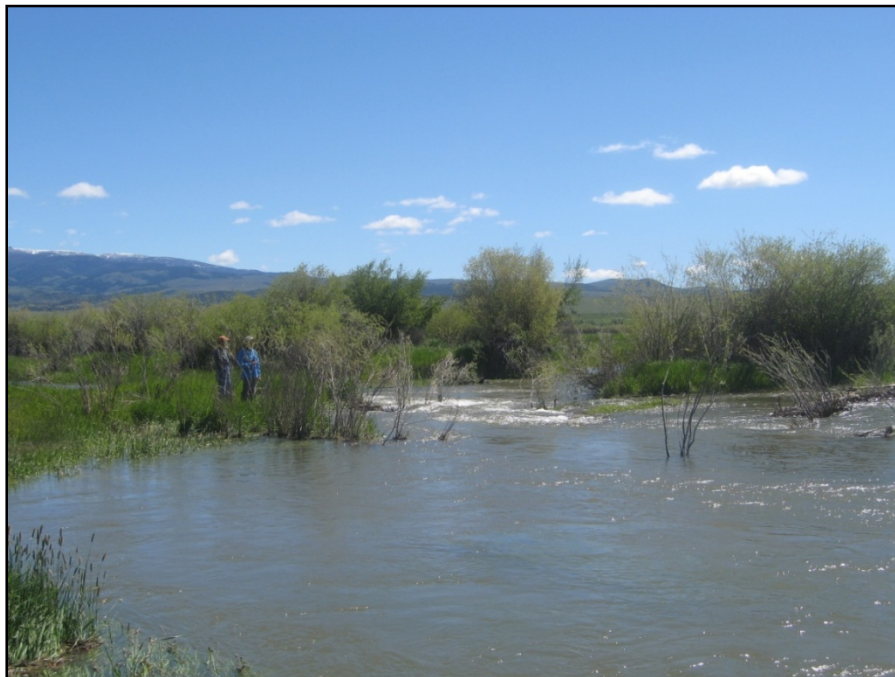
**Figure 7. Spring 2010 overbank flows creating avulsion hazard on Ruby River (S. Gillilan).**

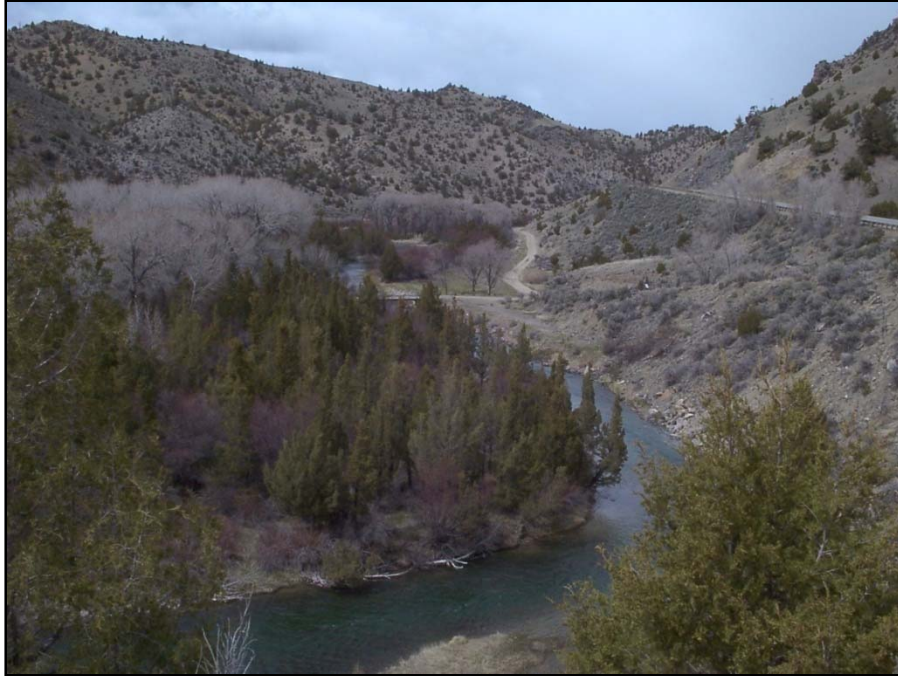
**Figure 11. Ruby River canyon section below Ruby Reservoir.**

Just below the reservoir, the Ruby River flows through a confined canyon that is bounded by Archean-age amphibolites, quartzites, and marble (Figure 11). These rocks are extremely old, having formed over 2.5 billion years ago (St. Jean and Teeter, 2004). These rocks confine the river within a ~500 ft-wide corridor for the first several miles of the project reach.

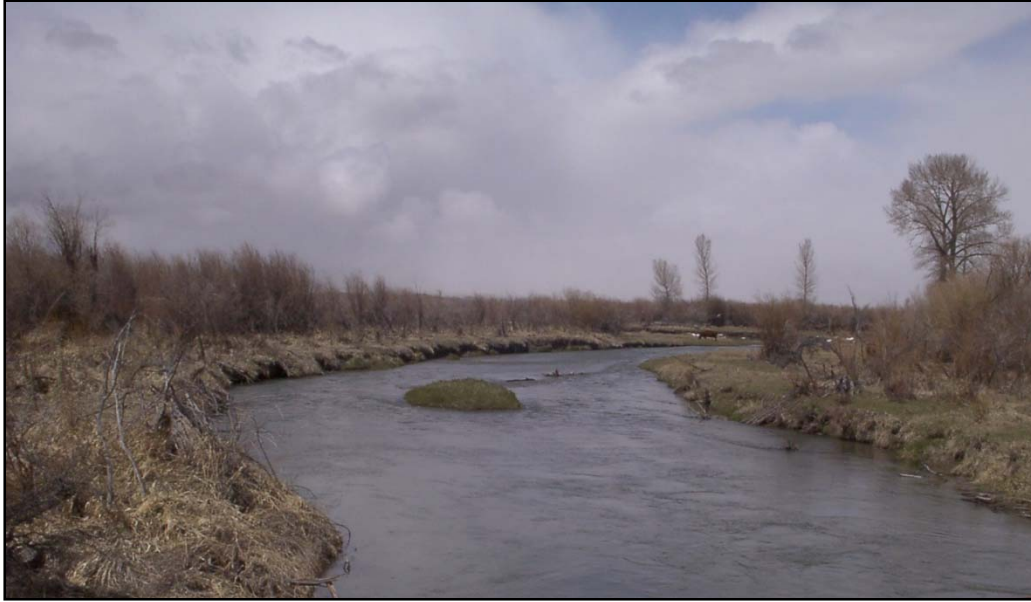
**Figure 15. Lower Ruby River showing low floodplain and lack of coarse bar features.**

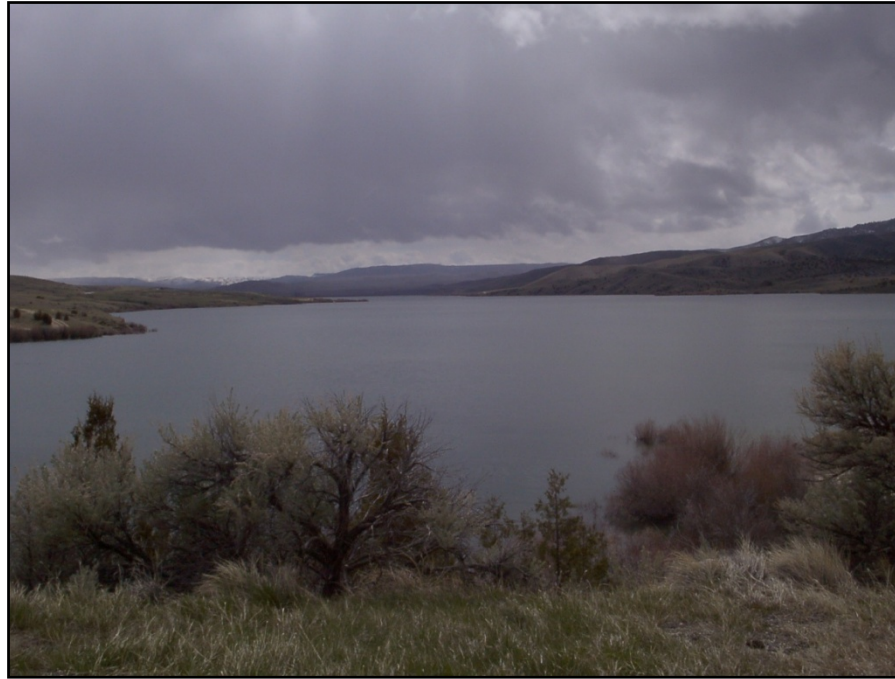
Figure 17. Ruby Reservoir.

The hydrology of the project reach largely reflects the managed flow releases through the Ruby Dam, a 111 ft high structure that was completed in 1939 (State of Montana Natural Hazards Mitigation Plan, 2001). Ruby Dam is a state-owned water project that impounds Ruby Reservoir, a 38,000 acre-foot impoundment managed primarily for irrigation water storage and flood control (Figure 17). The following is a brief summary of project reach hydrology, including average flow conditions as well as flood history.

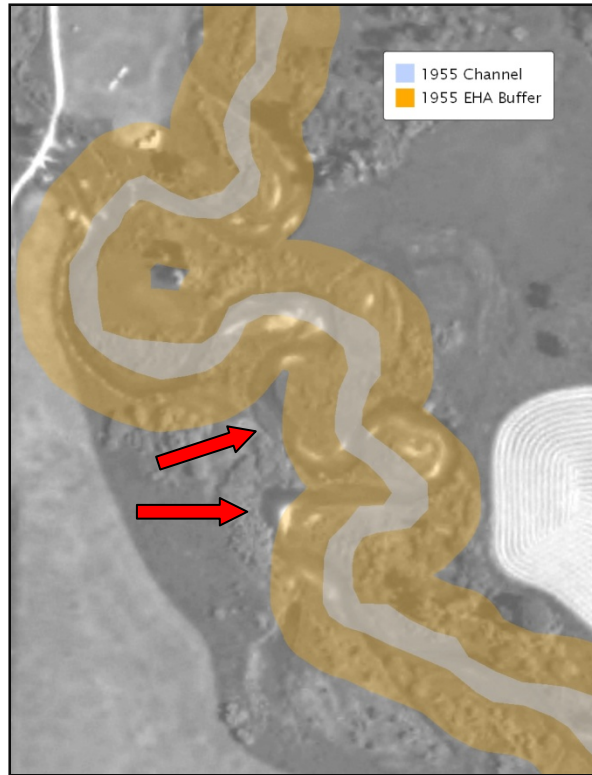
**Figure 28. Example of locations where 1955-2009 migration would have exceeded buffers.**

An important empirical test of the buffer widths is the application of the calculated buffers to the 1955 banklines, and determination of the number of sites that would have migrated through the buffer by 2009, 54 years later. In other words, if we had created these EHA buffers in 1955, how would they have performed by 2009? For Reaches 1 through 7, no more than 4% of the erosion sites would have reached the buffers edge between 1955 and 2009 (Figure 27). These sites are statistical outliers that demonstrate the fact that where bank erosion is exceptionally rapid, banklines may locally exceed the buffer over the next century. An area of extremely rapid migration in Reach 4 (just upstream of Clear Creek) where the buffers would have been exceeded is shown in Figure 28.
