County	Sweet Grass	Upstream River Mile	478.8
Classification	PCB: Partially confined braided	Downstream River Mile	475.4
General Location	Springdale	Length	3.40 mi (5.47 km)

Narrative Summary

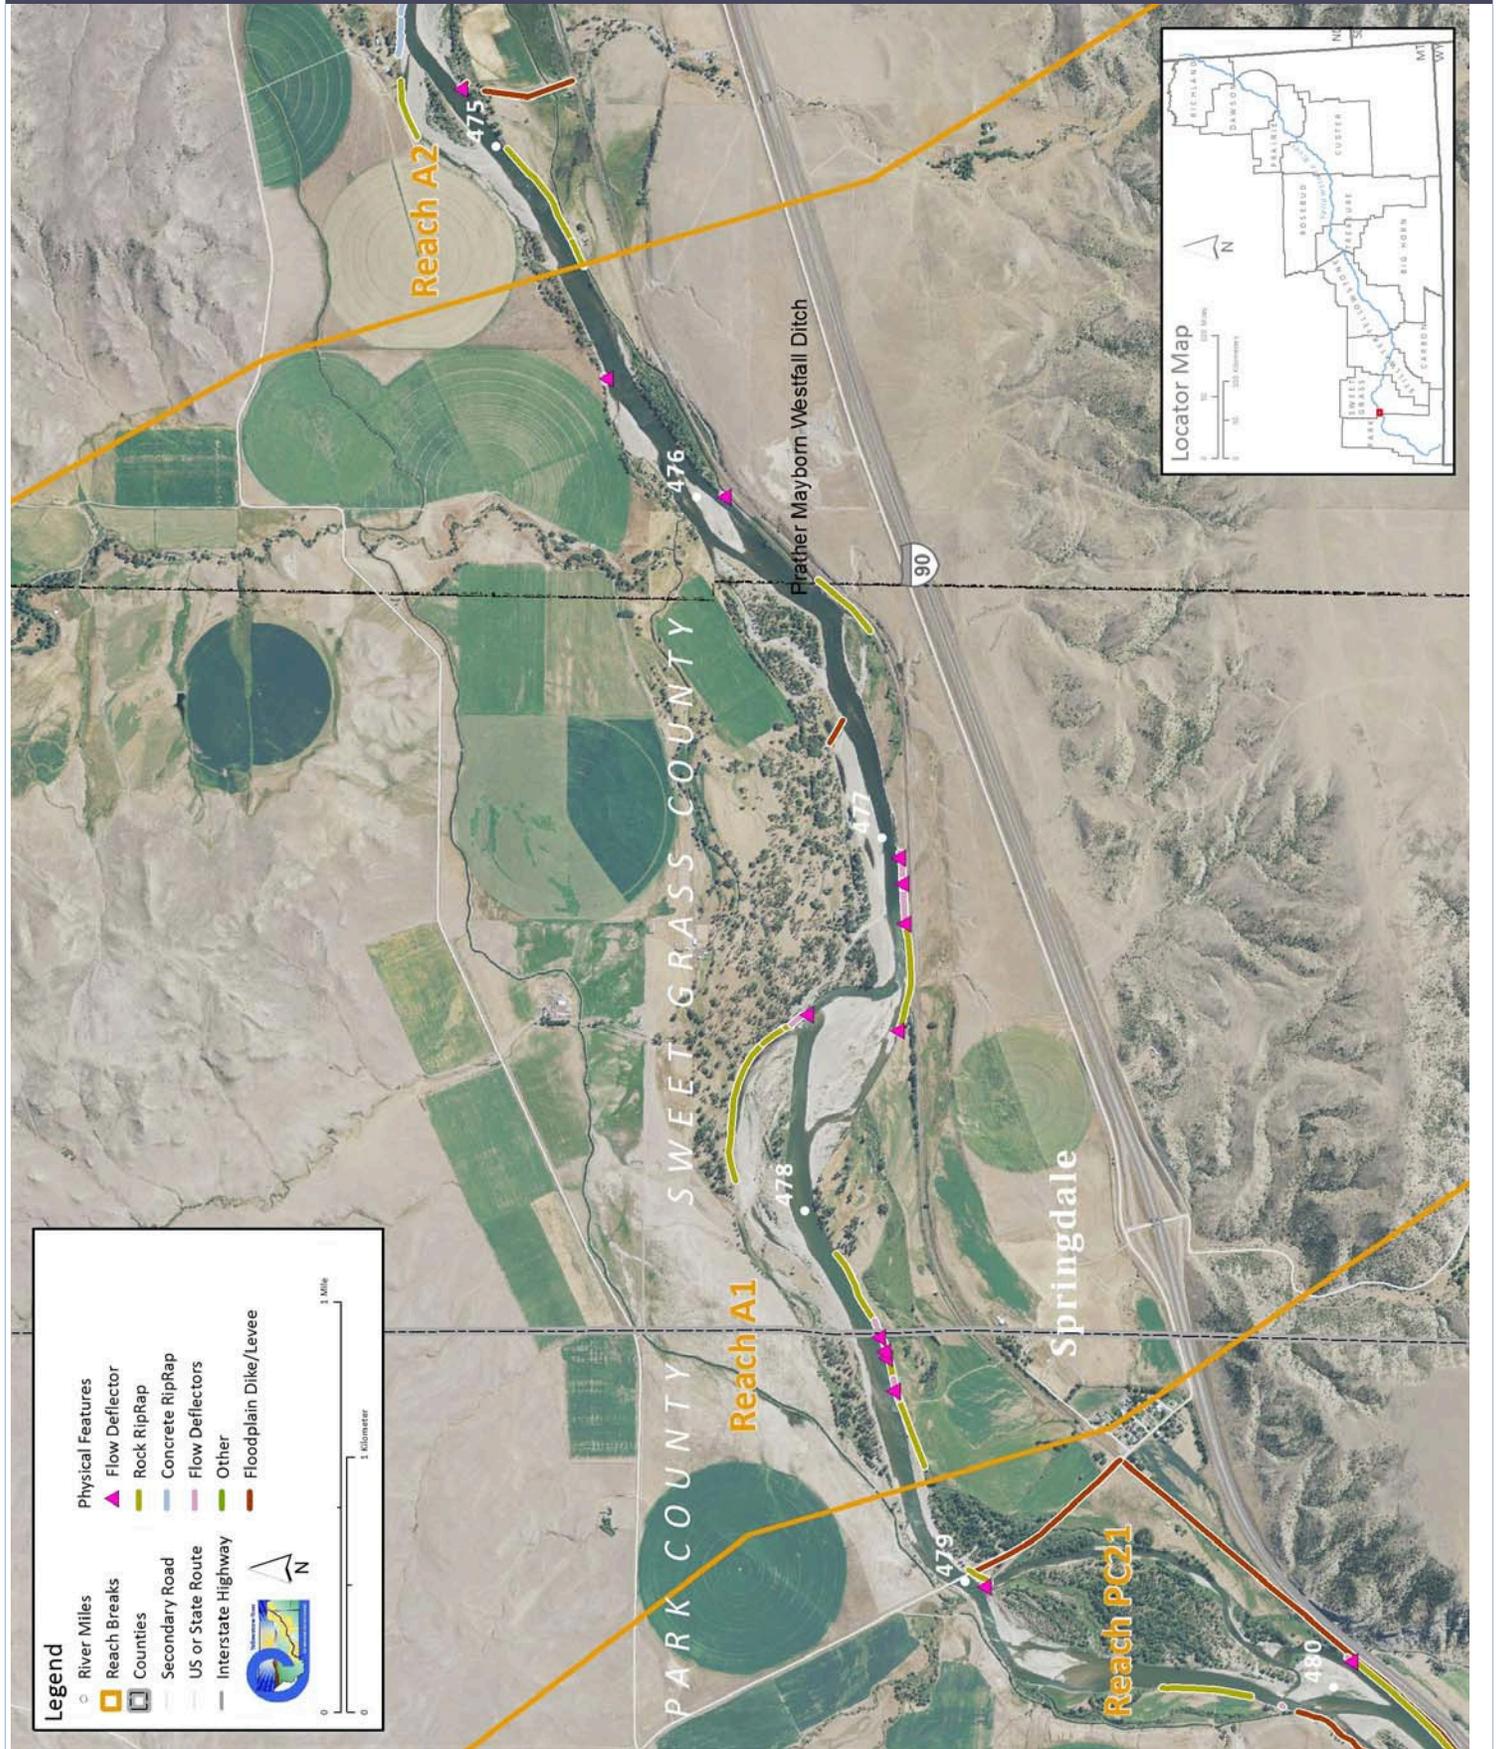
PHYSICAL FEATURES MAP (2011)

There are about 6,800 feet of rock riprap in the reach, over 1,500 feet of which was constructed since 2001. Several flow deflectors have been eroded out in Reach A1 since 2001. About 25 percent of the bankline was armored as of 2011. There are also over 6,800 feet of mapped transportation encroachment in the river corridor, most of which is the rail line that follows the south bank.
