Yellowstone River Reach Narratives

Reach C16

County	Custer	Upstream River Mile	192.3
Classification	PCM/I: Partially confined meandering/islands	Downstream River Mile	185
General Location	to Miles City	Length	7.30 mi (11.75 km)

Narrative Summary

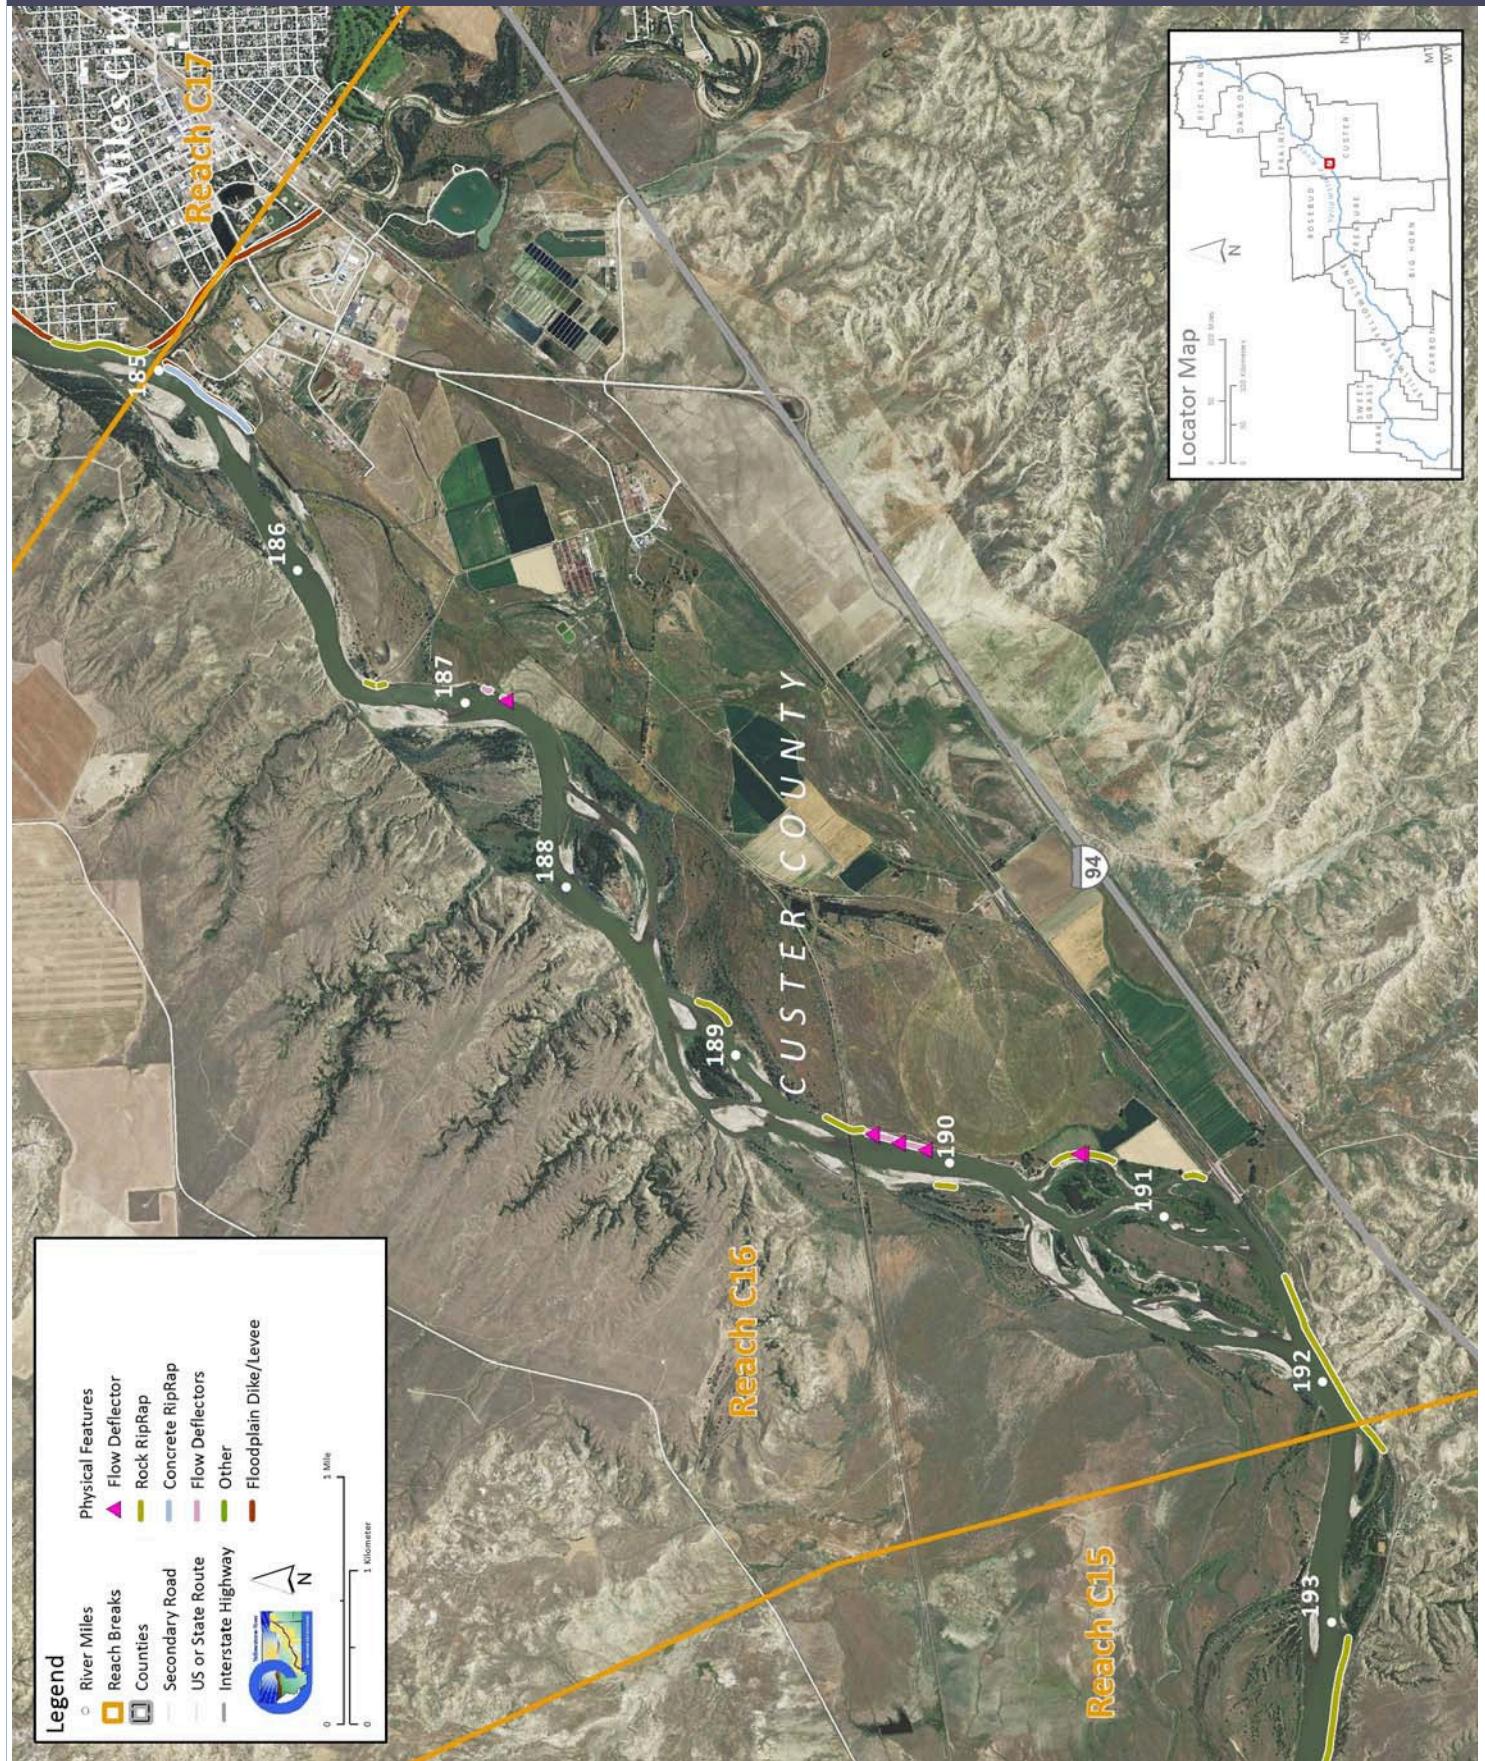
PHYSICAL FEATURES MAP (2011)

As of 2011 there were about two miles of armor protecting 14 percent of the total bankline in Reach C16, including 7,000 feet of rock riprap, 2,200 feet of concrete riprap, and 1,550 feet of flow deflectors. All of the concrete armor is protecting urban areas around the water treatment plant in Miles City. The flow deflectors protect non-irrigated agricultural land, and the rock riprap is protecting agricultural land (irrigated and non-irrigated), roads, and the rail line. A ~550 foot-long stretch of armor at RM 190.5R has been flanked since 2001, and erosion behind the armor now threatens a road; the river has locally eroded into the road embankment. There were also several miles of transportation encroachments and floodplain levees mapped in the reach.

At RM 186.6 a steel trestle bridge built for the now abandoned Milwaukee Railroad crosses the river where it is about 1,000 feet wide. There are several very large barbs on the right bank of the river upstream of the bridge that extend about 100 feet off of the bank, and there is riprap directly under the structure.

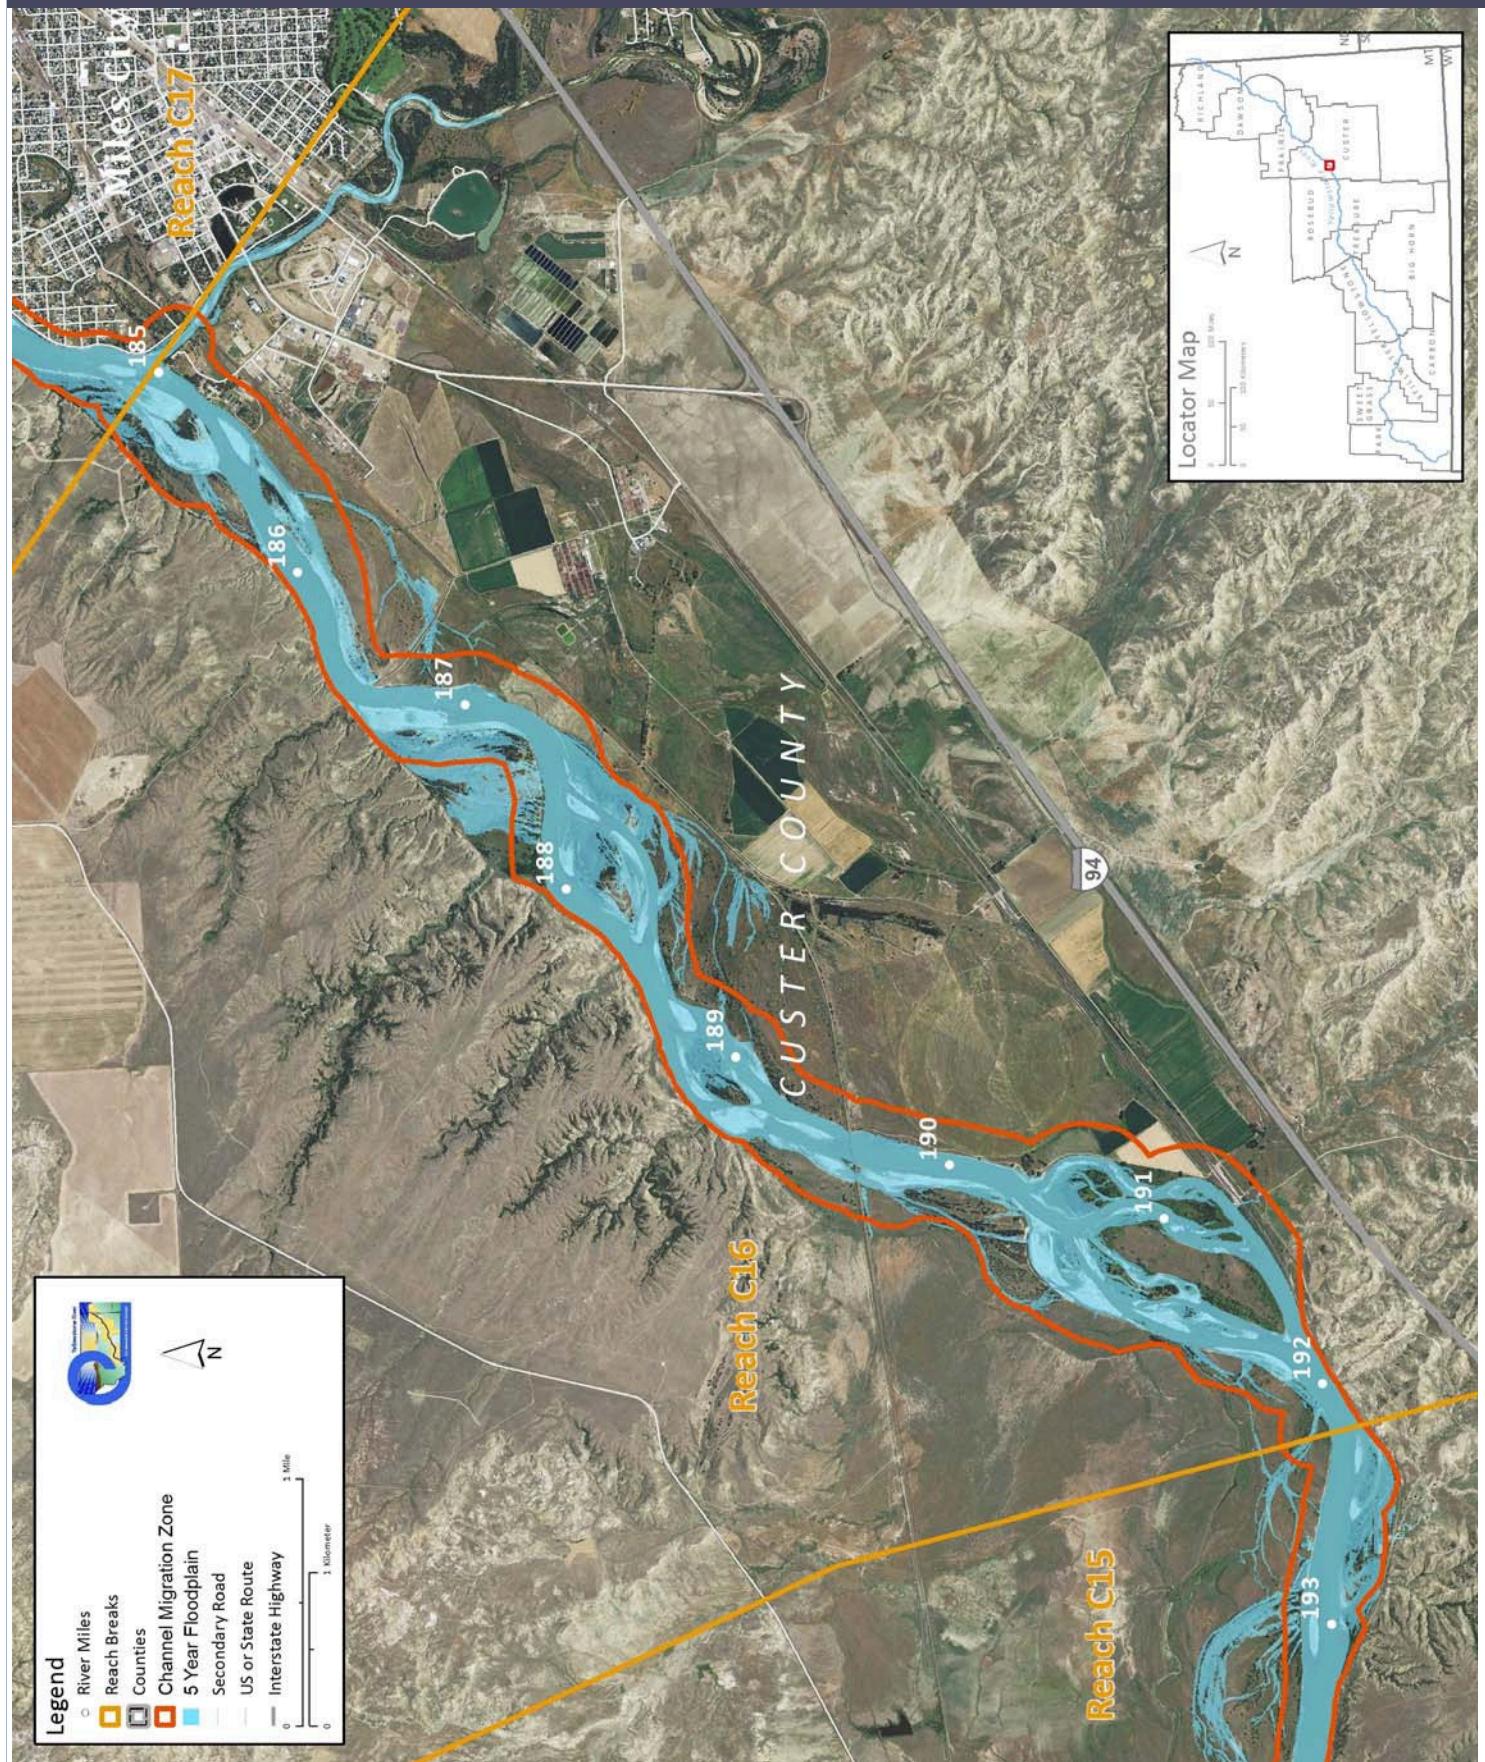
CHANNEL MIGRATION ZONE MAP

About 210 acres which represents 9 percent of the total CMZ have become restricted by physical features. Areas that have become restricted to channel migration include the water treatment plant just upstream of the mouth of the Tongue River, behind the railroad grade at RM 191.5, and locally behind stretches of bank armor protecting irrigated and non-irrigated fields.
