County	Treasure	Upstream River Mile	275
Classification	UA: Unconfined anabranching	Downstream River Mile	269.4
General Location	Mission Valley	Length	5.60 mi (9.01 km)

### Narrative Summary

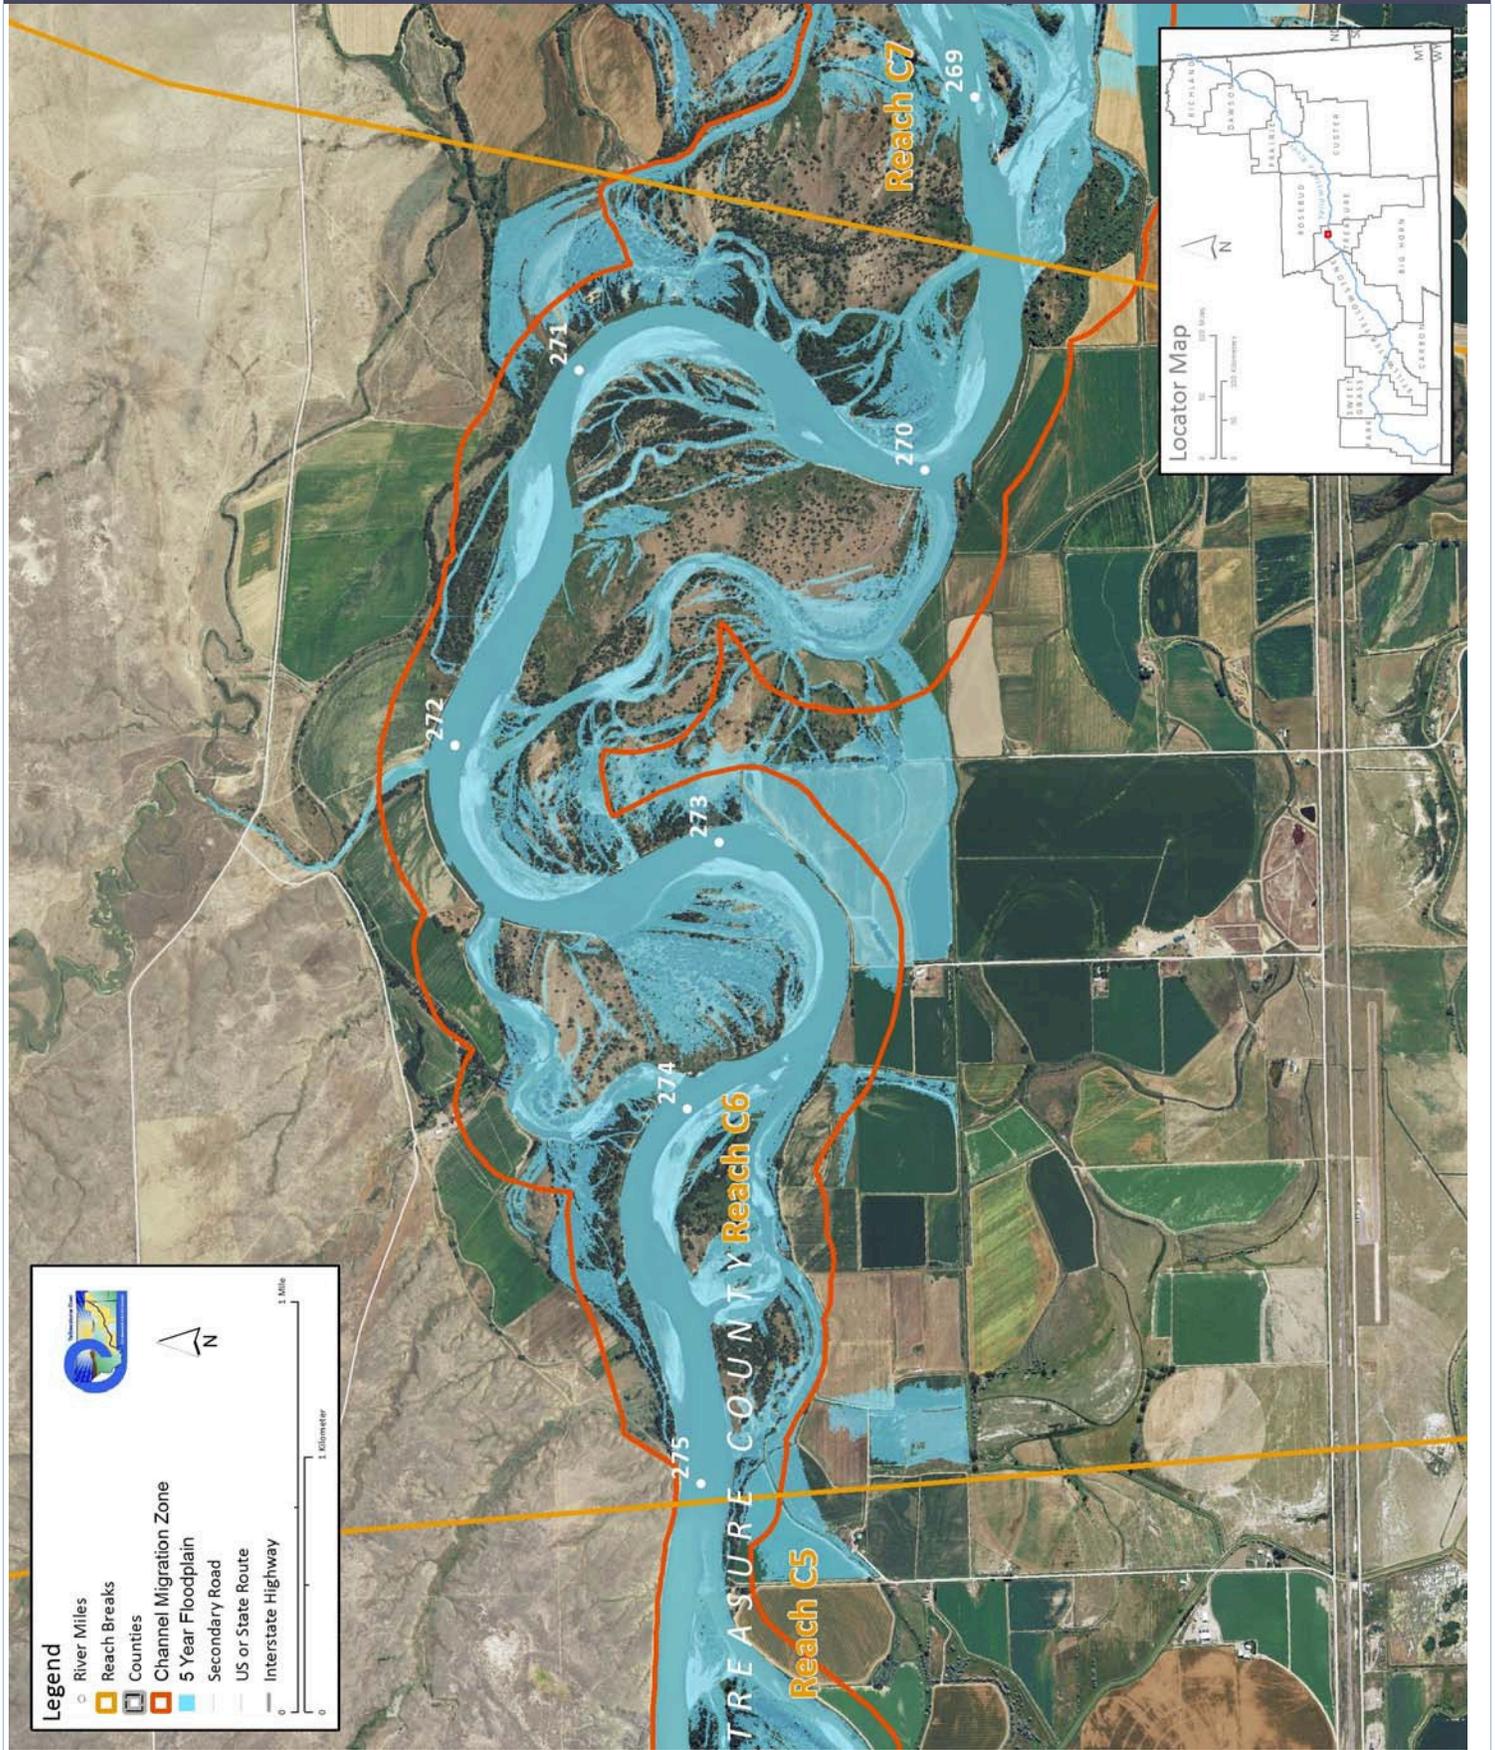
## CHANNEL MIGRATION ZONE MAP

Land use is dominated by agriculture, with 188 acres of pivot irrigation development since 1950. There are about 260 acres of flood irrigated land within the CMZ, but due to the lack of bank armor, none of the CMZ has become restricted.
