<b>County</b>	Dawson	<b>Upstream River Mile</b>	89
<b>Classification</b>	PCA: Partially confined anabranching	<b>Downstream River Mile</b>	81.4
<b>General Location</b>	Downstream of Glendive	<b>Length</b>	7.60 mi (12.23 km)

### Narrative Summary

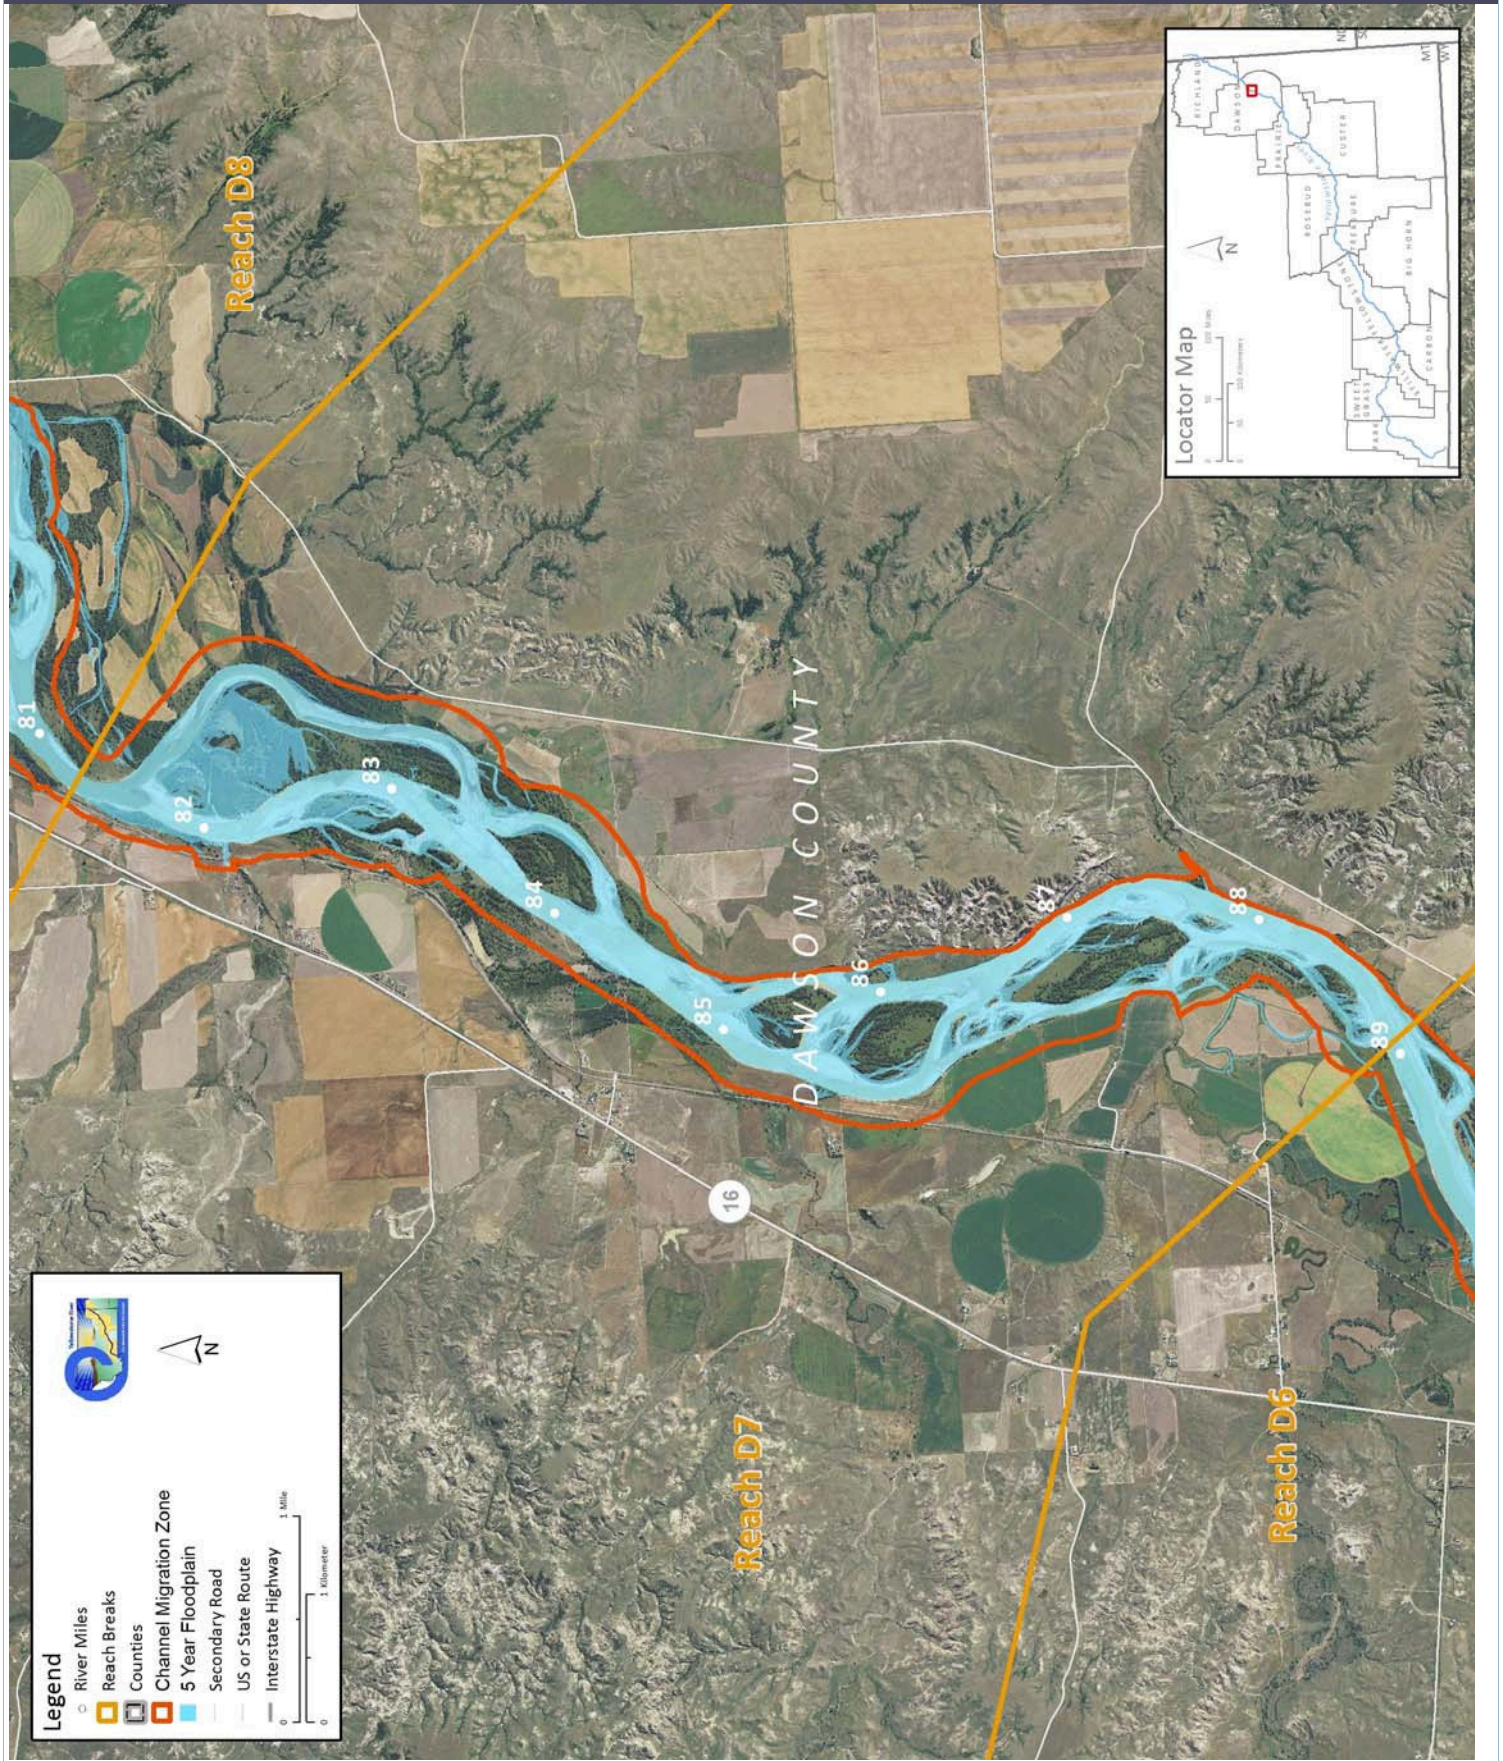
## CHANNEL MIGRATION ZONE MAP

5 Year	395.2	48%				
100 Year	43.6	2%				
<b>Restricted Migration Area</b>	<b>Acres</b>	<b>% of CMZ</b>	<b>Channel Migration Zone restrictions refer to the area and percent of the CMZ that has been isolated by features such as bank armor, dikes, levees, and transportation embankments.</b>
