County	Park	Upstream River Mile	564.8
Classification	CS: Confined straight	Downstream River Mile	560.2
General Location	Gardiner to Little Trail Cr.	Length	4.60 mi (7.40 km)

Narrative Summary

Reach PC1 is the upstream-most reach of the project area, beginning at Gardiner Montana, and extending northward almost five miles to the Trail Creek confluence. Reach PC1 is confined/straight reach type and shows minimal impact in terms of flow alterations, bank armoring, and side channel loss. The bankfull area has remained essentially unchanged since 1950. Land use is dominated by non-irrigated agriculture, with some conversion of flood irrigation to sprinkler from 1950 to 2011. There are over 300 acres of urban/exurban development in the reach, dominated by the town of Gardiner. Although the development in Gardiner is very close to the river, it is located high on bluffs that are outside of the Channel Migration Zone (CMZ) and floodplain. The bluffs are composed of glacial outwash deposits that are very coarse and erosion resistant. The total CMZ area in Reach PC1 is only 115 acres, and there is essentially no riparian zone in this reach. This section of river is relatively steep, with s

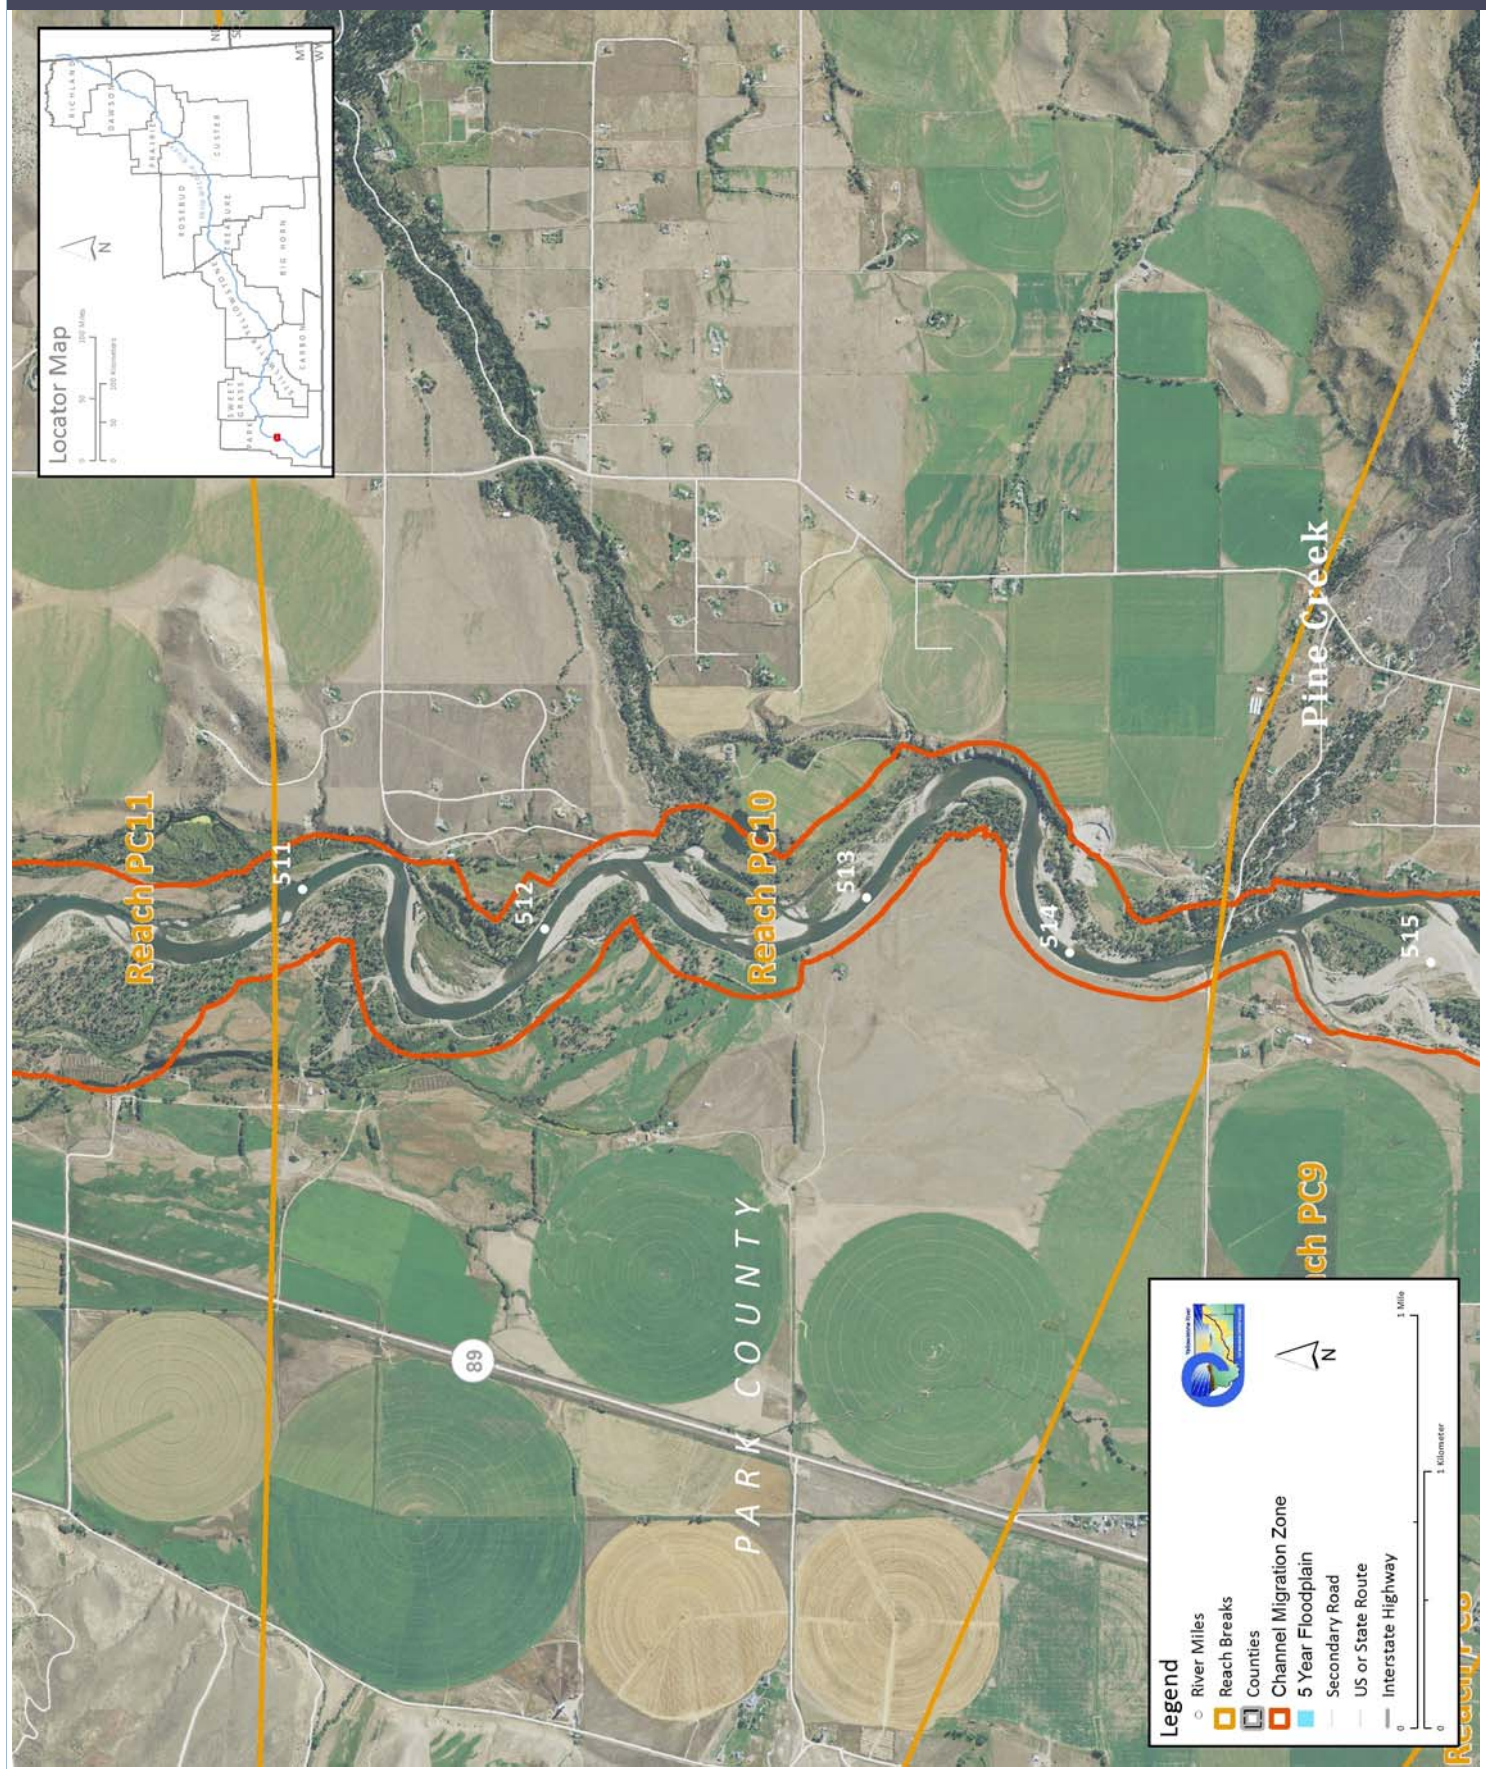
CHANNEL MIGRATION ZONE MAP

- Extensive dike construction Floodplain dikes constructed to protect spring creek fisheries have narrowed the active meander corridor
- Exurban encroachment into the Channel Migration Zone (CMZ) has occurred on terrace surfaces
- Gravel pit and recreational pond development in a meander core may contribute to avulsion risk in the reach.
- Rapid dike construction and armoring following major flooding (1996/1997).
- Increase in primary channel length (sinuosity) with loss of side channels.
- Isolation of 38 percent of the CMZ, mostly avulsion hazard areas that support spring creeks.
