County	Park	Upstream River Mile	564.8
Classification	CS: Confined straight	Downstream River Mile	560.2
General Location	Gardiner to Little Trail Cr.	Length	4.60 mi (7.40 km)

### Narrative Summary

Reach PC1 is the upstream-most reach of the project area, beginning at Gardiner Montana, and extending northward almost five miles to the Trail Creek confluence. Reach PC1 is confined/straight reach type and shows minimal impact in terms of flow alterations, bank armoring, and side channel loss. The bankfull area has remained essentially unchanged since 1950. Land use is dominated by non-irrigated agriculture, with some conversion of flood irrigation to sprinkler from 1950 to 2011. There are over 300 acres of urban/exurban development in the reach, dominated by the town of Gardiner. Although the development in Gardiner is very close to the river, it is located high on bluffs that are outside of the Channel Migration Zone (CMZ) and floodplain. The bluffs are composed of glacial outwash deposits that are very coarse and erosion resistant. The total CMZ area in Reach PC1 is only 115 acres, and there is essentially no riparian zone in this reach. This section of river is relatively steep, wi

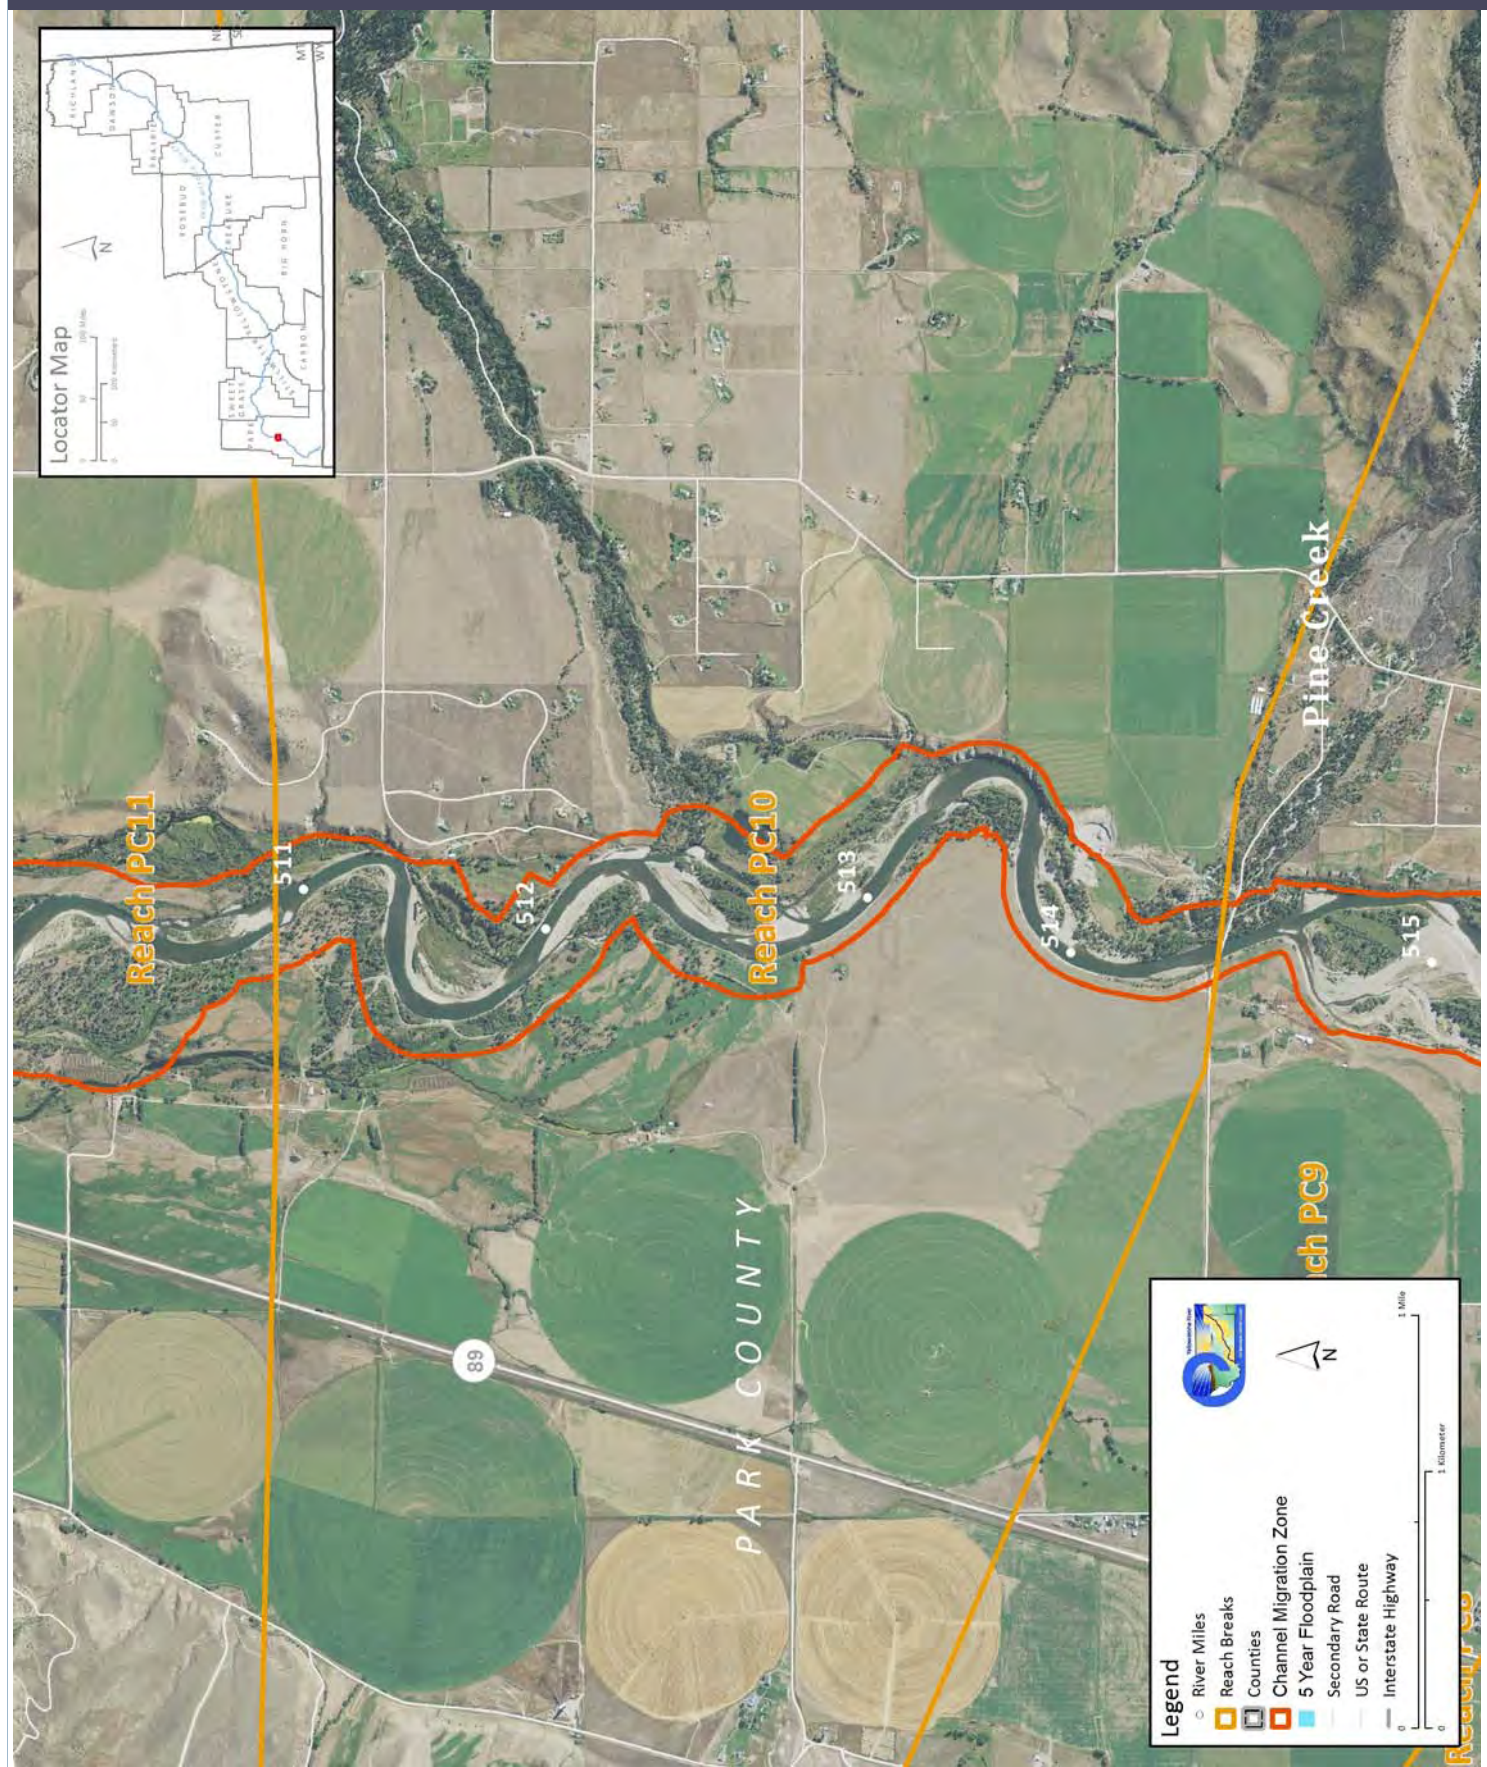
### CHANNEL MIGRATION ZONE MAP

- Extensive dike construction Floodplain dikes constructed to protect spring creek fisheries have narrowed the active meander corridor
- Exurban encroachment into the Channel Migration Zone (CMZ) has occurred on terrace surfaces
- Gravel pit and recreational pond development in a meander core may contribute to avulsion risk in the reach.
- Rapid dike construction and armoring following major flooding (1996/1997).
- Increase in primary channel length (sinuosity) with loss of side channels.
- Isolation of 38 percent of the CMZ, mostly avulsion hazard areas that support spring creeks.

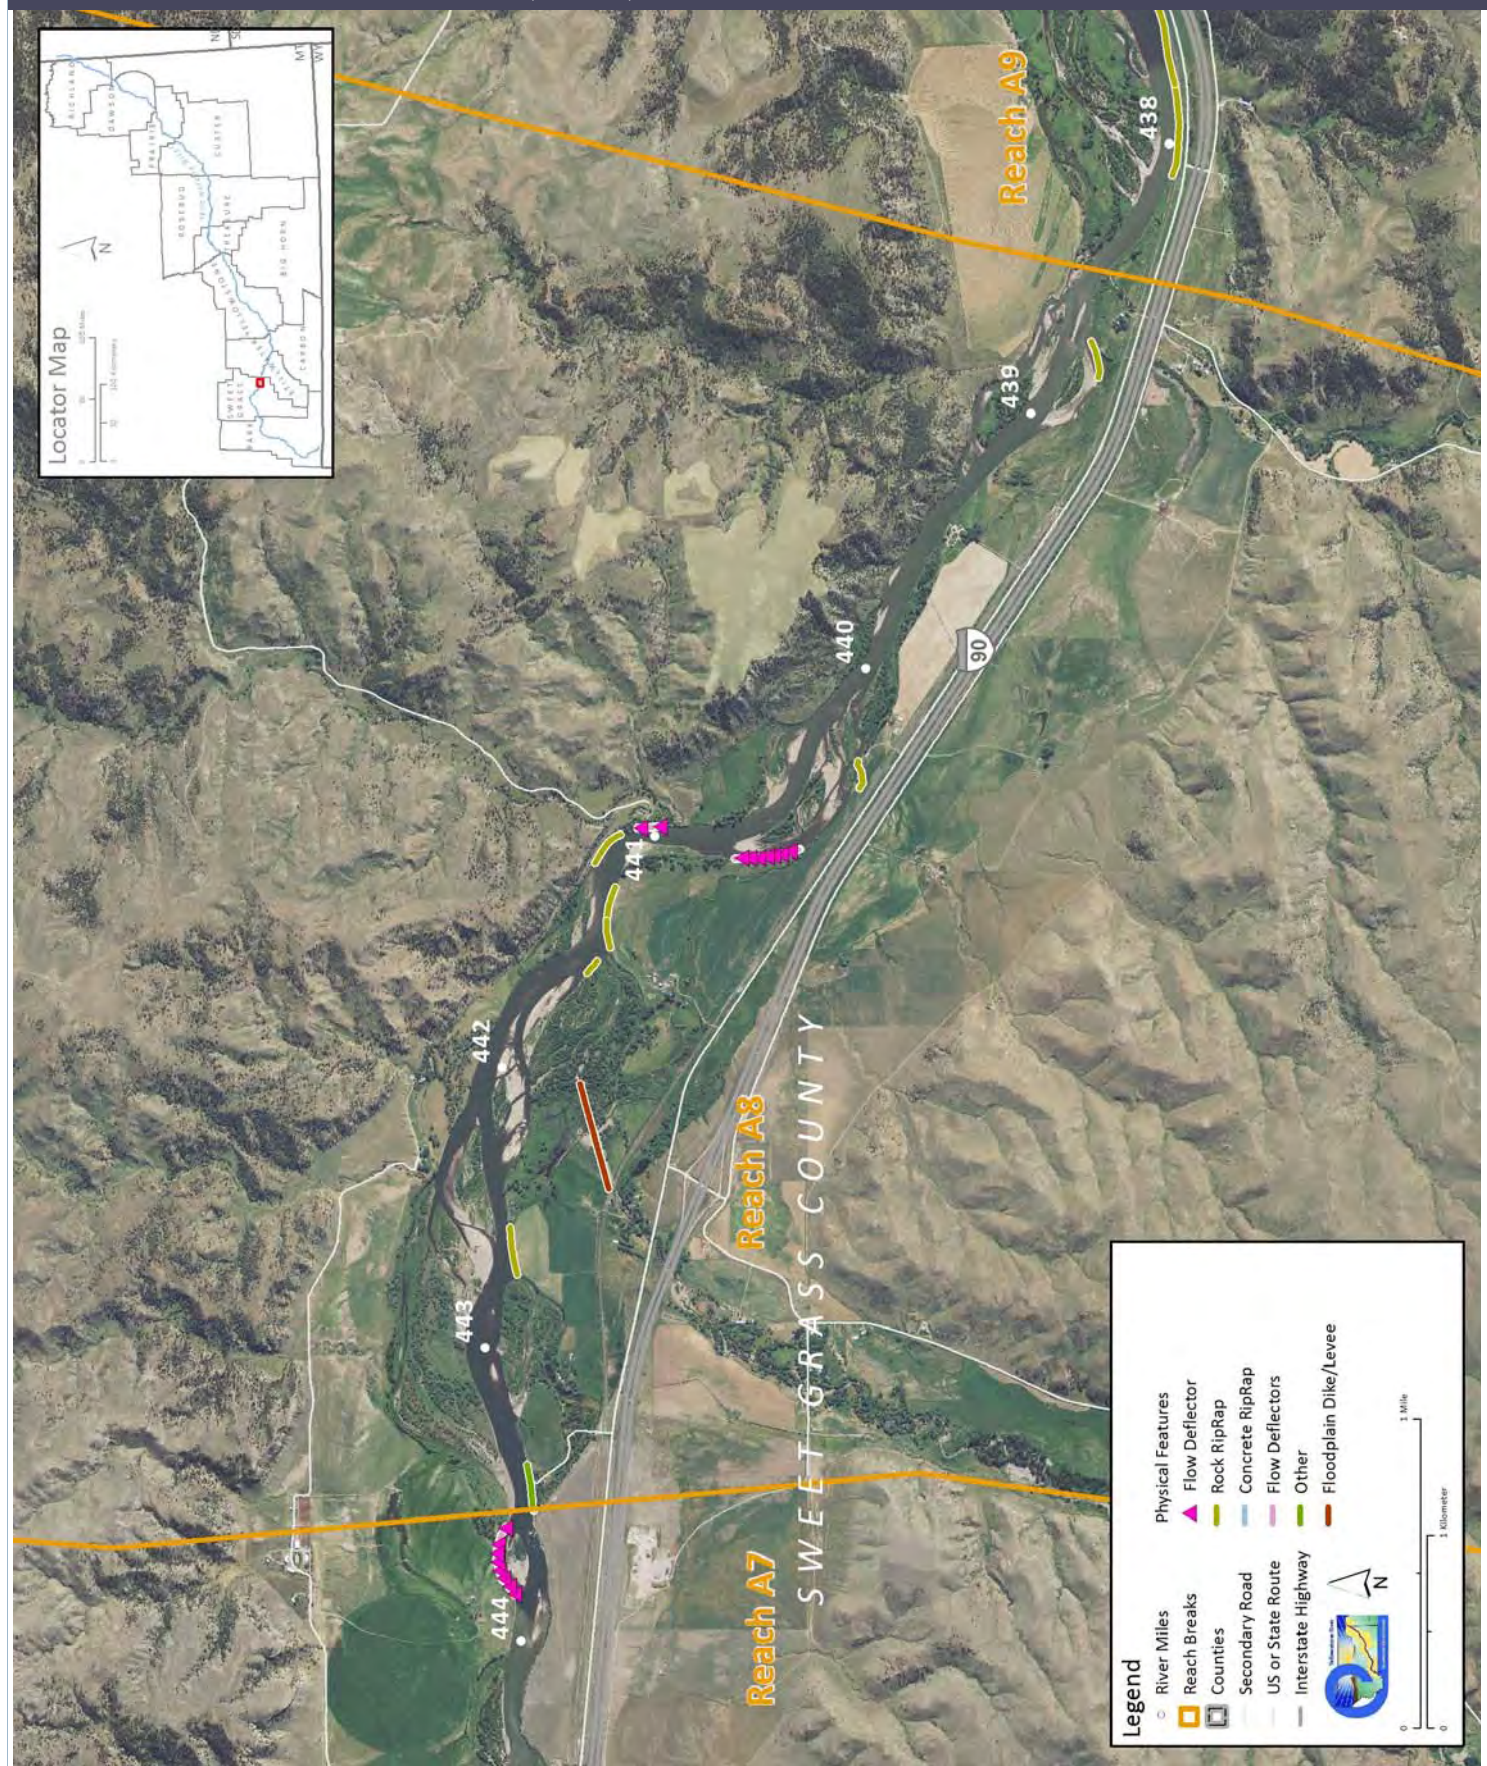
### PHYSICAL FEATURES MAP (2011)

County	Sweet Grass	Upstream River Mile	443.6
Classification	PCB: Partially confined braided	Downstream River Mile	438.5
General Location	Bridger Creek	Length	5.10 mi (8.21 km)

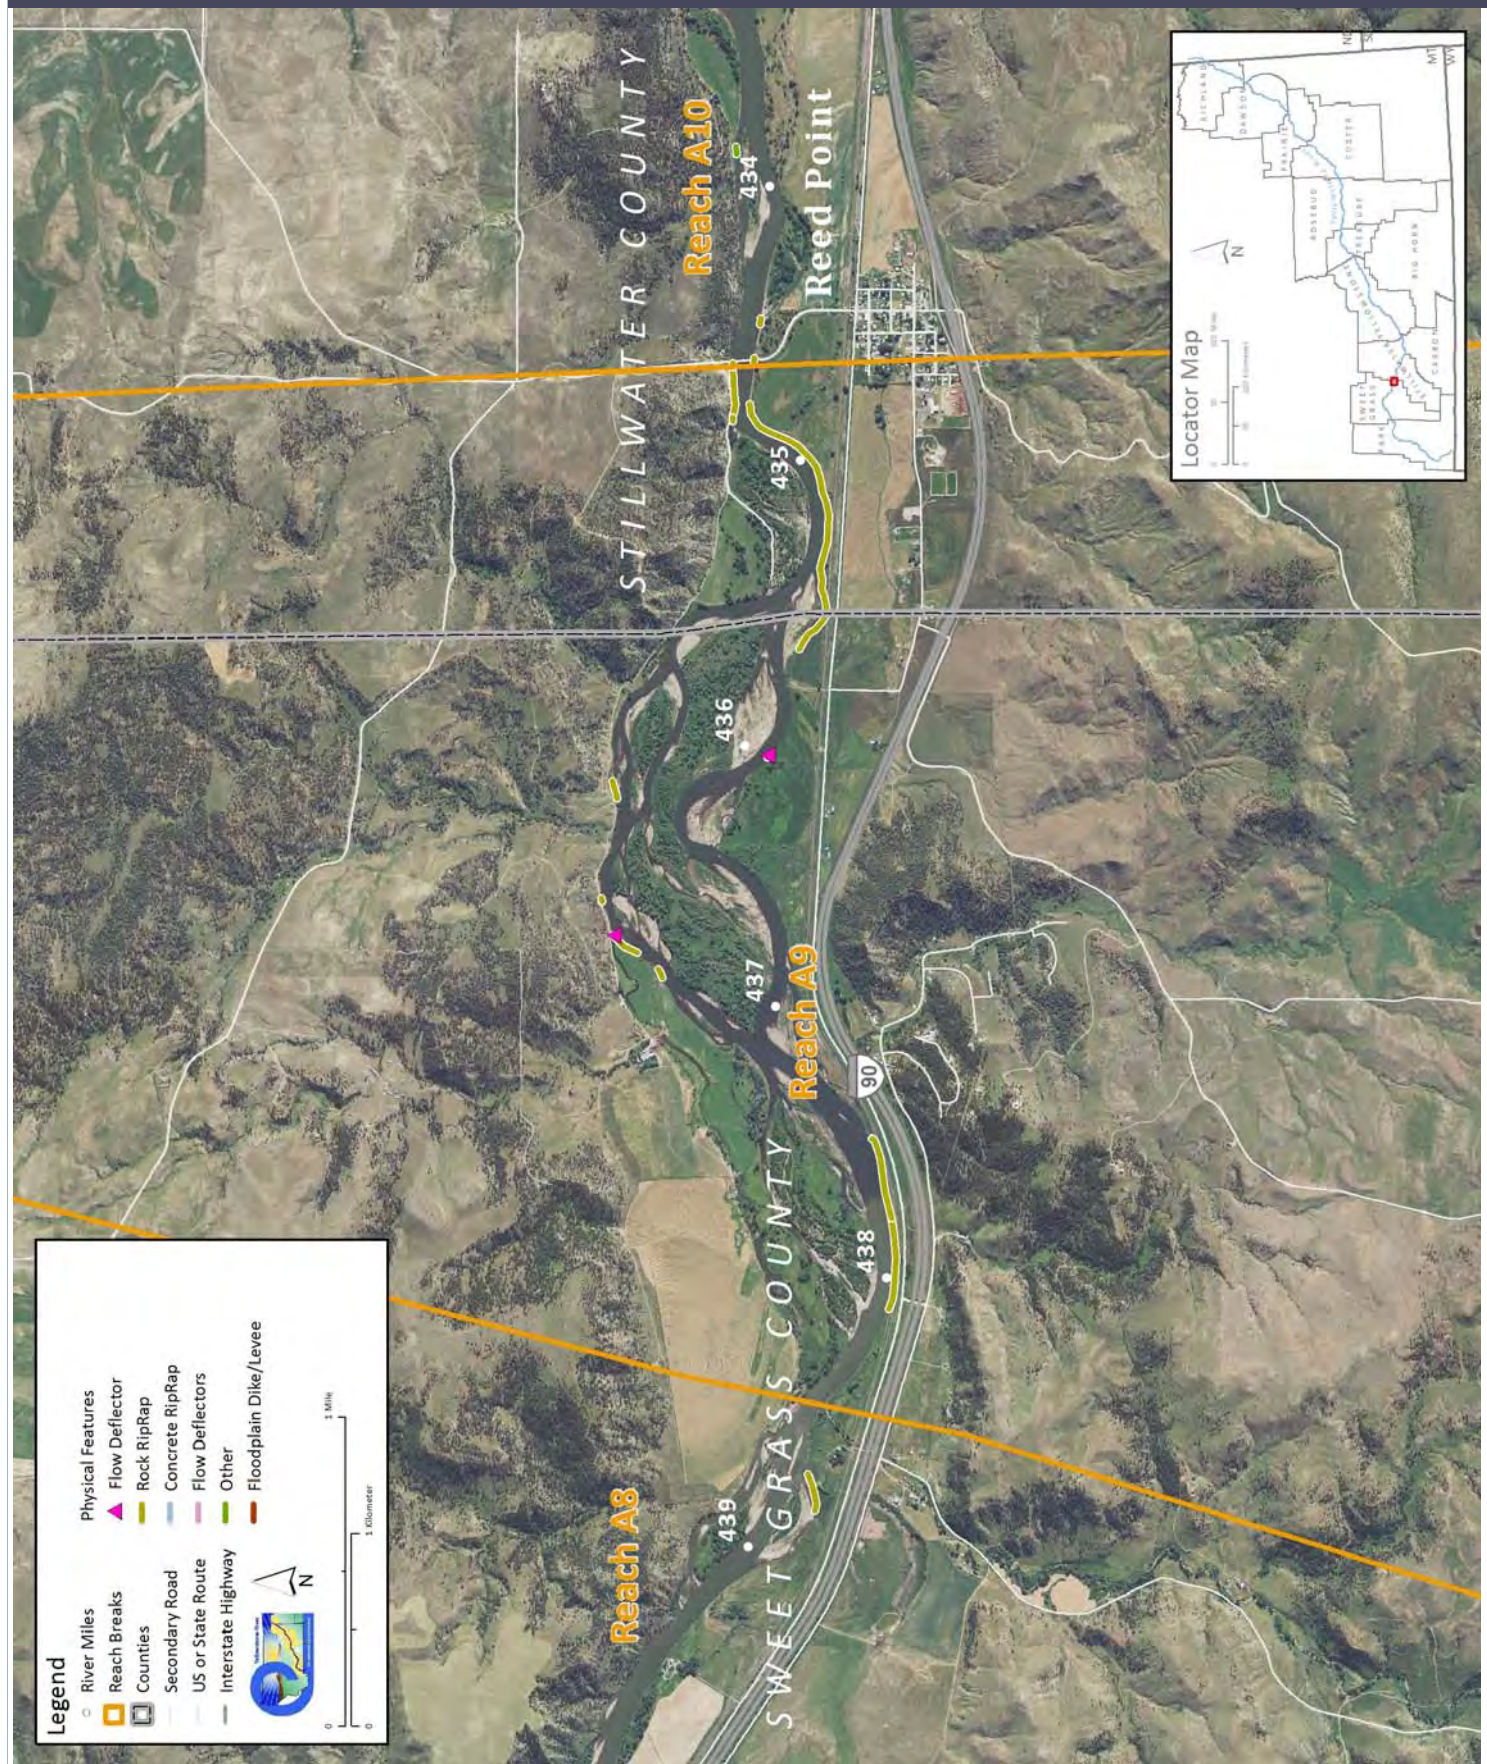
### PHYSICAL FEATURES MAP (2011)

County	Sweet Grass	Upstream River Mile	438.5
Classification	UA: Unconfined anabranching	Downstream River Mile	434.7
General Location	Reed Point	Length	3.80 mi (6.12 km)

Much of the riprap in Reach A9 is located along the south bank of the river on lower end of the reach where the Yellowstone River approaches the bridge near Reed Point. This bridge marks a major narrowing of the river corridor from about 2,000 feet wide ½ mile upstream of the bridge to 360 feet at the bridge itself. The narrowing is achieved by a ~mile long section of bank armor on the right bank that on its lower end runs due north/south, which is perpendicular to the overall east/west trend of the river. This has caused the river to consolidate into a main thread and abandon an historic side channel just upstream of the bridge at the Indian Fort Fishing Access Site.

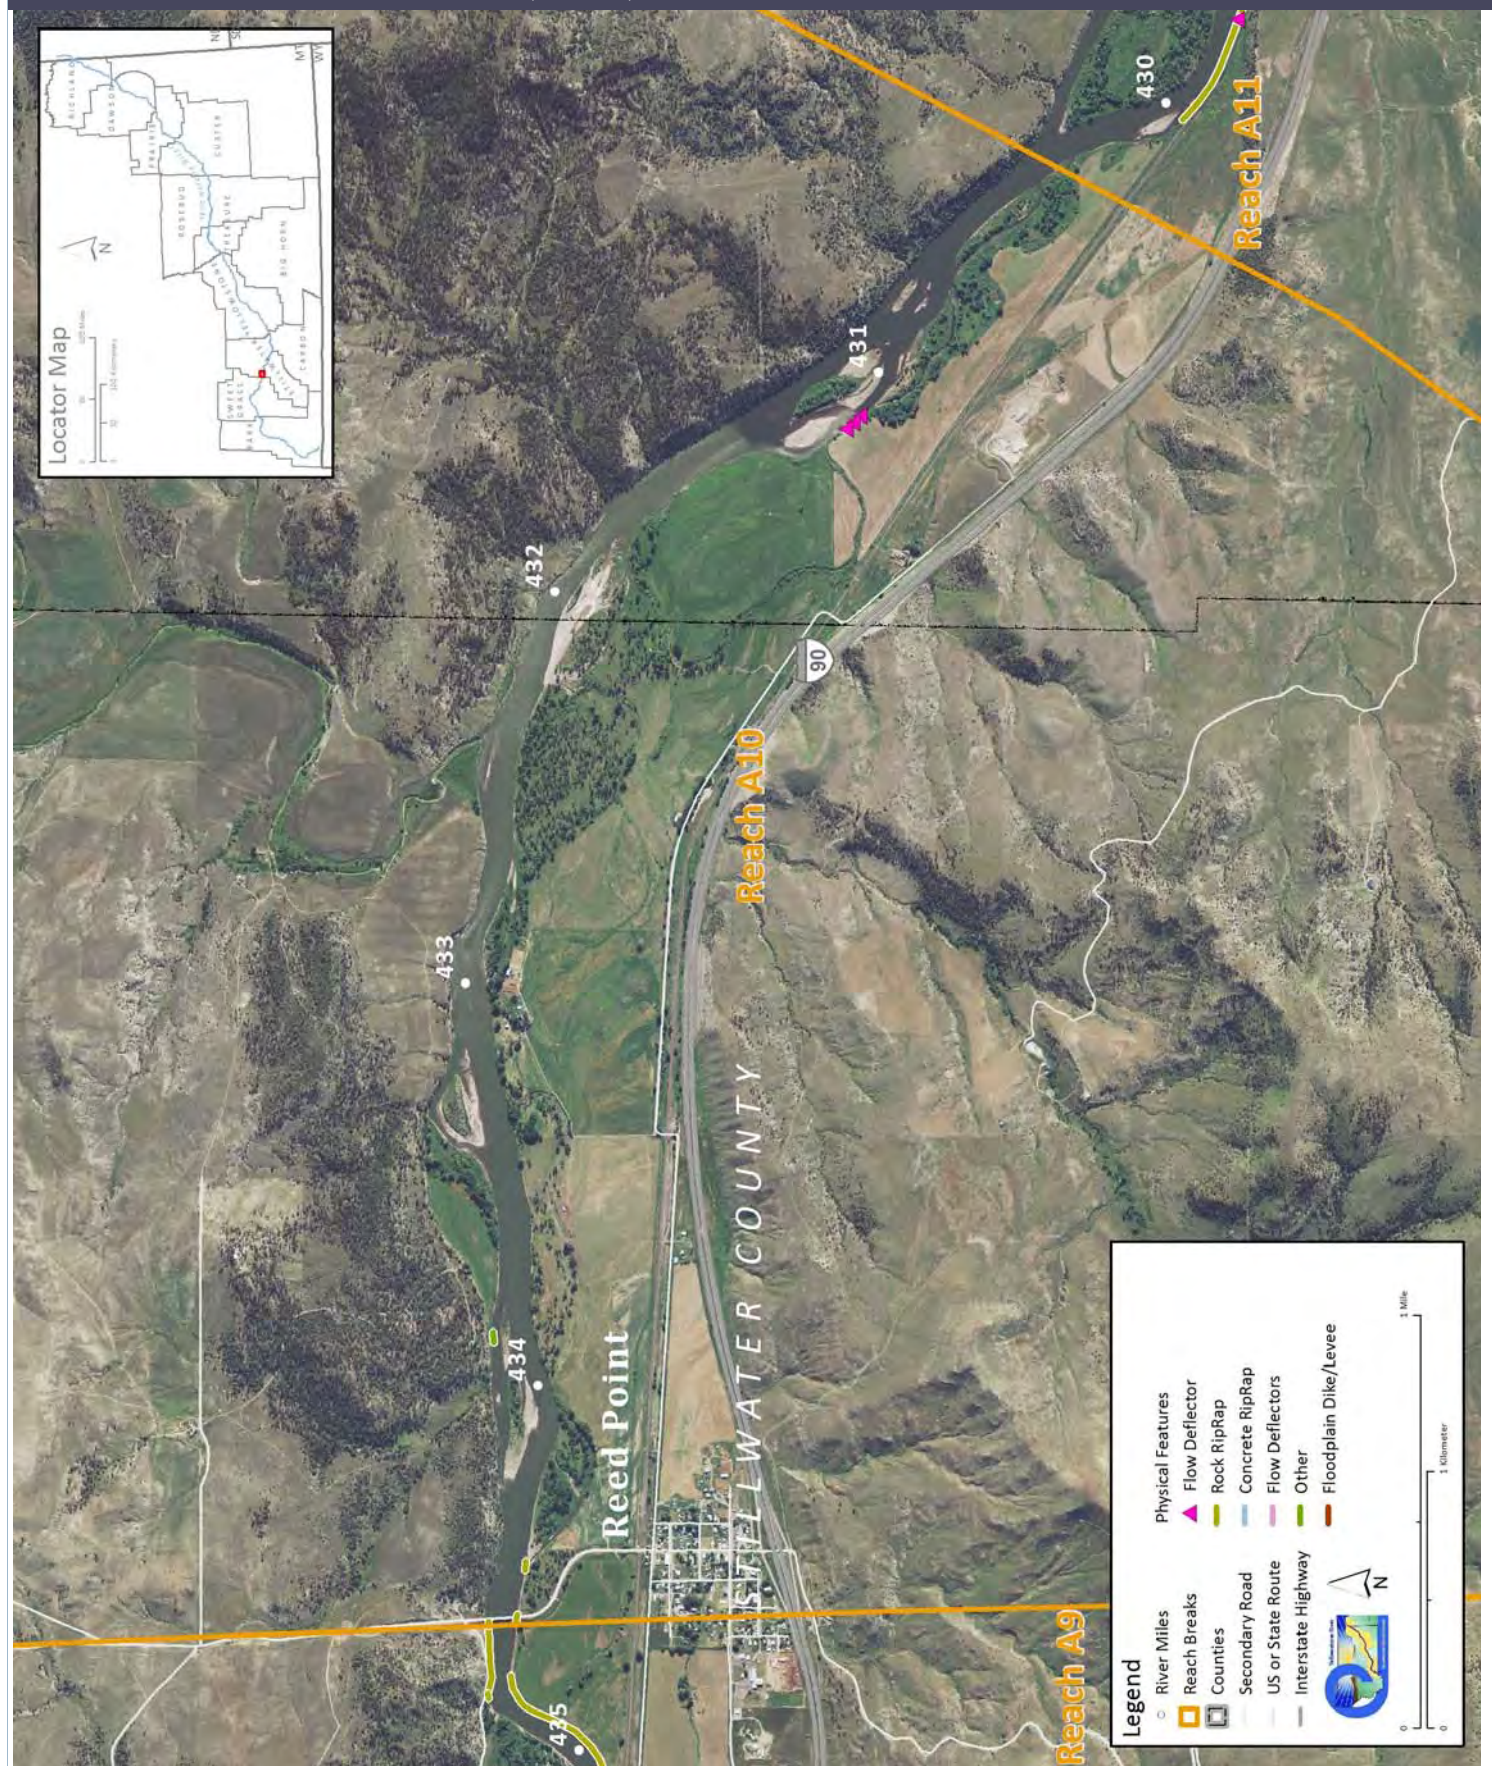
### PHYSICAL FEATURES MAP (2011)

County	Stillwater	Upstream River Mile	434.7
Classification	PCS: Partially confined straight	Downstream River Mile	430.3
General Location	Reed Point	Length	4.40 mi (7.08 km)

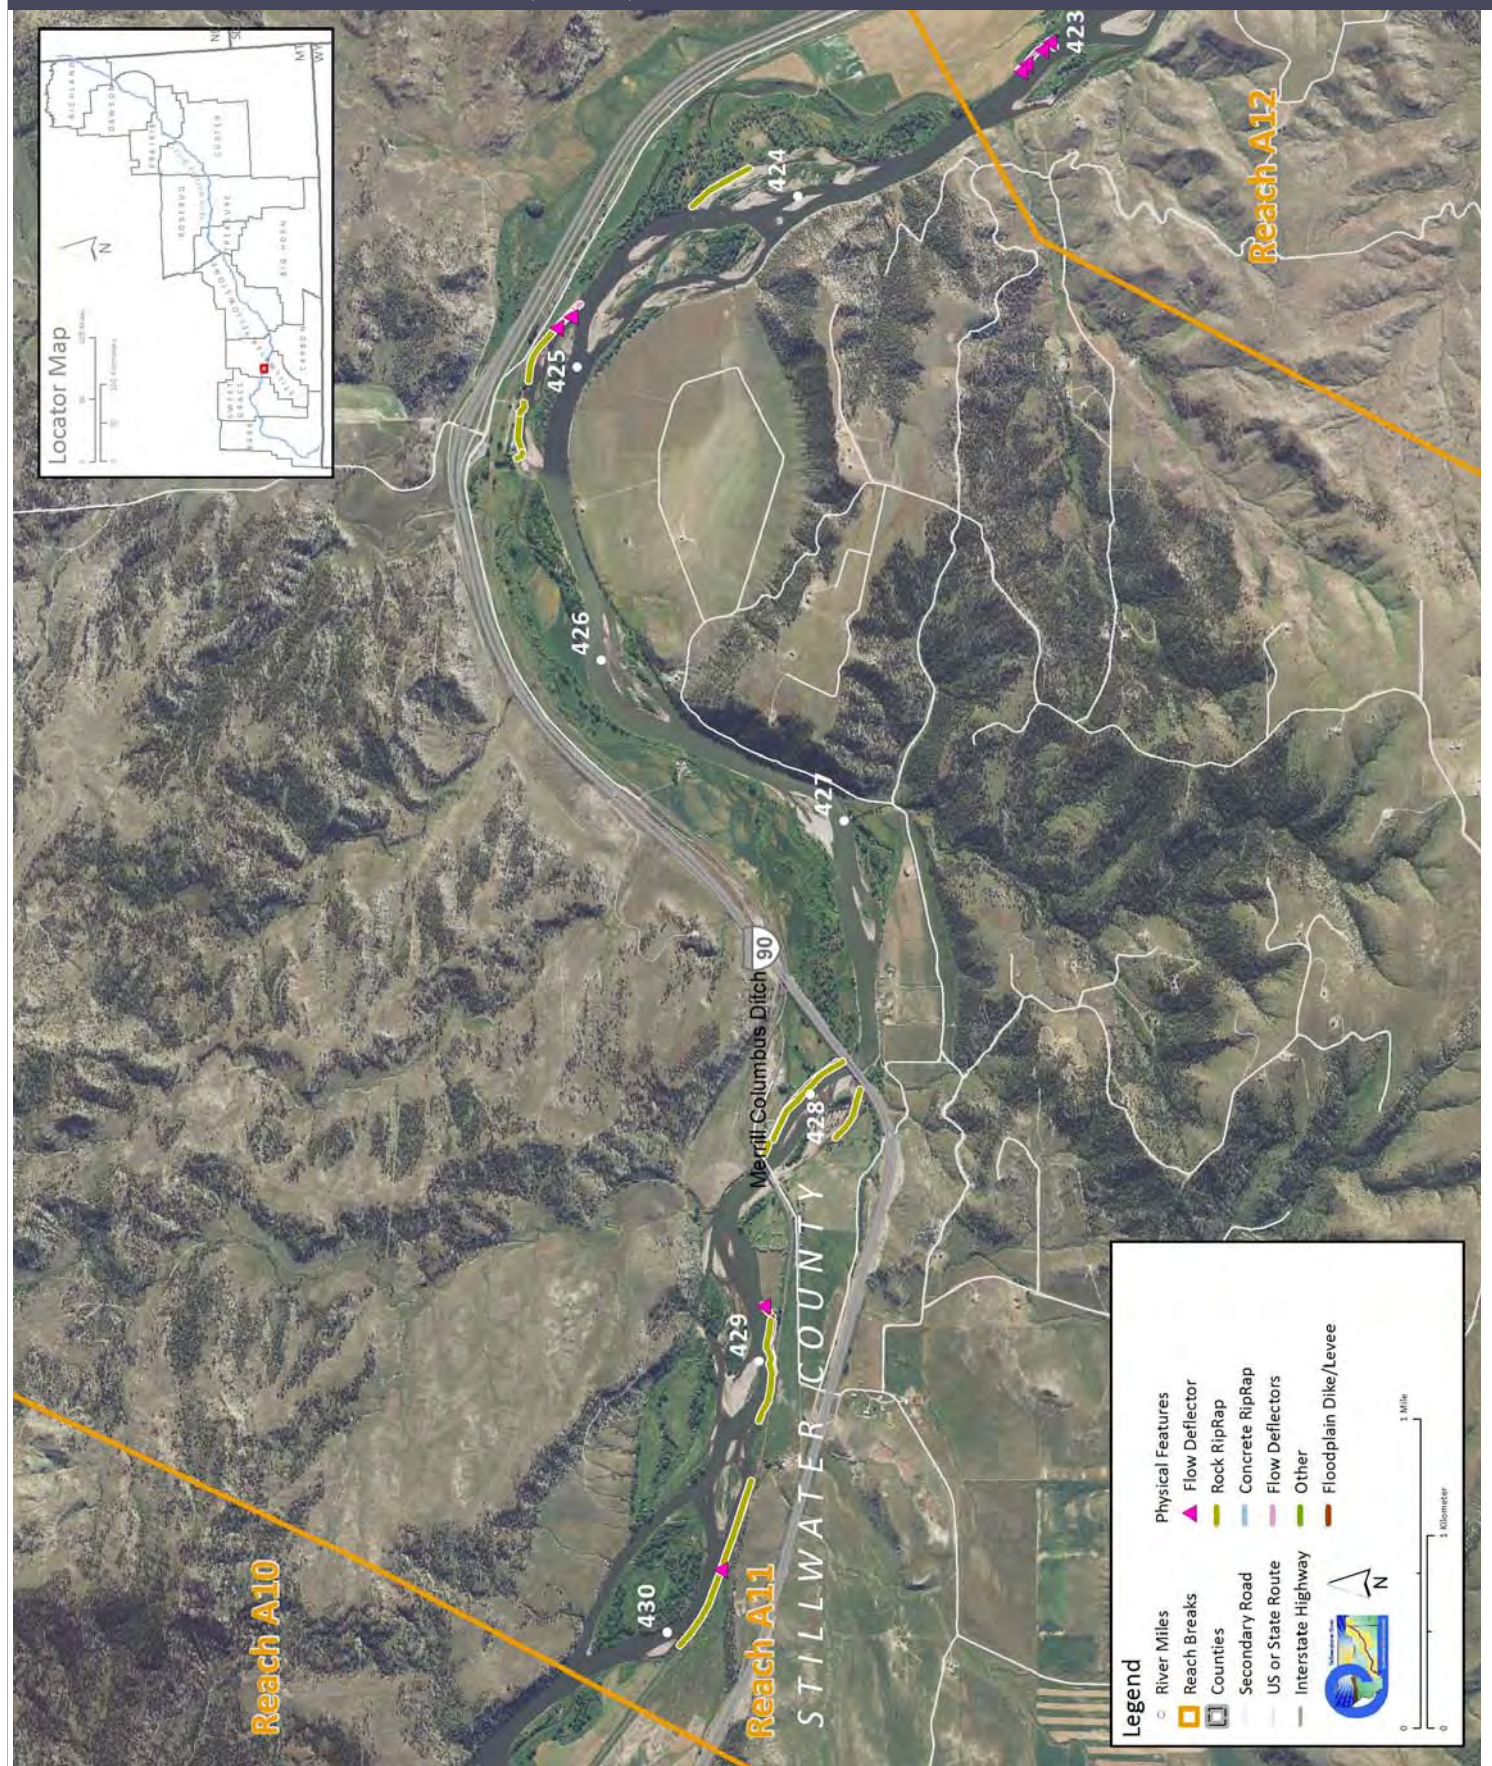
## PHYSICAL FEATURES MAP (2011)

County	Stillwater	Upstream River Mile	430.3
Classification	PCB: Partially confined braided	Downstream River Mile	423.3
General Location	I-90 bridge crossing	Length	7.00 mi (11.27 km)

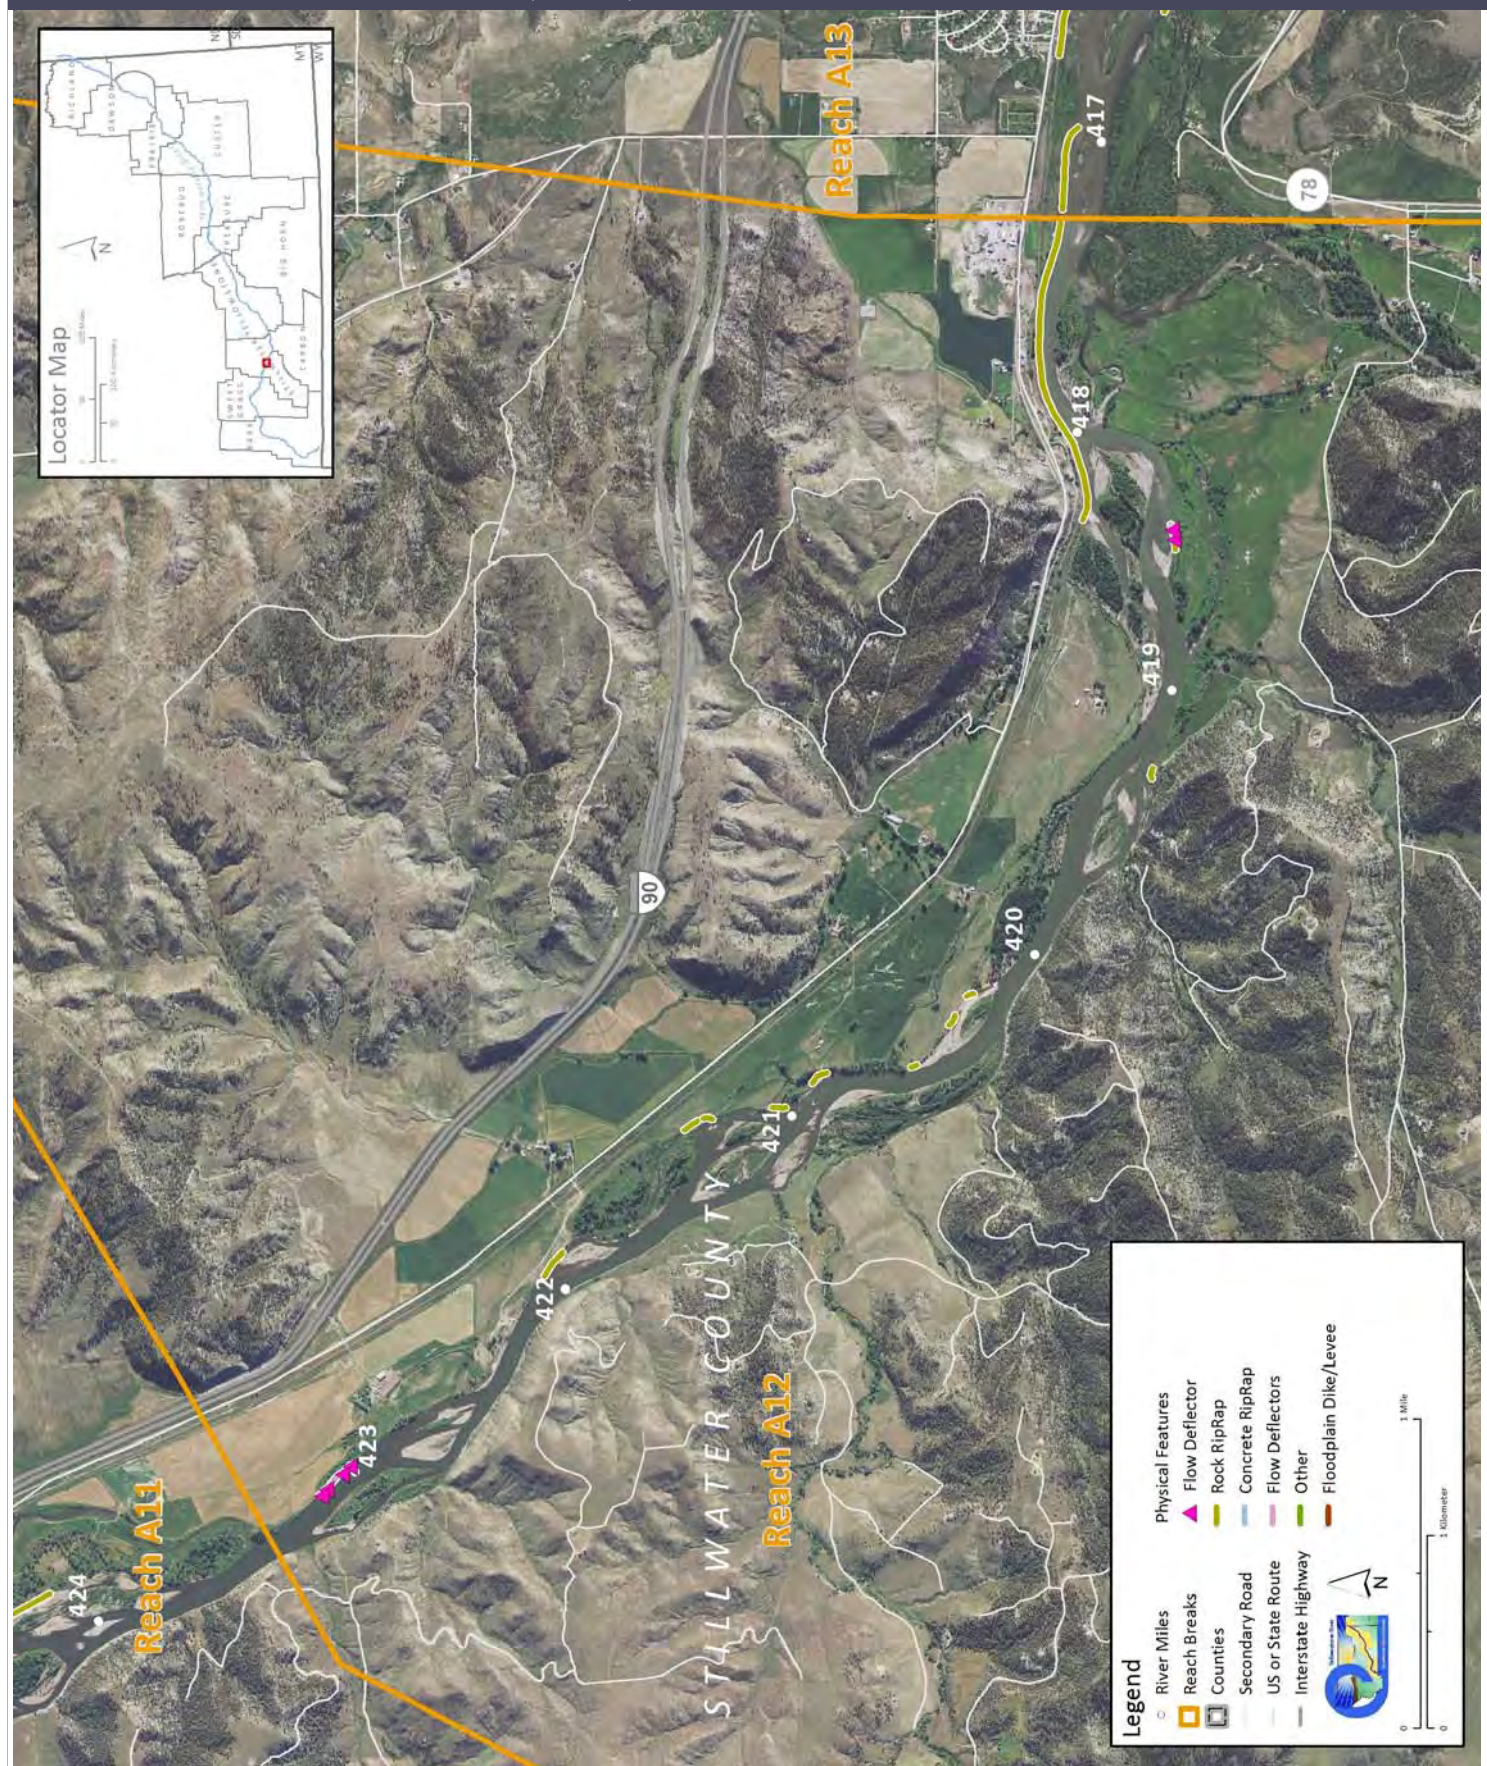
### PHYSICAL FEATURES MAP (2011)

County	Stillwater	Upstream River Mile	423.3
Classification	PCB: Partially confined braided	Downstream River Mile	417.3
General Location	To Stillwater confluence	Length	6.00 mi (9.66 km)

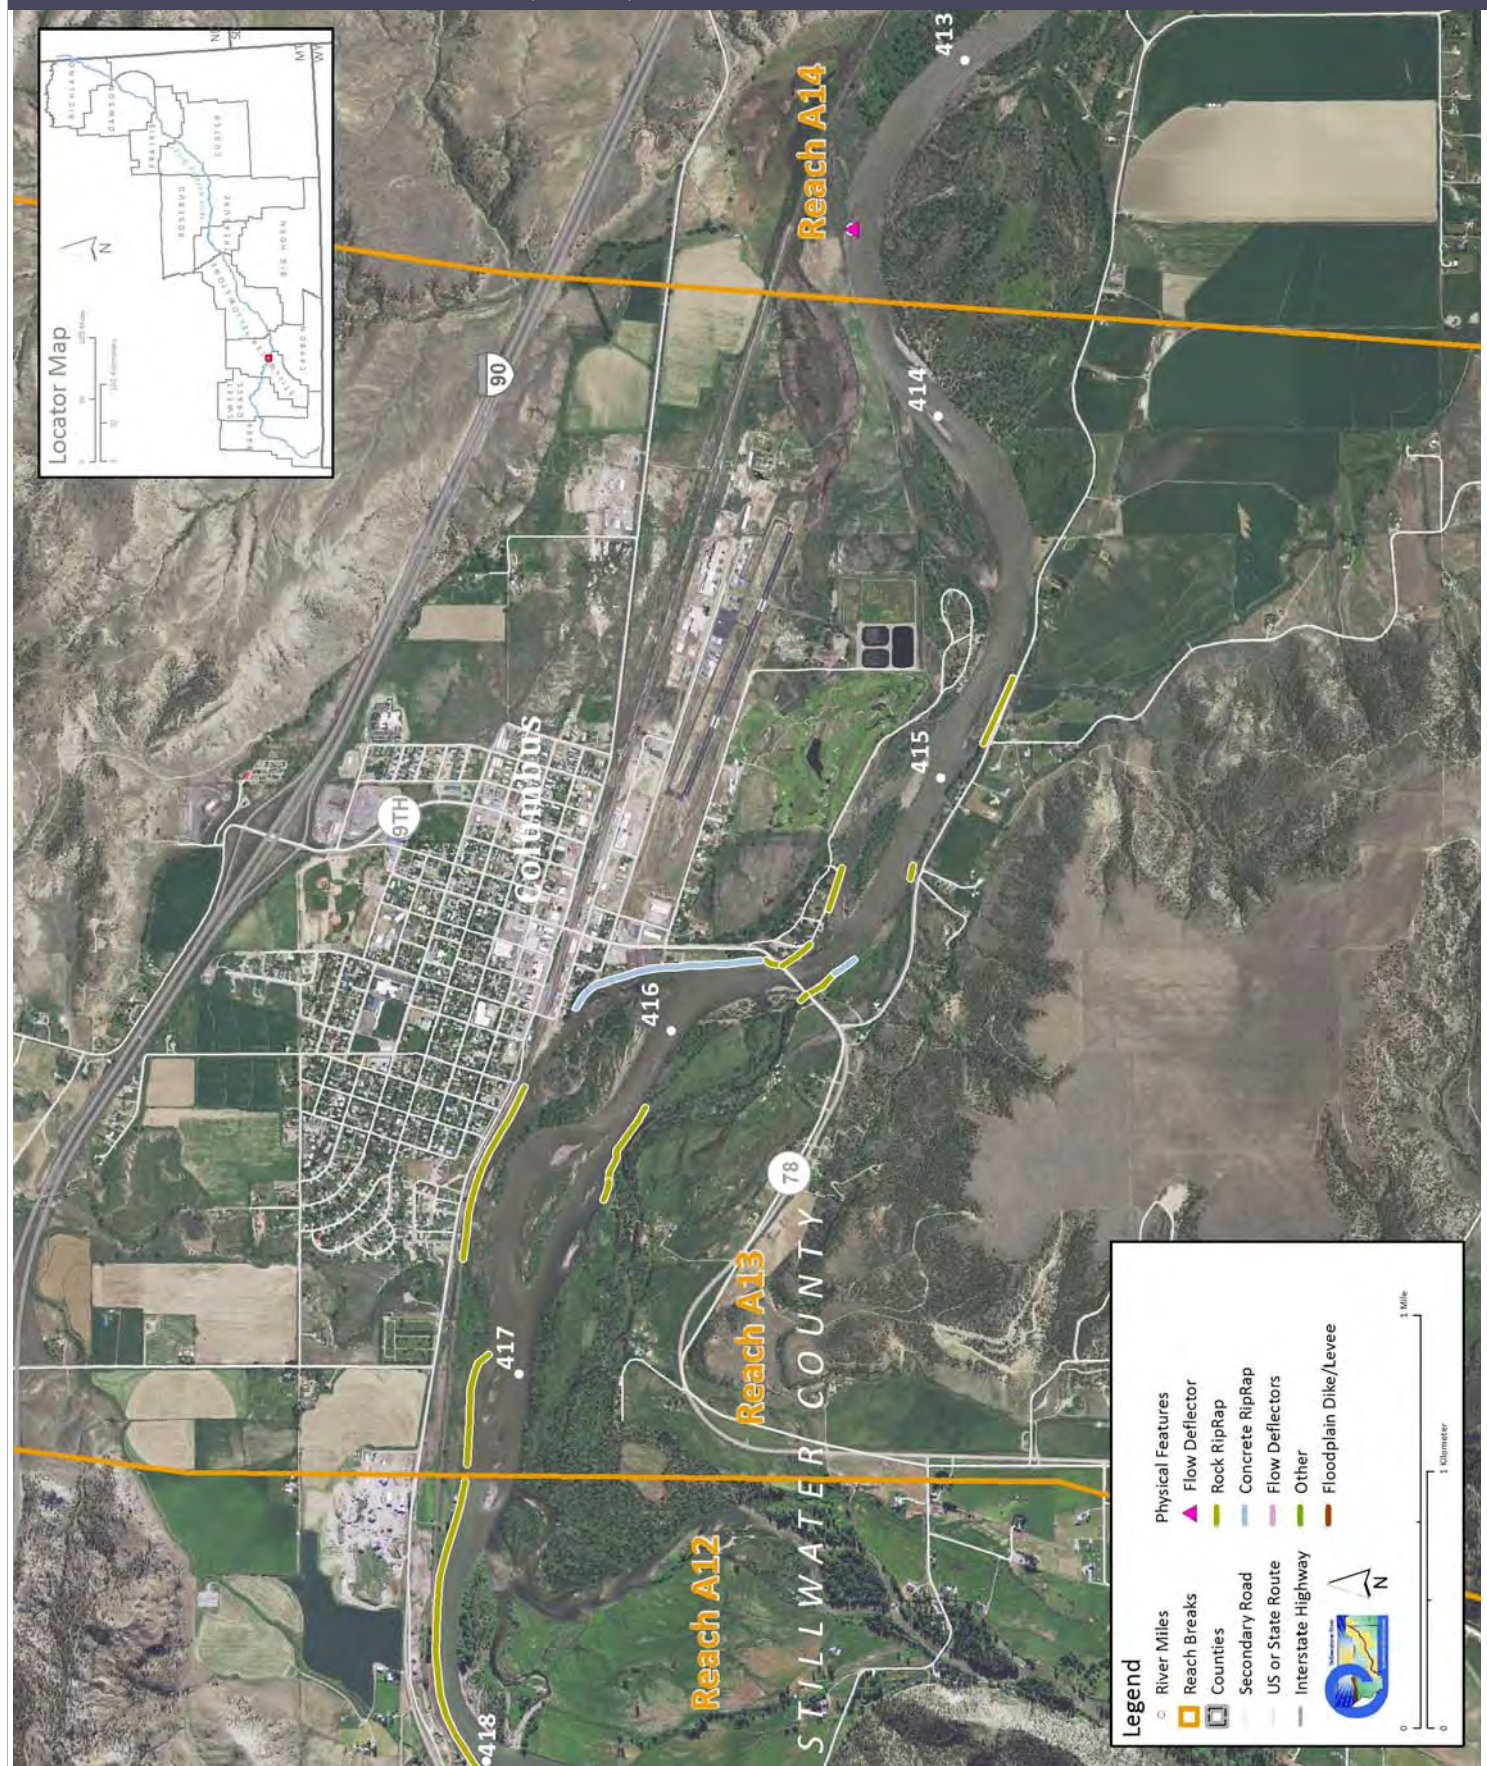
### PHYSICAL FEATURES MAP (2011)

County	Stillwater	Upstream River Mile	417.3
Classification	PCA: Partially confined anabranching	Downstream River Mile	413.7
General Location	Columbus	Length	3.60 mi (5.79 km)

About 18 percent of the historic 100-year floodplain has become isolated from the river due primarily to the downstream shadow caused by the Columbus Bridge embankment on the north side of the river.

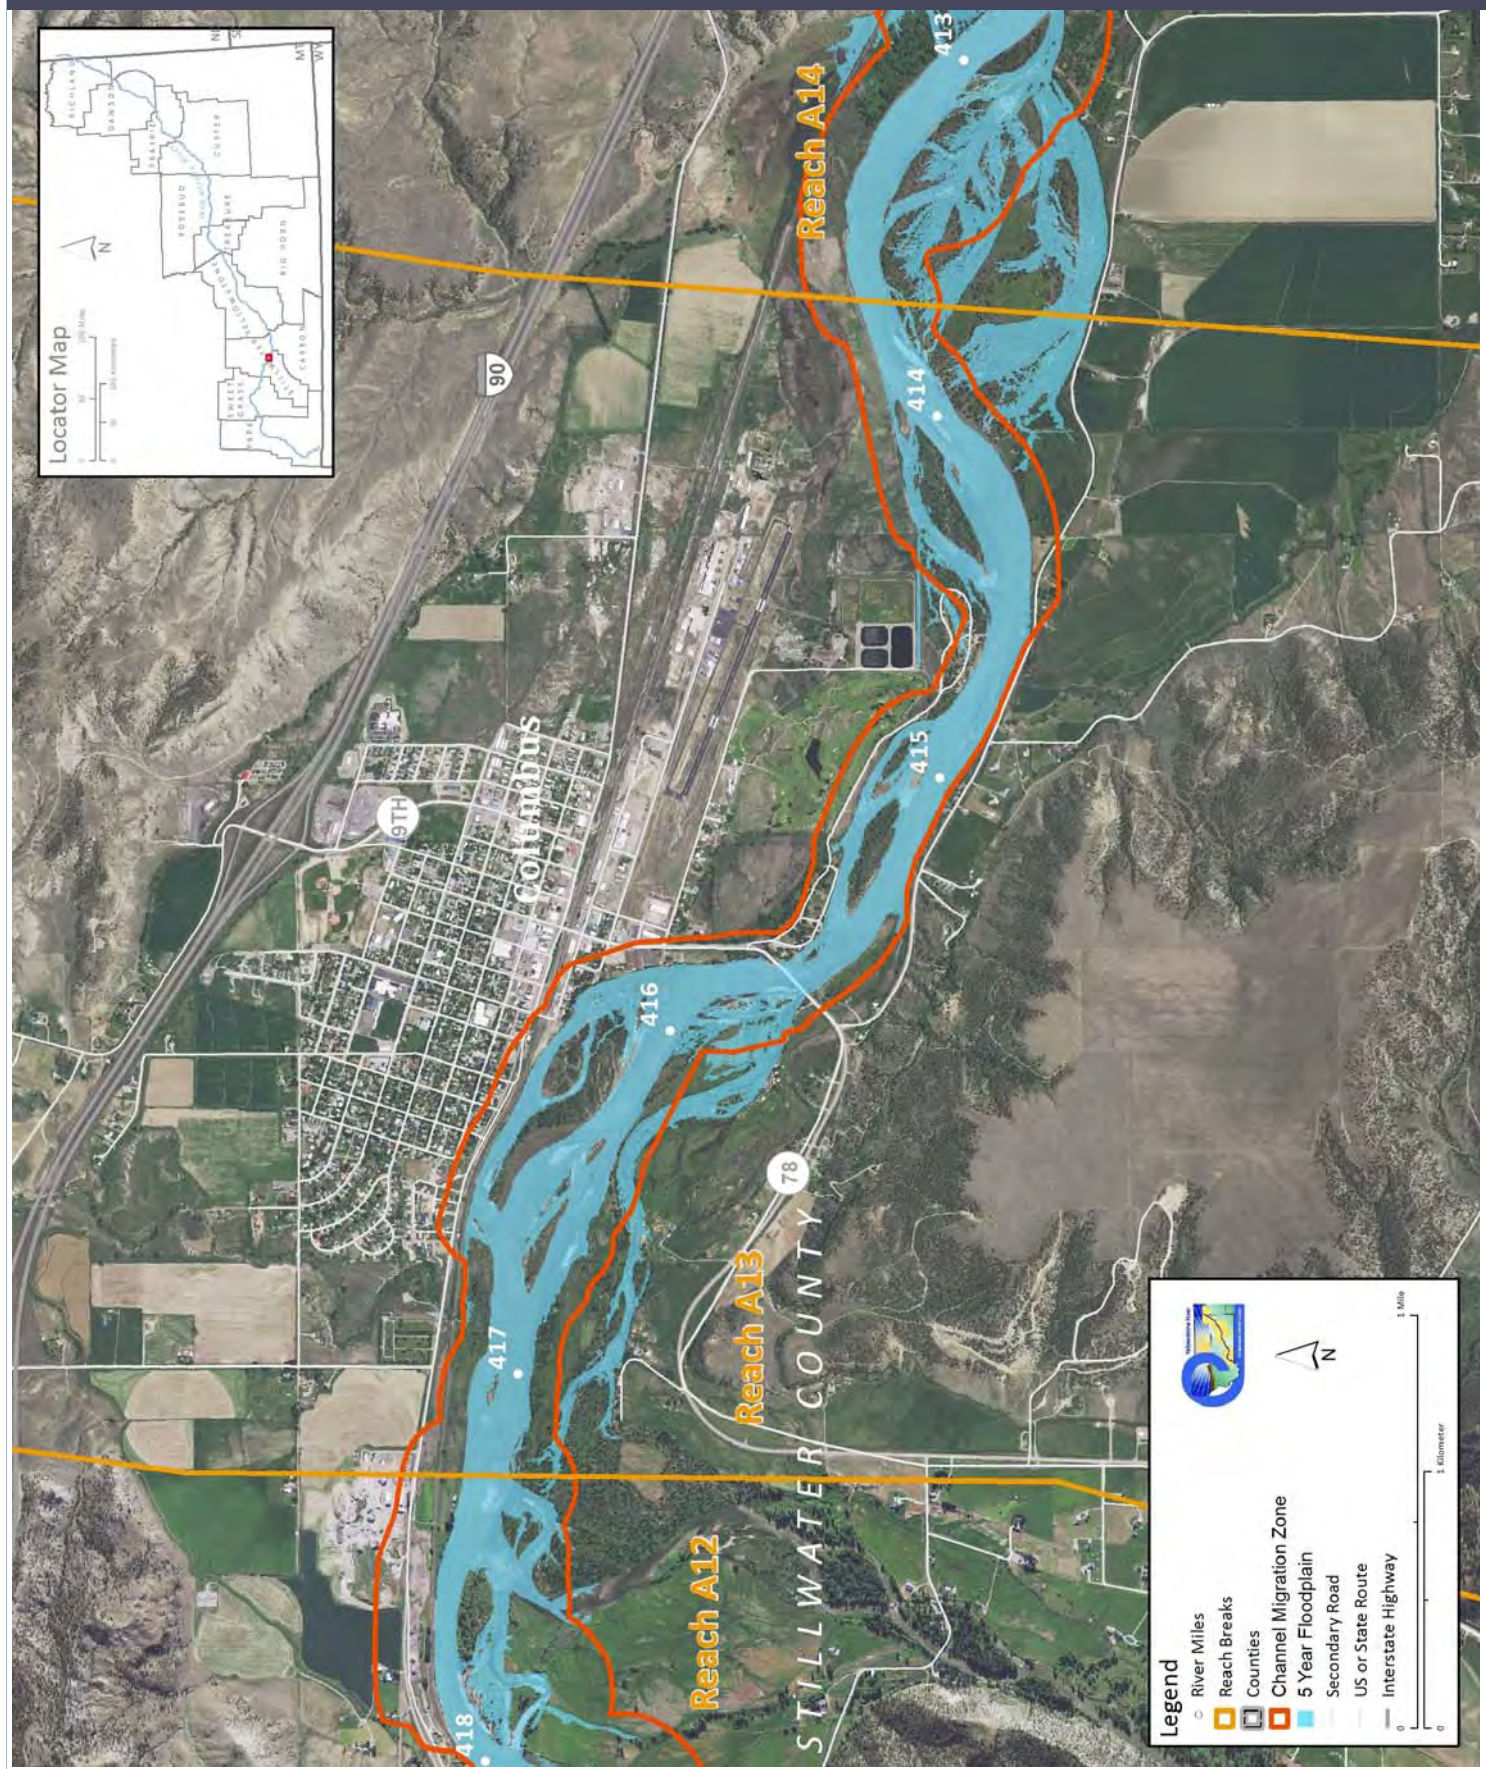
### CHANNEL MIGRATION ZONE MAP

- CMZ management at Columbus due to high level of encroachment
- Nutrient management at corrals at RM 414
- Bank Stabilization Recommended Practices due to extent of armoring in reach (28 percent)
- Russian olive removal (5 acres)
- Pipeline management (natural gas) for main river crossing at RM 417
- Wetland restoration/management due to extent of mapped wetland (110 acres)
