County	Park	Upstream River Mile	564.8
Classification	CS: Confined straight	Downstream River Mile	560.2
General Location	Gardiner to Little Trail Cr.	Length	4.60 mi (7.40 km)

### Narrative Summary

Reach PC1 is the upstream-most reach of the project area, beginning at Gardiner Montana, and extending northward almost five miles to the Trail Creek confluence. Reach PC1 is confined/straight reach type and shows minimal impact in terms of flow alterations, bank armoring, and side channel loss. The bankfull area has remained essentially unchanged since 1950. Land use is dominated by non-irrigated agriculture, with some conversion of flood irrigation to sprinkler from 1950 to 2011. There are over 300 acres of urban/exurban development in the reach, dominated by the town of Gardiner. Although the development in Gardiner is very close to the river, it is located high on bluffs that are outside of the Channel Migration Zone (CMZ) and floodplain. The bluffs are composed of glacial outwash deposits that are very coarse and erosion resistant. The total CMZ area in Reach PC1 is only 115 acres, and there is essentially no riparian zone in this reach. This section of river is relatively steep, wi

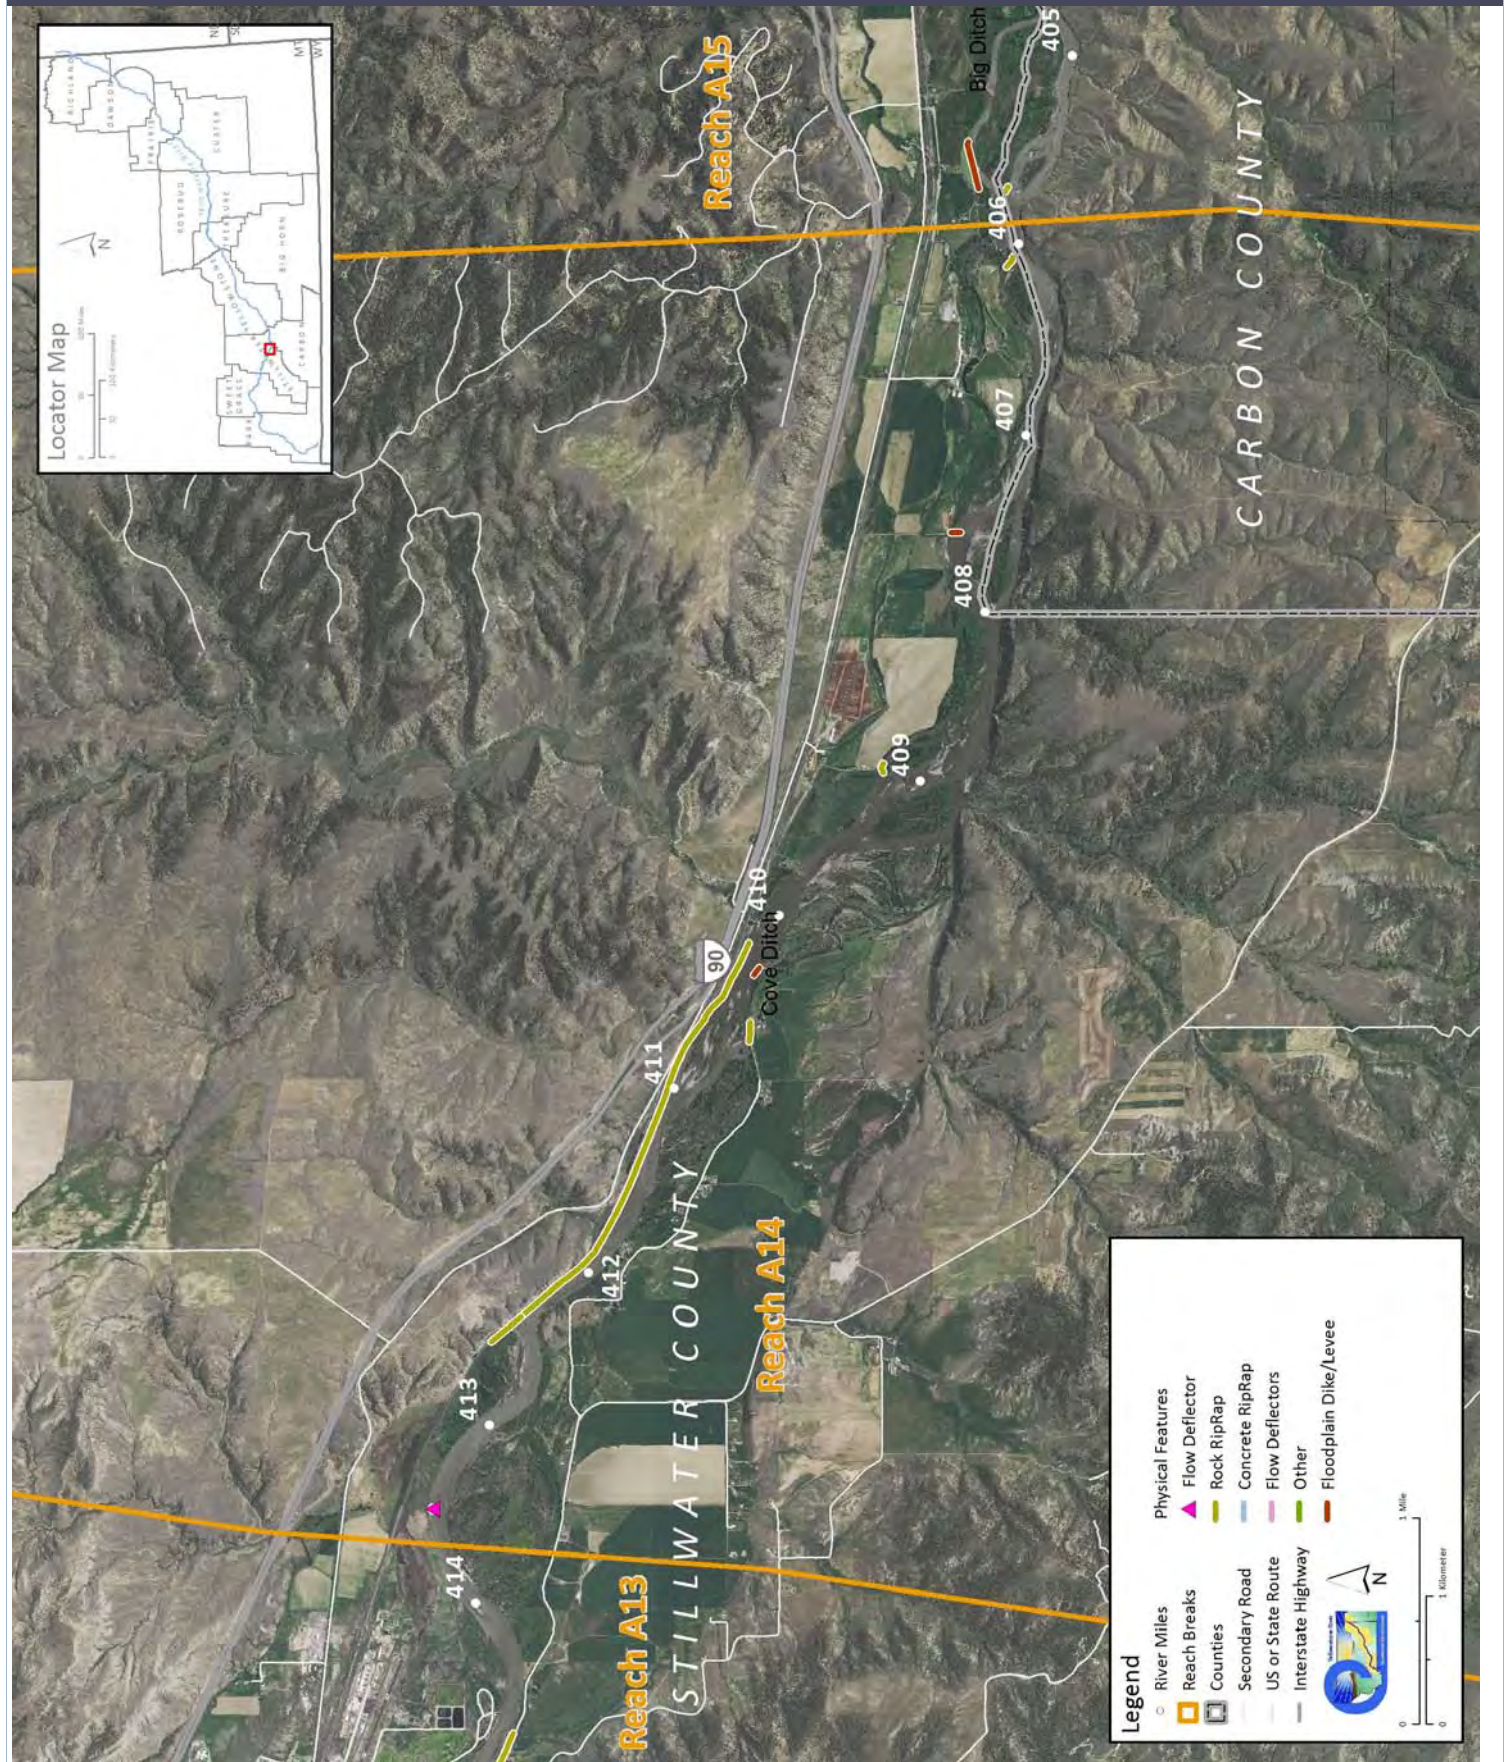
### PHYSICAL FEATURES MAP (2011)

County	Stillwater	Upstream River Mile	413.7
Classification	PCA: Partially confined anabranching	Downstream River Mile	405.9
General Location	Below Columbus	Length	7.80 mi (12.55 km)

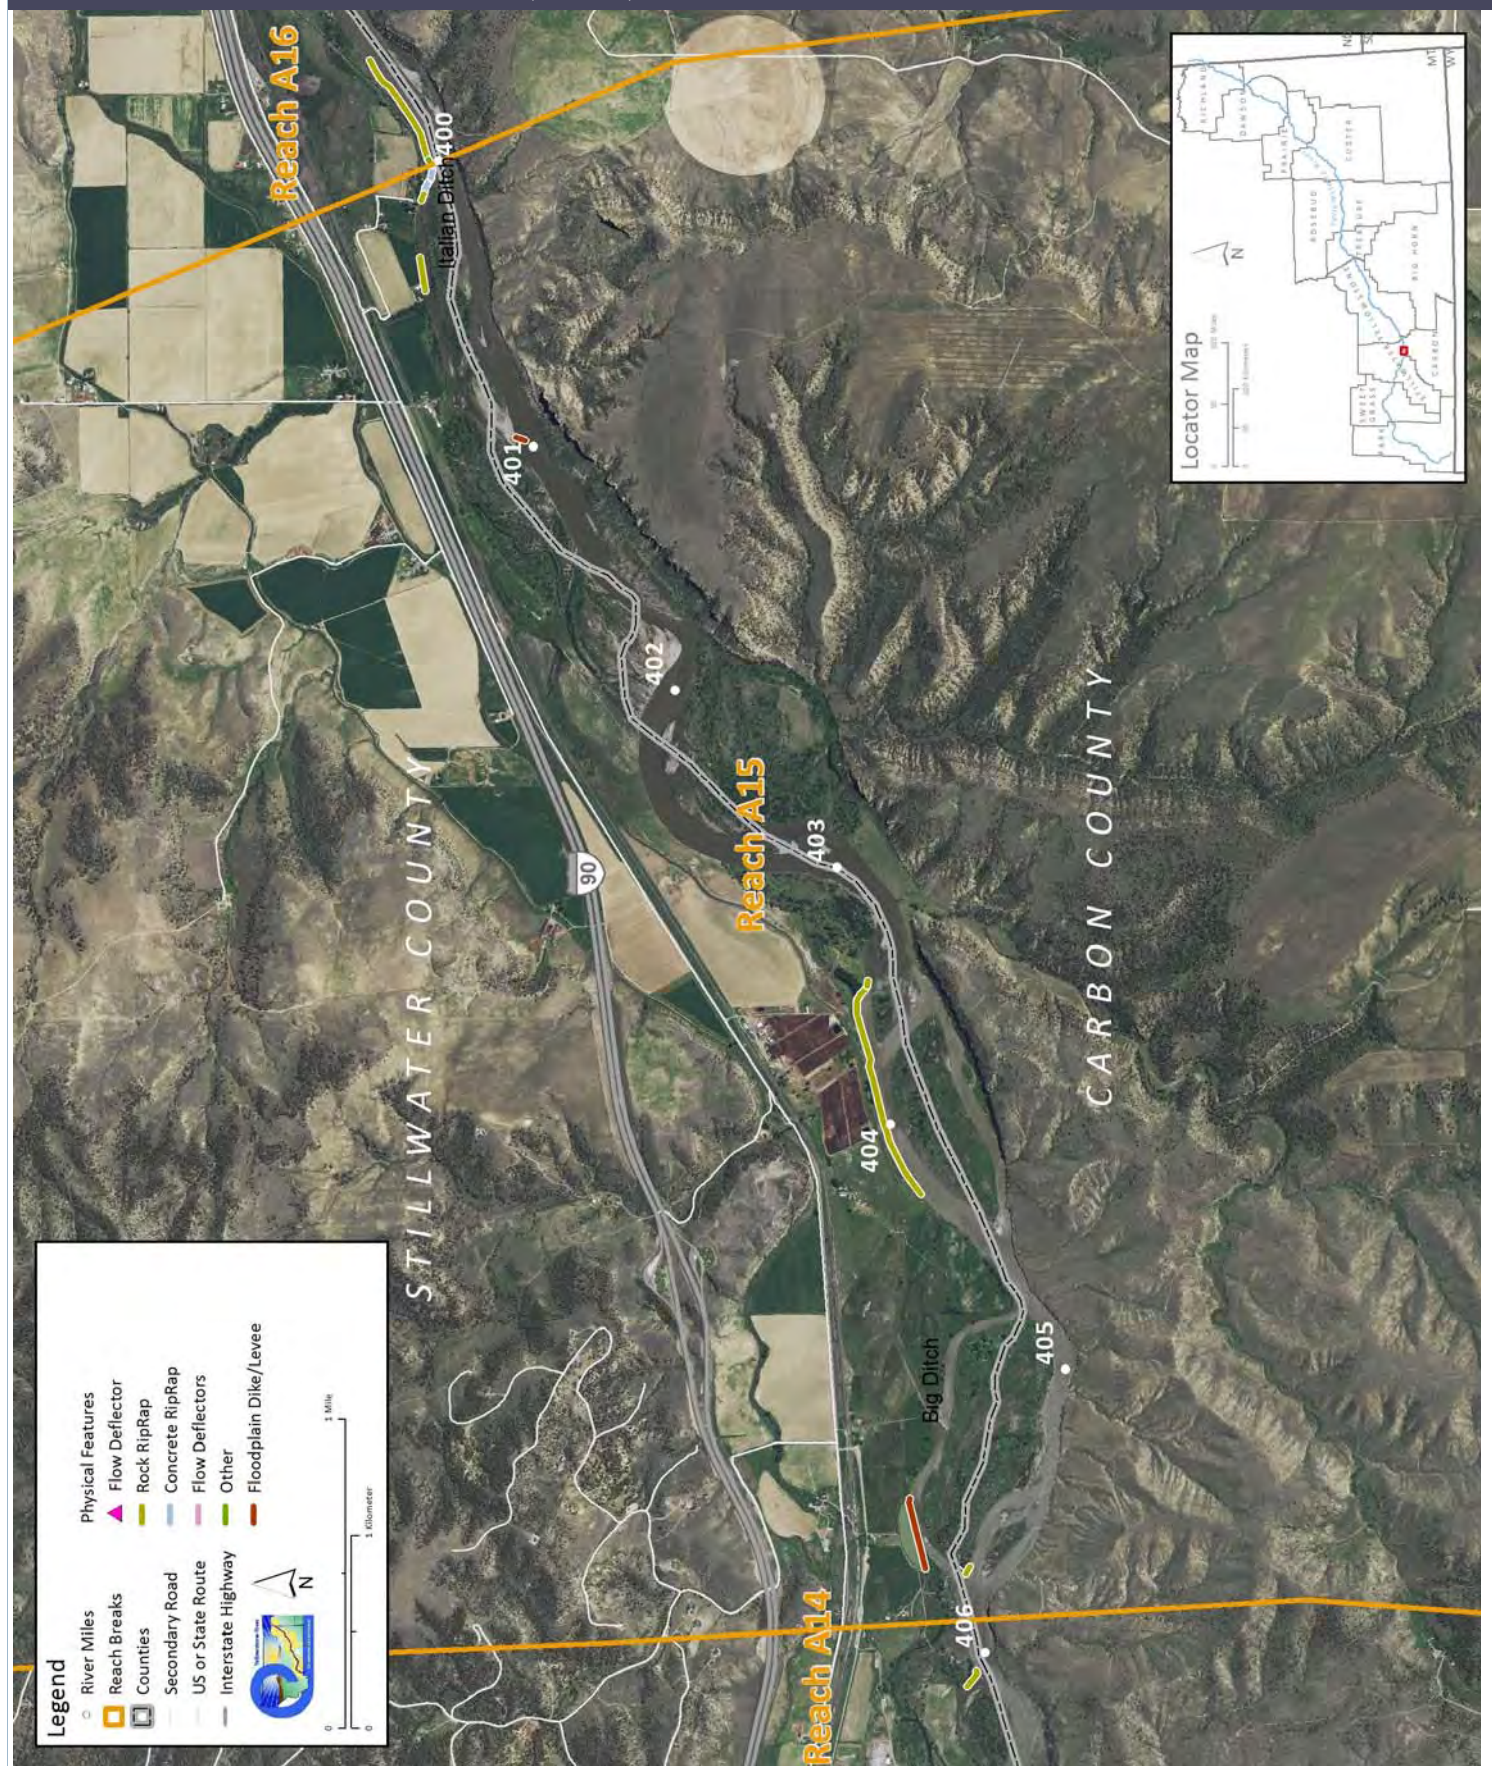
## PHYSICAL FEATURES MAP (2011)

County	Stillwater	Upstream River Mile	405.9
Classification	PCB: Partially confined braided	Downstream River Mile	400
General Location	Follows Stillwater/Carbon County line	Length	5.90 mi (9.50 km)

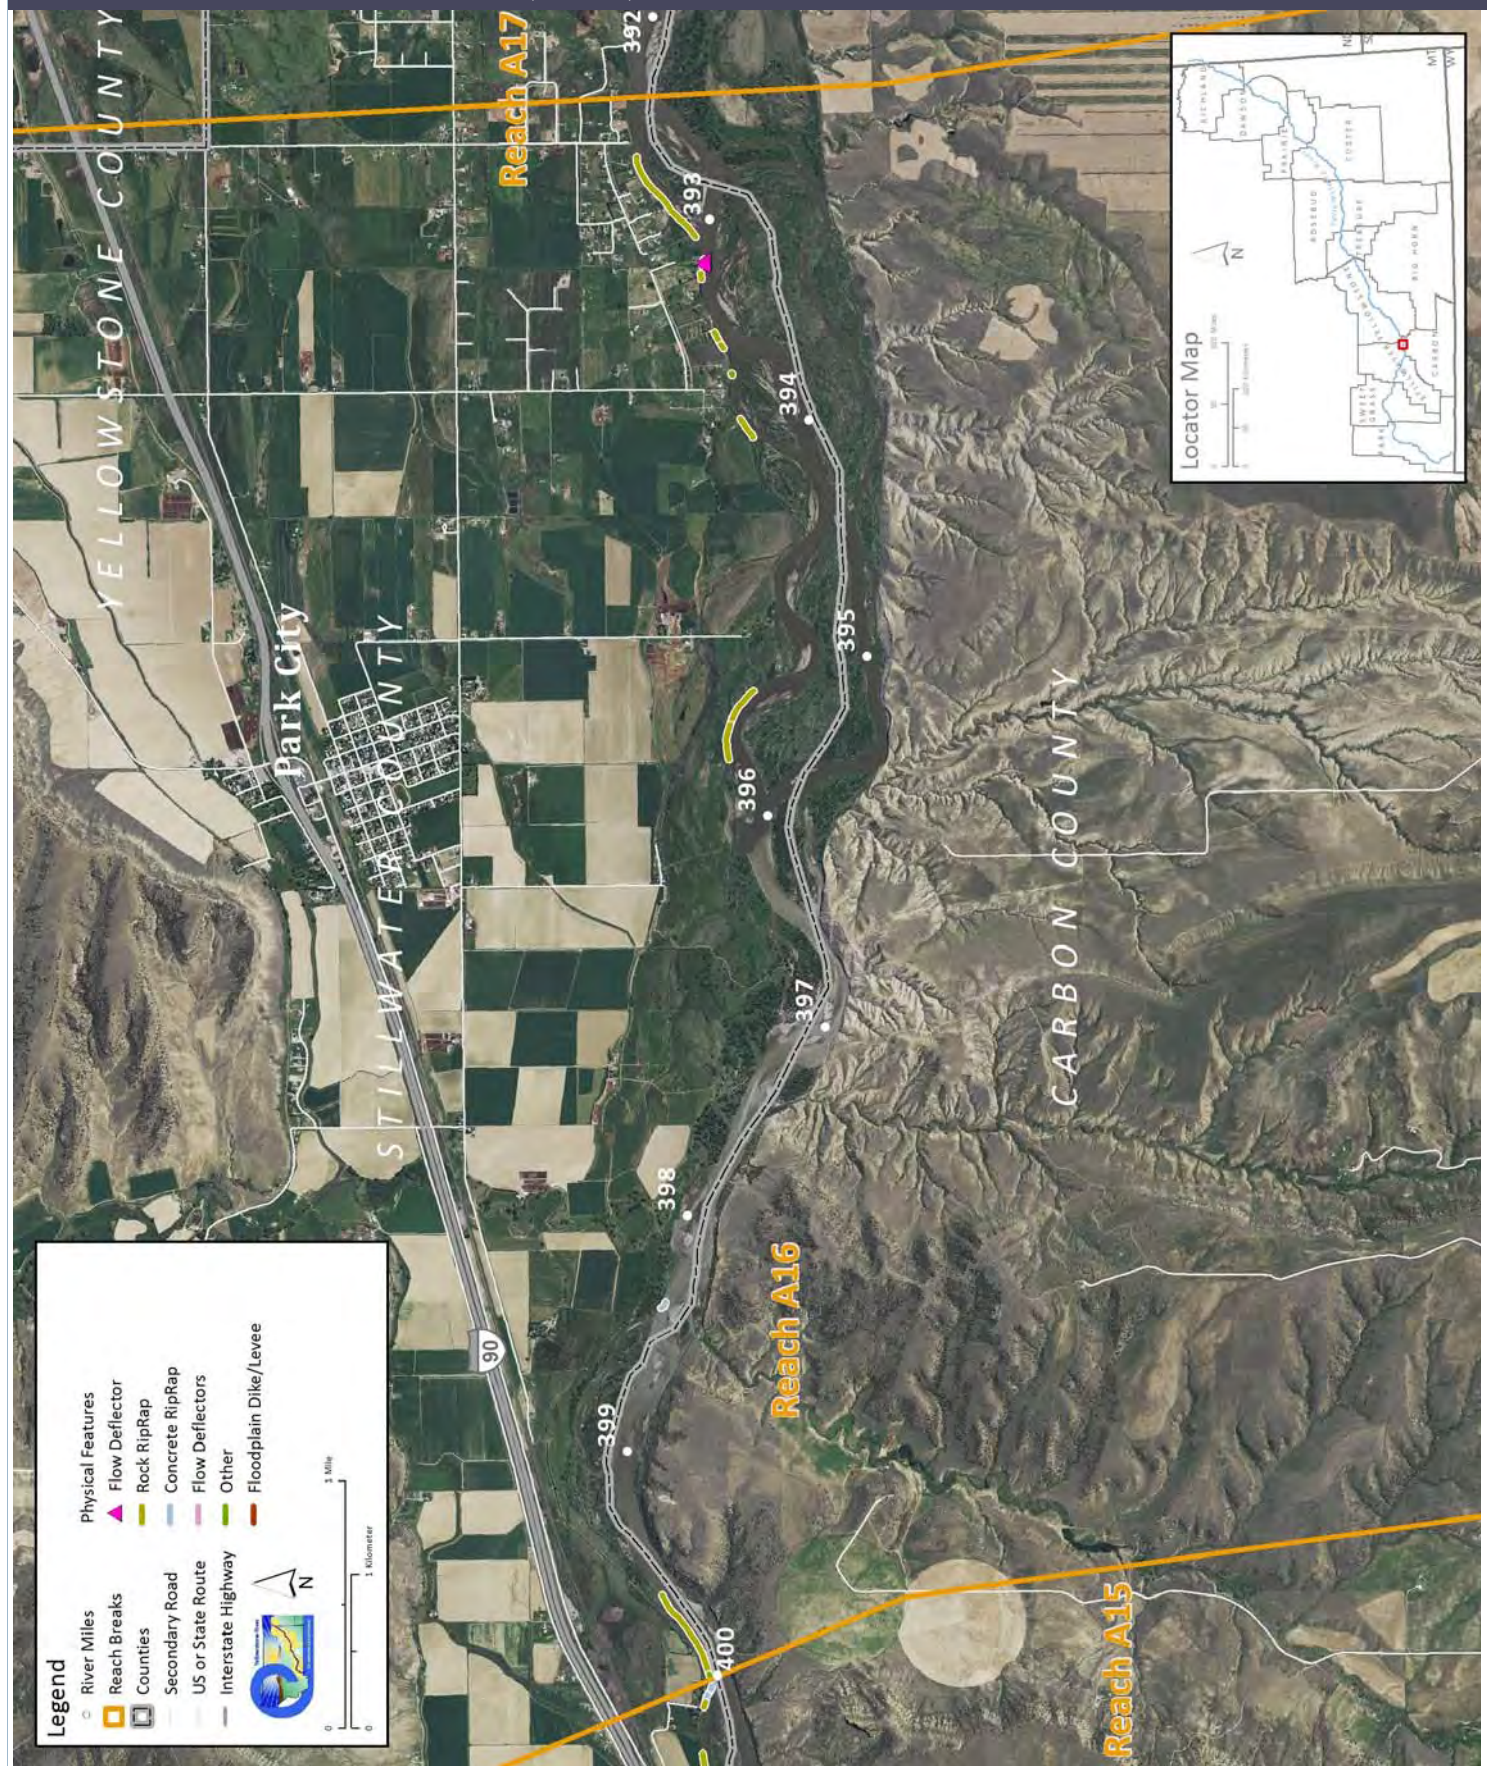
### PHYSICAL FEATURES MAP (2011)

County	Stillwater	Upstream River Mile	400
Classification	PCA: Partially confined anabranching	Downstream River Mile	392.4
General Location	Park City	Length	7.60 mi (12.23 km)

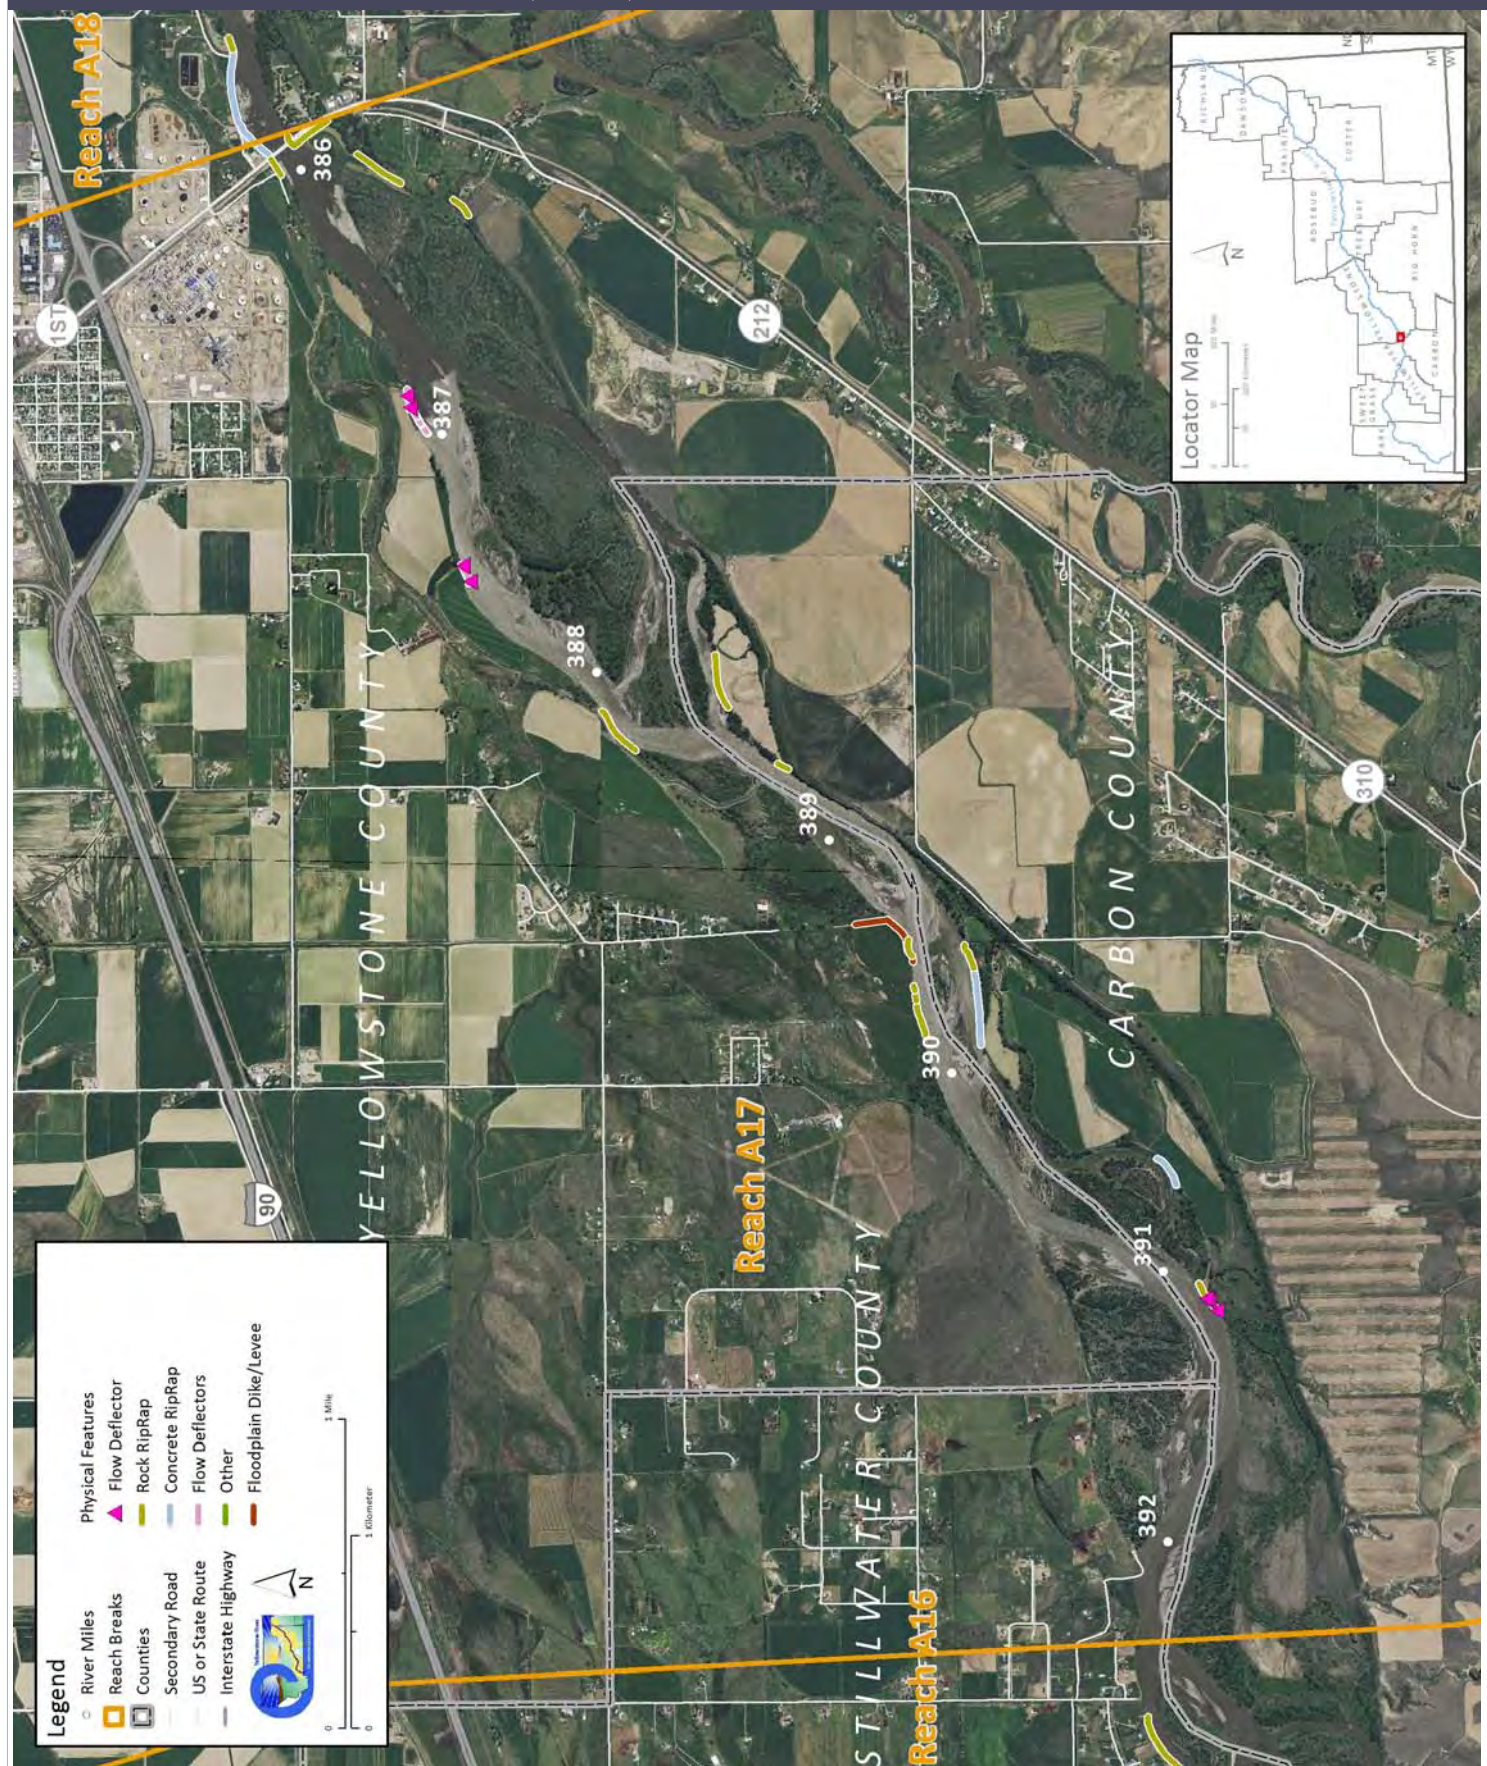
## PHYSICAL FEATURES MAP (2011)

County	Yellowstone	Upstream River Mile	392.4
Classification	UA: Unconfined anabranching	Downstream River Mile	386
General Location	To Laurel	Length	6.40 mi (10.30 km)

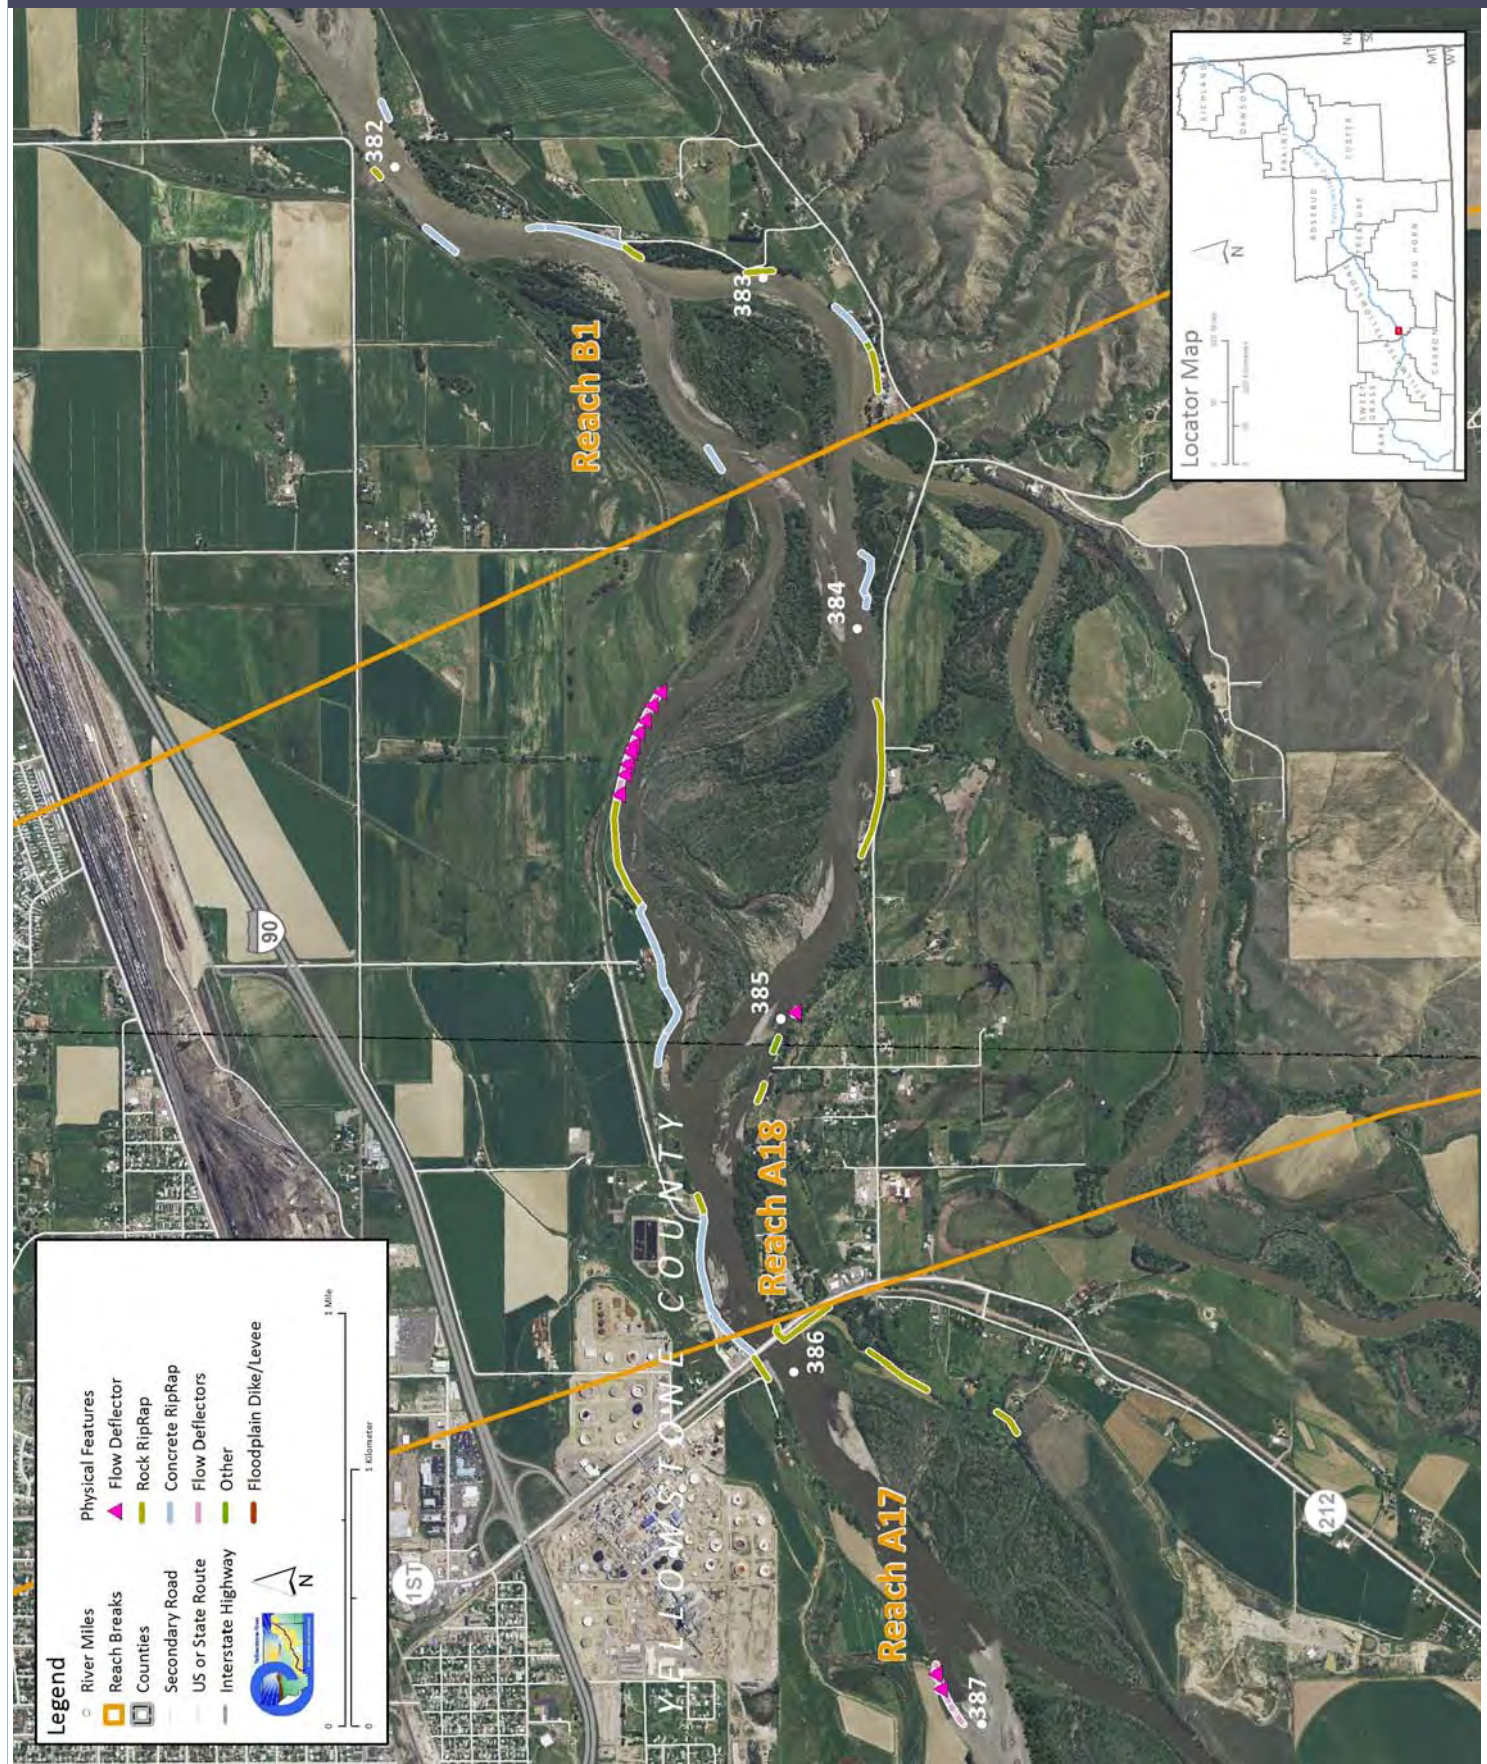
## PHYSICAL FEATURES MAP (2011)

County	Yellowstone	Upstream River Mile	386
Classification	UA: Unconfined anabranching	Downstream River Mile	383.5
General Location	To Clarks Fork	Length	2.50 mi (4.02 km)

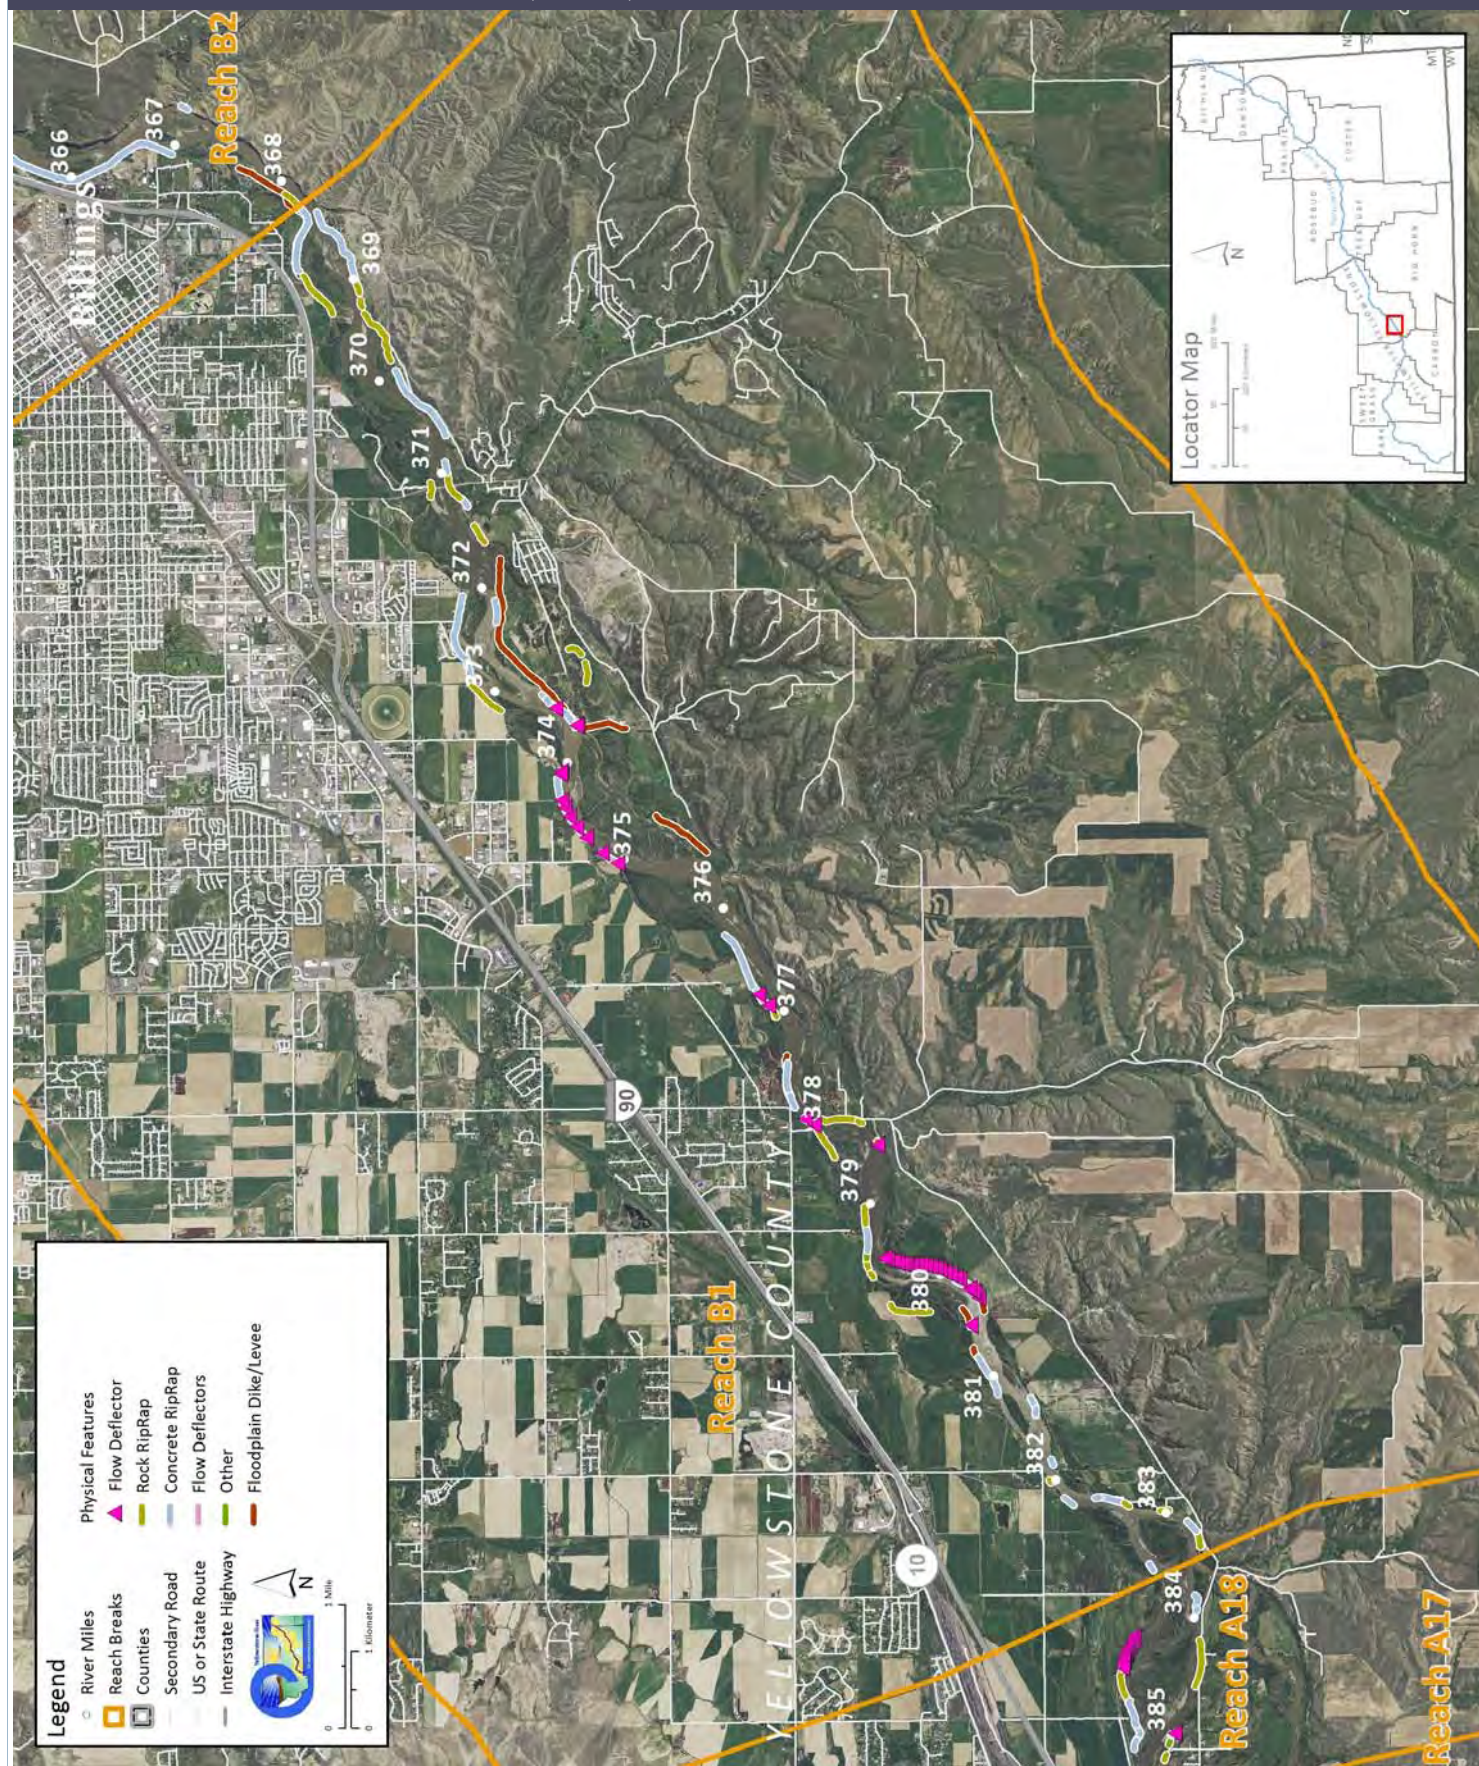
### PHYSICAL FEATURES MAP (2011)

<b>County</b>	Yellowstone	<b>Upstream River Mile</b>	383.5
<b>Classification</b>	UB: Unconfined braided	<b>Downstream River Mile</b>	368.3
<b>General Location</b>	Laurel to Billings	<b>Length</b>	15.20 mi (24.46 km)

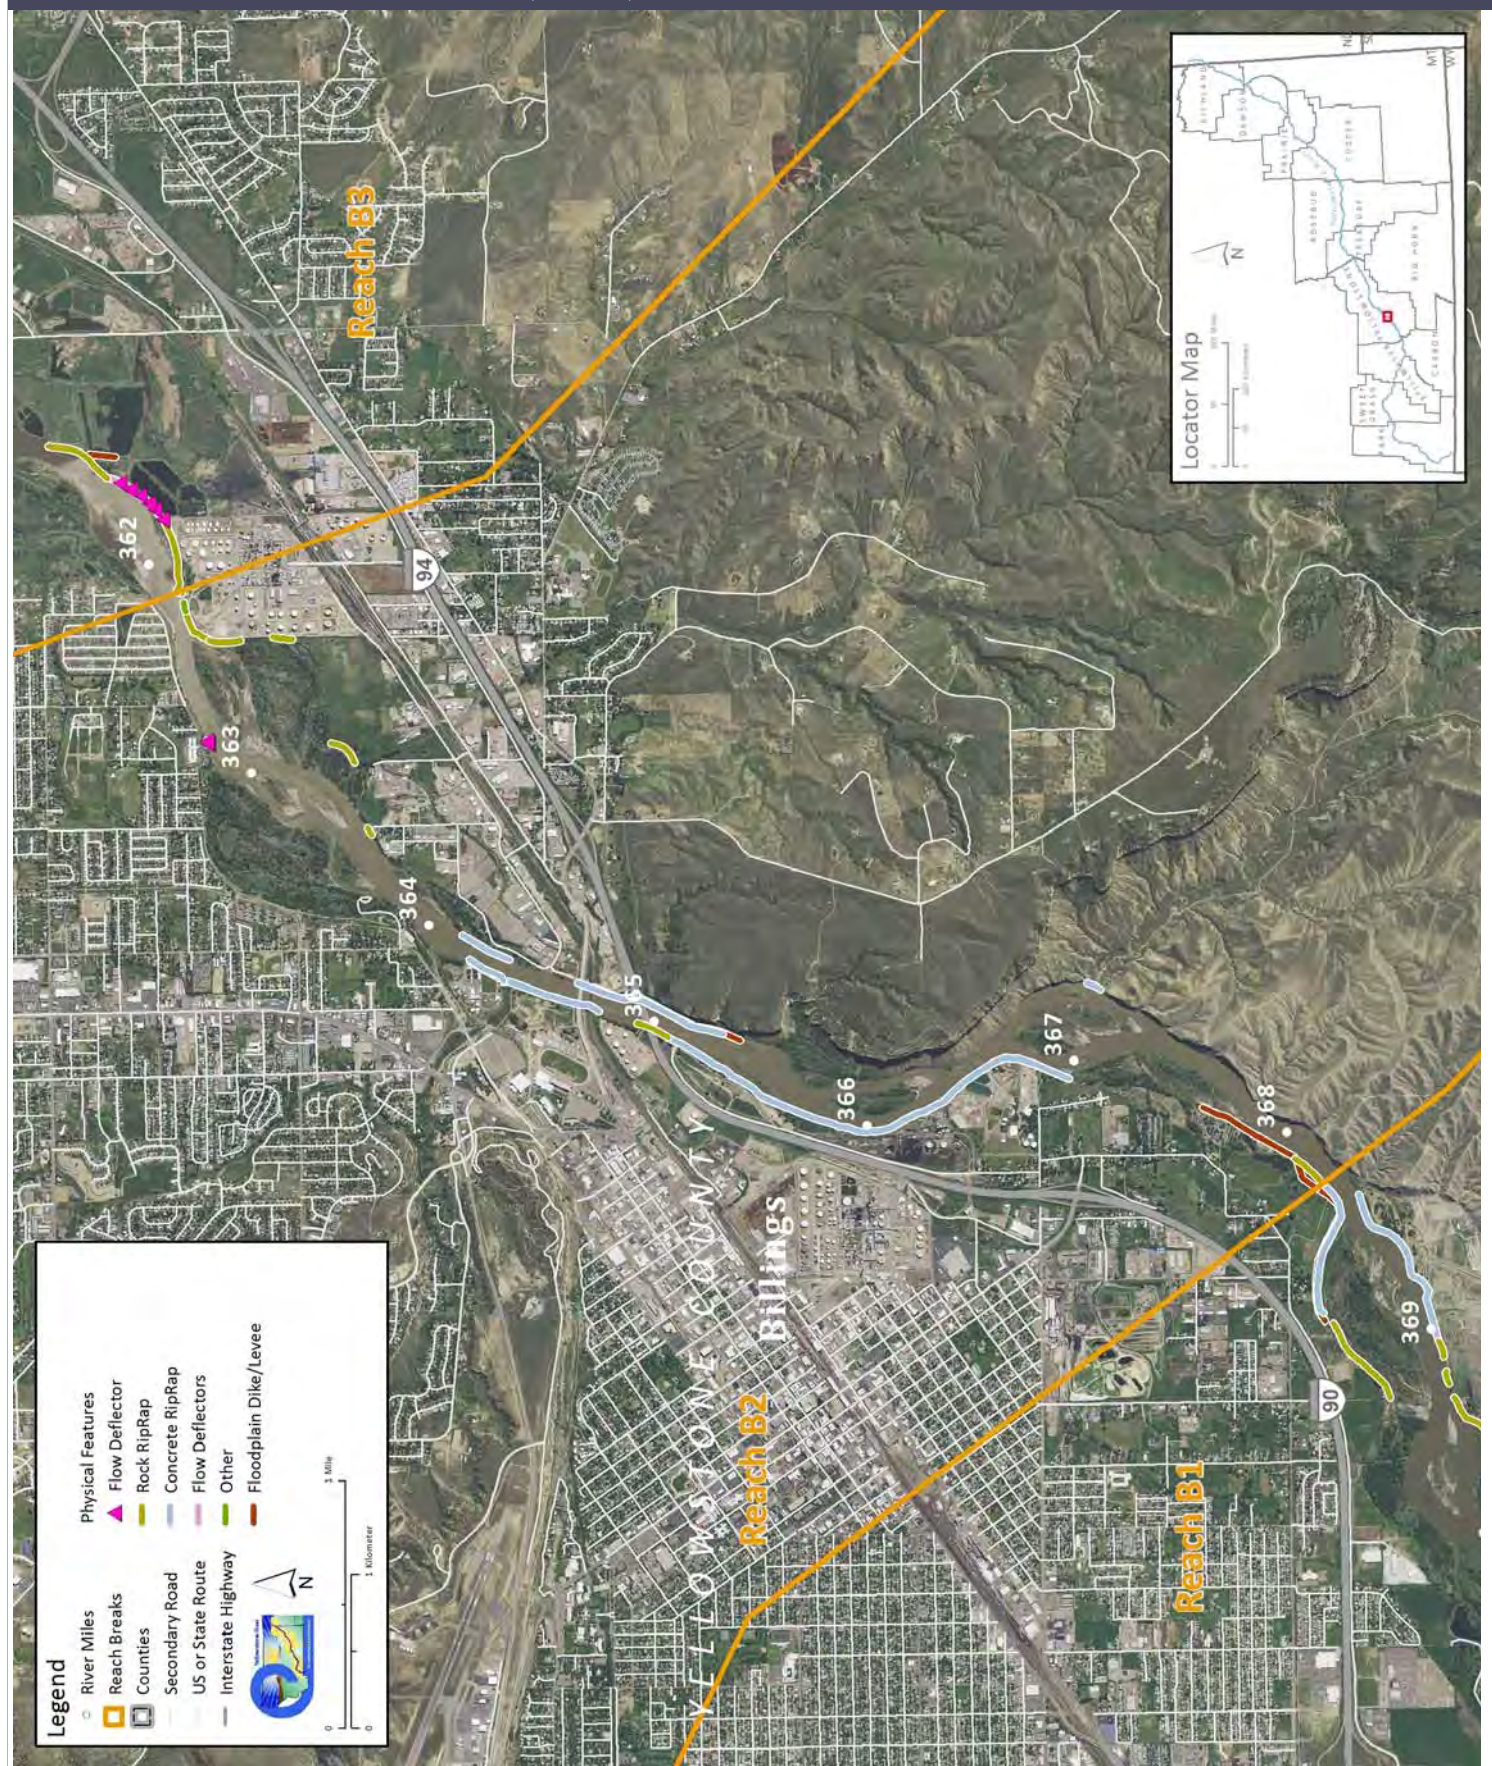
### PHYSICAL FEATURES MAP (2011)

County	Yellowstone	Upstream River Mile	368.3
Classification	PCB: Partially confined braided	Downstream River Mile	362.2
General Location	Billings	Length	6.10 mi (9.82 km)

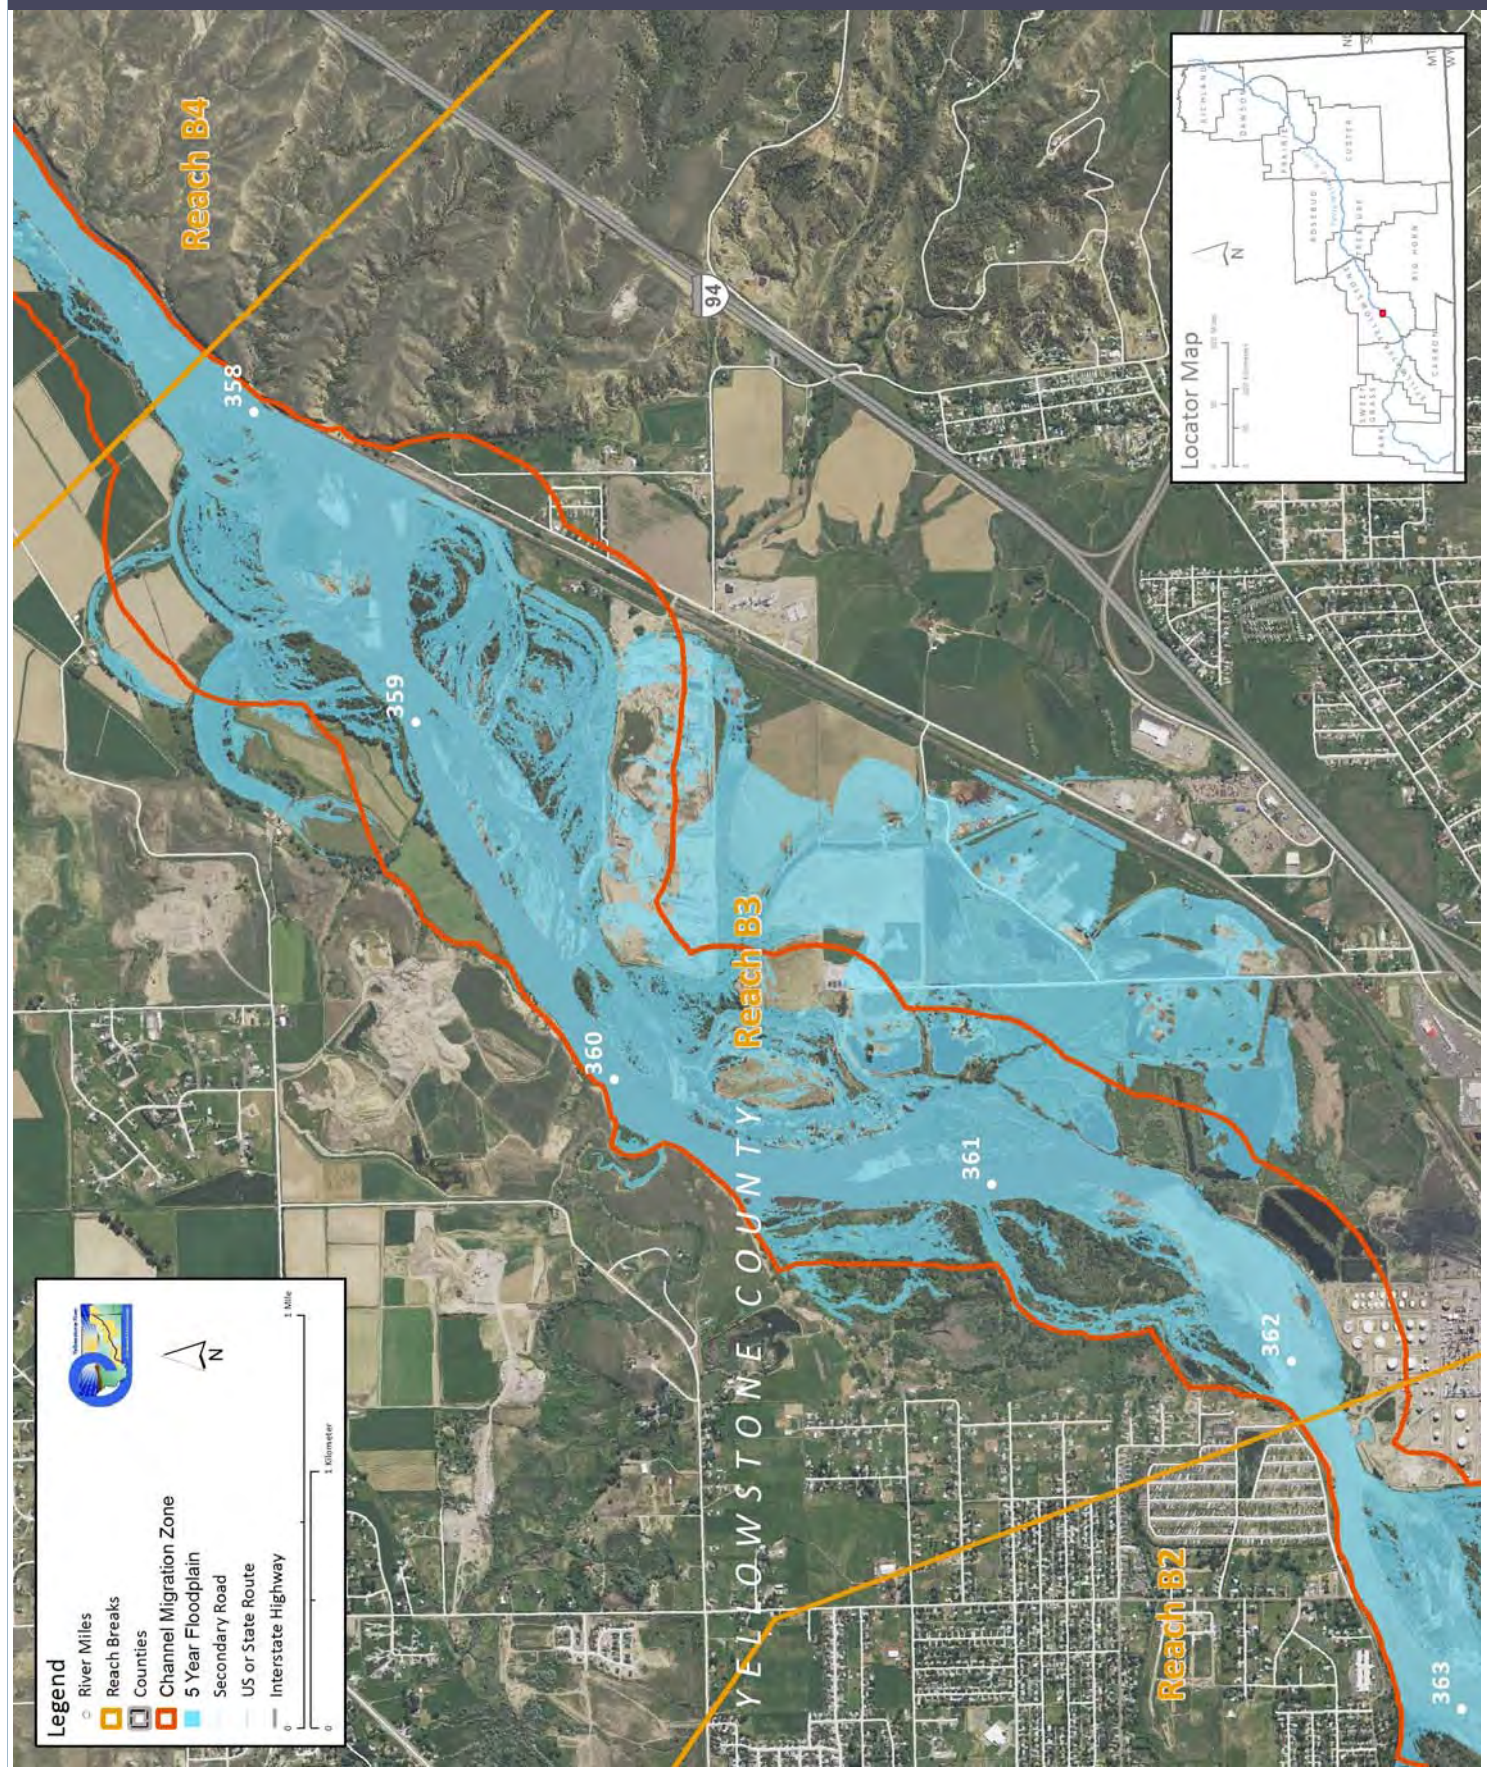
### CHANNEL MIGRATION ZONE MAP

County	Yellowstone	Upstream River Mile	362.2
Classification	UB: Unconfined braided	Downstream River Mile	357.9
General Location	East Billings	Length	4.30 mi (6.92 km)
