County	Park	Upstream River Mile	564.8
Classification	CS: Confined straight	Downstream River Mile	560.2
General Location	Gardiner to Little Trail Cr.	Length	4.60 mi (7.40 km)

### Narrative Summary

Reach PC1 is the upstream-most reach of the project area, beginning at Gardiner Montana, and extending northward almost five miles to the Trail Creek confluence. Reach PC1 is confined/straight reach type and shows minimal impact in terms of flow alterations, bank armoring, and side channel loss. The bankfull area has remained essentially unchanged since 1950. Land use is dominated by non-irrigated agriculture, with some conversion of flood irrigation to sprinkler from 1950 to 2011. There are over 300 acres of urban/exurban development in the reach, dominated by the town of Gardiner. Although the development in Gardiner is very close to the river, it is located high on bluffs that are outside of the Channel Migration Zone (CMZ) and floodplain. The bluffs are composed of glacial outwash deposits that are very coarse and erosion resistant. The total CMZ area in Reach PC1 is only 115 acres, and there is essentially no riparian zone in this reach. This section of river is relatively steep, wi

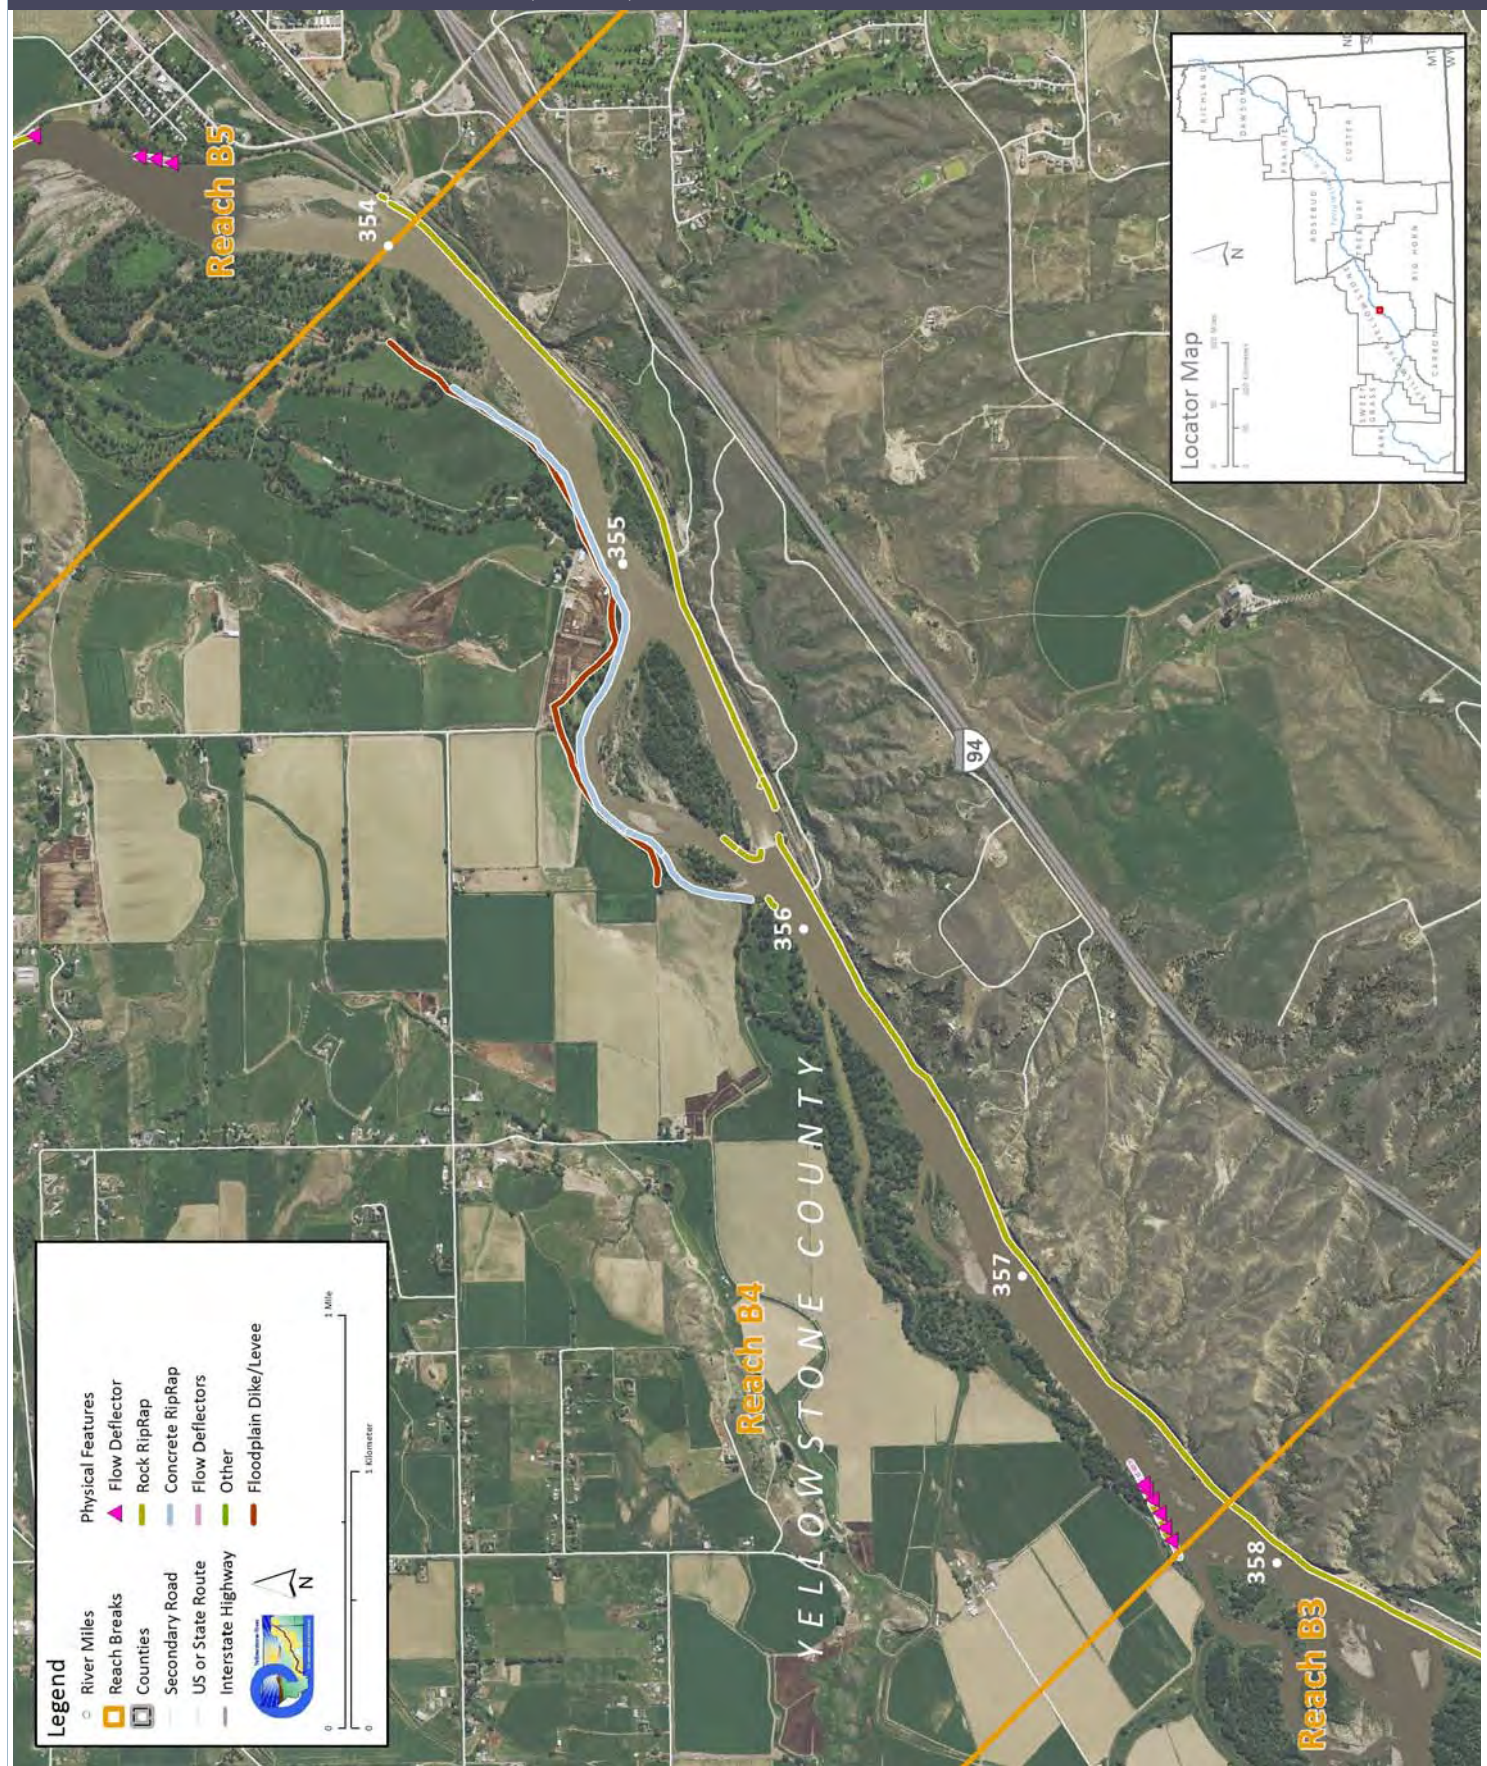
### PHYSICAL FEATURES MAP (2011)

County	Yellowstone	Upstream River Mile	357.9
Classification	PCS: Partially confined straight	Downstream River Mile	354
General Location	Upstream of Huntley	Length	3.90 mi (6.28 km)

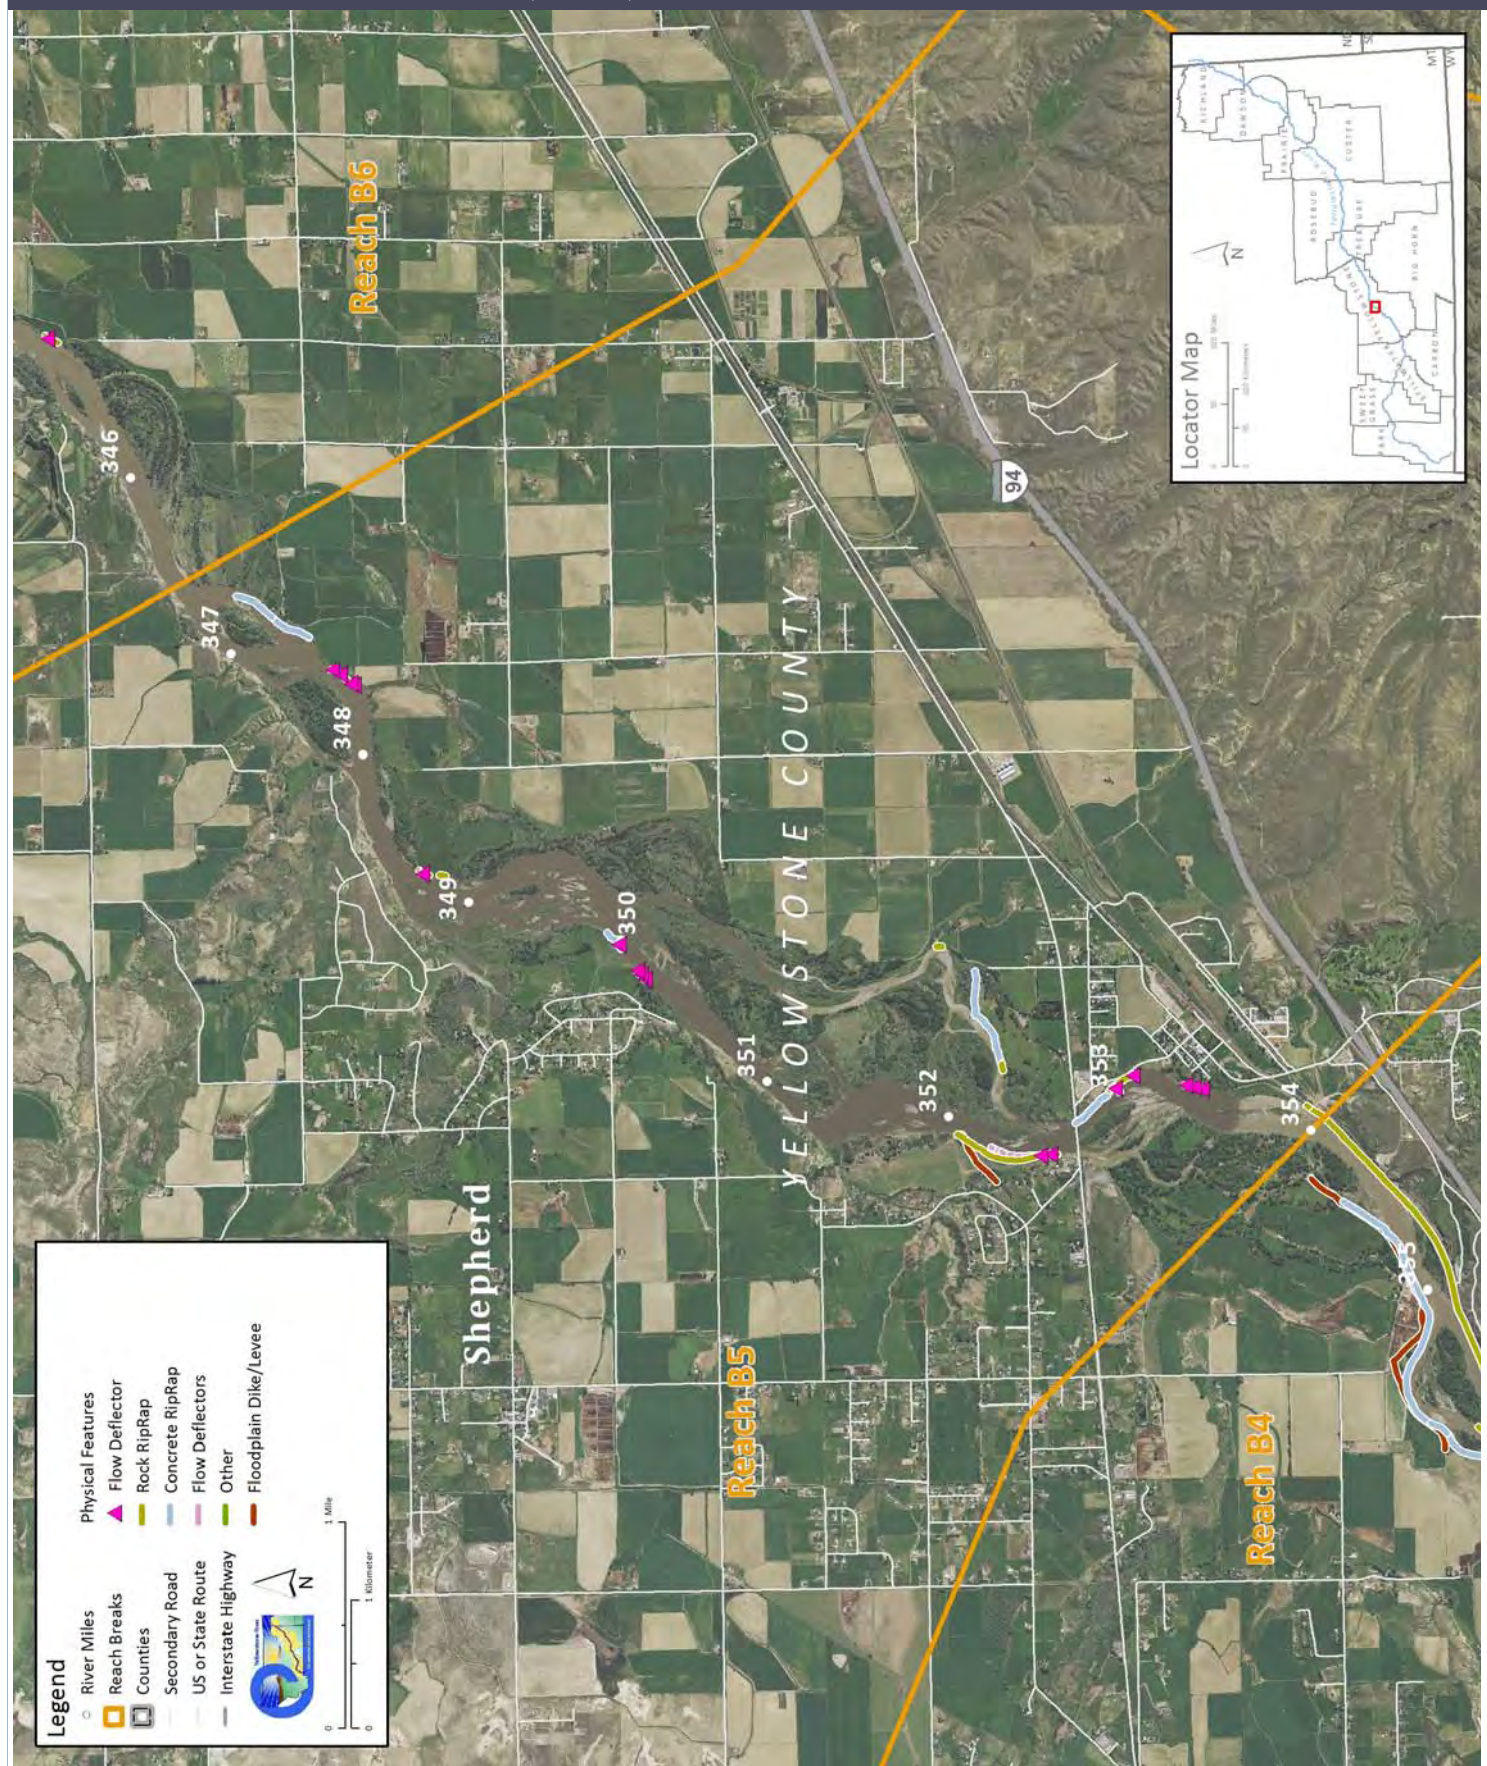
### PHYSICAL FEATURES MAP (2011)

<b>County</b>	Yellowstone	<b>Upstream River Mile</b>	354
<b>Classification</b>	UA: Unconfined anabranching	<b>Downstream River Mile</b>	346.7
<b>General Location</b>	Huntley: includes Spraklin Island	<b>Length</b>	7.30 mi (11.75 km)

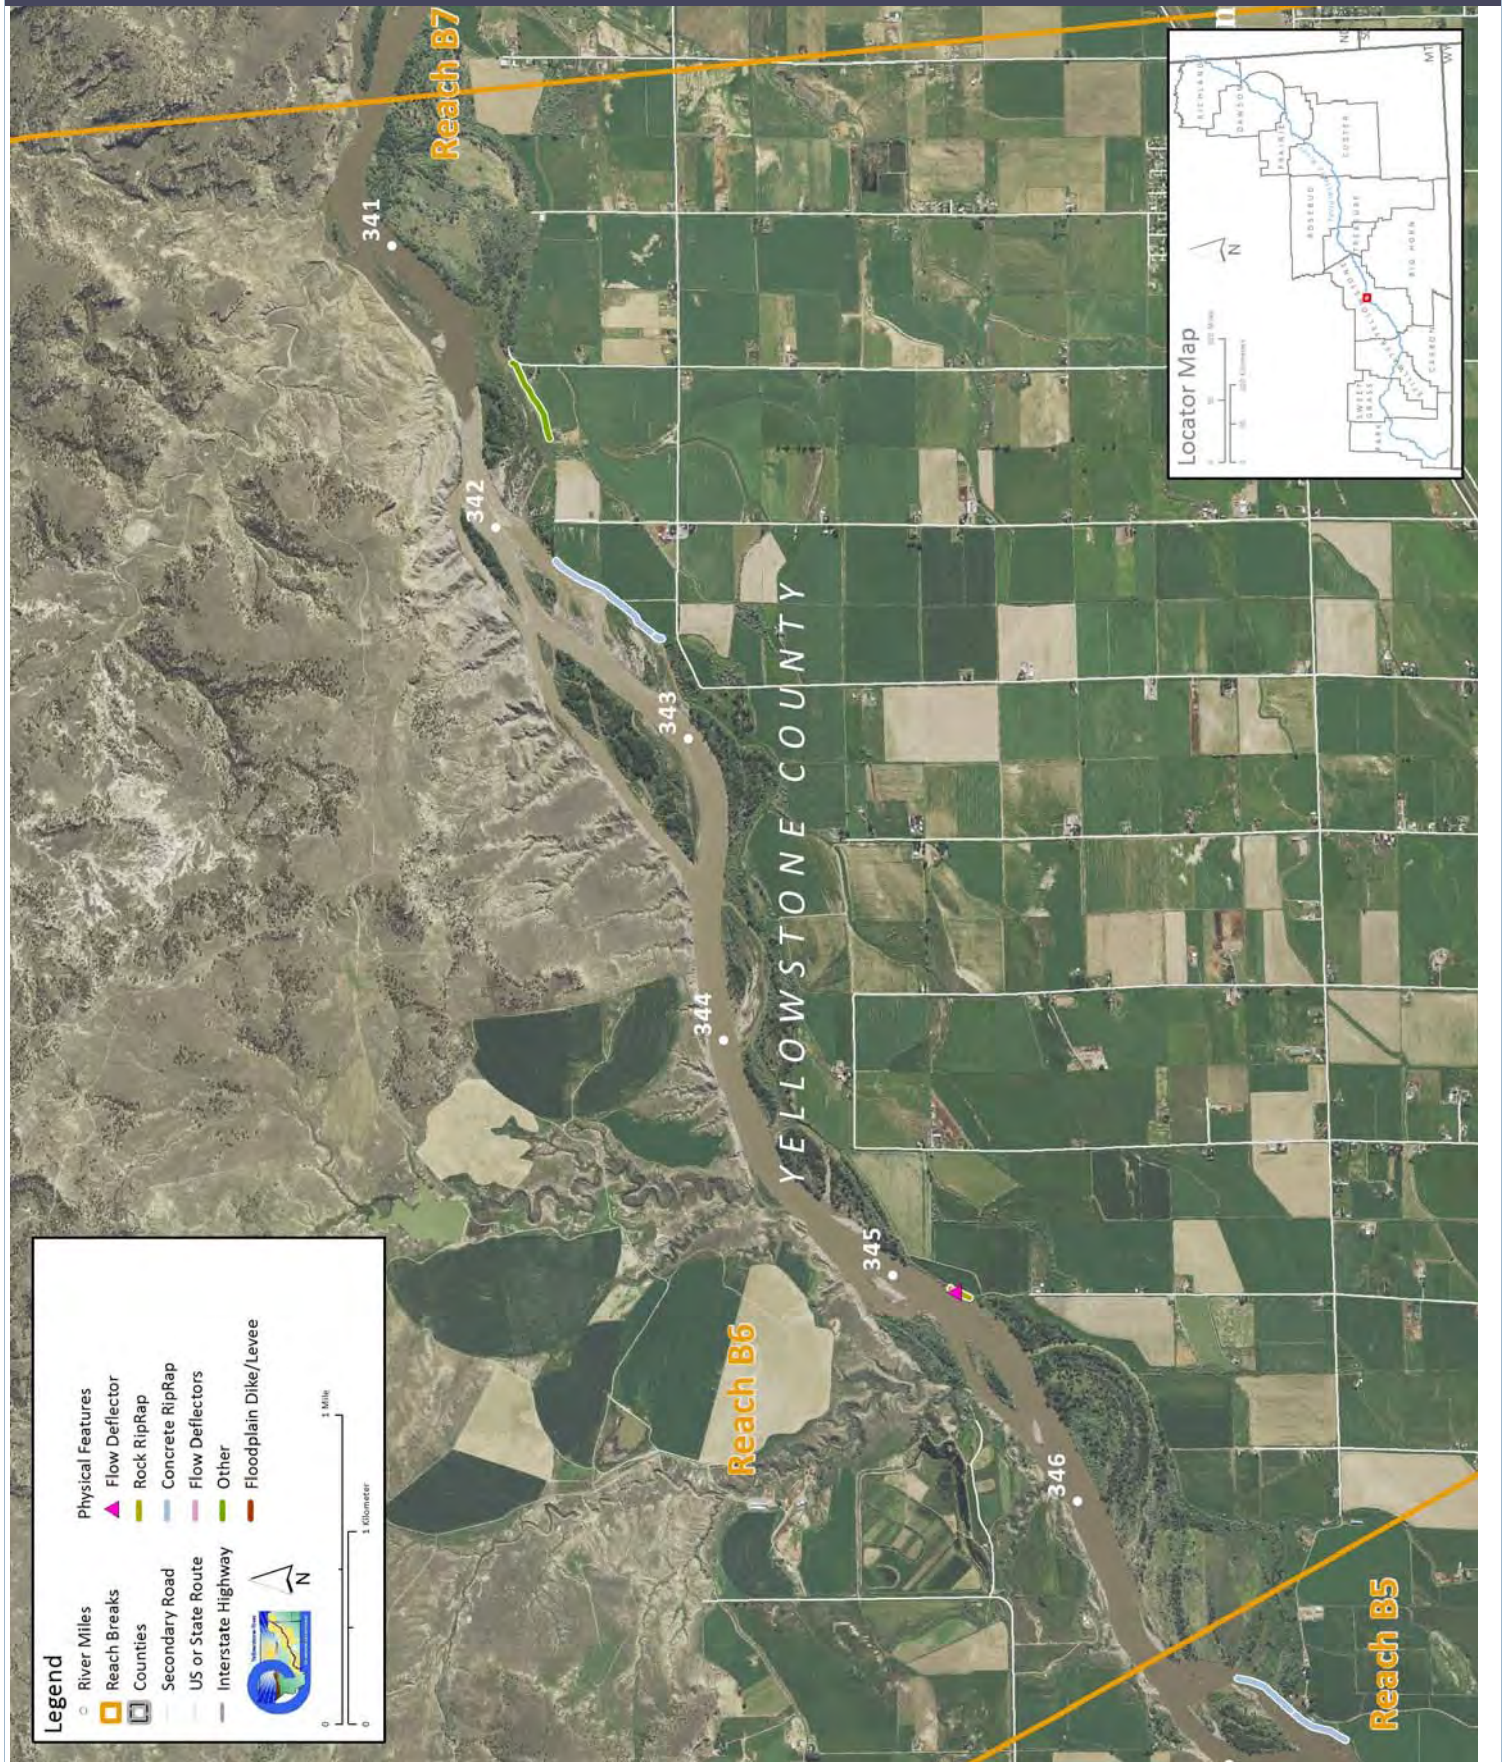
### PHYSICAL FEATURES MAP (2011)

County	Yellowstone	Upstream River Mile	346.7
Classification	PCB: Partially confined braided	Downstream River Mile	340.6
General Location	Ballantine	Length	6.10 mi (9.82 km)

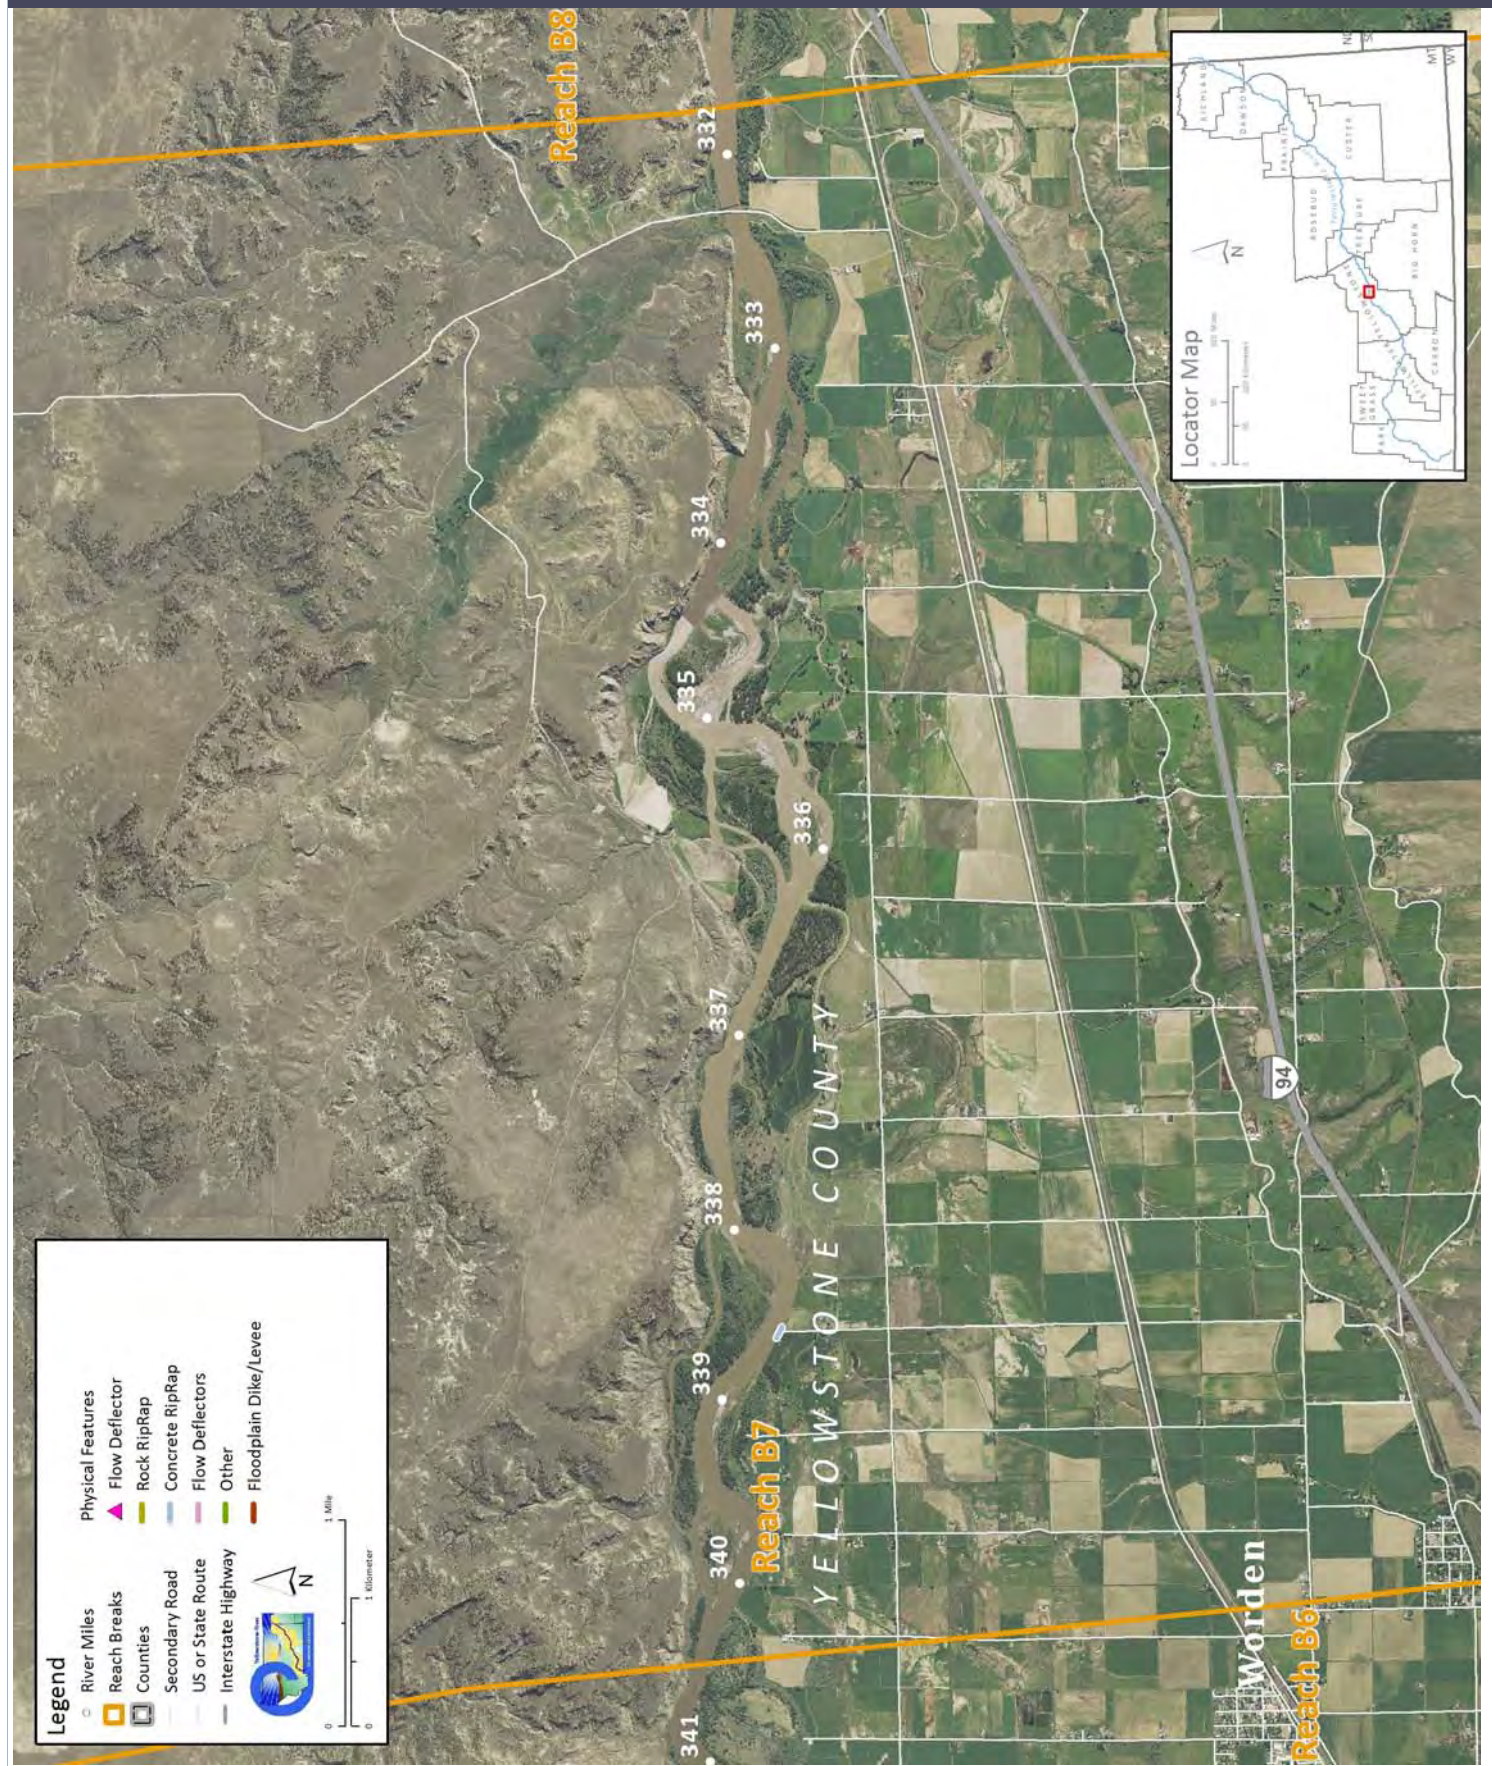
### PHYSICAL FEATURES MAP (2011)

County	Yellowstone	Upstream River Mile	340.6
Classification	UB: Unconfined braided	Downstream River Mile	331.8
General Location	To Pompey's Pillar	Length	8.80 mi (14.16 km)

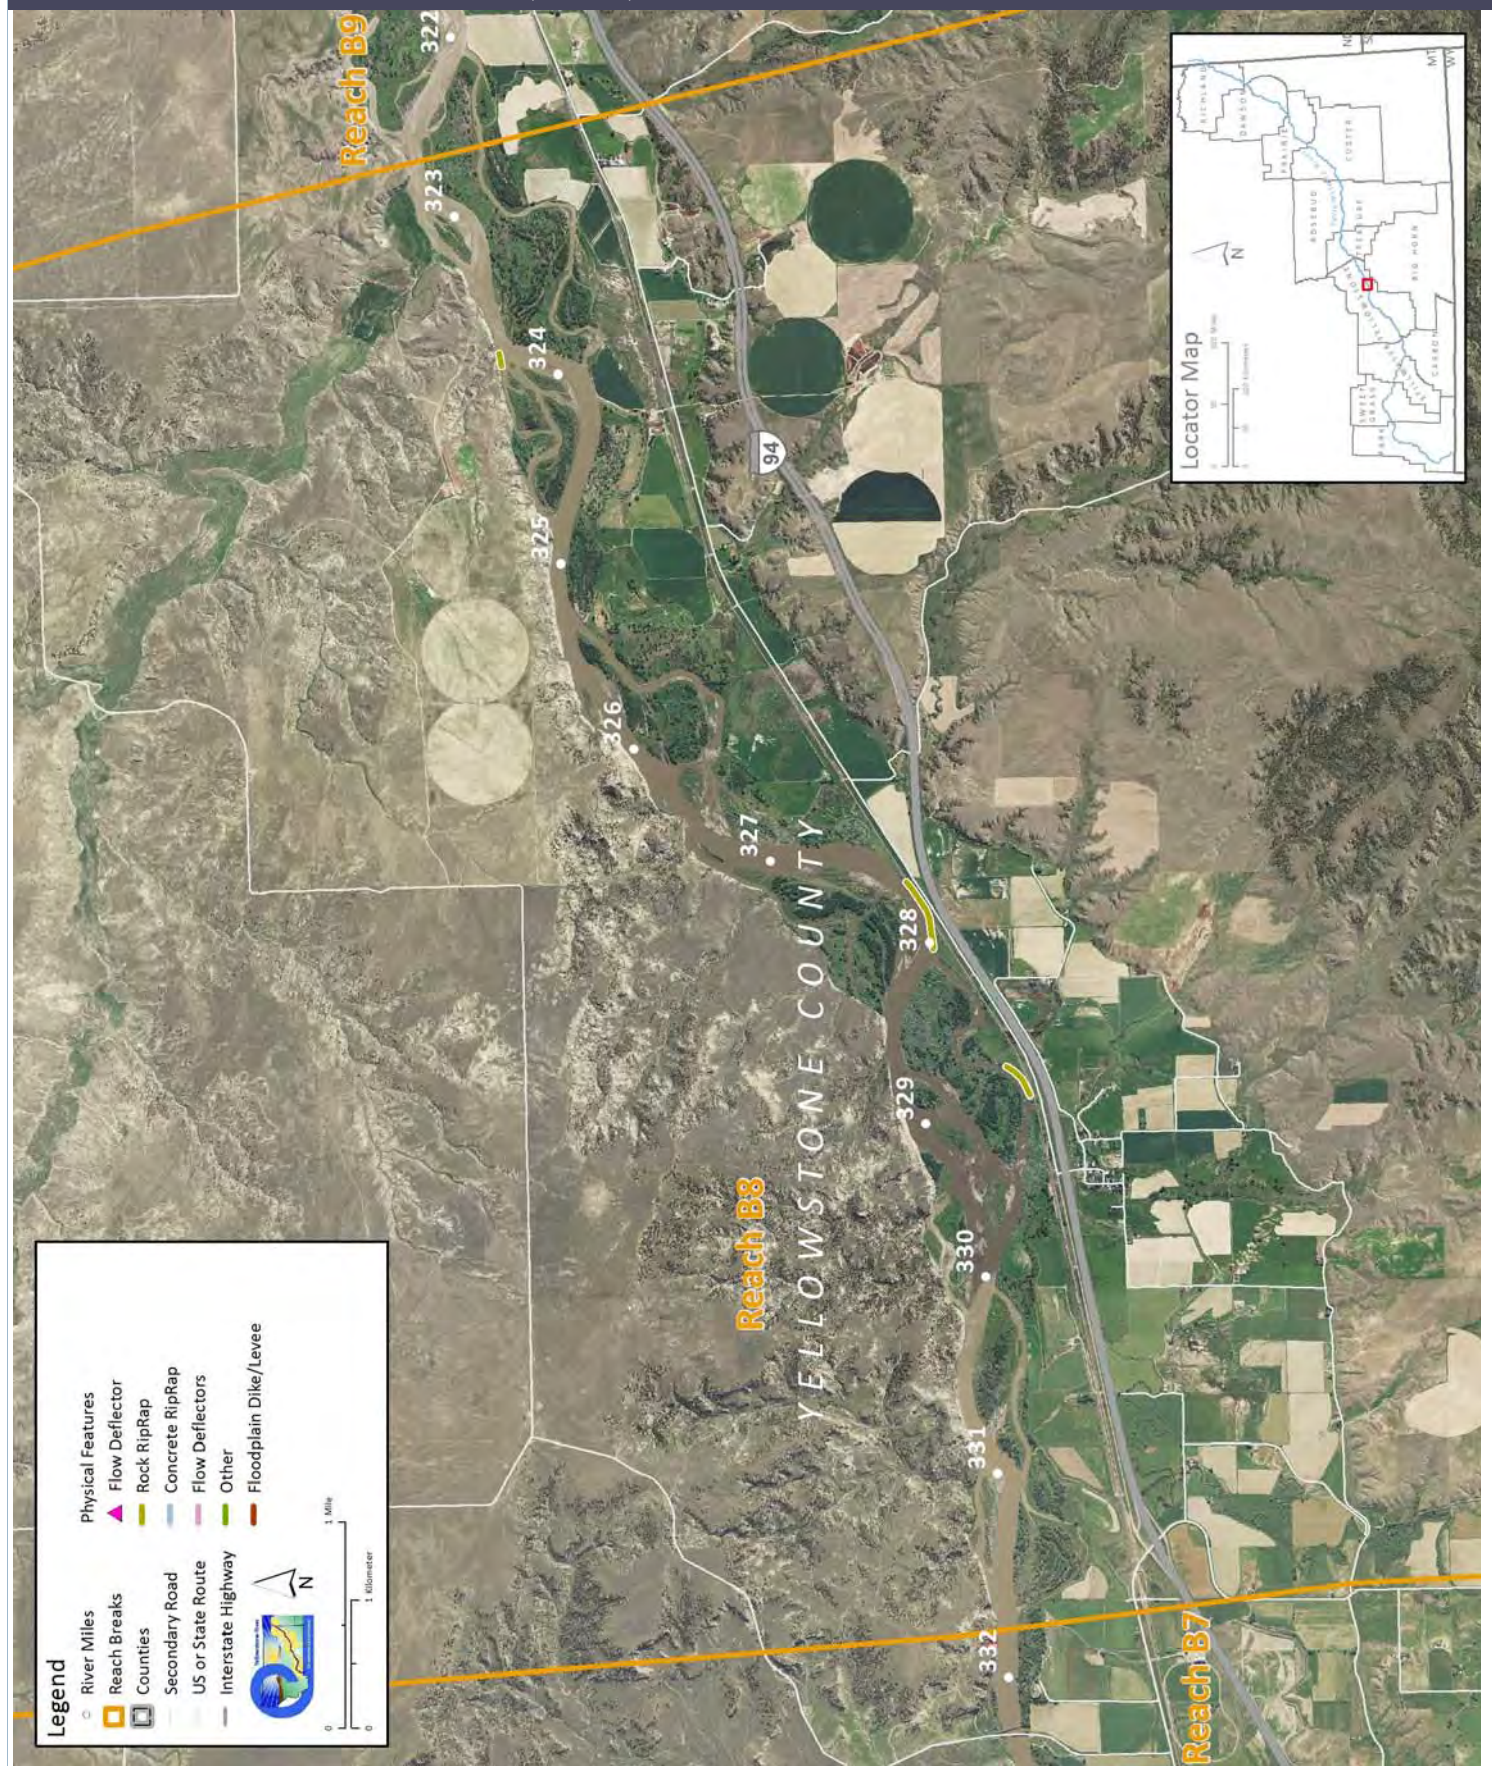
### PHYSICAL FEATURES MAP (2011)

County	Yellowstone	Upstream River Mile	331.8
Classification	PCA: Partially confined anabranching	Downstream River Mile	322.7
General Location	Bull Mountain	Length	9.10 mi (14.65 km)

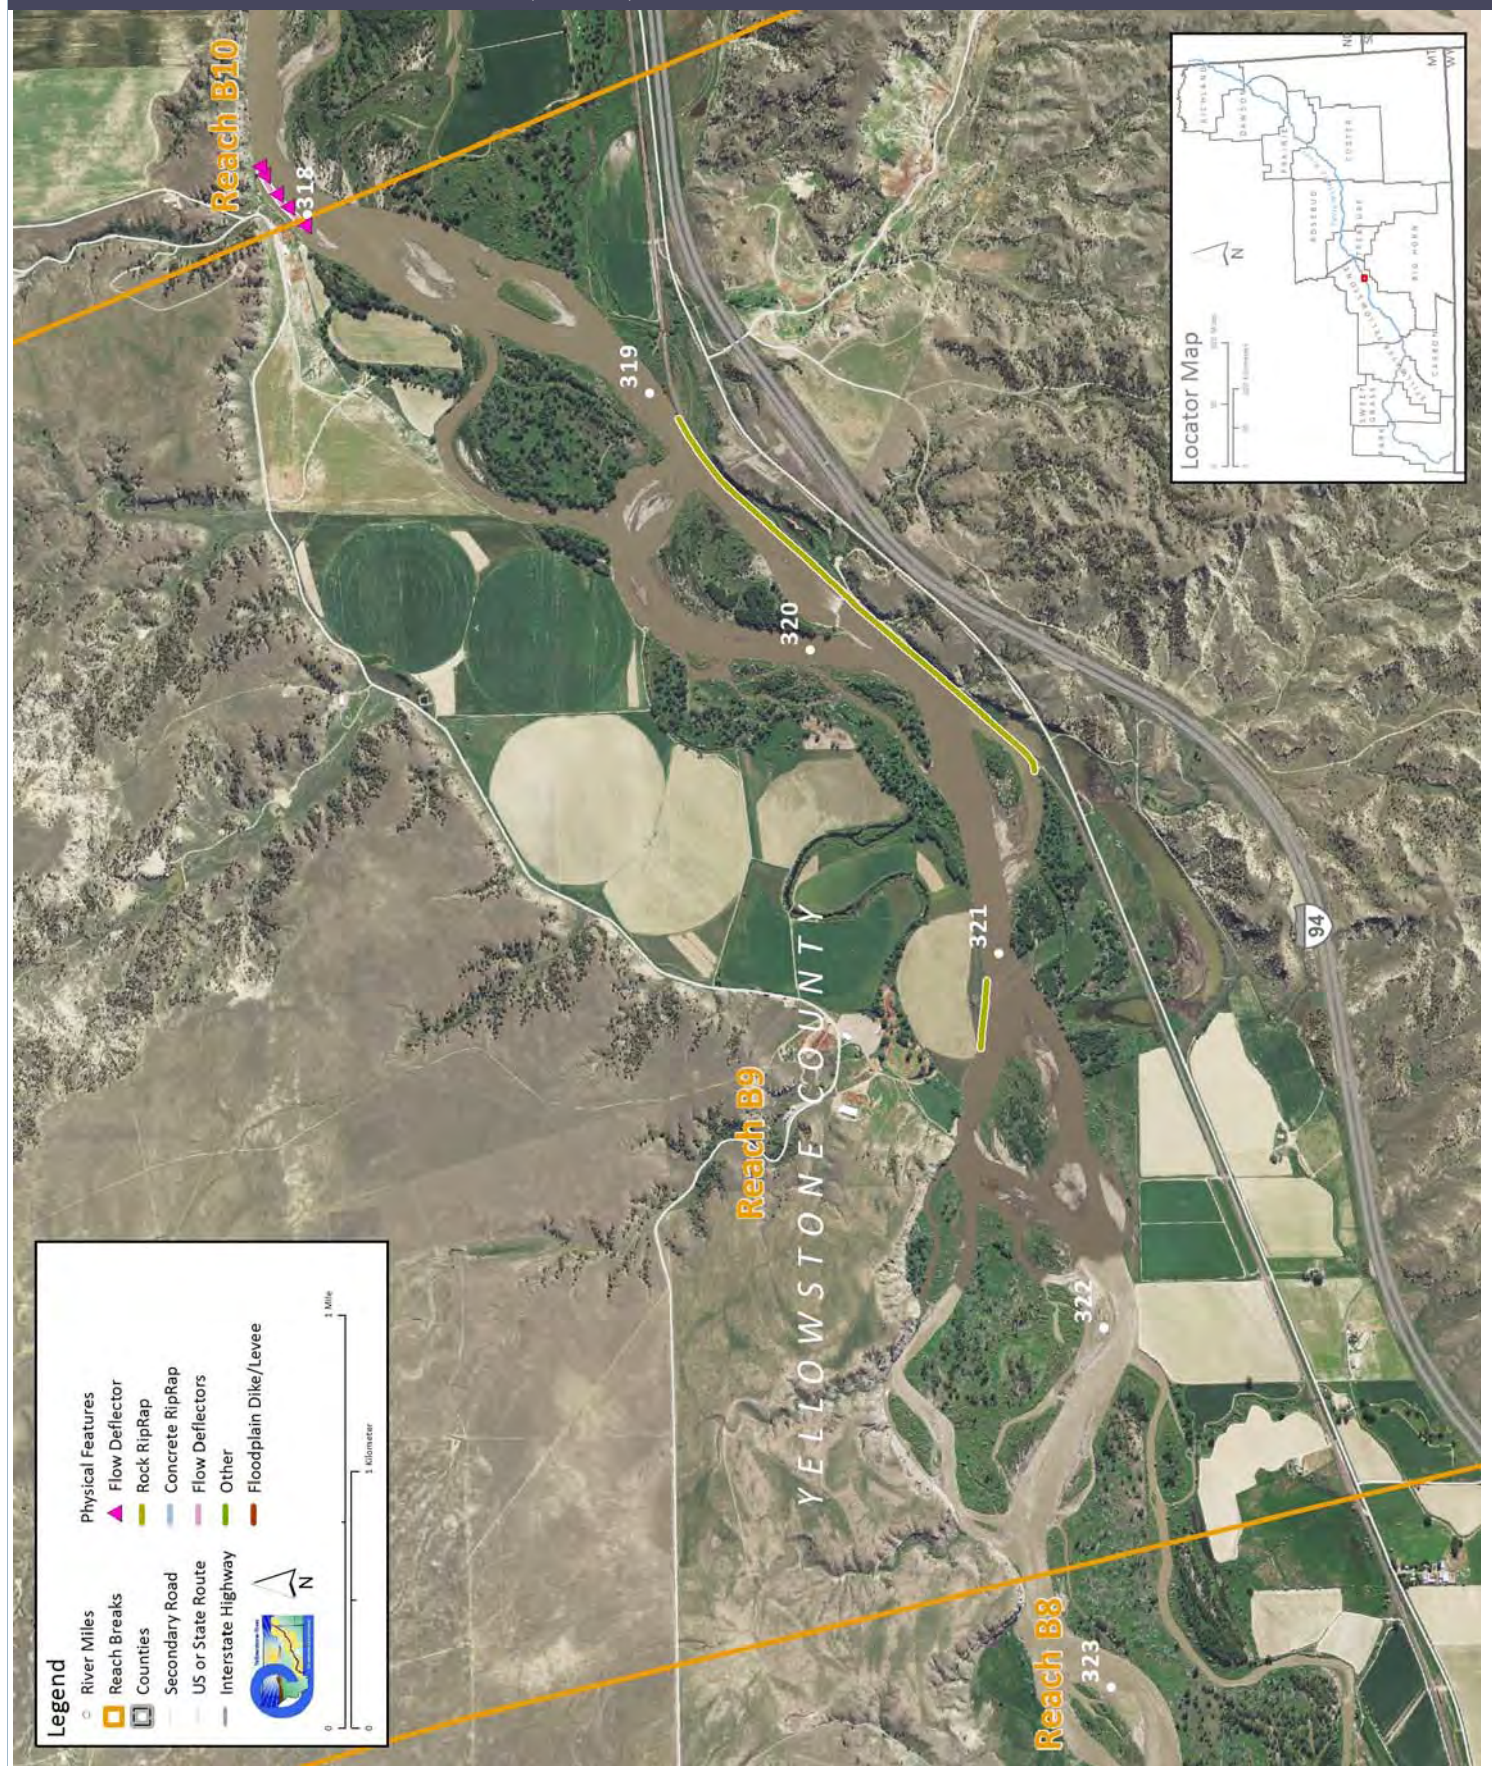
### PHYSICAL FEATURES MAP (2011)

County	Yellowstone	Upstream River Mile	322.7
Classification	UA: Unconfined anabranching	Downstream River Mile	318
General Location	Reed Creek	Length	4.70 mi (7.56 km)
