Clark Fork River Plains Reach Assessment & Restoration Prioritization

May 14, 2014

**CLARK FORK RIVER
PLAINS REACH ASSESSMENT
AND
RESTORATION PRIORITIZATION**

RESPEC

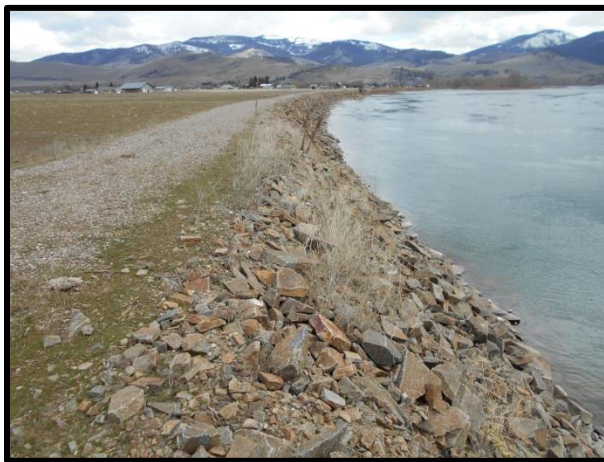
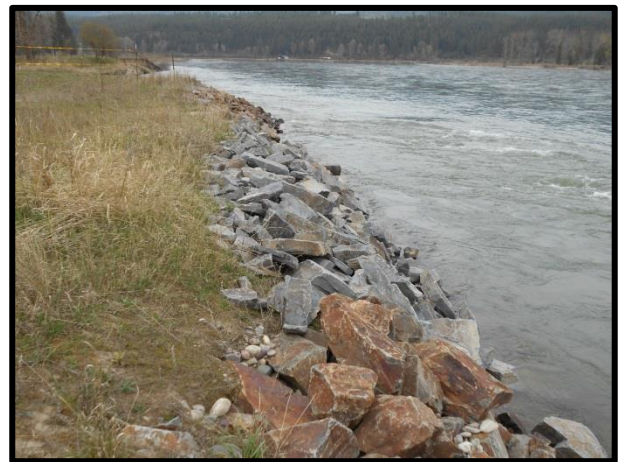
Figure 3-3. Rock Riprap Upstream of Bank 5 (Left) and at the Town of Plains WWTP (Right)

Both man-made obstructions and naturally occurring bedrock confine the channel in the Plains Reach of the Clark Fork River. This assessment identified approximately 4,000 feet of rock riprap between Henry Creek and Lynch Creek, while an additional 4,600 feet of the river right bank along the town of Plains has been stabilized using a variety of materials including old cars, concrete blocks, wooden poles, sheet metal, and native rock material. Within the Plains Reach, rock riprap and other bank stabilization measures have been implemented along the railroad, River Road East, the town of Plains, the abutments of the 5th Avenue South Bridge, the Sanders County Fairgrounds, the Garrison/Herschbach Property, and along the Town of Plains WWTP (**Figure 3-3**). Natural channel confinement occurs at the bedrock outcrop at the downstream end of Big Eddy, along with periodic valley confinement along river left downstream of the island that separates the west channel from the main channel (**Figure 3-4**). In addition, the 5th Avenue South Bridge constricts the river to approximately 896 feet, which is a 17% constriction at bankfull flows when compared to a mean active channel width of 1,049 feet. The bridge is at an angle to the current channel configuration, which further constricts the flow, while the historic bridge pylons remain in the channel, creating additional turbulence as water passes under the bridge (**Figure 3-5** and **Figure 3-6**).

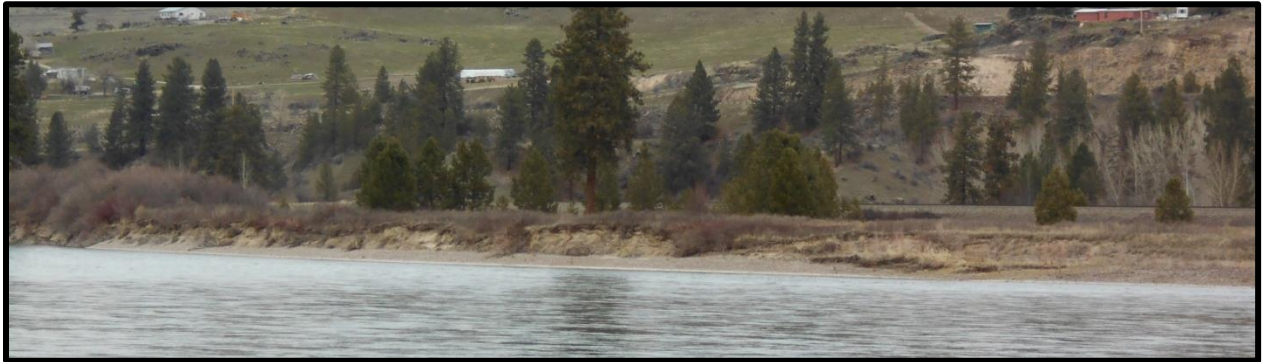
Figure 5-5. Bank 1 Viewed Downstream from River Road East, March 2014

Bank 1 is 1,129 feet long and located on river right adjacent to Smiley's Slough. Between 1995 and 2013, bank 1 has eroded an average of 11 feet, with a mean annual retreat rate of 0.6 feet. Bank 1 is comprised of fine grained material, with gravel and cobble in the toe (**Figure 5-4**). The primary factor influencing erosion of bank 1 is a mid-channel bar that directs water towards the channel margin. Compounding factors include upstream channelization on river left by the levee along River Road East and on river right by the railroad, which has cut off the river's access to Smiley's slough (**Figure 5-7**).

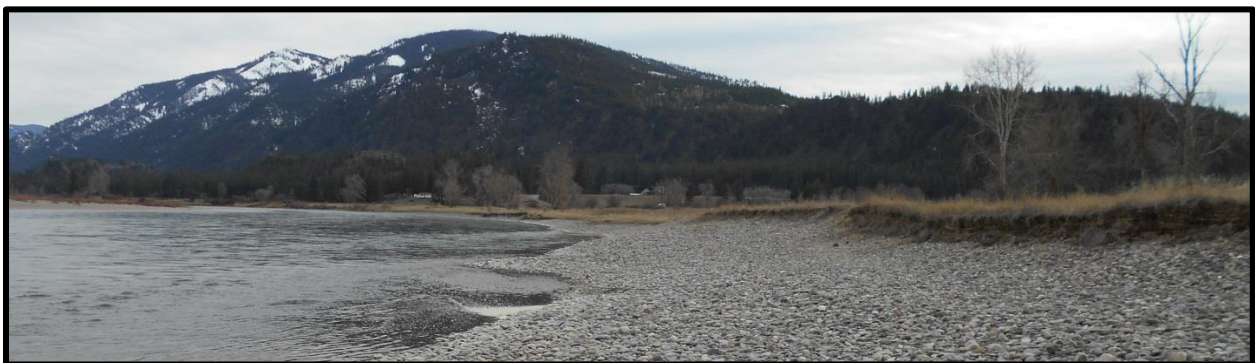
Figure 5-6. Bank 2 Viewed Upstream from the Bend on River Road East, March 2014

Bank 2 is 3,215 feet long and is located on river left along River Road East and across from Smiley's Slough. Between 1995 and 2013, bank 2 has eroded an average of 23 feet, with a mean annual retreat rate of 1.3 feet. Bank 2 is comprised of course grained material, including gravel and cobble (**Figure 5-6**). The primary factors influencing erosion of bank 2 are a mid-channel bar that directs water towards the channel margin, the banks location along the outside of meander bend, and a lack of deep rooted riparian vegetation. Compounding factors include upstream channelization on river left by the levee along River Road East and on river right by the railroad, which has cut off the river's access to Smiley's slough (**Figure 5-7**).

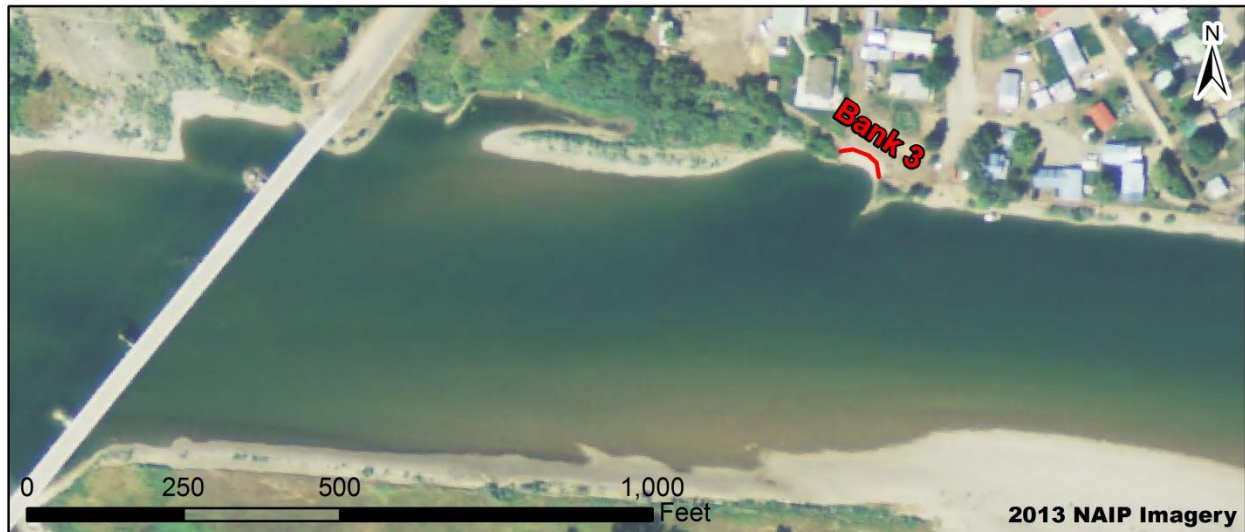
Figure 5-8. Bank 3 Upstream of the 5th Avenue South Bridge

Bank 3 is 87 feet long and is located on river right in the town of Plains just upstream of the 5th Avenue South Bridge crossing (**Figure 5-8**). An assessment of bank retreat since 1995 was not conducted along this short bank, though aerial imagery from 1995 indicates it used to be lined by woody vegetation. The majority of the river right bank along the town of Plains upstream of the 5th Avenue South Bridge has been stabilized and this short section appears to be eroding due to a lack of bank armoring, along with flow deflection from upstream stabilization measures. Bank 3 is primarily comprised of course grained material, with fine grained material in the upper portion of the bank (**Figure 5-9**).

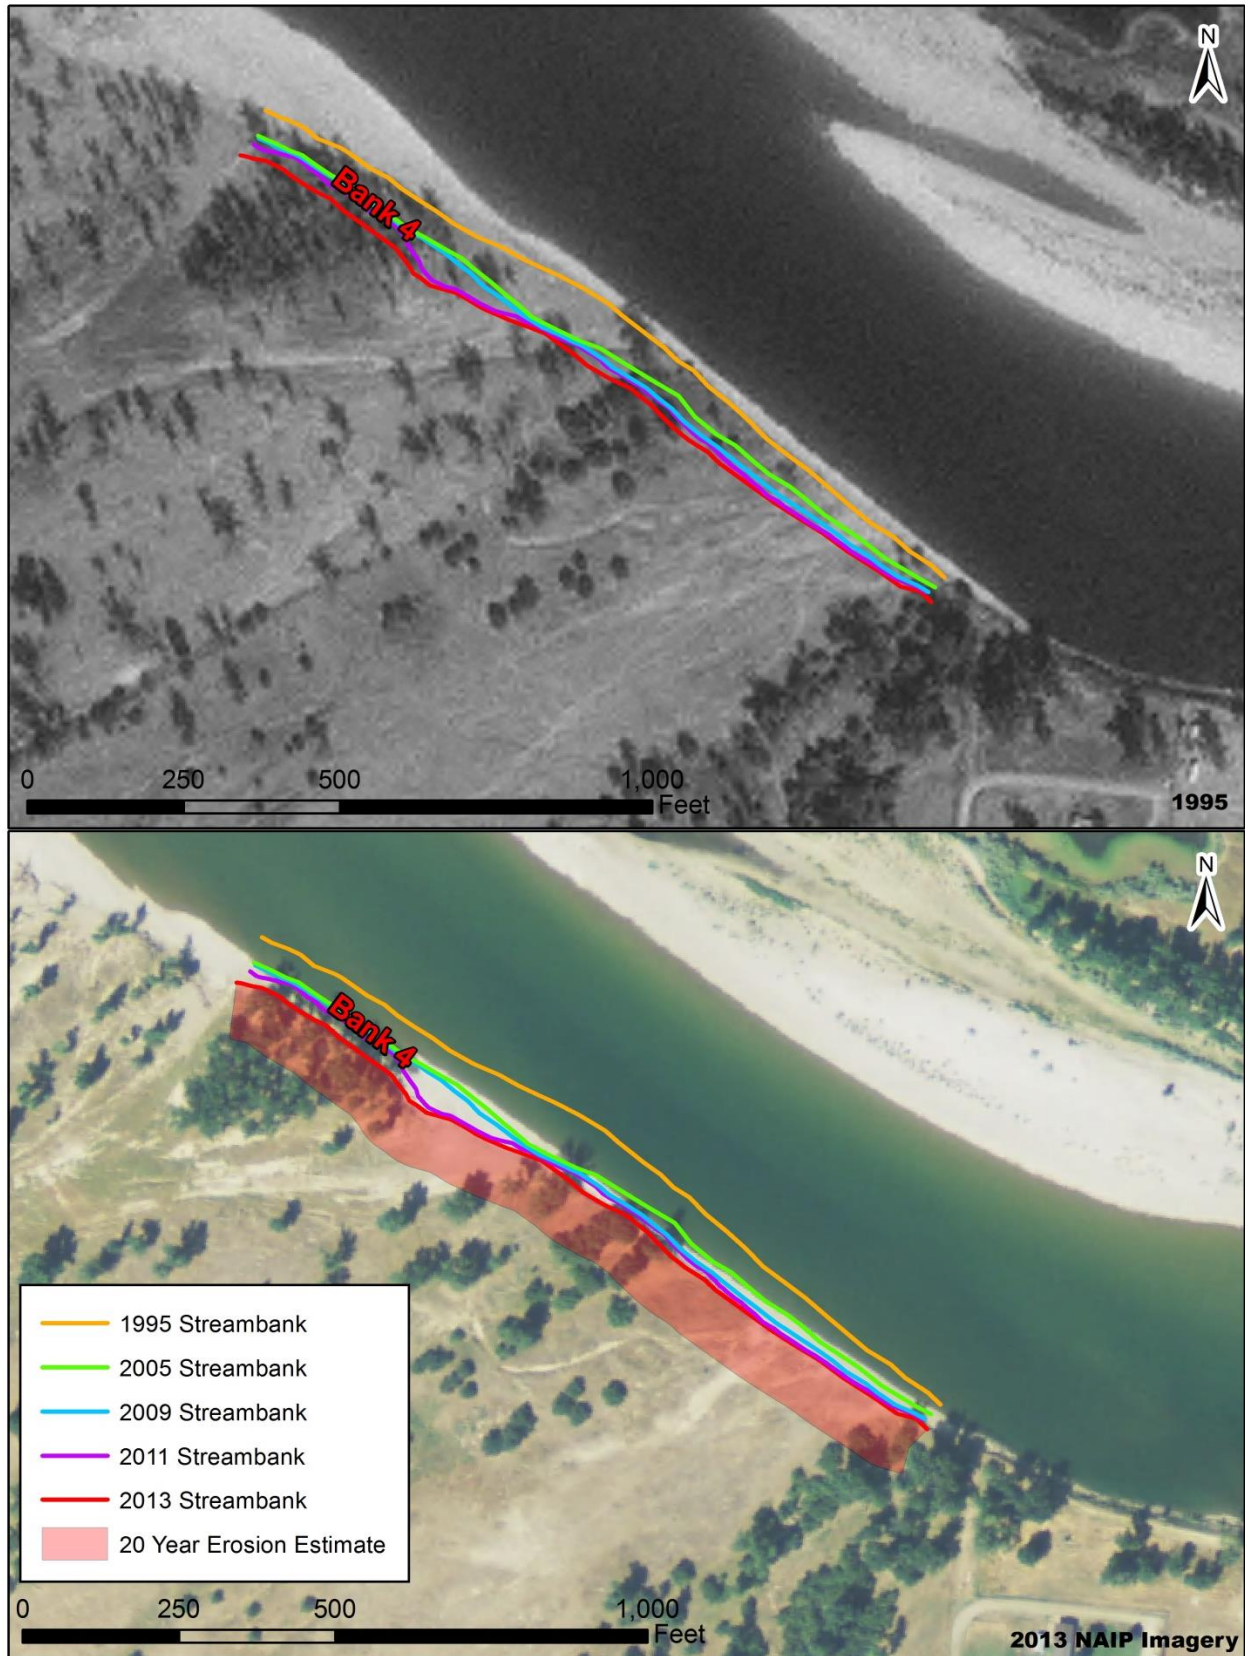
Figure 5-11. Bank 4 Erosion 1995-2013

Bank 4 is 1,334 feet long and is located on river left downstream of the Sanders County Fairgrounds. Bank 4 extends downstream from the end of the rock riprap placed along the fairgrounds by the Army Corps of Engineers, which covered the fairgrounds under approximately four feet of water (Randy Garrison, personal communication, 2/4/14). Riprap extends nearly 1,600 feet above the start of bank 4. Bank 4 is partially vegetated with ponderosa pine and cottonwoods and bisected by two overflow channels that lead into Big Eddy (**Figures 5-10 and 5-11**). Between 1995 and 2013, bank 4 has eroded an average of 81 feet, with a mean annual retreat rate of 4.5 feet. Portions of the bank occupied by the overflow channels are comprised of gravel and cobble, while vegetated areas have fine grained material throughout the bank with gravel and cobble in the toe. The primary factors influencing erosion of bank 4 are upstream channel constriction by the 5th Avenue South Bridge and the growth of the gravel bar on the opposite side of the channel. The gravel bar has developed downstream of the 5th Avenue South Bridge and likely formed in response to the placement and alignment of the bridge, which was originally constructed in 1911. A review of aerial imagery dating back to 1955 indicates this gravel bar has become larger and more vegetated over the past 58 years, which has directed the river towards bank 4. Compounding factors influencing erosion along bank 4 include upstream channelization on river right along the town of Plains which has effectively restricted lateral migration of the river upstream of the bridge over the past 100 years.

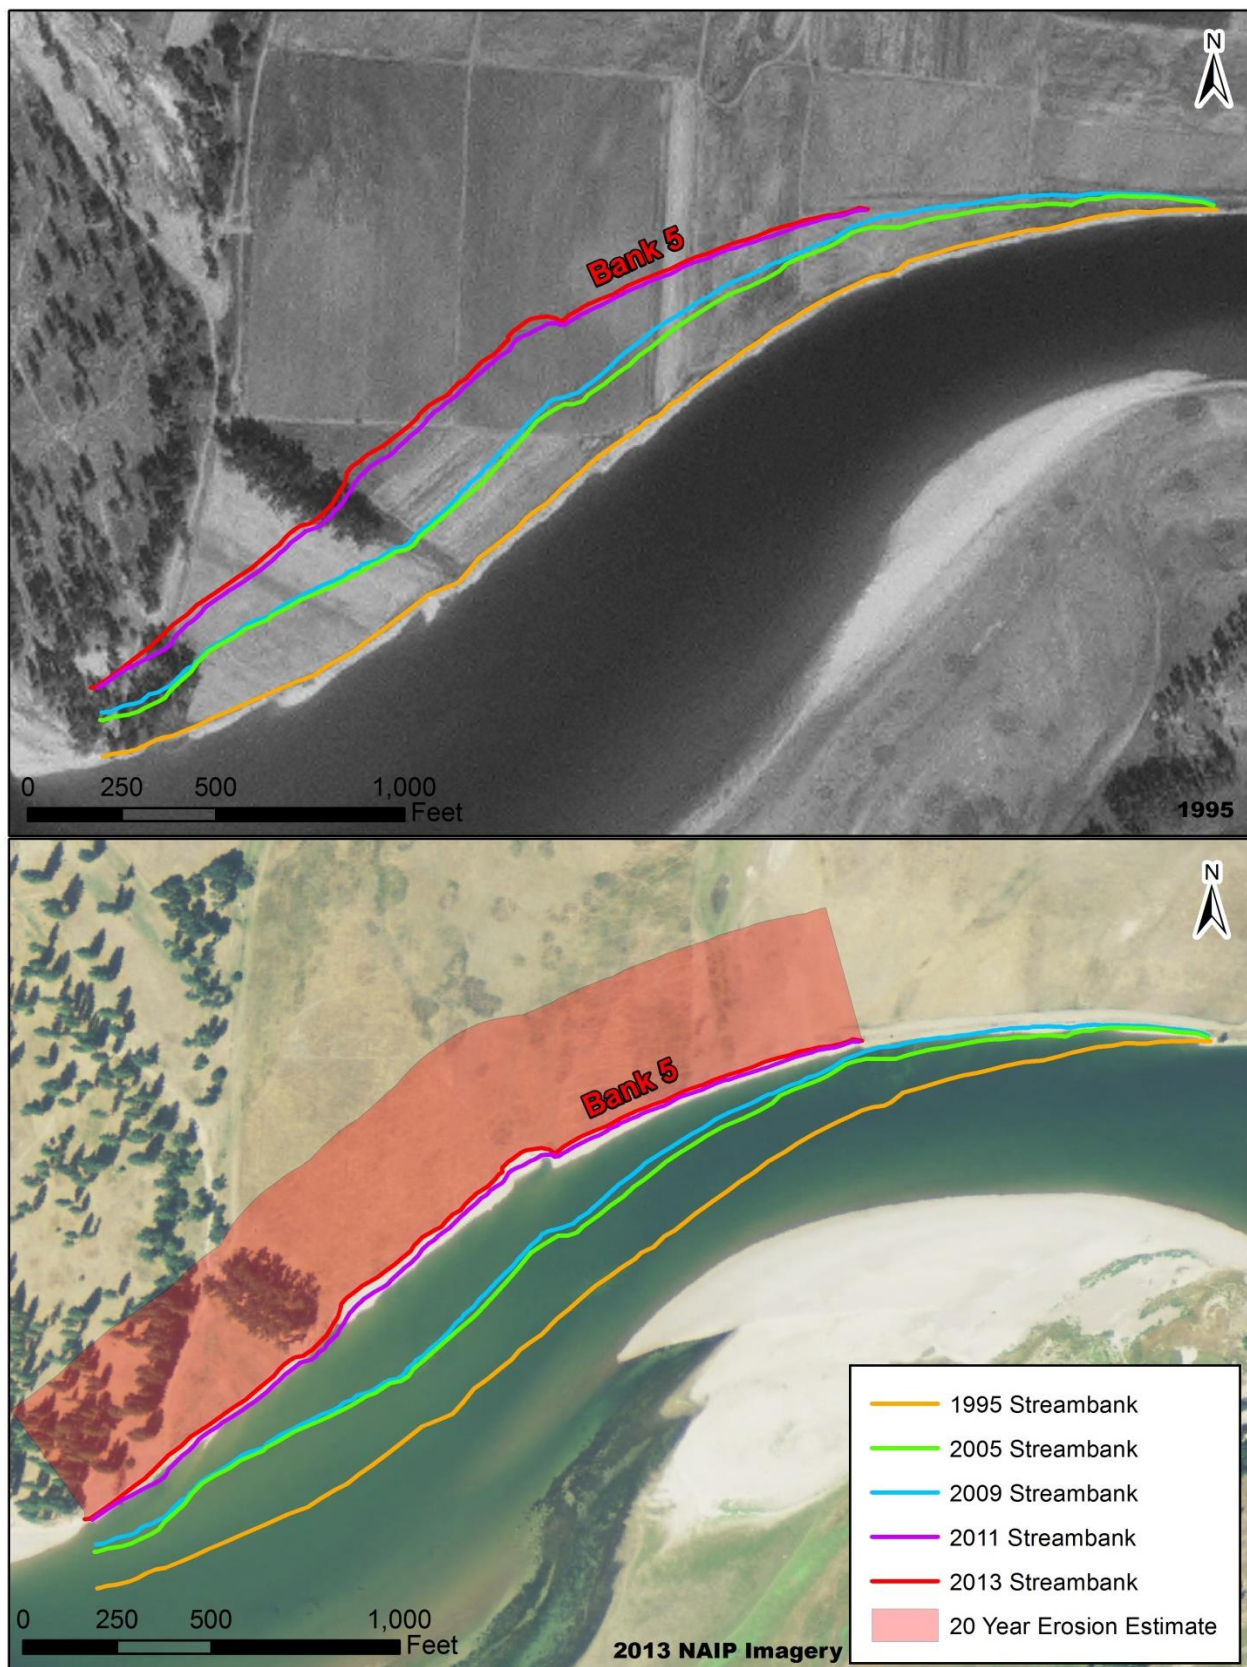
Figure 5-13. Bank 5 Erosion 1995-2013

Bank 5 is 2,515 feet long and located on river right at the outside of a meander bend that is naturally experiencing lateral retreat and has been partially stabilized with rock riprap. Erosion along bank 5 extends downstream from a section of riprap placed by the Army Corps of Engineers that was reinforced in 2011 as water was overtopping the bank. The newly placed riprap extends approximately 900 feet upstream from the upper end of bank 5, while the historic riprap extends approximately 600 additional feet, leading to approximately 1,500 feet of bank stabilization upstream of bank 5. Prior to 2011, active retreat was observed along the 900 feet of bank that was reinforced with riprap in 2011. The majority of bank 5 is actively eroding into an agricultural field currently used for livestock grazing, though a stand of cottonwoods and a stand of ponderosa pines reduce the retreat rate at the downstream end (**Figures 5-12 and 5-13**). The majority of bank 5 is comprised of gravel in the toe that often extends up into the lower third of the bank, with fine grained material in the upper two thirds. A 150 foot section of bank 5 is comprised entirely of fine grain material and is eroding at an accelerated rate. Between 1995 and 2013, bank 5 has eroded an average of 322 feet, with a mean annual retreat rate of 17.8 feet. The primary factors influencing erosion of bank 5 are its location at the outside of meander bend and the lack of deep rooted riparian vegetation along the top of the bank. Compounding factors include upstream bank stabilization along the fairgrounds, channel constriction under the 5th Avenue South Bridge, and upstream channel confinement by the levee along River Road East that restricts higher flows from accessing the floodplain in the South Plains area. Material eroded from bank 5 has been deposited on the next point bar downstream where a young stand of cottonwoods is becoming established (**Figures 5-14 and 5-15**).

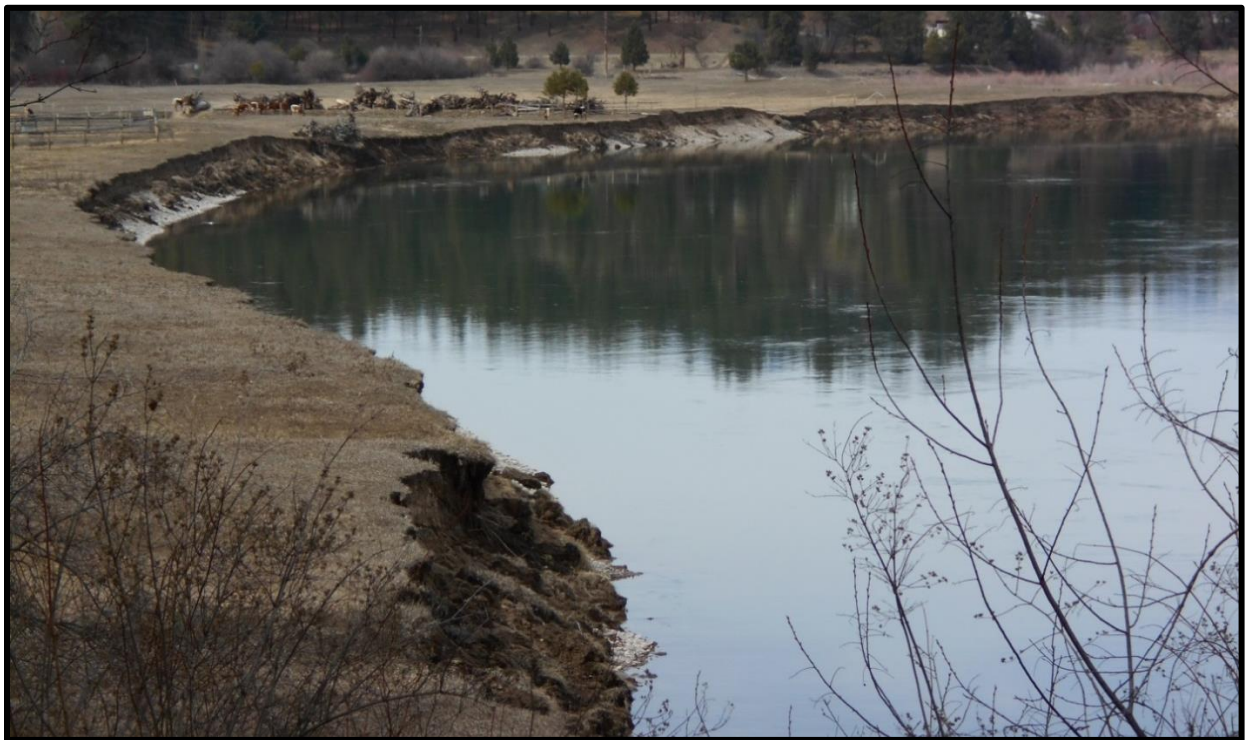
Figure 5-16. Bank 6 Looking Downstream from River Road West, March 2014

Bank 6 is 2,389 feet long and located on river left downstream of the bedrock outcrop below Big Eddy. Bank 6 is comprised of fine grained material with gravel and cobble in the toe and periodically extending approximately a third of the way up the bank (**Figures 5-16** and **5-17**). This bank is actively eroding into an area currently used for livestock grazing. Between 1995 and 2013, bank 6 has eroded an average of 207 feet, with a mean annual retreat rate of 11.5 feet. The primary factor influencing the erosion of bank 6 since 1995 is downstream channel migration which now directs the majority of the stream power directly at bank 6, along with the lack of deep rooted riparian vegetation along the top of the bank. An analysis of aerial imagery extending back to 1955 indicates that this area was relatively stable for the 40 year period between 1955 and 1995 (**Figure 5-18**). During the past 18 years, active bank erosion has occurred at this site and appears to have been initiated by the 1997 flood event (**Figure 5-19**). In 1997, a house built near the edge of this bank was burned down as the river undercut the foundation of the house, which remains visible within the channel. Prior to the 1997 flood event, the bedrock outcrop on river left downstream of Big Eddy dissipated much of the stream power, allowing the water to flow past bank 6 in a naturally straight section of the channel (**Figure 5-20**). The bedrock outcrop essentially “reset” the channel to a natural meander pattern relatively uninfluenced by upstream channel alterations. As bank 5 upstream has eroded and the channel has meandered downstream and to the north, the majority of the flow has begun to bypass the bedrock outcrop and be directed at bank 6, which has developed into a meander bend that continues to actively erode, while the point bar on the opposite side of the channel expands. Material eroded from bank 6 has been deposited at the head of the west channel, which has become aggraded and cut off from lower flows (**Figure 5-21**).

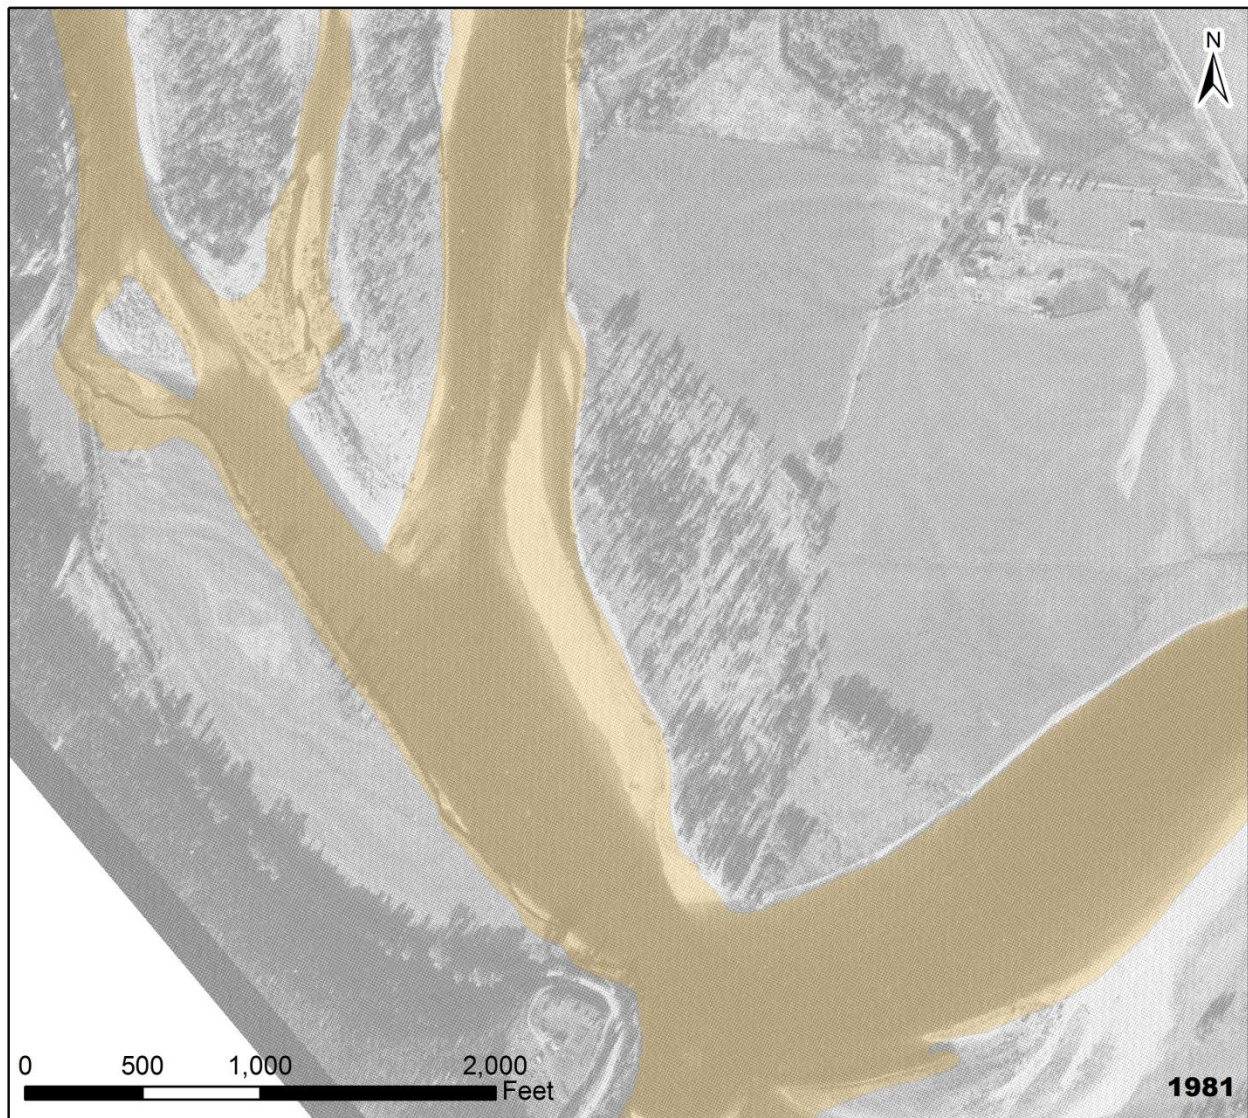
Figure 5-18. 1981 Aerial Imagery Compared to 1995 Active Channel (in orange) along Bank 6

During the 1997 flood event, a house that was built along bank 6 was burned down to prevent it from falling into the river. The foundation of the house remains in the channel and is visible in aerial imagery approximately 200 feet from the 2013 bank line (**Figure 5-18**). It is unknown what impact the house foundation has on channel dynamics, though it essentially acts like a bedrock outcrop below the surface of the water and is currently located at the tail end of the pool formed by the bedrock outcrop below Big Eddy. If possible, it would be beneficial to remove the foundation of the house from the channel. If bank 6 is not stabilized, the existing barn and fence should be removed from the floodplain before additional debris is added to the channel. Woody debris added to the top of the bank and a rock pile on the edge of the bank could also be removed before they are washed away. Woody debris in the form of root wads along the top of the bank and on the floodplain is likely to moderate bank erosion for only a brief period of time (**Figure 6-19**). The rock pile provides some stabilization for the lower end of bank 6, but may also be preventing the channel from migrating towards the west and accessing the west channel.

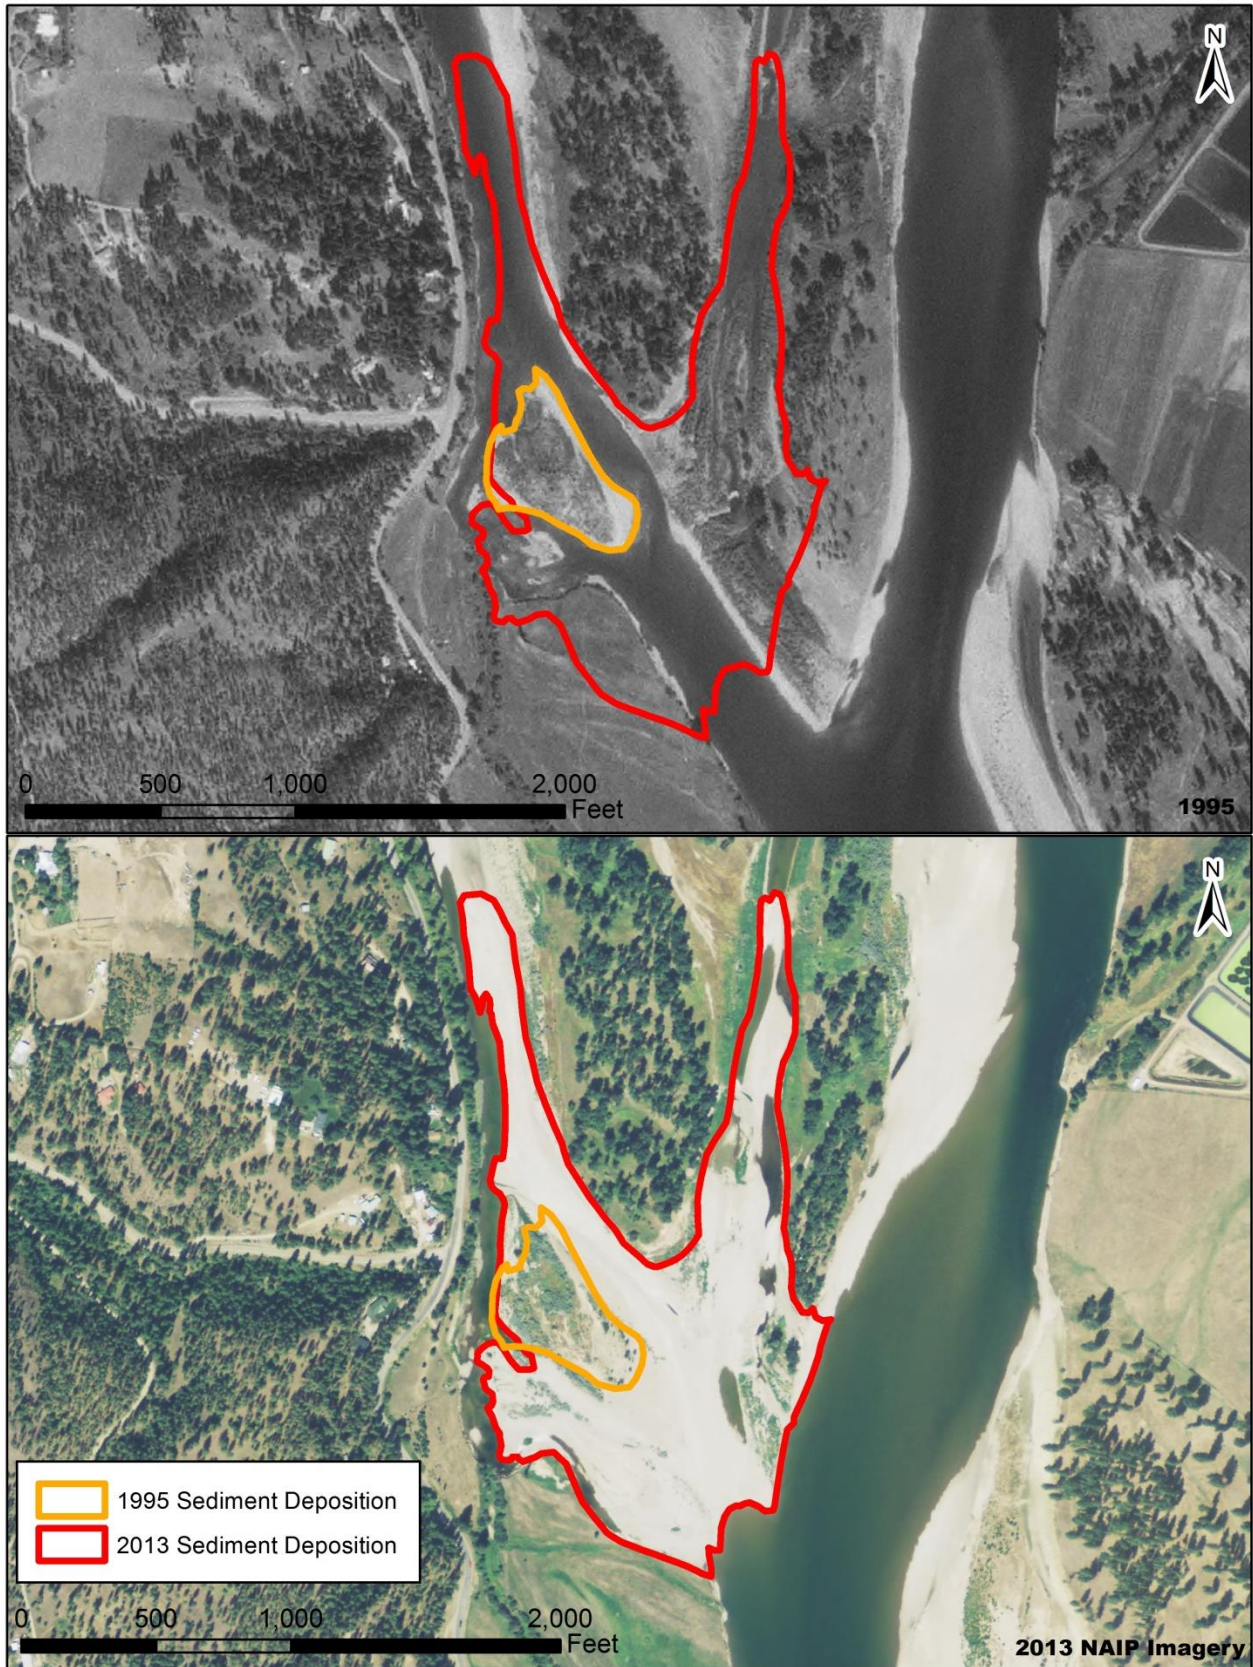
Figure 5-21. Sediment Deposition at the Head of the West Channel, 1995-2013

Removal of sediment from the head of the west channel could enhance flows within the west channel during lower flows, while also alleviating stream power along bank 9 and bank 10 during high flow events. However, while bank 6 and bank 7 remain sources of sediment, any sediment removed from the head of the west channel will likely be replaced by sediment eroded from these banks. Alternatively, continued erosion along bank 6 and downstream channel migration may allow the river to naturally flush sediment out of the head of the west channel, potentially sending more water down the west channel. In addition, the point of the island that separates the west channel from the main channel has eroded and retreated downstream, reducing its ability to deflect flows into the west channel. The river has also become much wider at the head of the west channel, leading to decreased stream power and sediment transport capacity. The addition of woody debris to the point of the island through the construction of an engineered log jam could help stabilize the point of the island and direct additional flow towards the west channel. Engineered log jams mimic natural large woody debris accumulations often found at the heads of islands and are observed within the Plains Reach (**Figure 6-23**).

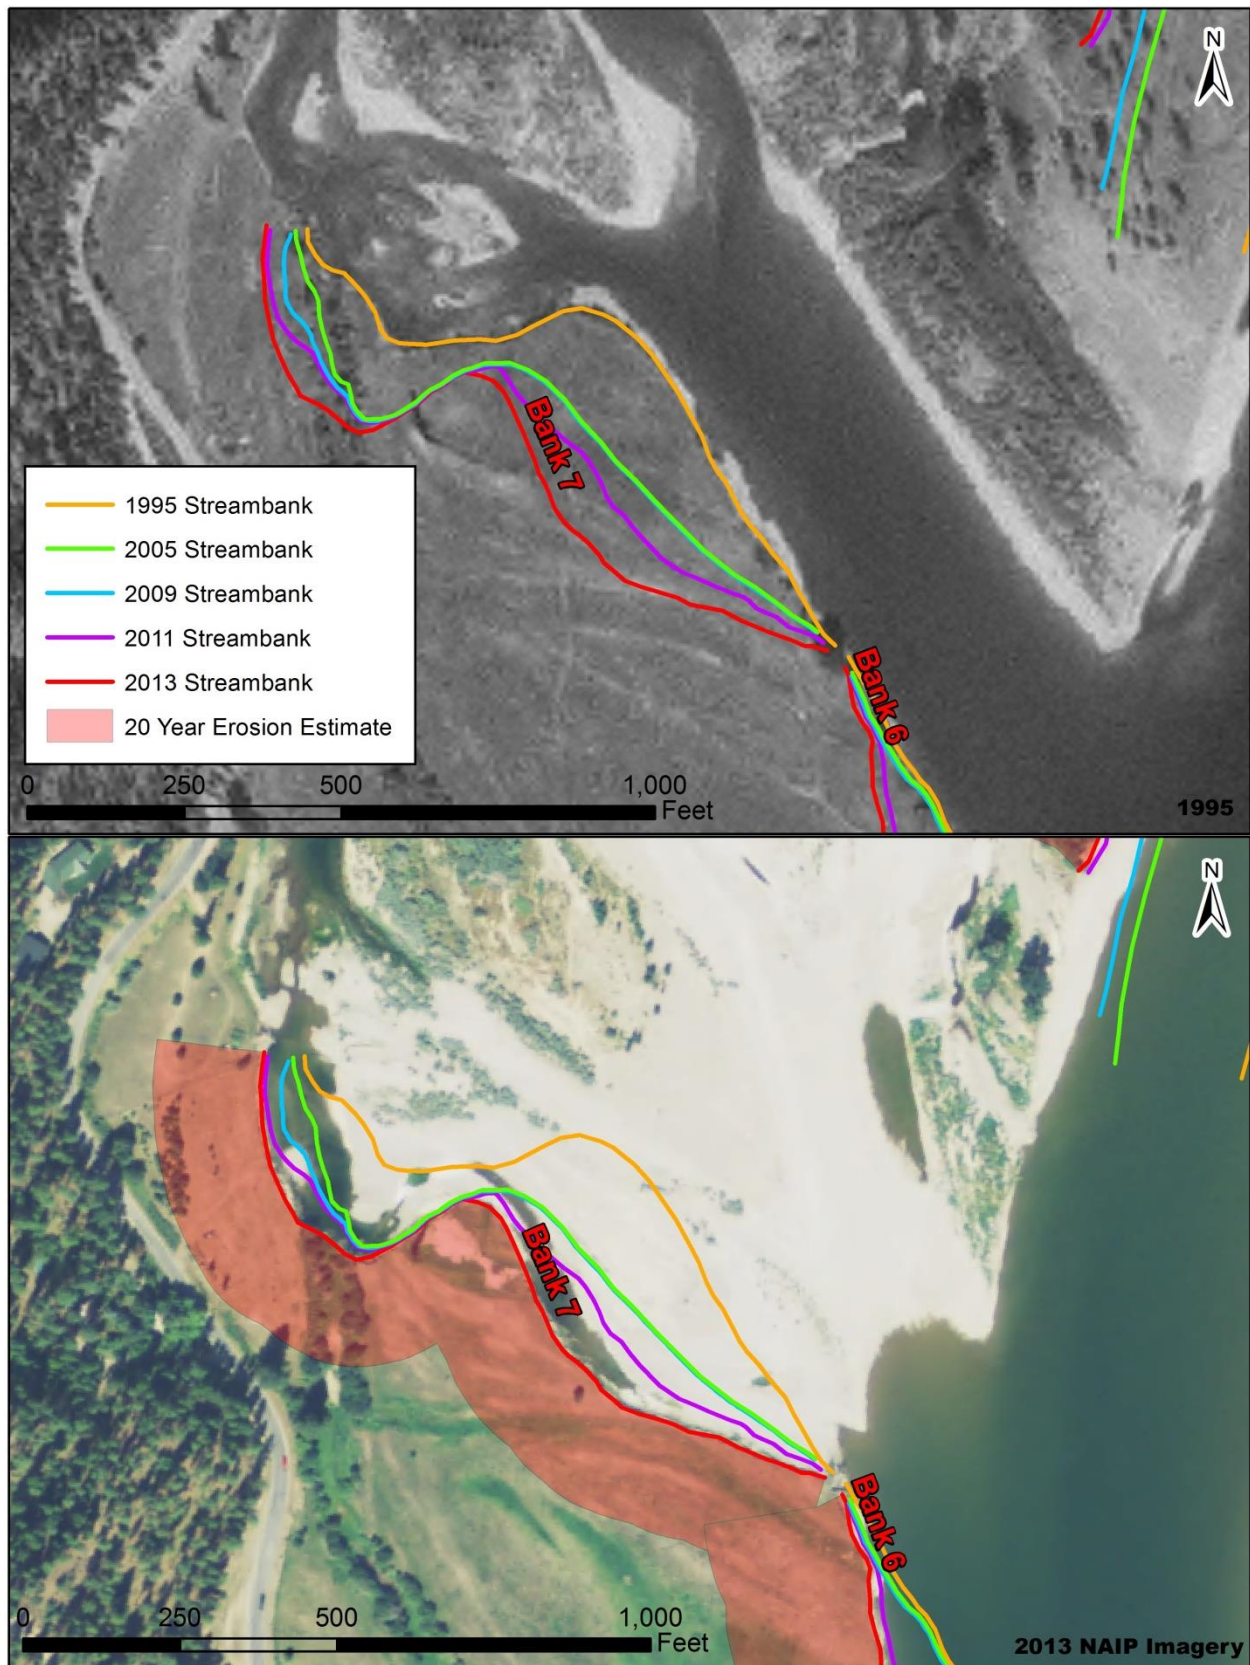
Figure 5-23. Bank 7 Erosion 1995-2013

Between 1995 and 2013, bank 7 has eroded an average of 154 feet, with a mean annual retreat rate of 8.6 feet. Bank 7 is an extension of bank 6, but is along the west channel instead of the main channel. Bank 7 is a vertical bank comprised almost entirely of fine grained material. Due to the lower stream power along the west channel, and a lack of flow during certain times of the year, there is the potential to stabilize this bank using bioengineering techniques. Stabilization of bank 7 should be conducted in concert with stabilization of bank 6 or account for additional retreat of bank 6. If stabilization measures are implemented, it may be beneficial to remove a portion of the point of land where bank 6 and bank 7 meet to allow greater access to the west channel. Benefits of stabilizing bank 7 include protecting River Road West and adjacent properties, along with decreasing the sediment load currently being deposited at the head of the west channel. In addition, a power pole located along bank 7 is precipitously close to the bank.

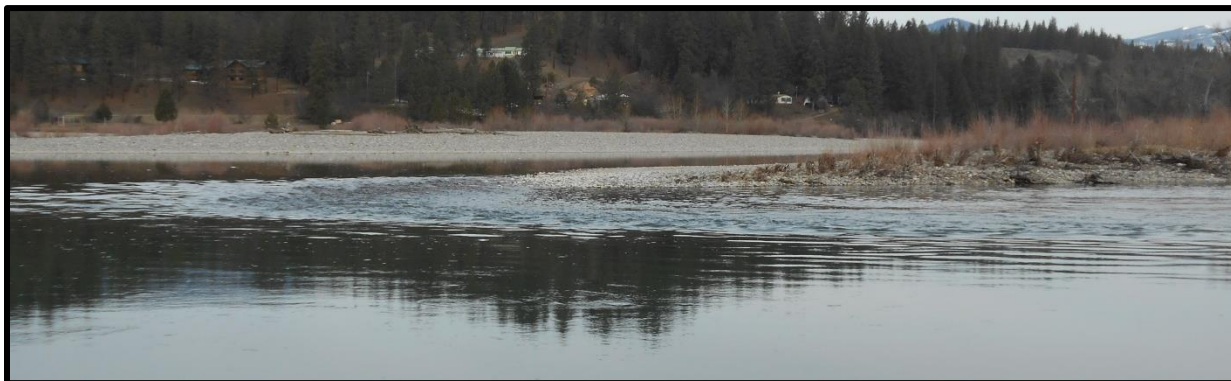
Bank 8 is 1,096 feet long and is located along the point of the island that separates the west channel from the main channel. Since 1995, this point has migrated downstream, with the majority of the erosion occurring along the outside of the island along the main channel. The point of the island is a partially vegetated gravel bar bisected by two overflow channels (**Figures 5-24 and 5-25**). Progressing downstream, the island gains elevation and contains mature riparian vegetation. Between 1995 and 2013, bank 8 has eroded an average of 140 feet, with a mean annual retreat rate of 7.8 feet. The majority of bank retreat since 1995 has occurred at the upstream end of bank 8 along the lower elevation portion of the point of the island that separates the west channel from the main channel (**Figure 5-26**). The primary factors influencing erosion of bank 8 are downstream channel migration and aggradation at the head of the west channel. Downstream channel migration observed since 1995 is being driven by erosion of bank 5 and subsequent deposition of eroded material on the downstream point bar, along with erosion of bank 6 and bank 7 and deposition of material at the head of the west channel. Reduced access to the west channel leads to increased stream power in the main channel, which is now actively meandering into bank 8. Material eroded from bank 8 at the point of the island is being deposited along the channel margin downstream, leading to the development of a point bar that is directing more of the flow towards bank 9, the Town of Plains WWTP, and bank 10.

Figure 5-24. Point of Island Separating the West Channel from the Main Channel, March 2014

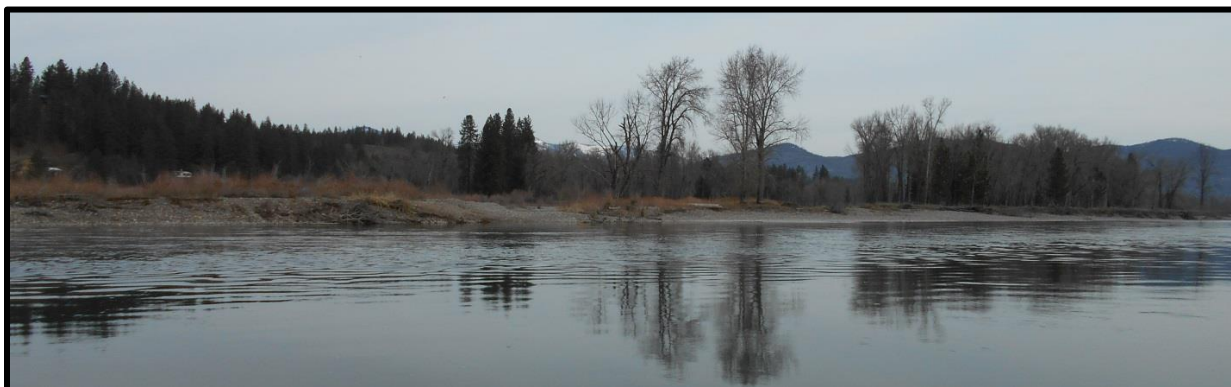
Figure 5-25. Bank 8, March 2014

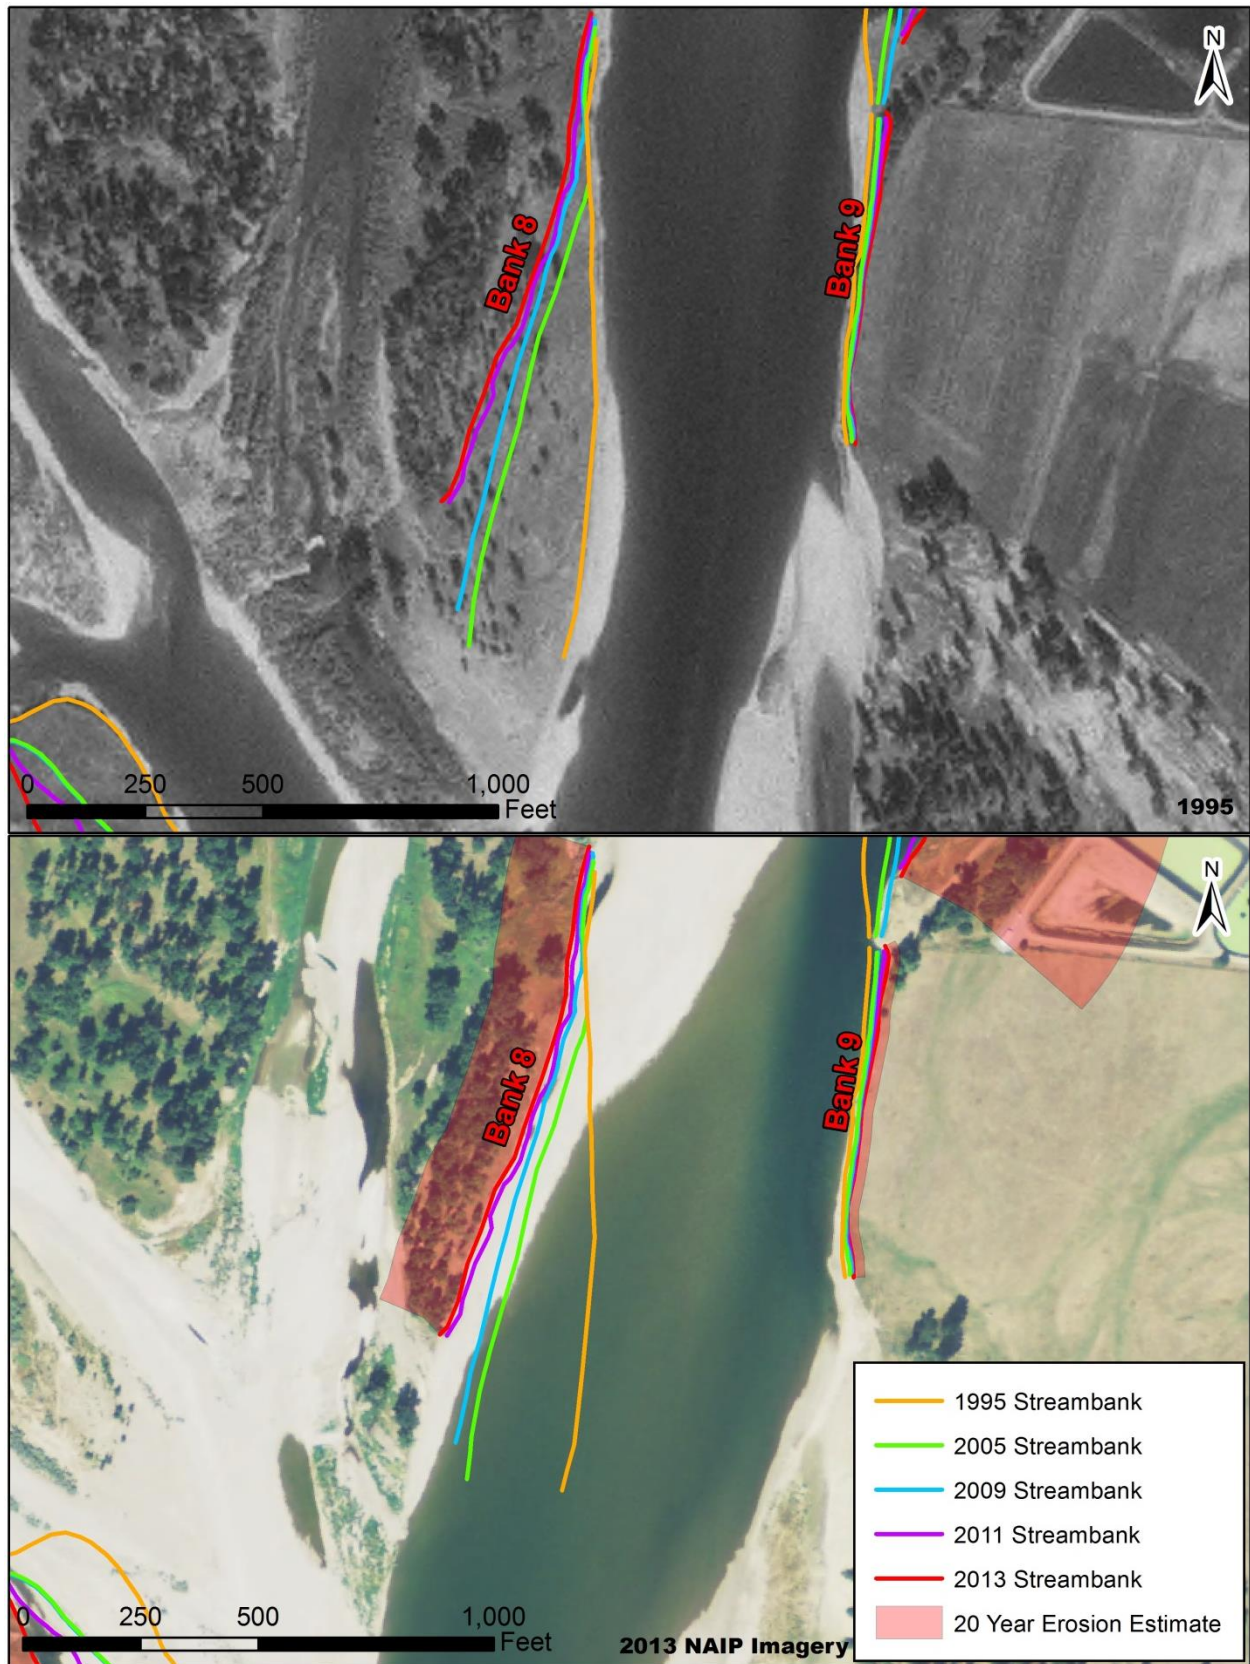
Figure 5-26. Bank 8 and Bank 9 Erosion 1995-2013

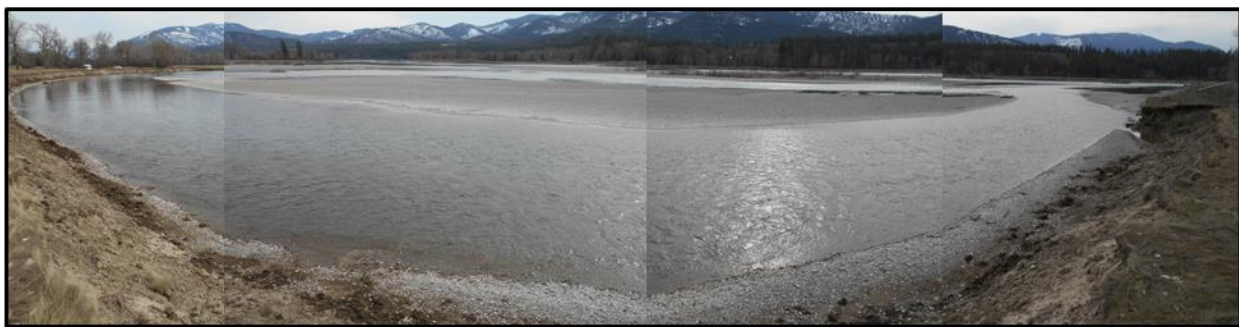
Bank 10 is 4,175 feet long and located on river right downstream of the WWTP outfall. Prior to stabilization of the Town of Plains WWTP outfall in 2010, bank 9 and bank 10 formed one continuous bank extending approximately 5,000 feet. Bank 10 is comprised almost entirely of fine grained material with a layer of gravel at the toe that is essentially the bed of the channel (**Figure 5-28**). At the downstream end of bank 10, a layer of woody material from historic mill waste dumped on the floodplain partially hardens the bank and reduces the rate of erosion (**Figure 5-29**). This layer of hard woody material has restricted lateral channel migration at the downstream end of bank 10 and forced the channel to erode into the fine grained material in the upstream portion of the bank, resulting in an area of extreme erosion and channel over-widening, with a maximum bank retreat of 742 feet observed over the 18 year period between 1995 and 2013 along Lawyer Nursery property. Prior to 1995, a review of aerial imagery indicates this bank was relatively stable during the 40 year period between 1955 and 1995 along an area used for agricultural production, with the current accelerated rate of erosion likely initiated by the 1997 flood event (**Figure 5-30**). Between 1995 and 2013, bank 10 has eroded an average of 437 feet, with a mean annual retreat rate of 24.3 feet. The primary factors influencing erosion of bank 10 are increased stream power due to reduced access to the west channel, a mid-channel bar that directs water towards the channel margin, the banks location along the outside of a developing meander bend, and a lack of deep rooted riparian vegetation along the top of the bank. While the mid-channel bar is visible in the historic aerial imagery, it has expanded significantly since 1995 (**Figure 5-31**). The source of material in the mid-channel bar is thought to be material transported from upstream bank erosion, along with material from the toe of bank 10 that has remained in place as the finer grained material higher in the bank washed away. Material eroded from bank 10 is also being deposited at the head of the east channel, with finer grained material extending further downstream (**Figures 5-32 and 5-33**). On the opposite side of the channel, bank 11 has also been eroding and the channel has become over-widened in this area from a maximum width of approximately 900 feet in 1995 to a maximum width of approximately 1,700 feet in 2013.

Figure 5-28. Erosion along Bank 10 and Sediment Deposition on Mid-channel Bar, March 2014

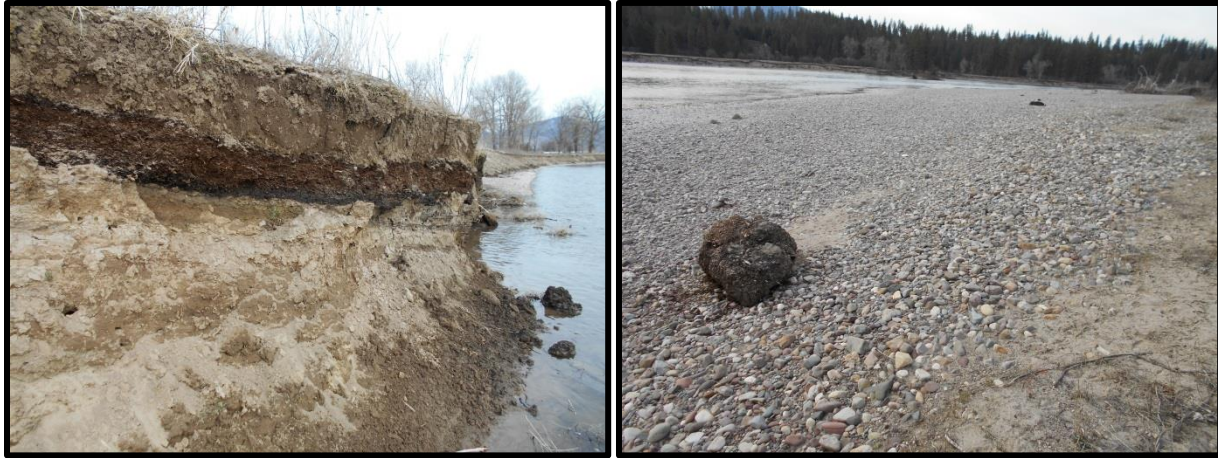
Figure 5-29. Mill Waste in Downstream End of Bank 10 and Deposited on Gravel Bar, March 2014

Bank 10 exhibits two distinct characteristics progressing from upstream to downstream, with a vertical bank at the upstream end transitioning to a lower angled bank at the downstream end. The upper portion of bank 10 is located downstream of the riprap at the Town of Plains WWTP outfall where the thalweg is along the channel margin (**Figure 6-31**). Stabilization at the upstream end may require extending the rock riprap downstream of the existing riprap at the WWTP outfall downstream. In April of 2014, a large eddy was observed off the downstream of the rock riprap and was recirculating from approximately 300 feet downstream at a flow of approximately 31,000 cfs. Recirculating water in this large eddy is leading to accelerated bank erosion at the head of an overflow channel. At the tail end of this eddy, plumes of sediment were observed washing from the streambank, which contained a high amount of sandy material (**Figure 6-32**). As the channel becomes shallower along bank 10 in the vicinity of the mid-channel bar and the bank height decreases, bioengineering techniques may be appropriate. However, flow deflection from the mid-channel bar may increase the relative stream power along this portion of the bank and partial dredging to remove sediment from this mid-channel bar may help reduce stream power along bank 10. Also, the influence of mill waste material within the bank at the downstream end should be considered when developing a restoration strategy for bank 10. A potential option would be to remove a portion of the area with the mill waste, thereby opening up additional flow
