Clark Fork River Plains Reach Assessment & Restoration Prioritization

May 14, 2014

**CLARK FORK RIVER
PLAINS REACH ASSESSMENT
AND
RESTORATION PRIORITIZATION**

RESPEC

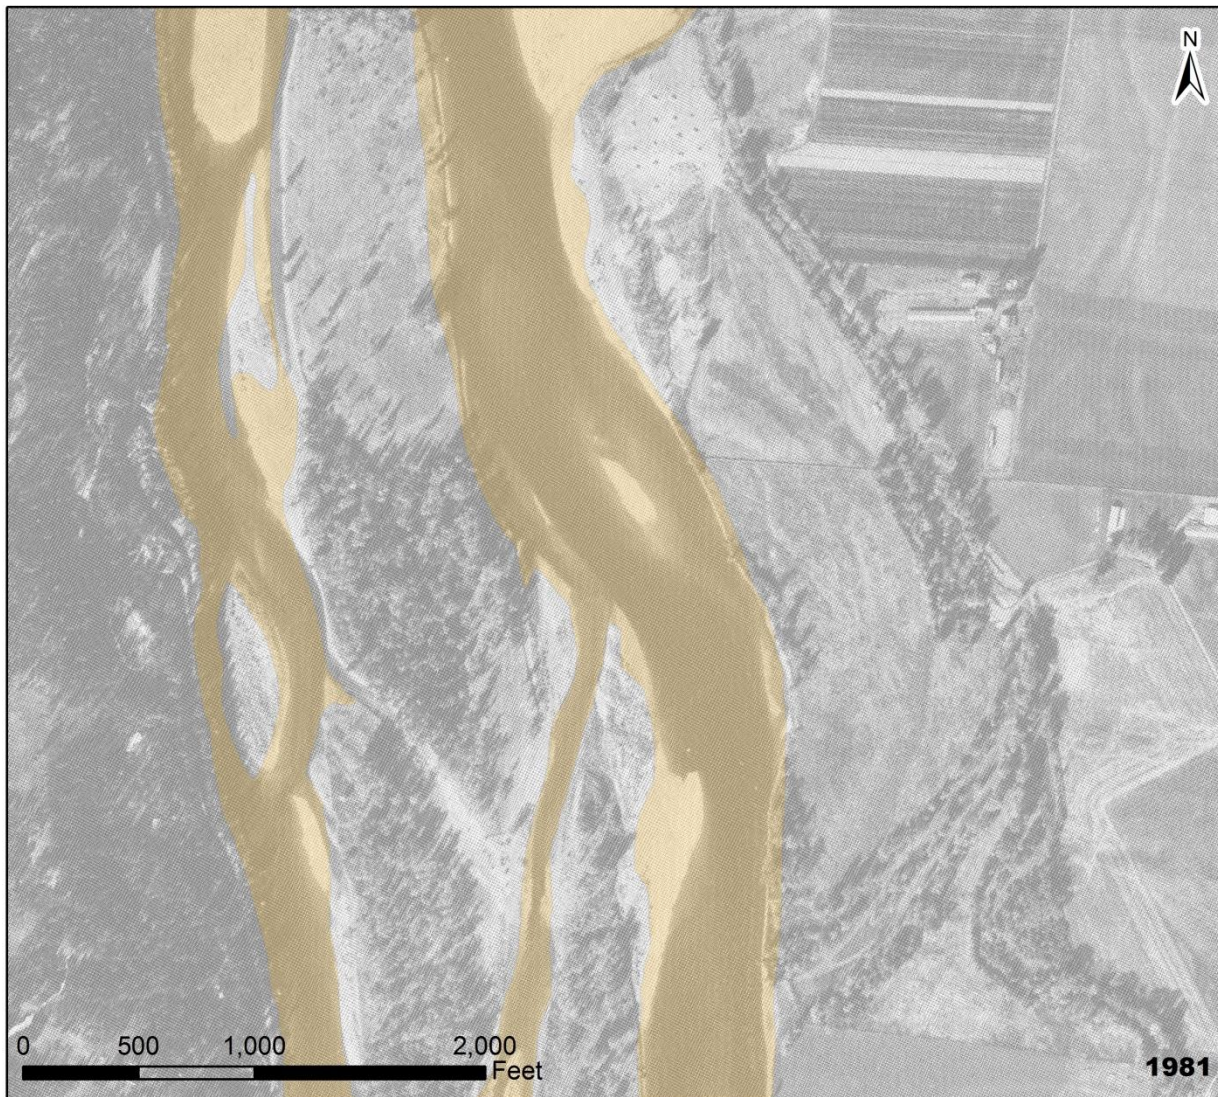
Figure 5-30. 1981 Aerial Imagery Compared to 1995 Active Channel (in orange) along Bank 10

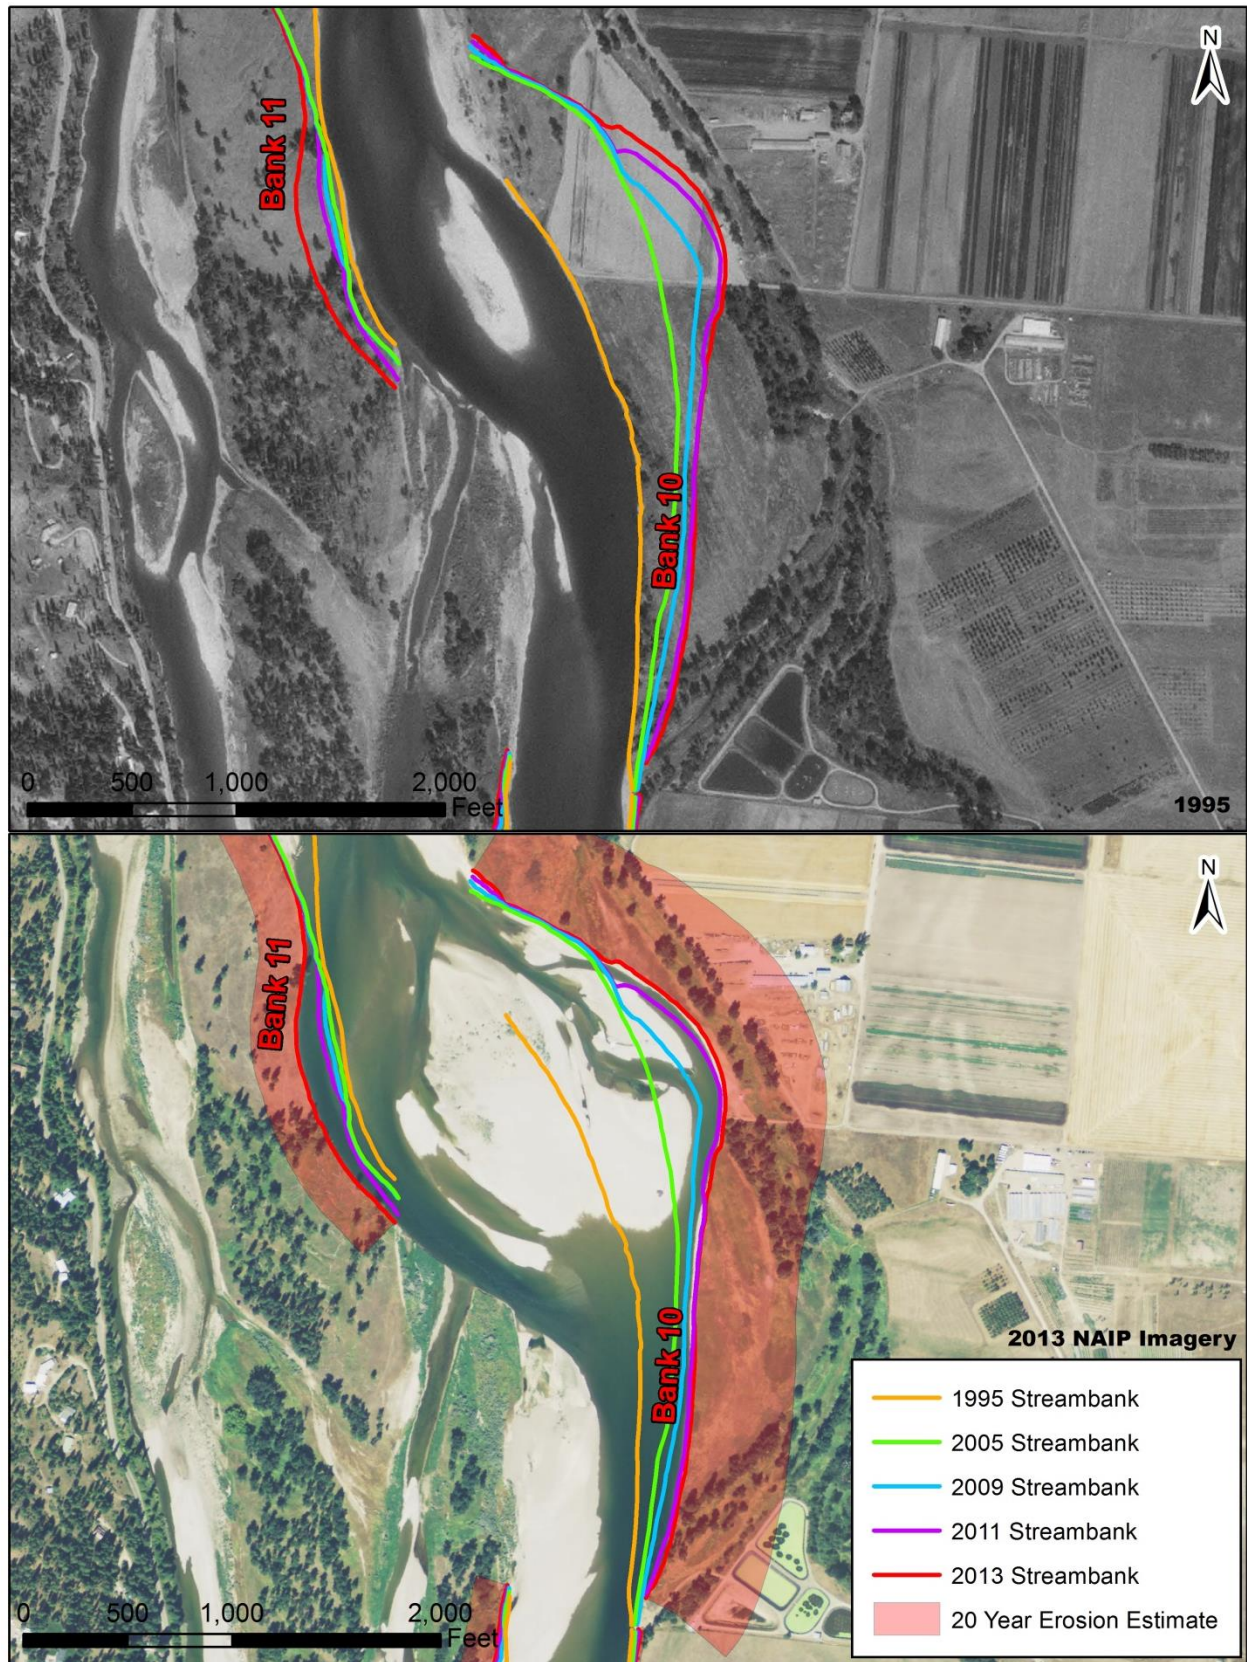
Figure 5-31. Bank 10 Erosion 1995-2013

Between 1995 and 2013, bank 10 has eroded an average of 437 feet, with a mean annual retreat rate of 24.3 feet. A maximum retreat of 742 feet was observed over the 18 year period between 1995 and 2013 along Lawyer Nursery property. While the estimated 20 year erosion zone indicates continued accelerated rates of erosion along bank 10, future rates of erosion will likely be reduced when the channel migrates into the band of cottonwoods along the margin of the overflow channel, which may also relieve stream power as water is routed down the overflow channel that leads into the east channel. The second band of cottonwoods along the overflow channel is located at the base of a terrace, which will likely slow the erosion rate even further. Thus, ongoing erosion is predicted while stream power is focused along the existing channel margin, which is comprised on fine grained material. As the channel migrates into established vegetation and the potentially coarser grained material of the terrace, erosion rates will likely be reduced. In addition, mill waste deposited on the floodplain influences lateral channel migration, reducing the rate of bank erosion at the downstream end of bank 10.

Establishment of riparian vegetation on the floodplain downstream of the Town of Plains WWTP and within the historic side channel along Lawyer Nursery is recommended to slow the rate of lateral channel migration and to help protect this area which was identified as a potential avulsion risk during the Channel Migration Zone analysis due to the presence of overflow channels across the floodplain (**Figures 6-33 and 6-34**). The floodplain area downstream of the Town of Plains WWTP resembles floodplain areas used for grazing along banks 5, 6, and 9, while the overflow channel along Lawyer Nursery is vegetated with native and introduced grass species (**Figures 6-35 and 6-36**). Signs of beaver activity were observed on the cottonwood trees along the channel margin at this site and protection from beaver would help maintain the existing vegetation.

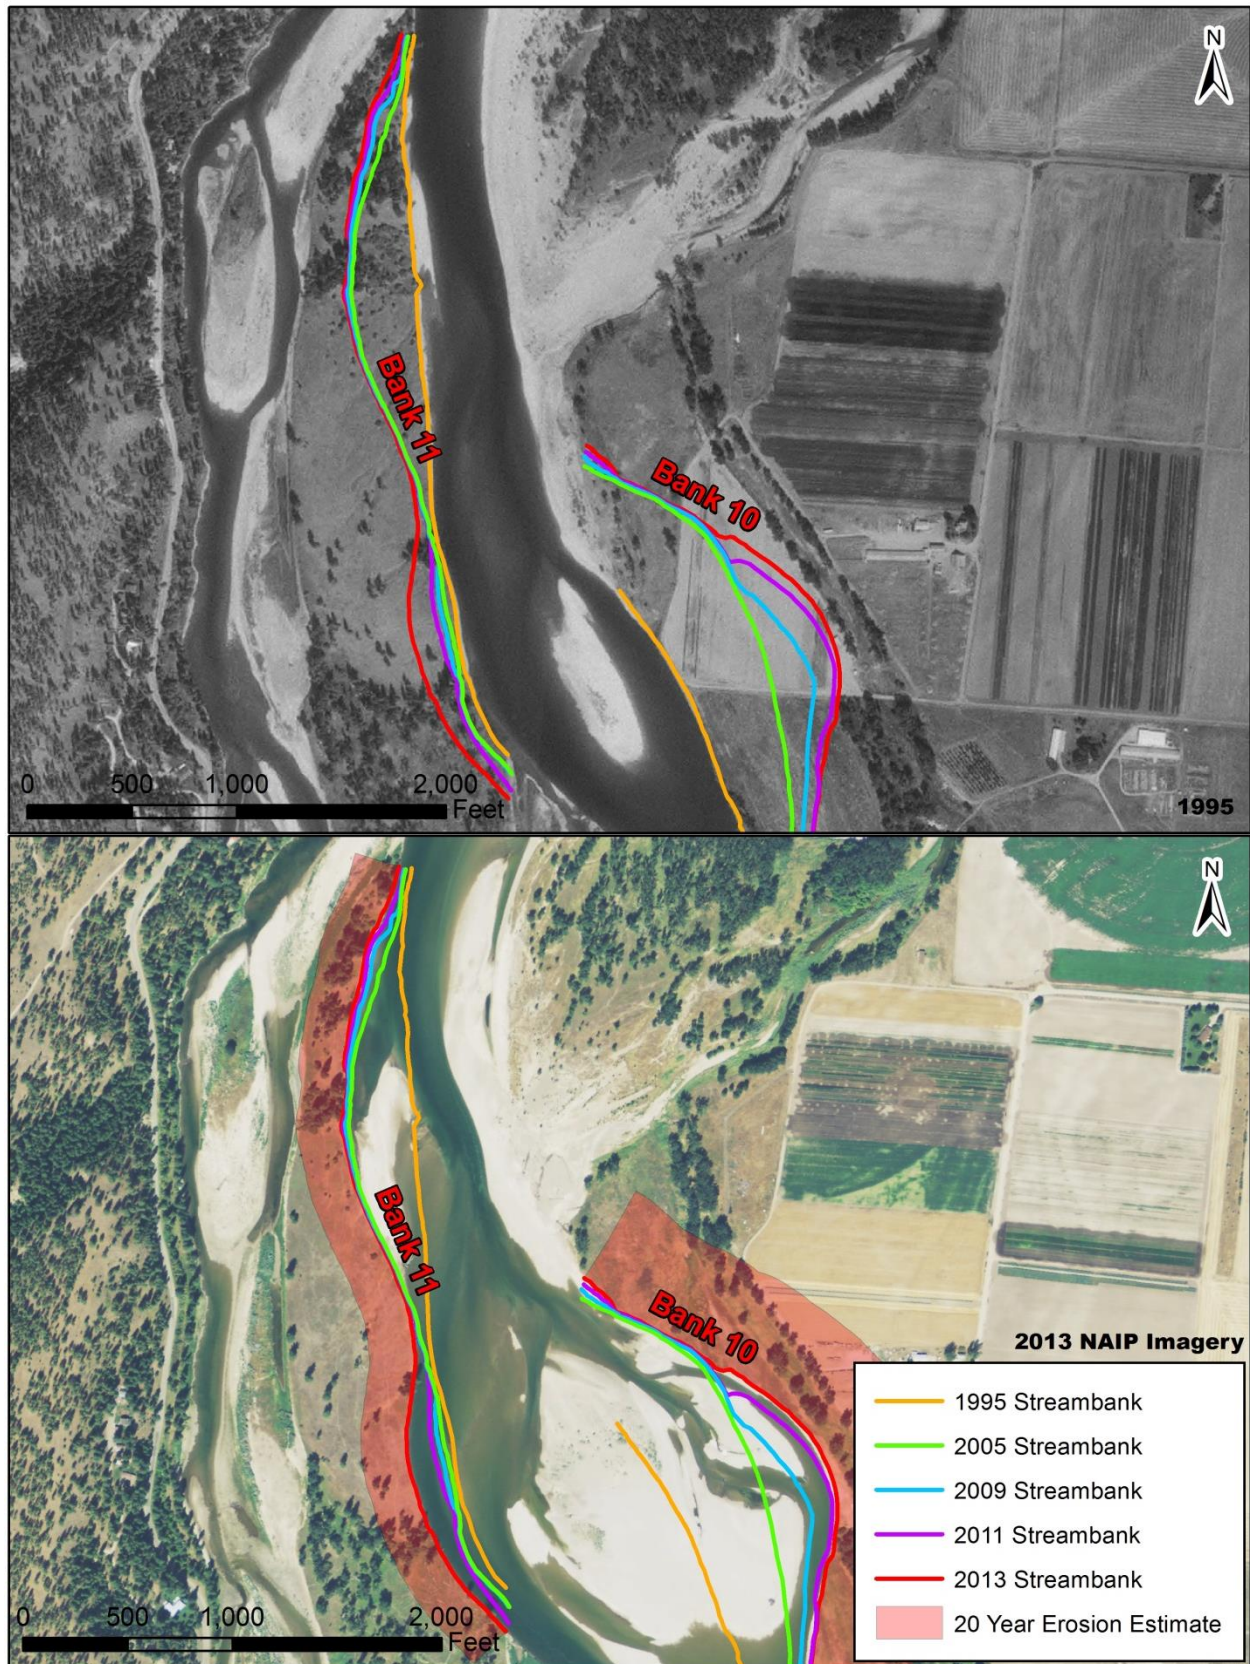
Bank 11 is 3,925 feet long and located at the downstream end of the island that separates the west channel from the main channel and is along the river left margin of the main channel across from Lawyer Nursery. Bank 11 is comprised primarily of fine grained material with periodic bands of gravel (**Figure 5-34**). Between 1995 and 2013, bank 11 has eroded an average of 196 feet, with a mean annual retreat rate of 10.9 feet (**Figure 5-35**). The primary factor influencing erosion of bank 11 is the large mid-channel bar that directs water towards the channel margin, along with reduced flows in the east channel due to the deposition of material eroded from bank 10, which influences the erosion along the lower end of bank 11. Decreased flows in the east channel are also indicated by more exposed gravel observed in the 1995 aerial imagery than in the 2013 aerial imagery (**Figure 5-35**). If the head of the east channel continues to aggrade and the current rate of erosion along bank 11 continues, the lower 1,500 feet of the island that separates the west channel from the main channel could become completely eroded away.

Figure 5-35. Bank 11 Erosion 1995-2013

Removal of sediment from the head of the east channel could enhance flows within the east channel during lower flows, while also alleviating stream power along bank 11 during high flow events. However, while bank 10 remains a source of sediment, any sediment removed from the head of the east channel will likely be replaced by sediment eroded bank 10. While not as extensive as the sediment deposition in the west channel, sediment deposition at the head of the east channel and decreased stream flows during high water directs additional flow towards bank 11, which is on the island that separates the west channel from the main channel. The estimated 20 year erosion zone for bank 11 indicates that the lower 1,500 feet of the island may become completely washed away if bank erosion continues at the rate of erosion observed over the past 18 years (**Figures 6-41** and **5-35**).

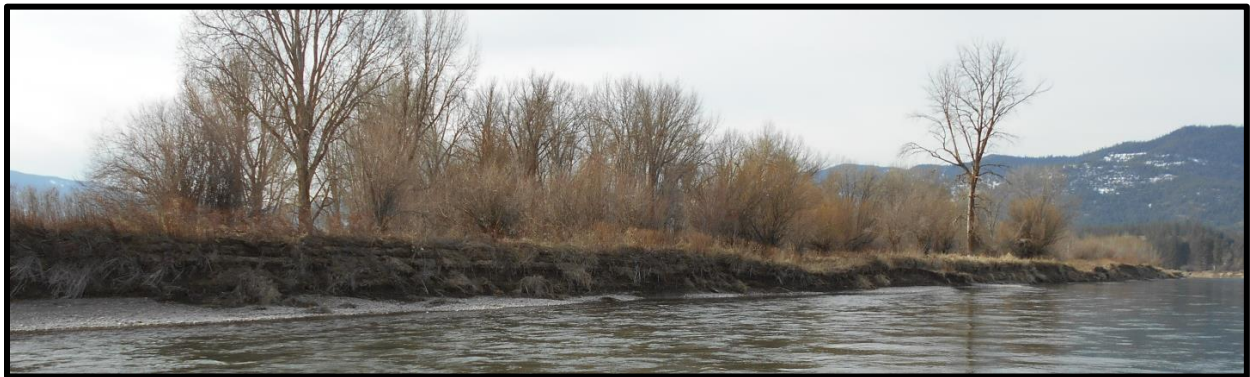
Bank 12 is 1,161 feet long and located along the river right bank on a portion of the Lawyer Nursery property referred to as the Clark Fork Reserve. Bank 12 is comprised of fine grained material with gravel in the toe (**Figure 5-36**). Between 1995 and 2013, bank 12 has eroded an average of 37 feet, with a mean annual retreat rate of 2.1 feet. This area contains undisturbed riparian vegetation and represents natural rates of streambank erosion expected in situations where there are mid-channel bars directing the flow towards the channel margins (**Figure 5-39**). However, decreased flows in the east channel, along with increased sediment deposition on the mid-channel bar from upstream bank erosion, may also influence erosion rates along this bank.

Figure 5-36. Bank 12, March 2014

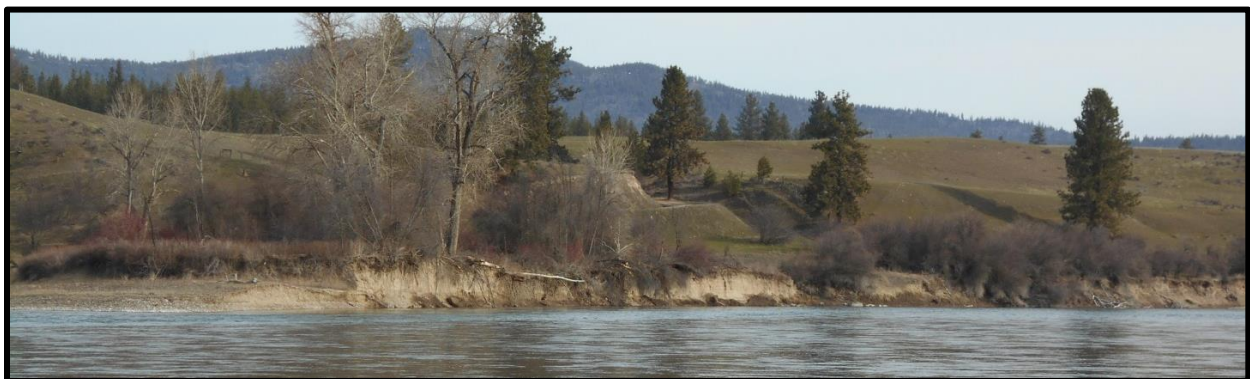
Bank 13 is 411 feet long and located along a small island on the river left margin of the main channel. Bank 13 is comprised of fine grained material with gravel in the toe (**Figure 5-37**). Between 1995 and 2013, bank 13 has eroded an average of 95 feet, with a mean annual retreat rate of 5.3 feet. This island contains undisturbed riparian vegetation and represents natural rates of streambank erosion expected in situations where there are mid-channel bars directing the flow towards the channel margins (**Figure 5-39**). However, decreased flows in the east channel, along with increased sediment deposition on the mid-channel bar from upstream bank erosion, may also influence erosion rates along this bank.

Figure 5-37. Bank 13, March 2014

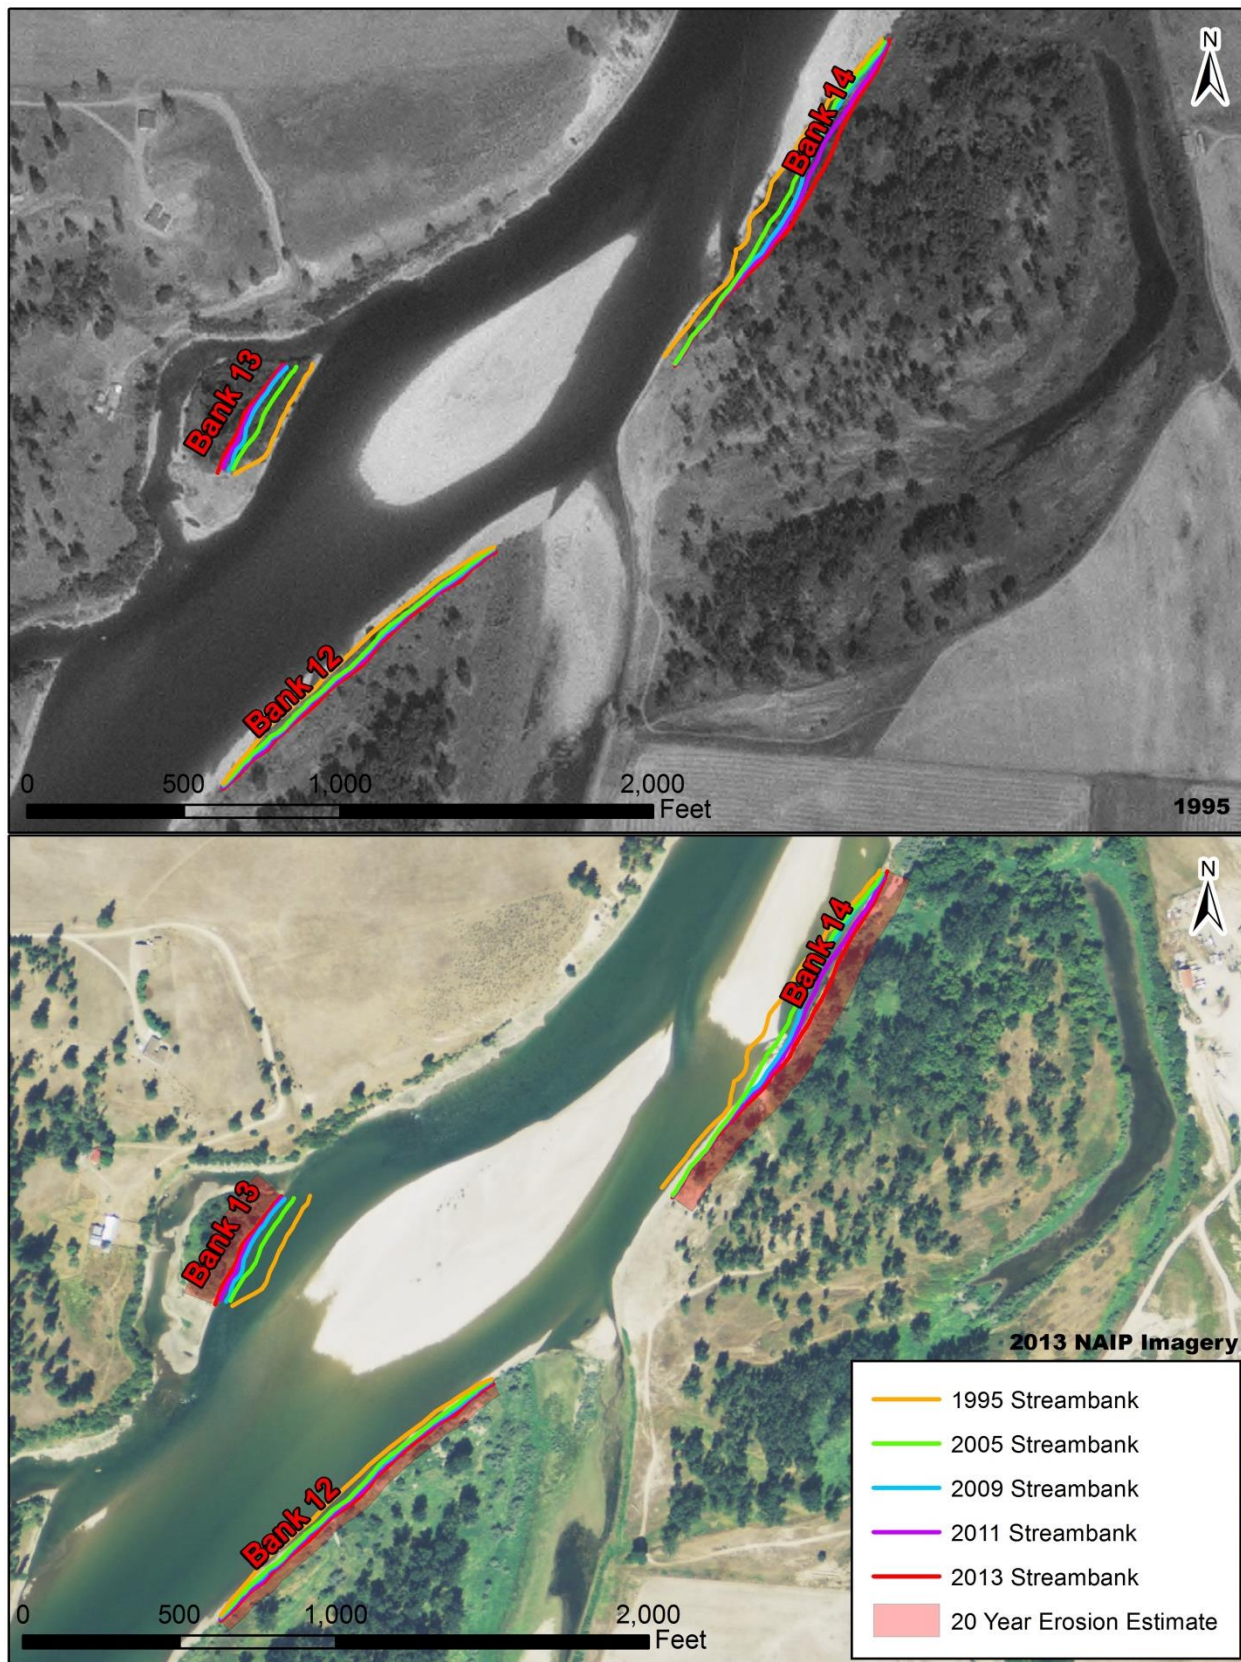
Bank 14 is 1,261 feet long and is located along the river right bank upstream of the confluence with Lynch Creek. Bank 14 is comprised of fine grained material with gravel in the toe that periodically extends higher into the bank (**Figure 5-38**). Between 1995 and 2013, bank 14 has eroded an average of 69 feet, with a mean annual retreat rate of 3.8 feet. This area contains undisturbed riparian vegetation and represents natural rates of streambank erosion expected in situations where there are mid-channel bars directing the flow towards the channel margins (**Figure 5-39**). However, decreased flows in the east channel, along with increased sediment deposition on the mid-channel bar from upstream bank erosion, may also influence erosion rates along this bank.

Figure 5-39. Banks 12, 13, and 14 Erosion 1995-2013

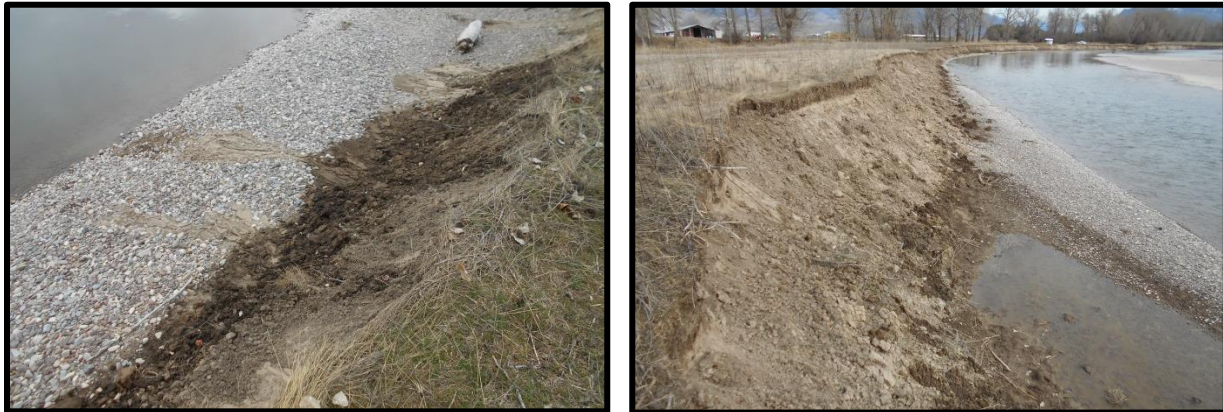
Figure 6-1. Potential Streambank Bioengineering and Revegetation Sites

continues to migrate. Recommended areas for streambank bioengineering and revegetation have been identified where the channel is shallower along the toe of the bank, such as along glides, and where mid-channel bars reduce the depth of the channel (**Figure 6-1**). Portions of an eroding bank where the channel is deep and the thalweg is situated along the toe of the bank will likely require the use of rock riprap in the toe or some other stabilization measure, such as large woody debris, with the goal of creating a smooth surface along the bank that does not include any scour features.

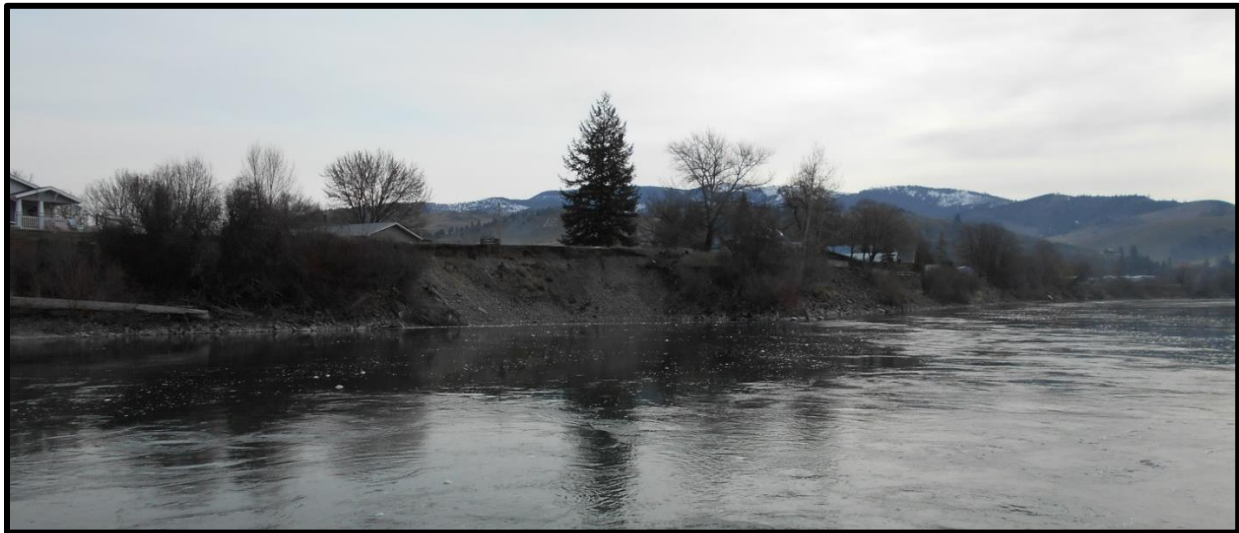
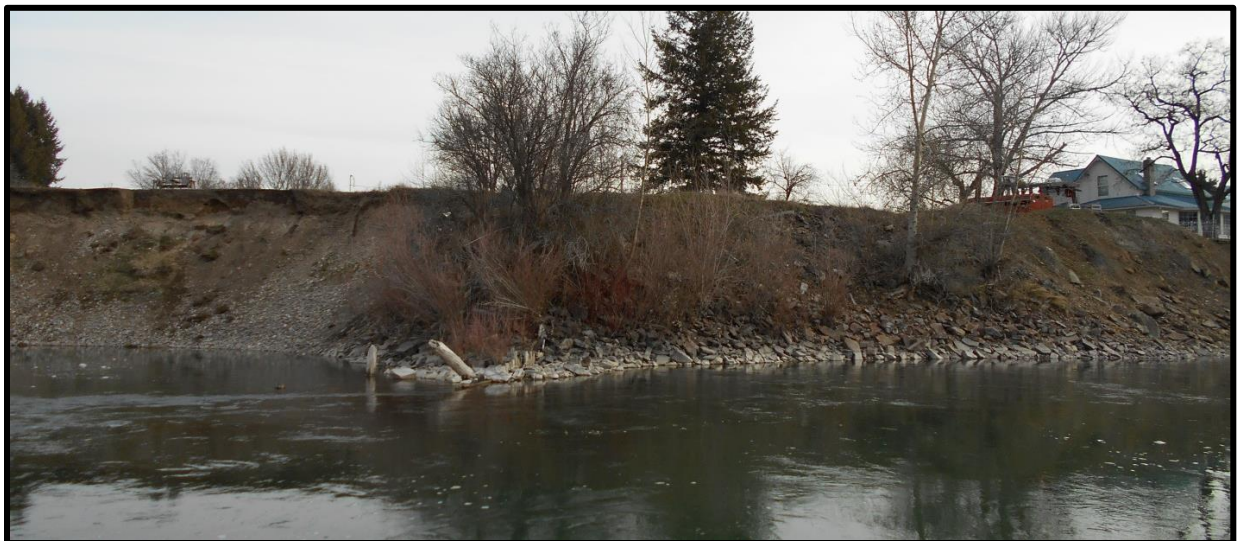
Bank 3 is 87 feet long and is located on river right in the town of Plains between 1st Street and 2nd Street just upstream of the 5th Avenue South Bridge crossing (**Figure 6-9**). Restoration activities for bank 3 include:

Figure 6-9. Bank 3 upstream of 5th Avenue South Bridge

Stabilization of bank 3 may be warranted due to its close proximity to residential development in Plains. Due to the height of this bank, stabilization will likely require some form of bank hardening, such as rock riprap, though vegetation could be included along the top of the bank.

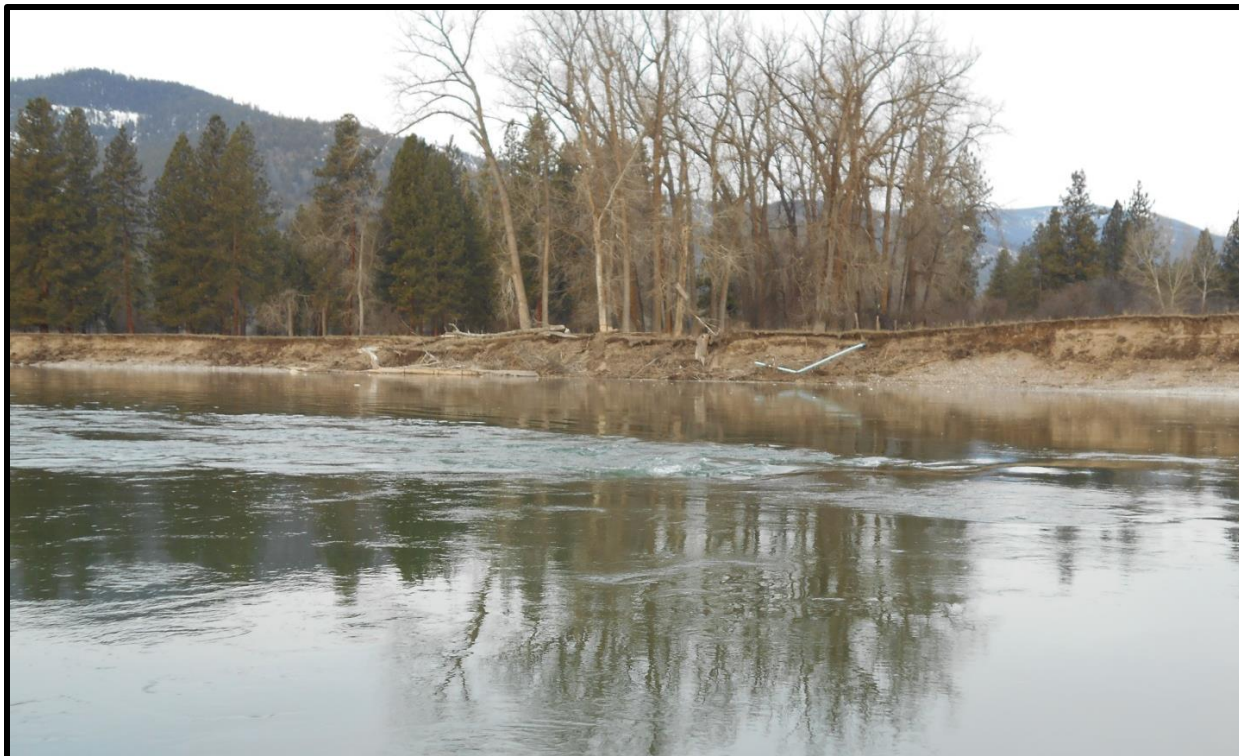
Figure 6-15. Underwater Obstruction along Bank 5 formed by Concrete Slab

Additional activities along bank 5 include the removal of an underwater obstruction formed by a concrete slab in the channel and removal of excess riprap residing at the downstream end of the riprap that can be seen in the 2013 NAIP aerial imagery extending over 100 feet into the channel (**Figures 6-15 and 6-16**). Riparian vegetation could also be added to the recently placed riprap as a mitigation measure.

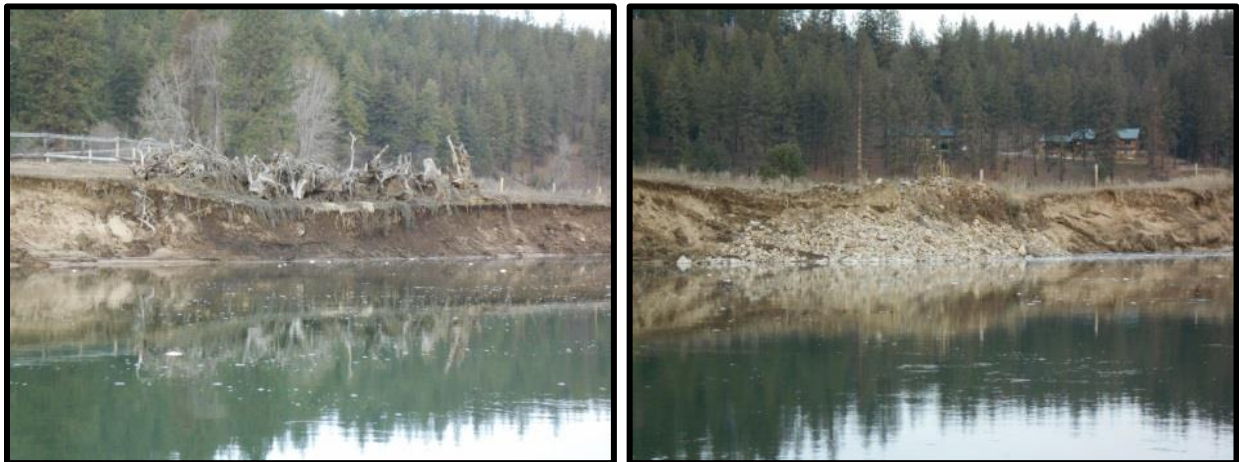
Bank 6 has been rapidly eroding since 1995, with an average retreat rate of 11.5 feet per year. There is a high amount of stream power directed at this bank and the channel is very deep. As this bank retreats, River Road West becomes more exposed to the river and will likely require stabilization at some point in the future. Stabilization of bank 6 will likely require rock riprap due to the high stream power and deep channel along the toe of the bank at the upstream end, while bioengineering techniques could be applied at the downstream end. Benefits of stabilizing bank 6 include protecting River Road West and the Keith property, along with decreasing the sediment load currently being deposited at the head of the west channel. However, stabilization of bank 6 will likely increase stream power on the next bank downstream, which is where the WWTP is located, along with potentially limiting access to the west channel. If bank 6 is stabilized, it may be beneficial to remove a portion of the small point currently stabilized by the pile of rocks and one remaining cottonwood to help direct additional flow into the west channel (**Figure 6-17**).

Figure 6-19. Temporary Bank Stabilization Measures along Bank 6

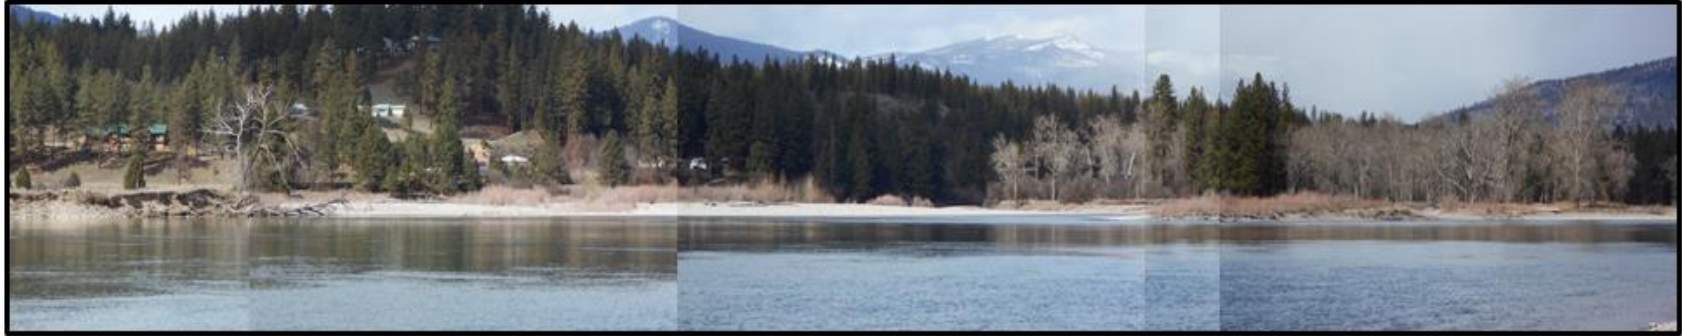
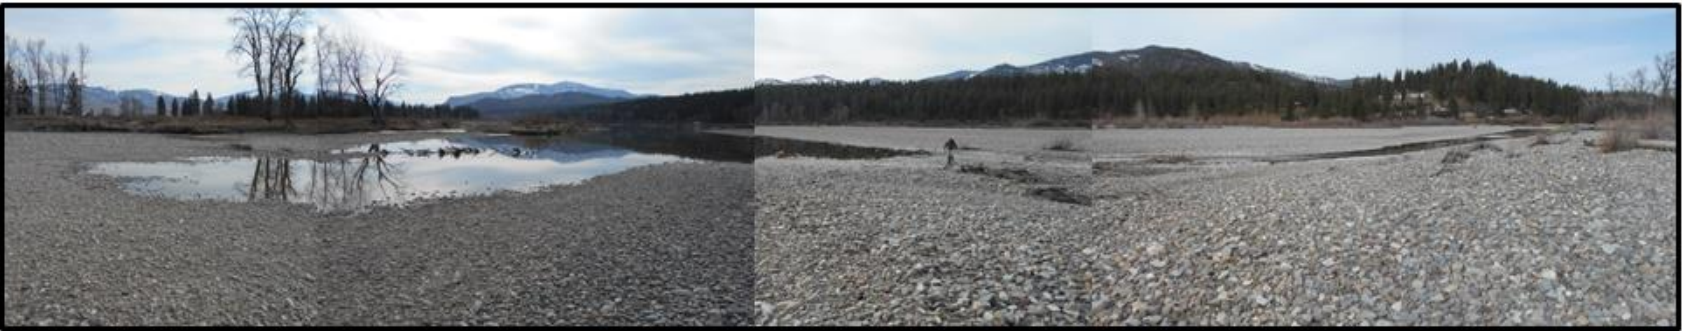
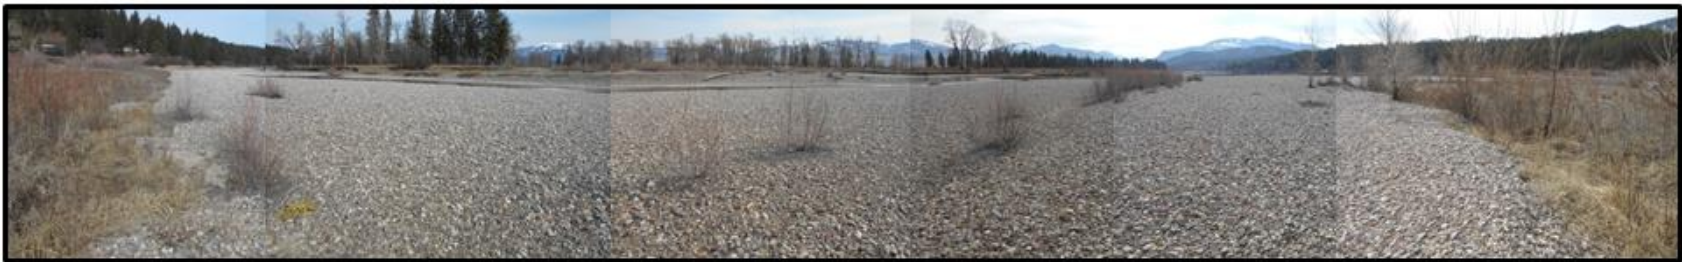
Sediment deposition at the upstream end of the west channel is due to sediment contributions from erosion along bank 6 and bank 7 (**Figures 6-22 and 6-24**). Restoration activities for the west channel include:

Figure 6-24. Overview of Sediment Deposition at the Head of the West Channel (13,500 cfs)

Removal of sediment from the head of the west channel could enhance flows within the west channel during lower flows, while also alleviating stream power along bank 9 and bank 10 during high flow events. However, while bank 6 and bank 7 remain sources of sediment, any sediment removed from the head of the west channel will likely be replaced by sediment eroded from these banks. Alternatively, continued erosion along bank 6 and downstream channel migration may allow the river to naturally flush sediment out of the head of the west channel, potentially sending more water down the west channel. In addition, the point of the island that separates the west channel from the main channel has eroded and retreated downstream, reducing its ability to deflect flows into the west channel. The river has also become much wider at the head of the west channel, leading to decreased stream power and sediment transport capacity. The addition of woody debris to the point of the island through the construction of an engineered log jam could help stabilize the point of the island and direct additional flow towards the west channel. Engineered log jams mimic natural large woody debris accumulations often found at the heads of islands and are observed within the Plains Reach (**Figure 6-23**).

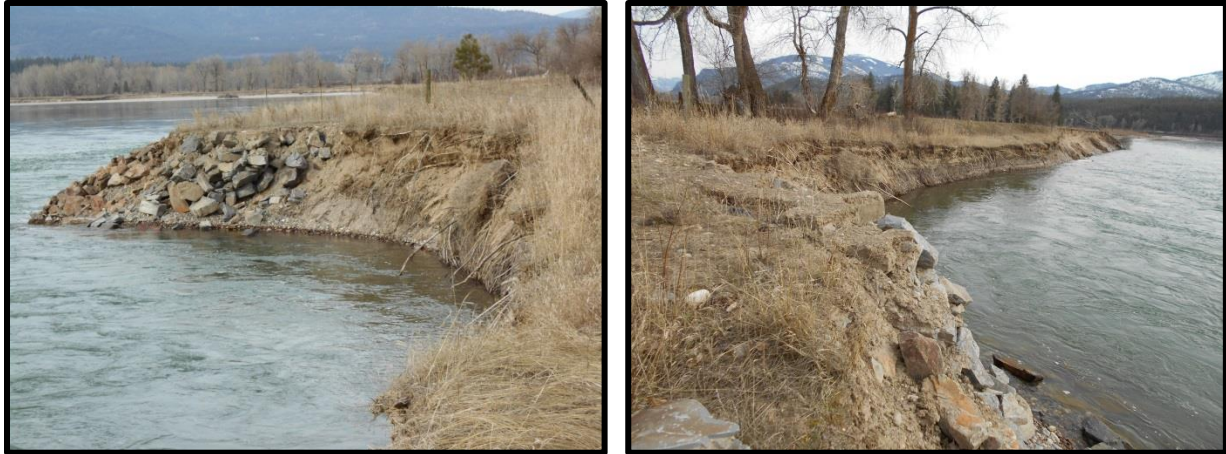
Figure 6-26. Bank 9 and Riprap at the Town of Plains WWTP Outfall

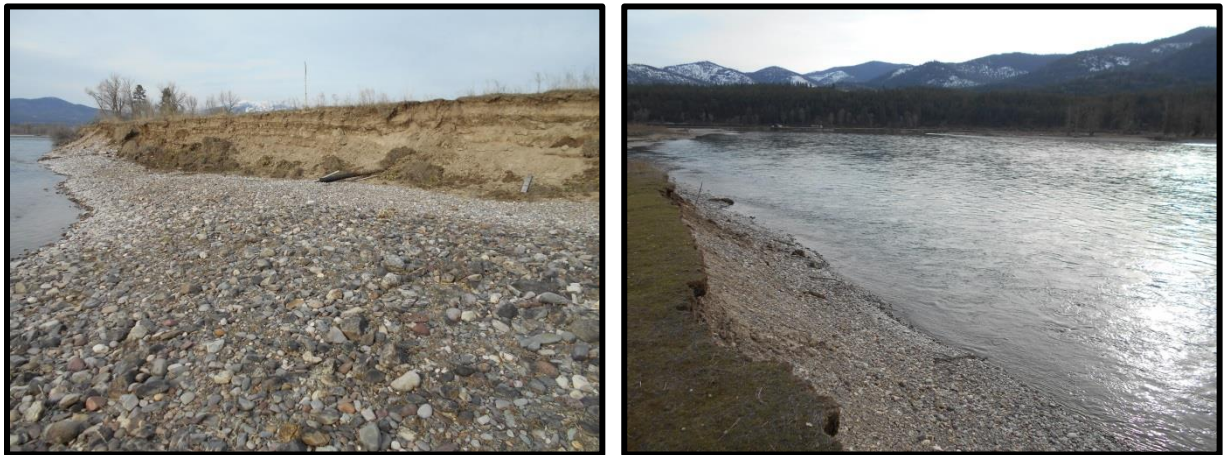
Figure 6-27. Upstream End of Bank 9

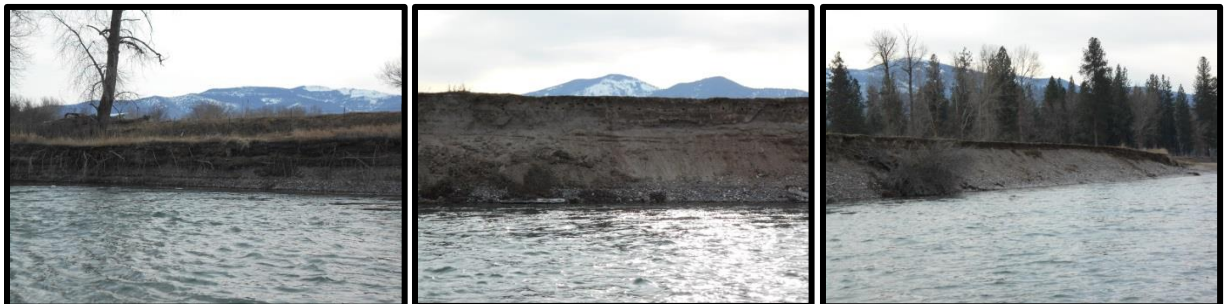
Figure 6-28. Bank 9 View from the River, from Downstream to Upstream (Left to Right)

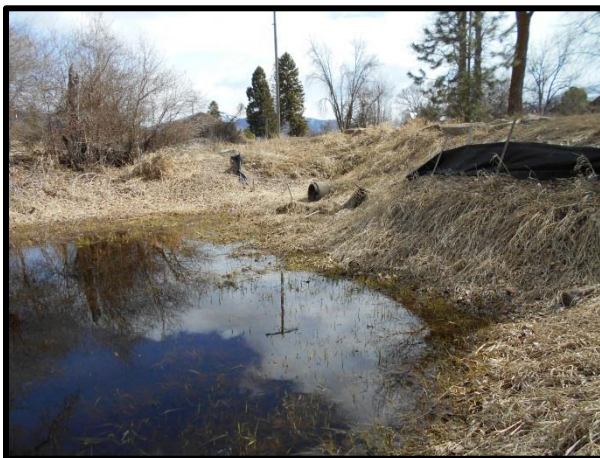
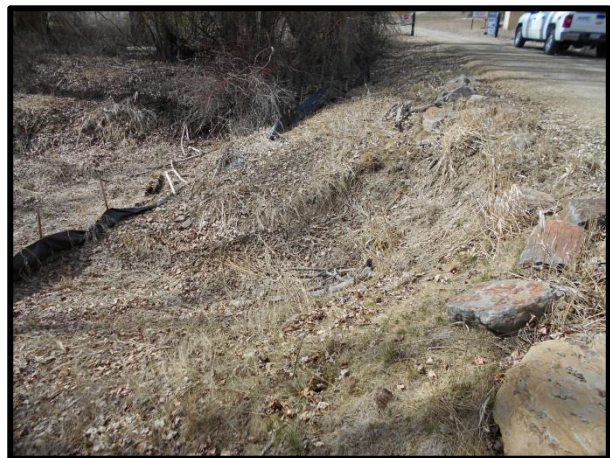
Additional activities along bank 9 include upgrades to the culvert on the WWTP access road crossing an overflow channel that flows behind the WWTP when water overtops bank 5 (**Figure 6-30**).

Figure 6-30. Town of Plains WWTP Access Road across Overflow Channel

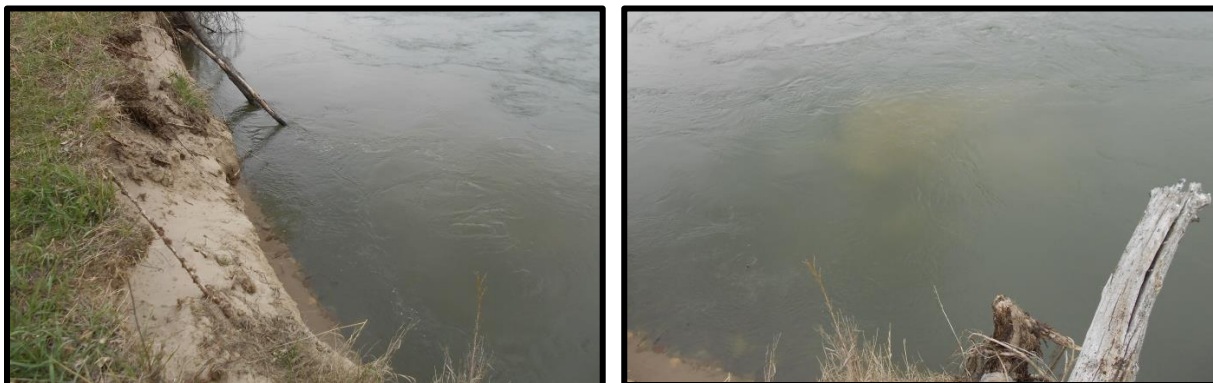
Bank 10 exhibits two distinct characteristics progressing from upstream to downstream, with a vertical bank at the upstream end transitioning to a lower angled bank at the downstream end. The upper portion of bank 10 is located downstream of the riprap at the Town of Plains WWTP outfall where the thalweg is along the channel margin (**Figure 6-31**). Stabilization at the upstream end may require extending the rock riprap downstream of the existing riprap at the WWTP outfall downstream. In April of 2014, a large eddy was observed off the downstream of the rock riprap and was recirculating from approximately 300 feet downstream at a flow of approximately 31,000 cfs. Recirculating water in this large eddy is leading to accelerated bank erosion at the head of an overflow channel. At the tail end of this eddy, plumes of sediment were observed washing from the streambank, which contained a high amount of sandy material (**Figure 6-32**). As the channel becomes shallower along bank 10 in the vicinity of the mid-channel bar and the bank height decreases, bioengineering techniques may be appropriate. However, flow deflection from the mid-channel bar may increase the relative stream power along this portion of the bank and partial dredging to remove sediment from this mid-channel bar may help reduce stream power along bank 10. Also, the influence of mill waste material within the bank at the downstream end should be considered when developing a restoration strategy for bank 10. A potential option would be to remove a portion of the area with the mill waste, thereby opening up additional flow

Figure 6-32. Plumes of Sediment Eroding from the Upper End of Bank 10 (~31,000 cfs)

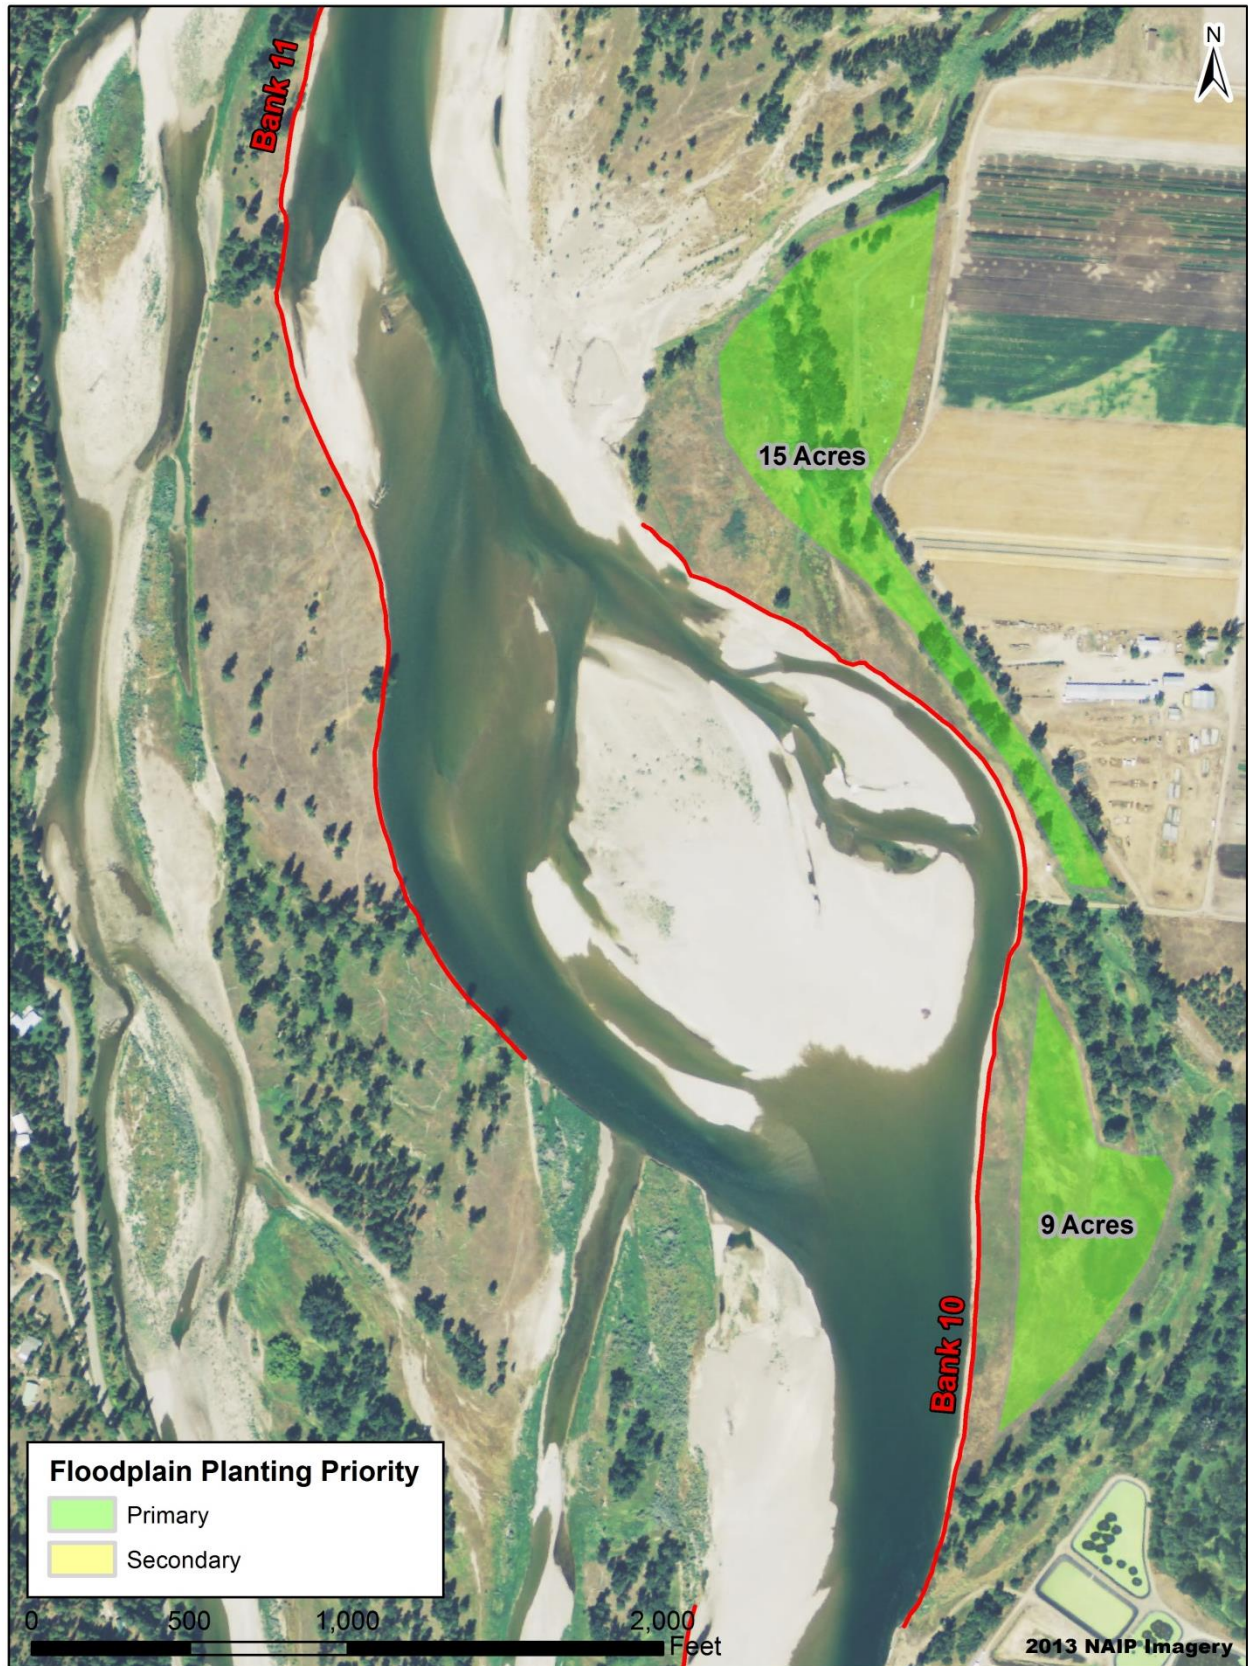
Figure 6-33. Floodplain Revegetation Sites along Bank 10

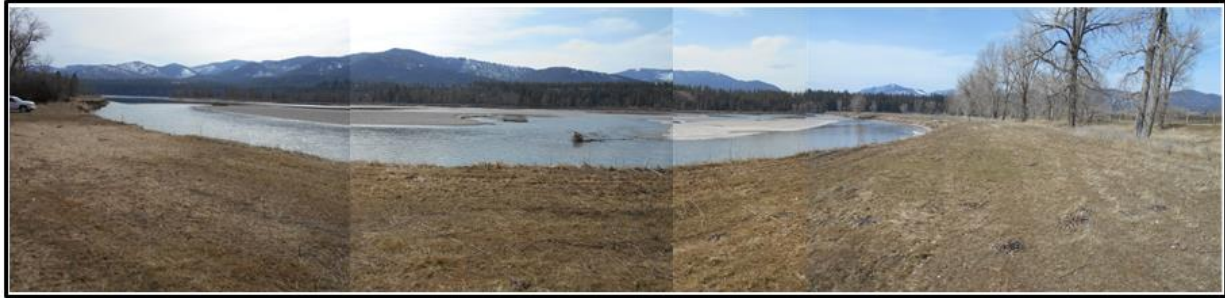
Figure 6-34. Avulsion Potential into Overflow Channel lined by Cottonwoods along Bank 10
