Clark Fork River Plains Reach Assessment & Restoration Prioritization

May 14, 2014

**CLARK FORK RIVER
PLAINS REACH ASSESSMENT
AND
RESTORATION PRIORITIZATION**

RESPEC

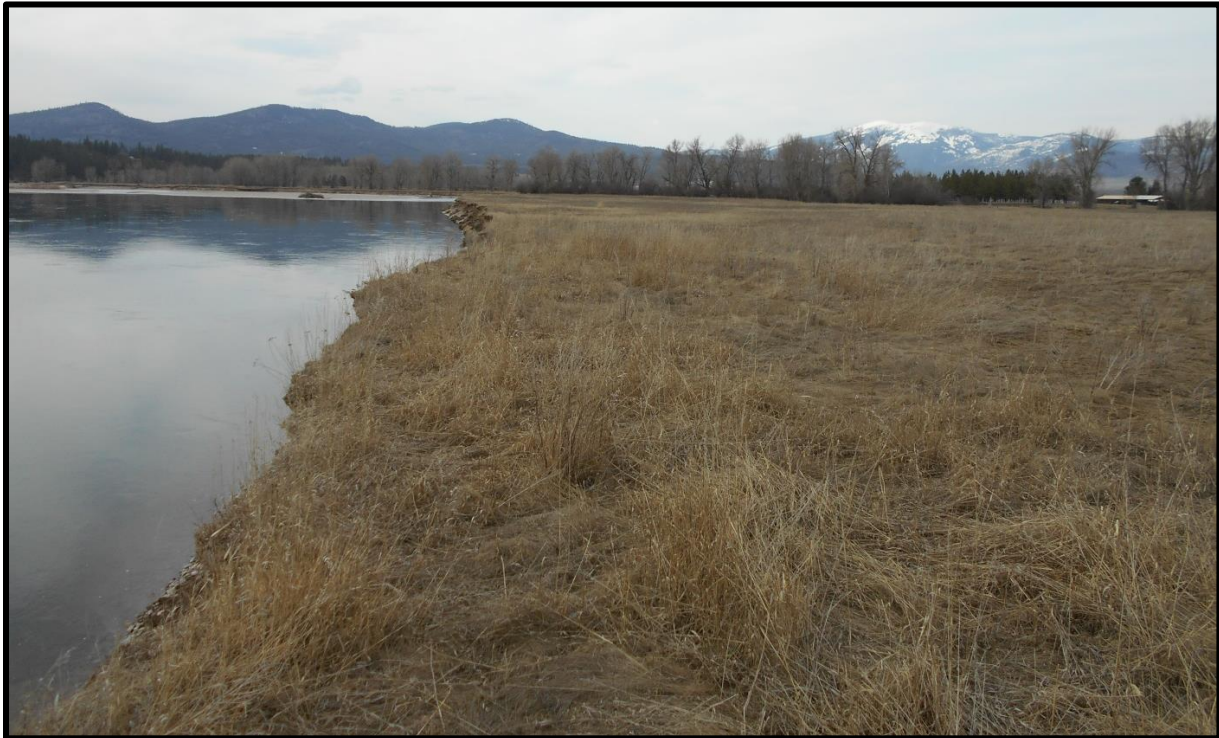
Figure 6-35. Floodplain Revegetation Site along Bank 10, Town of Plains Property

Establishment of riparian vegetation on the floodplain downstream of the Town of Plains WWTP and within the historic side channel along Lawyer Nursery is recommended to slow the rate of lateral channel migration and to help protect this area which was identified as a potential avulsion risk during the Channel Migration Zone analysis due to the presence of overflow channels across the floodplain (**Figures 6-33 and 6-34**). The floodplain area downstream of the Town of Plains WWTP resembles floodplain areas used for grazing along banks 5, 6, and 9, while the overflow channel along Lawyer Nursery is vegetated with native and introduced grass species (**Figures 6-35 and 6-36**). Signs of beaver activity were observed on the cottonwood trees along the channel margin at this site and protection from beaver would help maintain the existing vegetation.

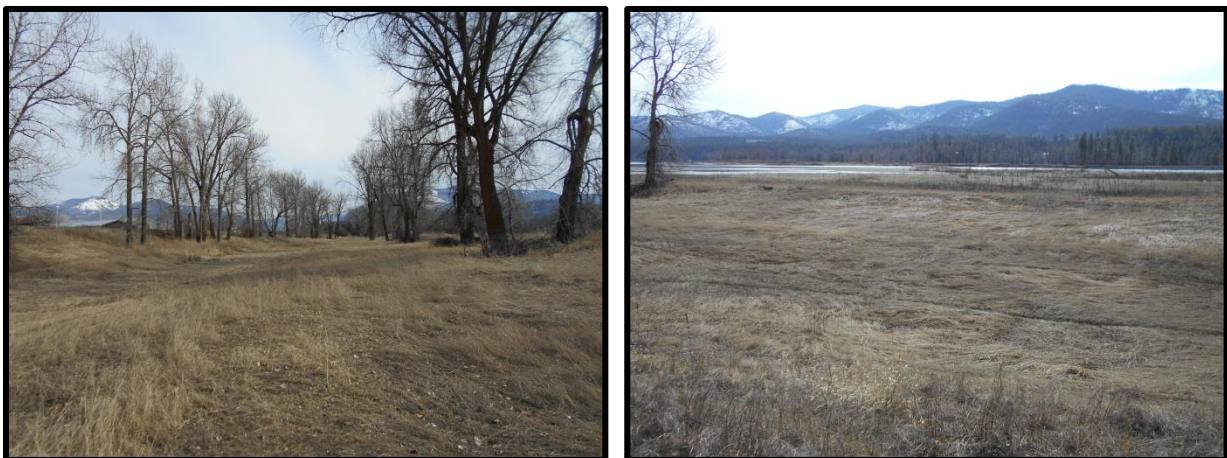
Figure 6-36. Floodplain Revegetation Site along Bank 10, Lawyer Nursery Property

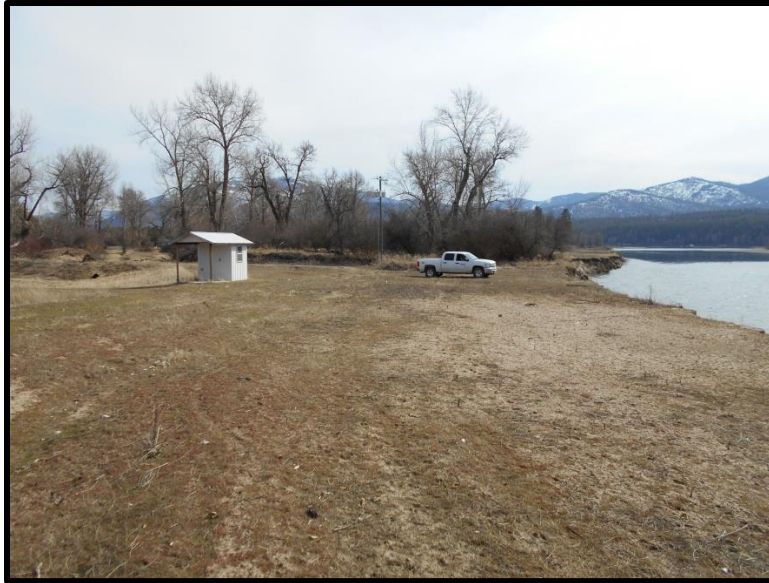
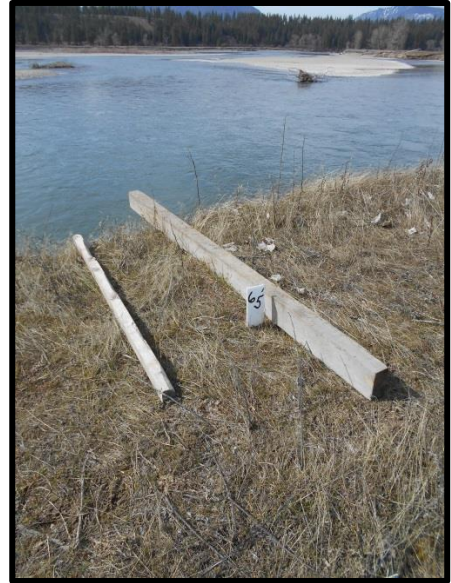
Figure 6-37. Pump House Located Approximately 65 Feet from Bank 10

Additional activities along bank 10 include upgrades to four identified culverts on roads crossing the overflow channel that starts downstream of the WWTP and outlets into the east channel, along with re-location of an irrigation pump and ground water well that is approximately 65 feet from the edge of bank 10 (**Figure 6-37**). Culverts on abandoned access roads could be removed, while culverts on roads that continue to be used could be replaced (**Figure 6-38 and 6-39**). In addition, a power pole located along bank 10 is precipitously close to the bank near the existing pump house.

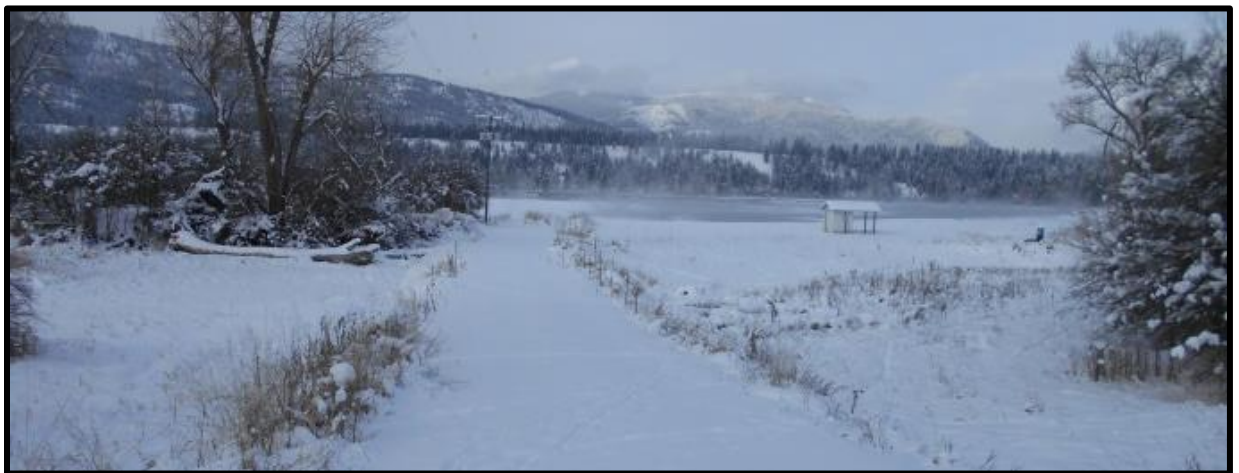
Figure 6-38. Pump House Access Road across Overflow Channel

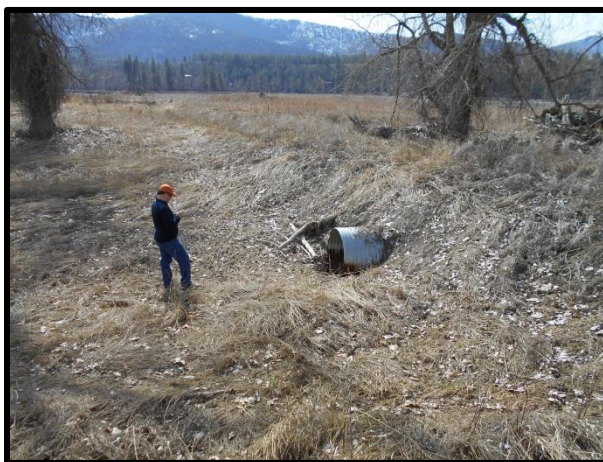
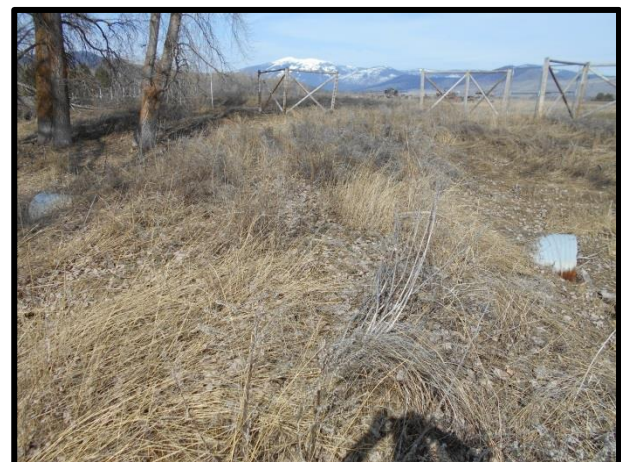
Figure 6-39. Abandoned Access Road across Overflow Channel

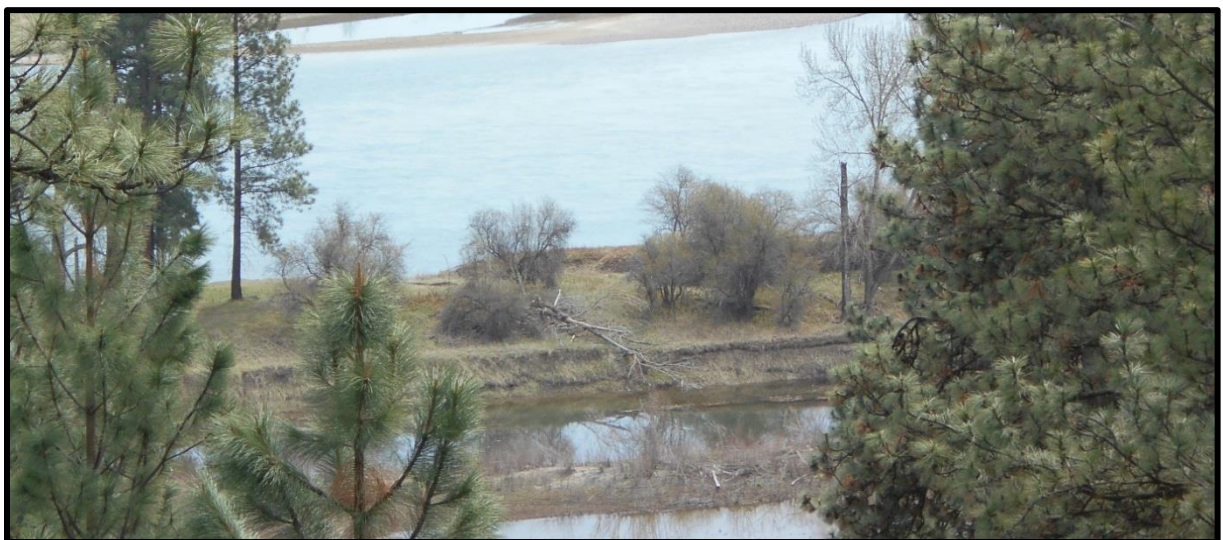
Removal of sediment from the head of the east channel could enhance flows within the east channel during lower flows, while also alleviating stream power along bank 11 during high flow events. However, while bank 10 remains a source of sediment, any sediment removed from the head of the east channel will likely be replaced by sediment eroded bank 10. While not as extensive as the sediment deposition in the west channel, sediment deposition at the head of the east channel and decreased stream flows during high water directs additional flow towards bank 11, which is on the island that separates the west channel from the main channel. The estimated 20 year erosion zone for bank 11 indicates that the lower 1,500 feet of the island may become completely washed away if bank erosion continues at the rate of erosion observed over the past 18 years (**Figures 6-41** and **5-35**).

Figure 6-41. Lower End of Island Separating the Main Channel (Top) from the West Channel (Bottom)
