December 31, 2017

Upper Missouri Headwaters River Channel Migration Mapping Summary Report

Tony Thatcher
DTM Consulting, Inc.
211 N Grand Ave, Suite J
Bozeman, MT 59715

Karin Boyd
Applied Geomorphology, Inc.
211 N Grand Ave, Suite C
Bozeman, MT 59715

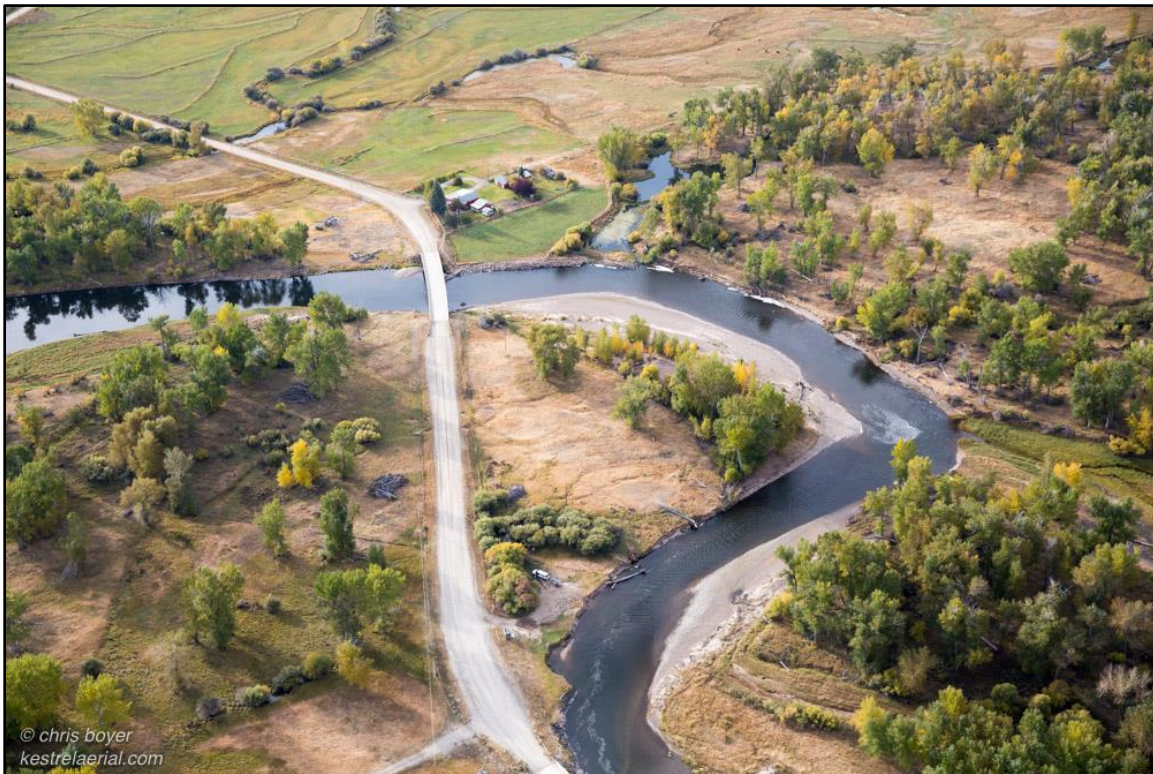
Figure 76. View west of main channel at Pennington Bridge; flow direction is to the left.

- b. Pennington Bridge: Active erosion, complex split flows and a major avulsion upstream of the bridge have degraded the channel alignment, and continued maintenance will be necessary.

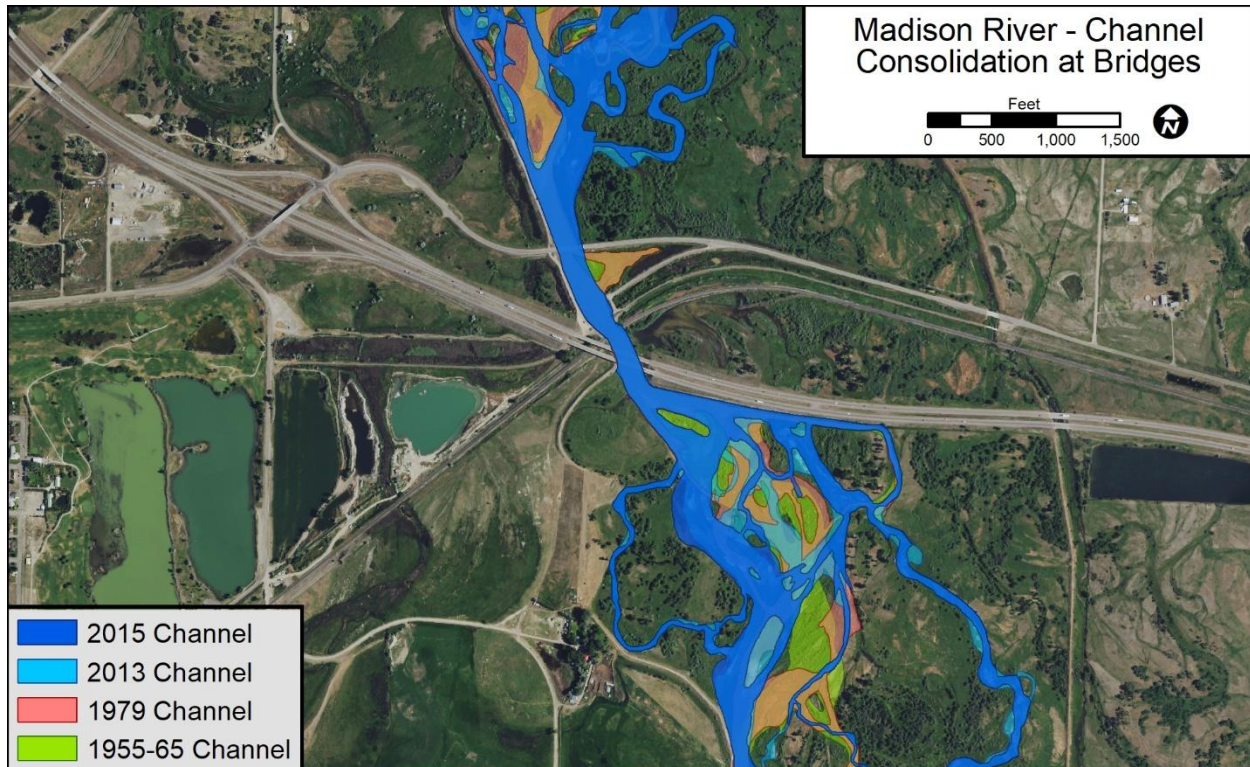
Figure 77 shows another common management issue at bridge crossings, which is the need to “hourglass” multiple river channels through a bridge opening that is much narrower than the natural CMZ. This can create

problems upstream of the bridge as channels run parallel to the road embankment, creating erosion problems. It is another example of how CMZ mapping can be used in transportation infrastructure design and management. For example, at Three Forks (Figure 77), it may be cost effective in the long run to construct bridges to accommodate a higher proportion of the CMZ through additional bridge spans or culverts.

3. Madison River
 - a. I-90 Bridge: Requires major channel consolidation.
4. Big Hole River
 - a. Burma Road (Glen Fishing Access): Right bank erosion above bridge into road approach will require treatment and continues to degrade channel alignment through the structure.

Figure 77. Madison River channel consolidation at I-90 Bridge crossing near Three Forks; flow direction is from bottom to top.

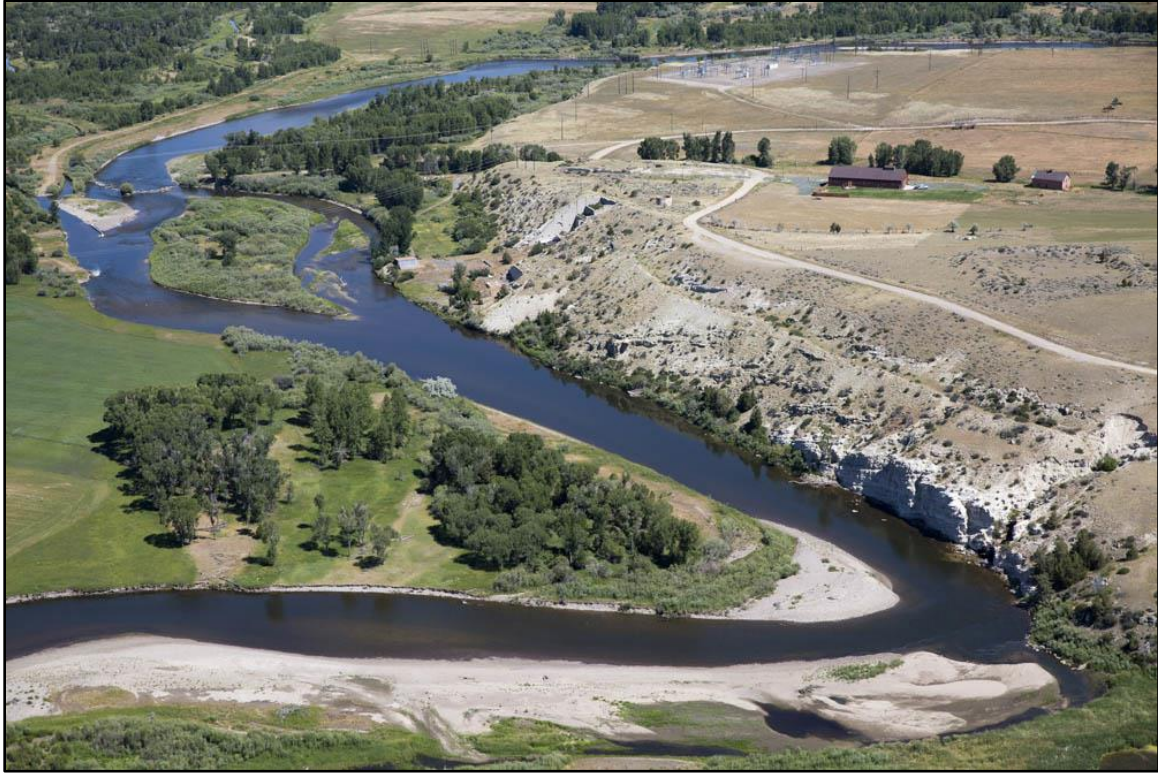
Managing irrigation infrastructure on dynamic rivers is challenging in several ways. First, channels can migrate away from headgates and major diversions, effectively abandoning them. At the Renova Diversion on the Jefferson River near Whitehall, for example, there is concern that island formation, bank erosion, and a possible avulsion will cause the Jefferson River to bypass the structure. On the Musselshell River, several diversion structures were flanked during a major flood in 2011 and few of them have been rebuilt to date because of exorbitant costs. That flood also resulted in over 50 avulsions that abandoned dozens of points of diversions.

Figure 79. View downstream towards Renova Diversion (upper left) showing channel migration away from right valley wall (Kestrel).

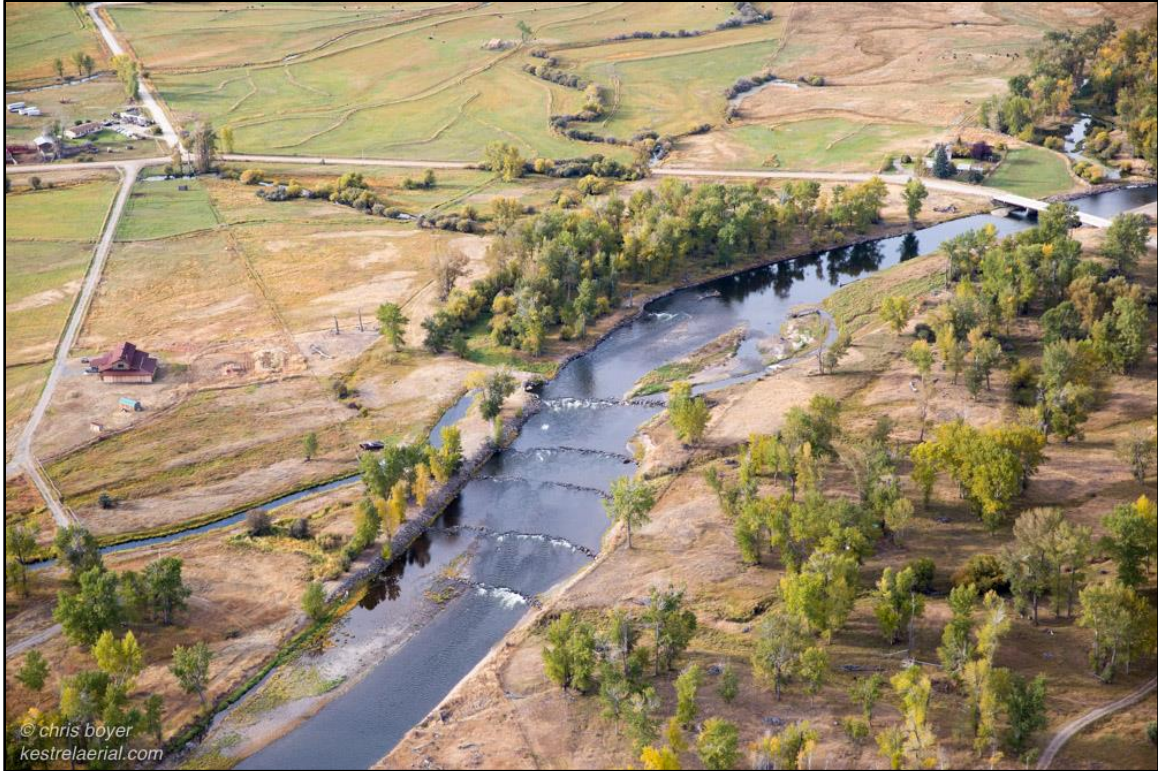
Another common problem with irrigation infrastructure stems from vertical changes in bed elevations, which may affect hydraulic head at diversion points and require grade controls to maintain diversion capacity (Figure 81). As stream channels move laterally or avulse into new pathways, bed elevations can change substantially on a local scale. Lastly, aggradation at headgates that are placed in passive areas in the CMZ can result in expensive, long-term maintenance needs (Figure 82).

Figure 81. View upstream of rock grade controls at diversion structure just below Pennington Bridge (Kestrel).

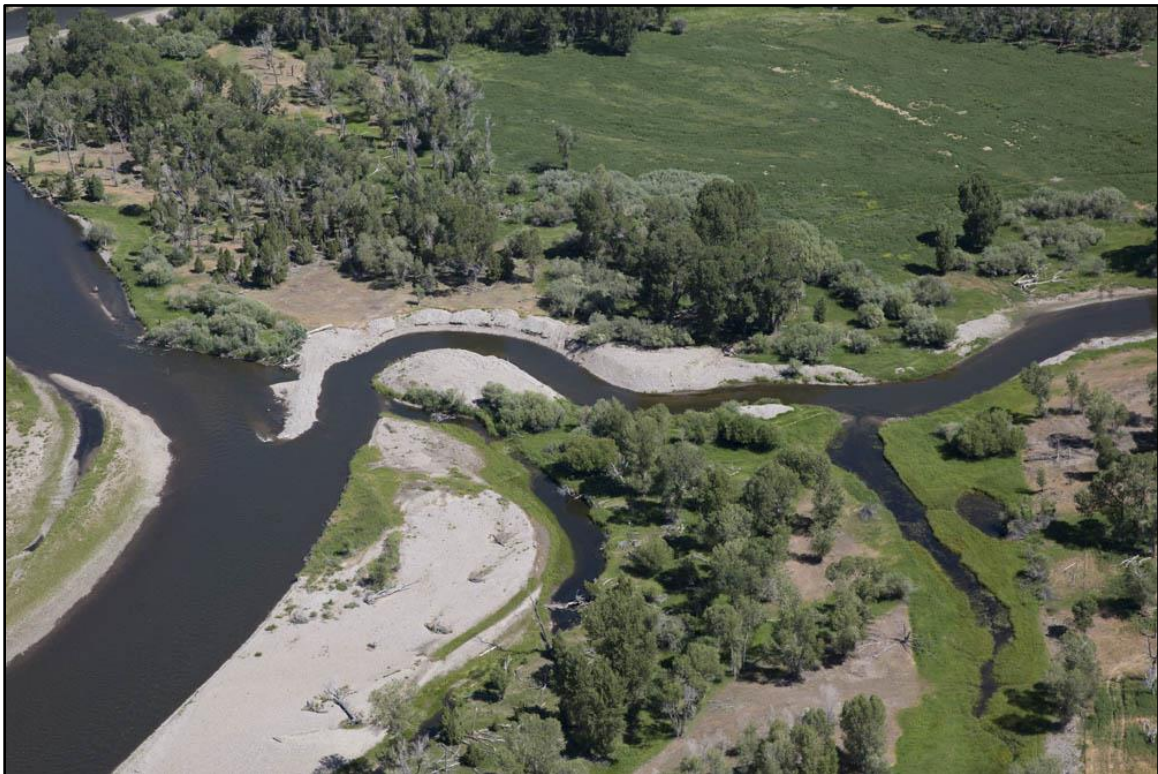
Figure 82. View downstream of dredging at head of side channel that supplies irrigation water, Jefferson River (Kestrel).

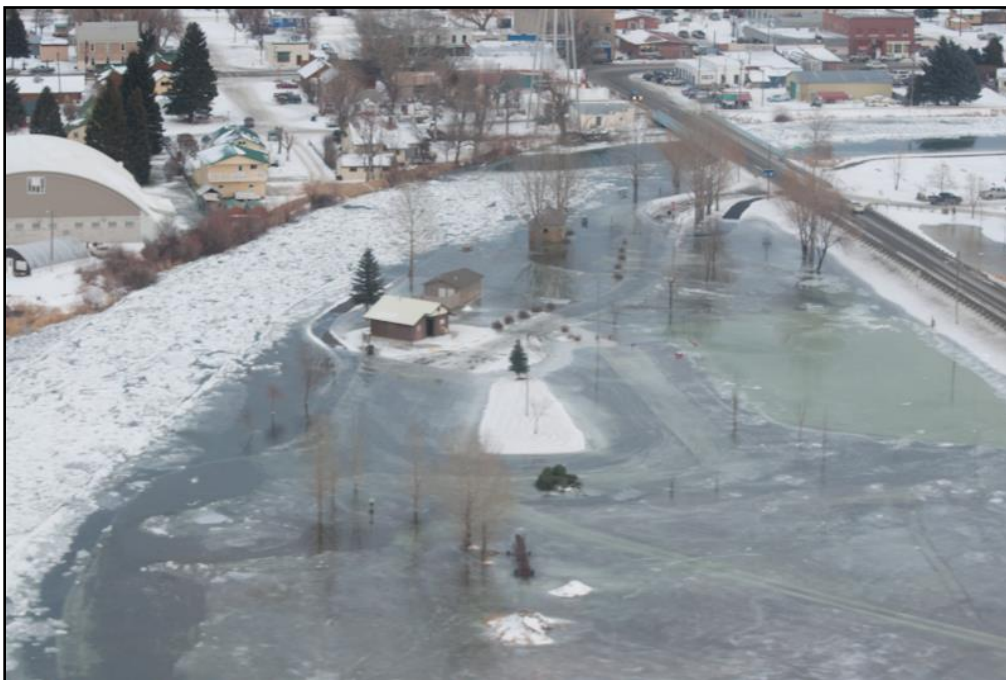
Figure 86. Ice jam and flooding at Twin Bridges, MT, January 4, 2011. (Madison County, MT Office of Emergency Management).
