Big Hole River Channel Migration Mapping

Abstract

This report contains the results of a Channel Migration Zone (CMZ) mapping effort for approximately 111 miles of the Big Hole River from the town of Wisdom in the Big Hole Valley to its confluence with the Beaverhead River at Twin Bridges, Montana. This is a part of a larger effort to map approximately 425 miles of rivers in the Missouri River Headwaters watershed.

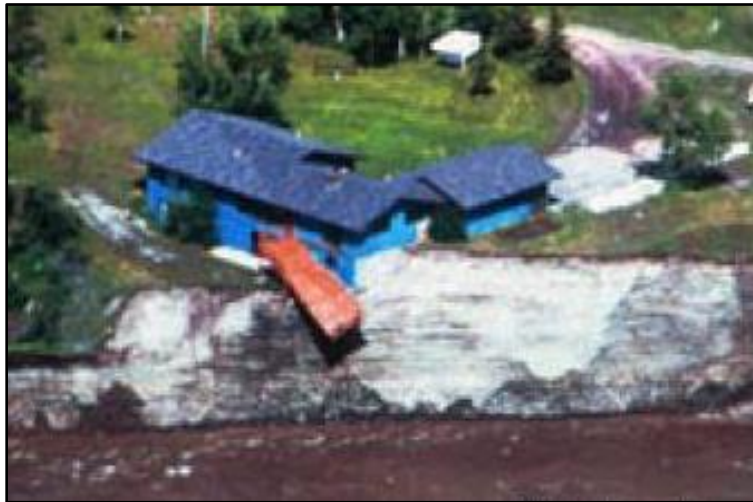
Figure 4. Yellowstone River home on high glacial terrace that was burned down in 1997 to prevent its undermining by the river.

Figure 4 shows a property on the Yellowstone River in Park County that was progressively undermined during the 1996-1997 floods, prompting the owner to burn it down to prevent any liability associated with the structure falling into the river. This has been a chronic problem in river management, as landowners assume that if their home is beyond the mapped floodplain margin, it is removed from all river hazards. After experiencing massive 2005 flood damages in Saint George Utah (Figure 5), several property owners reflected on this issue (www.Utahfloodrelief.com):

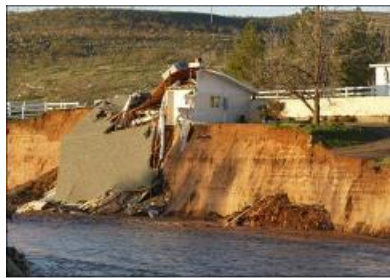
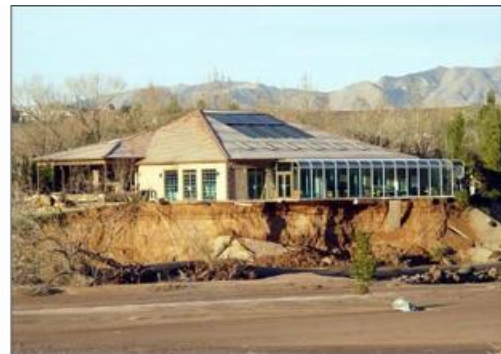
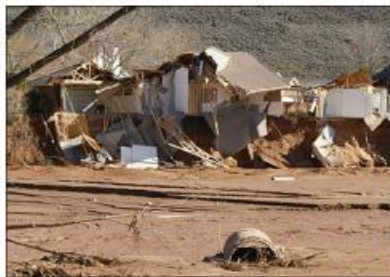
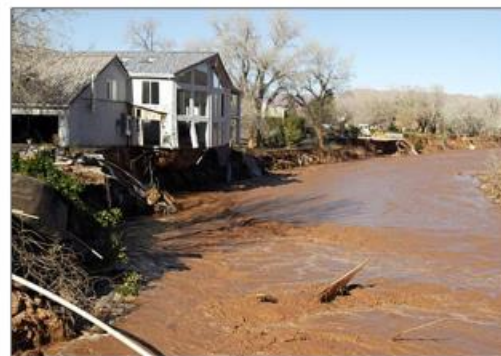
Figure 5. Photos from a 2005 in Saint George Utah, where homes several feet above the mapped floodplain were destroyed by channel migration (www.Utahfloodrelief.com).

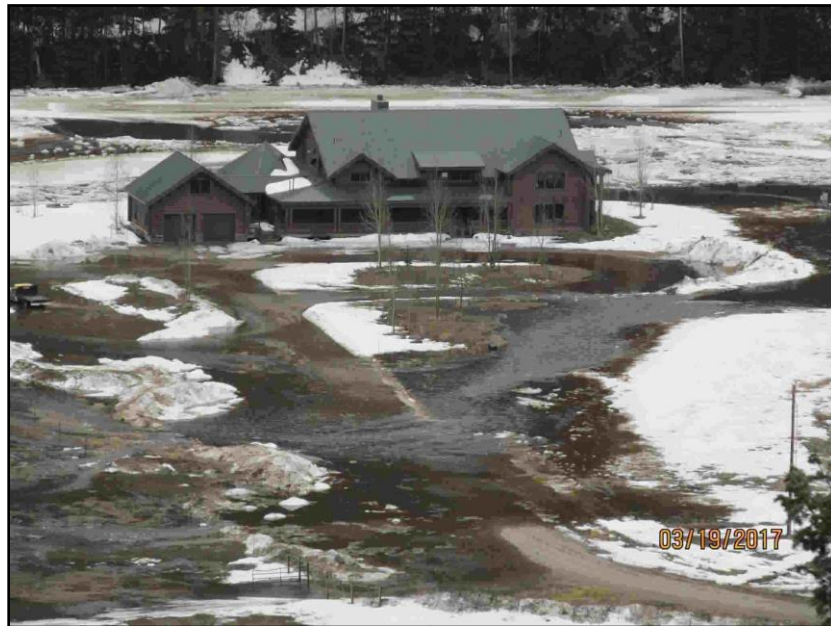
Figure 6. Big Hole River flooding due to ice jamming upstream of Wise River, March 2017 (Big Hole Watershed Committee).

Another serious river hazard, especially in Montana, is ice jamming. Over 1,470 ice jams have been recorded in Montana, which is the most of any of the lower 48 states (<http://dphhs.mt.gov/>). The ice jams are most common in February and March. Ice jams on the Big Hole River appear to form most frequently in the fairly confined river segments near and upstream of Wise River. In March 2017, ice-jam related flooding backed water up to surround a house and approach Highway 43 near Wise River (Big Hole River Watershed Committee; Figure 6). During this event Flood Warnings were issued from below Fishtrap to Divide (krtv.com). Ice-jam related flooding is an important potential mechanism for channel avulsion in this area, as the jams can by entirely blocking the river and force overflows into floodplain swales for long periods of time. This reach of river also experienced substantial jamming in 2009 and 2011 (Figure 7).

Another interesting aspect of Reach BH9 is the level of residential development adjacent to the river. Several homes have been constructed in recent years on low geomorphic surfaces adjacent to the channel, and in many locations there are avulsion pathways or overflow paths landward of the homes (Figure 47). At least one of these homes was flooded by ice jamming in 2017 (RM 72.0, Figure 6). This house is located on the landward edge of the mapped CMZ.

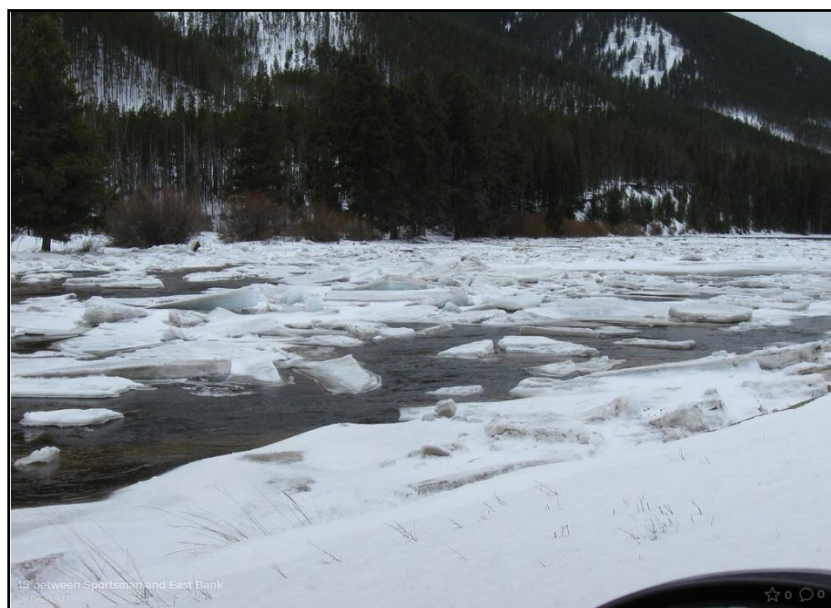
Figure 7. April 2009 ice jamming near Sportsmans Park, Big Hole River (DivideMT).

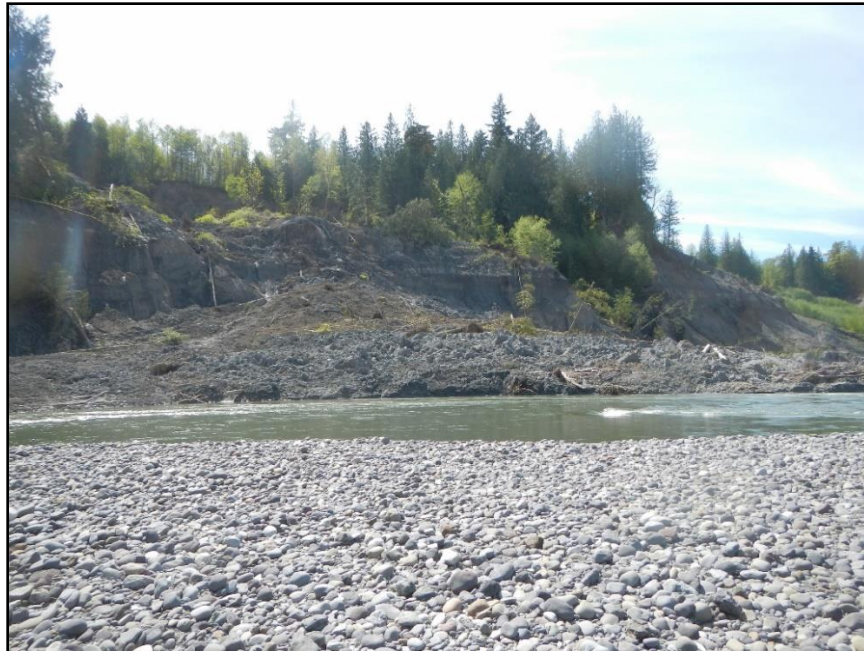
Figure 9. Hillslope failure on Nooksack River near Bellingham Washington on February 21, 2014 (K. Boyd).

Figure 9 shows an example of a relatively small landslide that occurred in February 2014 on the south wall of the Nooksack River Valley near Bellingham, Washington. The landslide originally blocked the channel, and the effect was seen at a gaging station downstream where river flows rapidly dropped from over 2,000 cubic feet per second to about 400 cubic feet per second in the early morning hours of February 21 (Figure 10). The river breached the landslide and flows returned to normal, however in some cases impacts have been much worse. Probably the most recently renowned landslide into a river system was the 2014 Oso Slide into the North Fork of the Stillaguamish River, which dammed the river causing extensive flooding upstream (Figure 11).

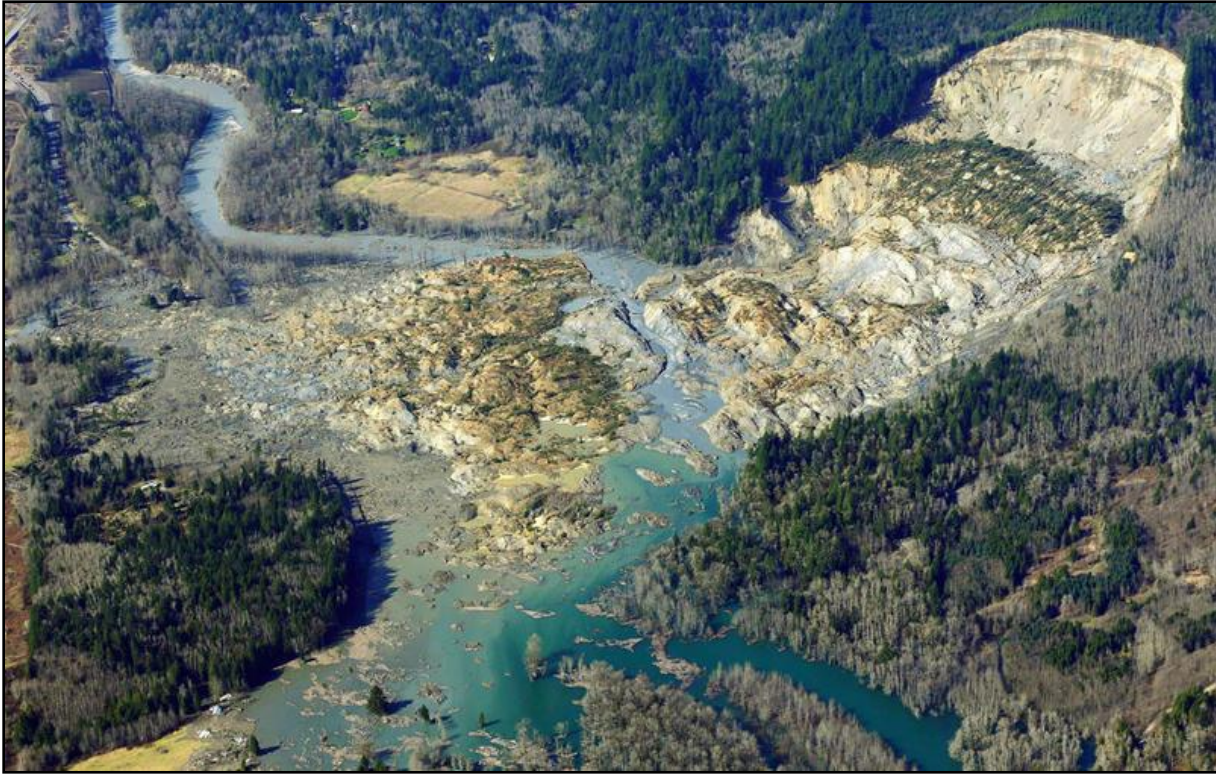
Figure 11. Massive mudslide in Oso Washington on March 22, 2014, deflecting the North Fork of the Stilliguamish River (AP Photo/Ted Warren).

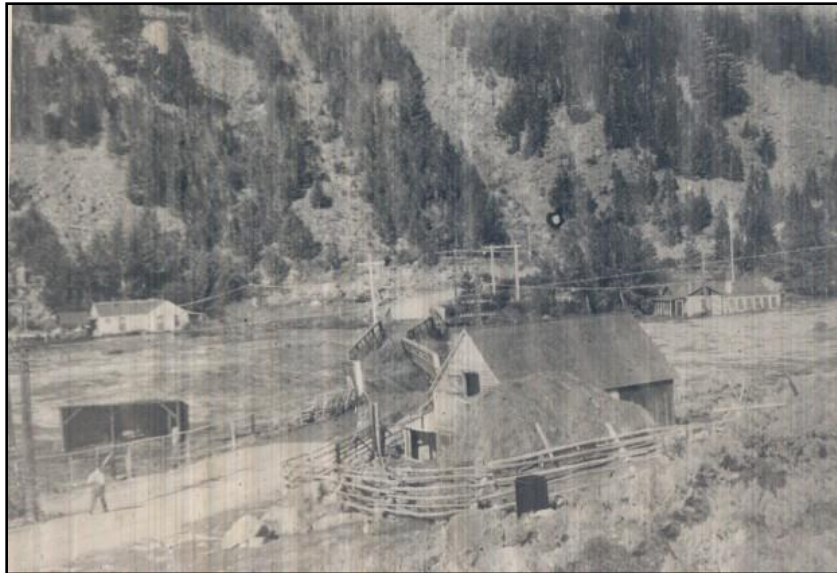
Figure 13. 1927 photo of Big Hole River Bridge washout following Pattengail Reservoir failure.

The most complete flood record on the Big Hole is from the USGS Melrose Gaging Station, which has been active since May of 1924 (USGS 06025500, Figure 14). The gage was installed just three years before recording the biggest flood to date, when in 1927 a dam failed on Pattengail Creek, a tributary to the Wise River. Pattengail Creek was named after a Civil War Veteran named George Pattengill, who was locally referred to as the "Wild Man of Montana"; Pattengail was a local character who lived in a wikiup and "regularly frightened Butte fisherman until his demise in 1895" (Davis, 2015). The dam was constructed to support irrigation in the area, but the dam failed in 1927 after a season of heavy snows and spring rain, creating a twenty-five foot wall of water that wiped out structures in Dewey and Wise River, killing four people in the process (Figure 13). The flood produced a flood of 23,000 cfs at Melrose. This site has since been reconsidered for new dam construction and storage (Davis, 2015).

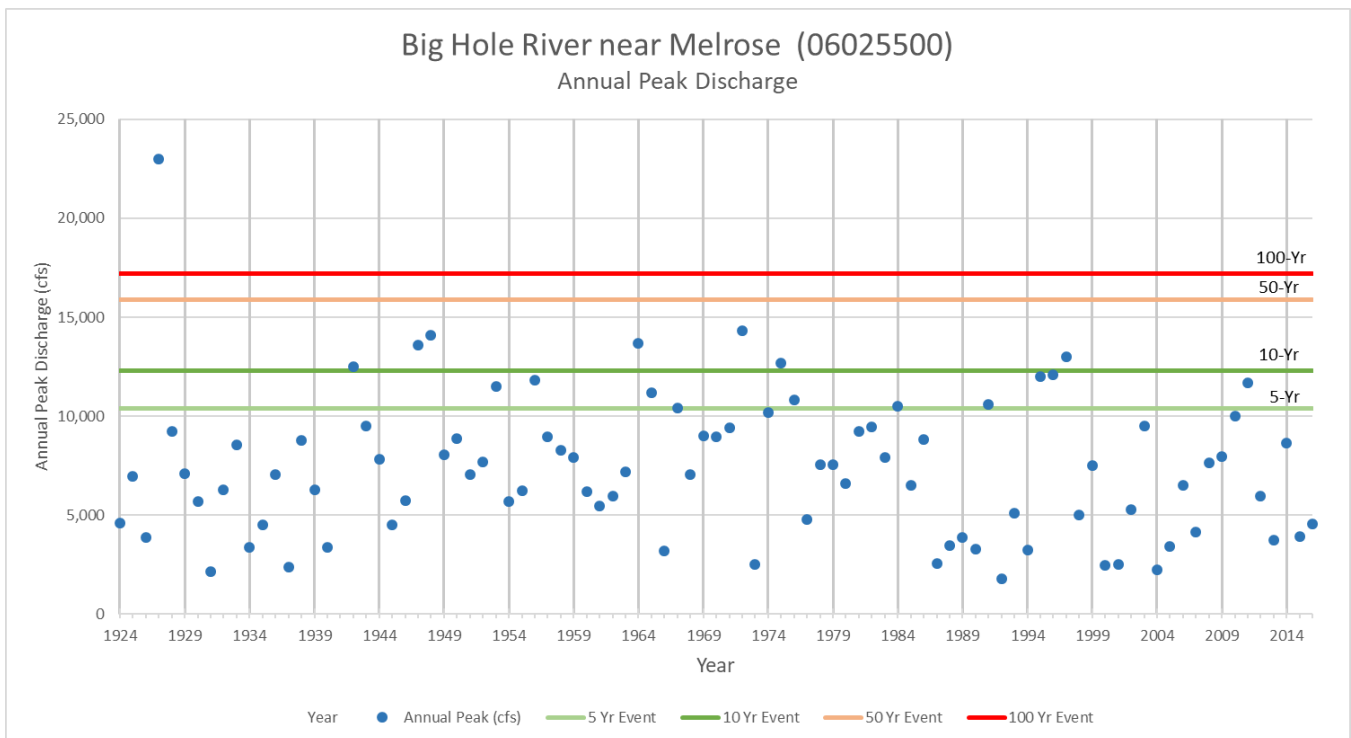
Figure 14. Annual peak flood record, Big Hole River near Melrose.

The largest flood on record that was not related to a structural failure occurred in 1972, when the Melrose gage recorded a peak discharge of 14,300 cfs. Since that time, substantial floods occurred in 1975, 1995, 1996, 1997, and 2011 (Figure 14).

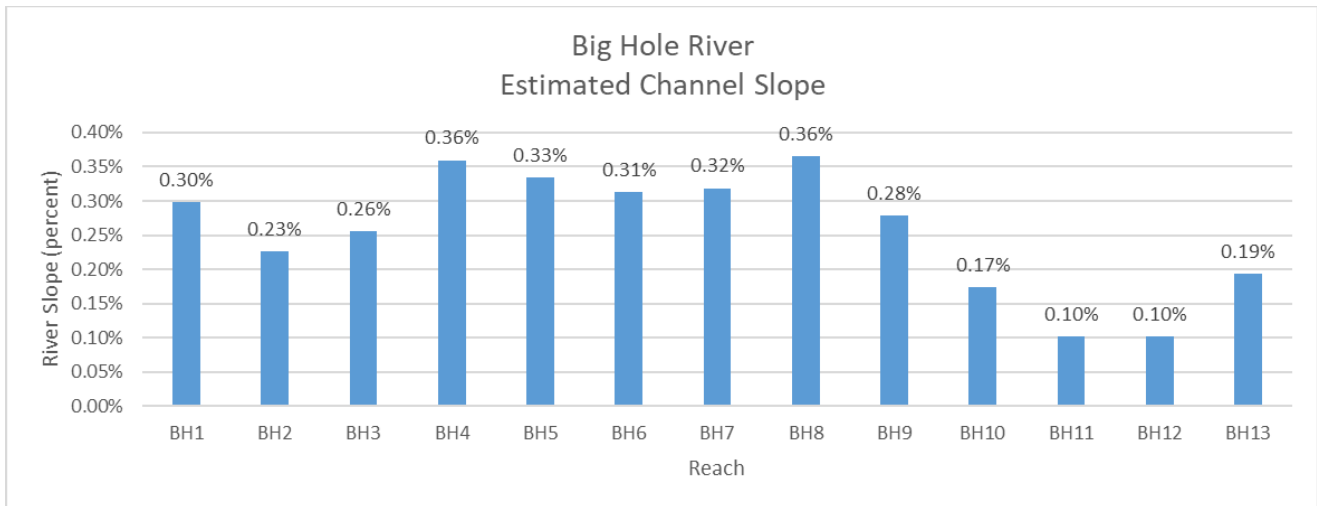
Figure 22. Estimated channel slope (in percent) for Big Hole project reaches.

northeast-trending fan has pinned the river against the north valley wall and inhibited channel movement (Figure 44). Another good example is at the mouth of Jerry Creek near Dewey (RM 61.0). The largest tributary in the reach is the Wise River, which flows northward from the core of the Pioneer Mountains onto a large Holocene/Pleistocene fan that intersects the Big Hole River valley as a major topographic feature that is 1.8 miles wide at its mouth. As this fan pins the Big Hole to the north side of the valley, the Big Hole CMZ is confined and narrowed. The Wise River itself is incised into this fan, forming an inset stream corridor that is about 0.3 miles wide. Reach BH9 marks an increase in slope relative to upstream; this reach has almost triple the stream gradient than Reach BH11 above Mudd Creek (Figure 22).

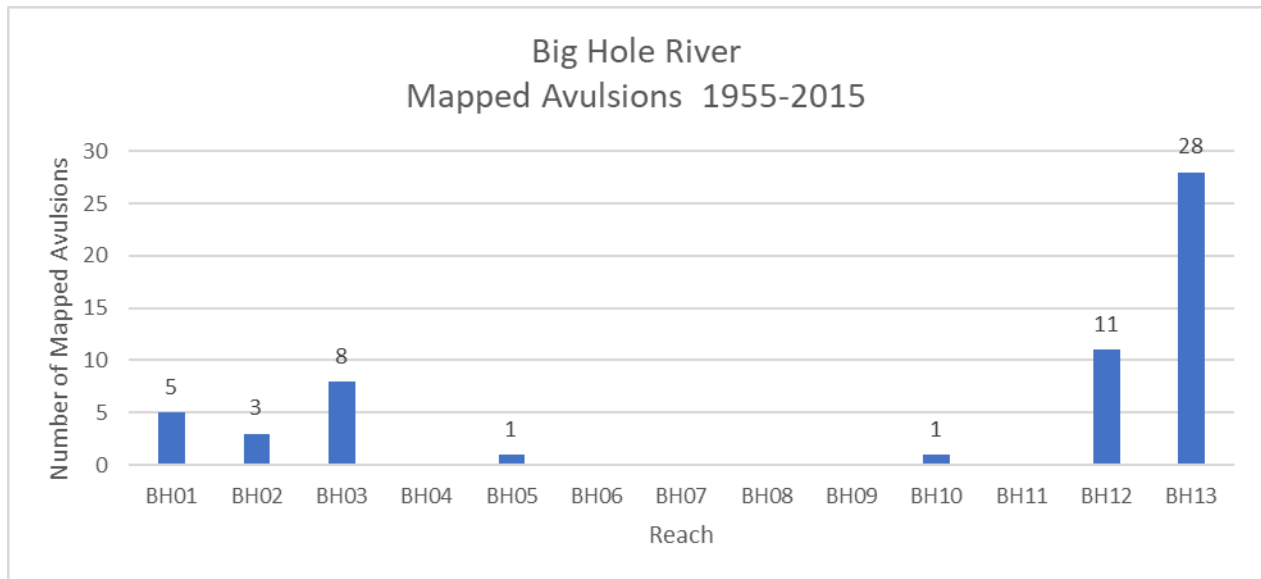
Figure 28. Number of avulsions mapped on Big Hole River between 1955 and 2015 by reach.

Relative to the other rivers of the Upper Missouri Watershed, the more dynamic reaches of the Big Hole River are highly prone to avulsions. A total of 57 avulsions were mapped on the Big Hole River between 1955 and 2015, with most concentrated above Pintler Creek and below Glen (Figure 28). When normalized by River Mile, Reach BH13 has the highest mapped spatial frequency of avulsions, with one occurrence per 3.2 miles of river (Figure 29 and Figure 30). The locations and patterns of historic avulsions were used to help identify where additional avulsions are most likely.

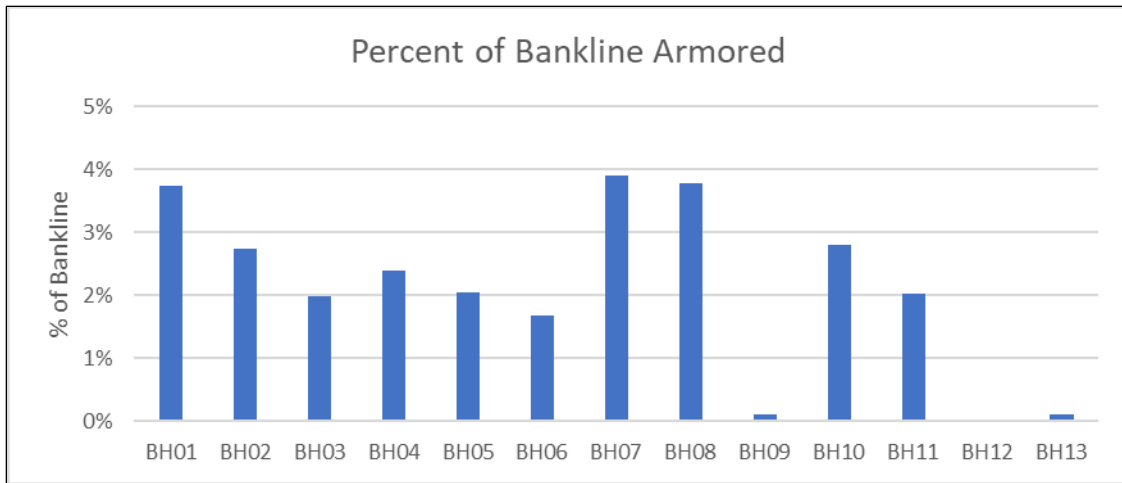
Figure 34. Percentage of bankline protected by armor by reach.

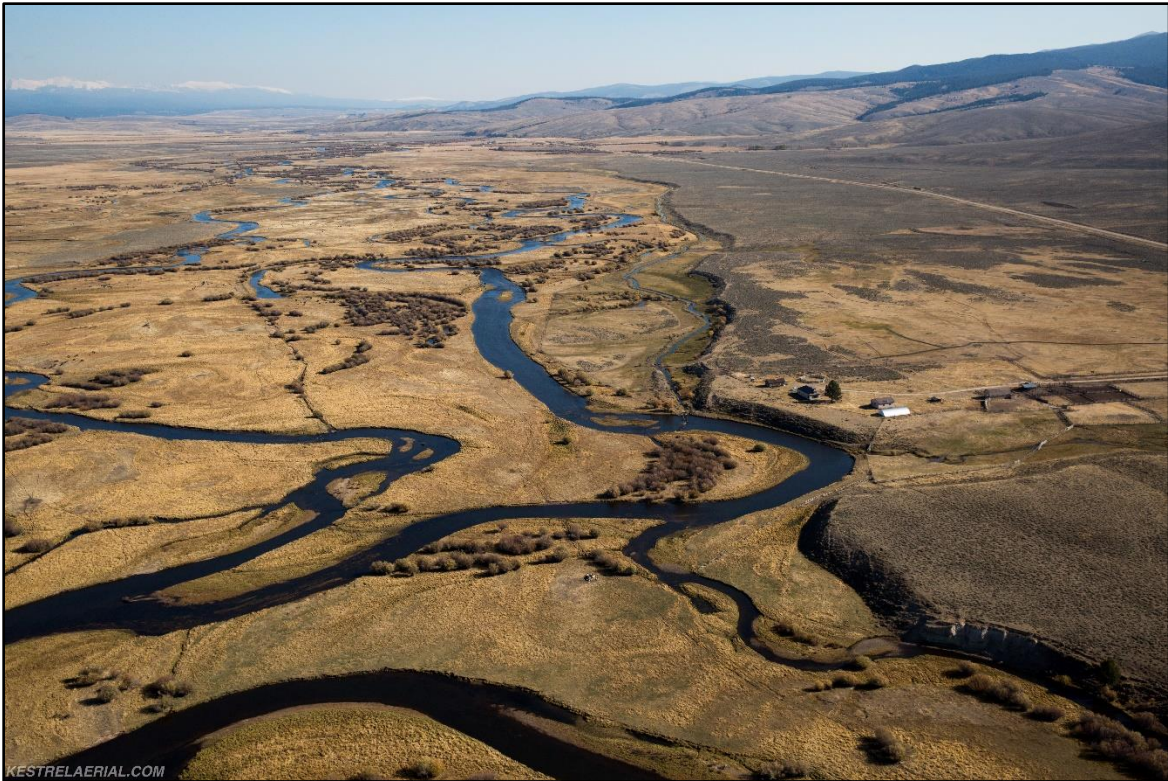
Figure 38. View of Reach BH13 showing broad floodplain with low willow density and persistent split flow; note discrete terrace surface to right. (Kestrel)

degraded riparian corridor (Figure 38). The broad floodplain coupled with a complex swale system creates a wide stream corridor footprint in Reach BH12; in several locations the CMZ is about a half-mile wide. The southern margin of the corridor is formed by a low terrace that has arcuate margins indicating historic erosion of its edges by the river and a long history of lateral channel movement. Although the CMZ in Reach BH12 is relatively wide, the mean measured migration rate is somewhat lower than Reach BH13 upstream, which is somewhat surprising considering the additional stream power contributed by the North Fork. There are areas in Reach BH12, however where saline soils appear to contribute to a relatively static planform and low migration rates. The low rates of migration are also likely due to the unusually low gradient in this reach (0.10%), which may be in part related to those saline soils (Figure 22). Although there are no Pleistocene-age lacustrine deposits mapped in the area, Alden (1953) describes exposures of older lake bed deposits in the area that may also affect the modern slope of the Big Hole Valley in reaches BH12 and BH11. With glacial moraines mapped on upper reaches of Fishtrap and Lamarche Creek, it is possible that the Big Hole Valley was intermittently dammed with glacial activity in this area.

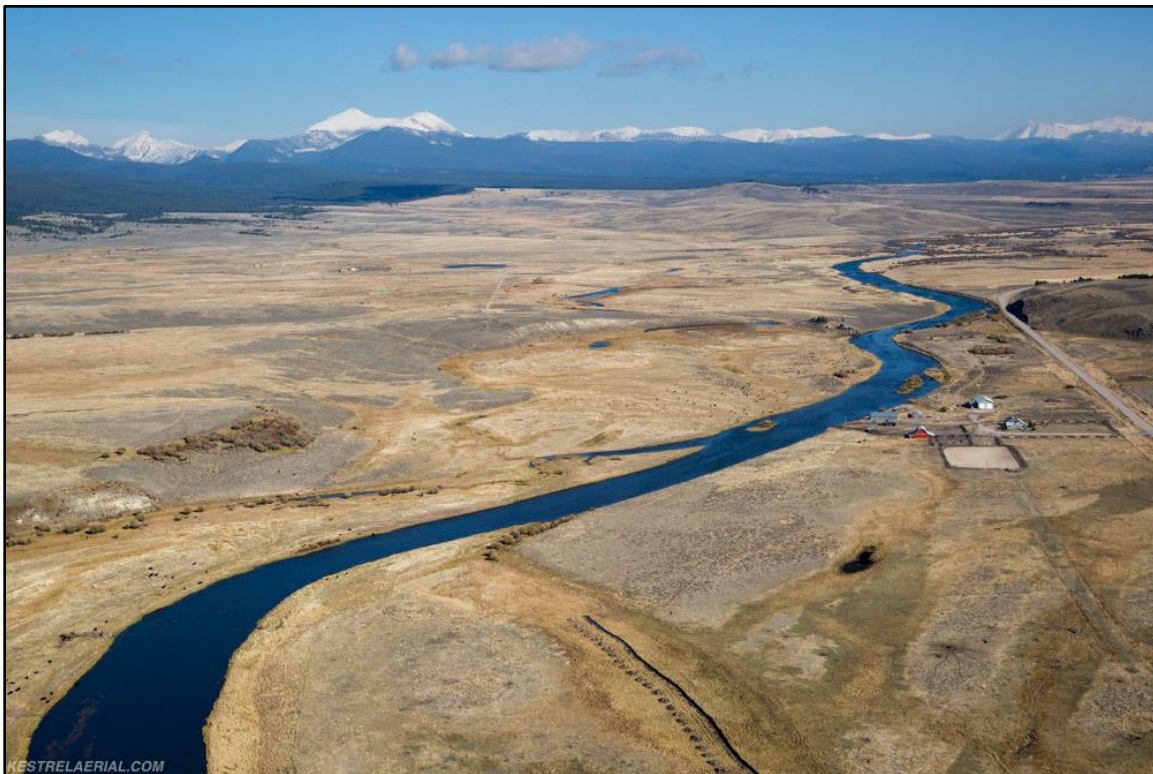
Figure 40. View downstream showing single thread channel in Reach BH11. (Kestrel)

At RM 93.2, outbuildings at a farmstead extend into the Erosion Hazard Area, although no active migration has been measured at the site (Figure 40).

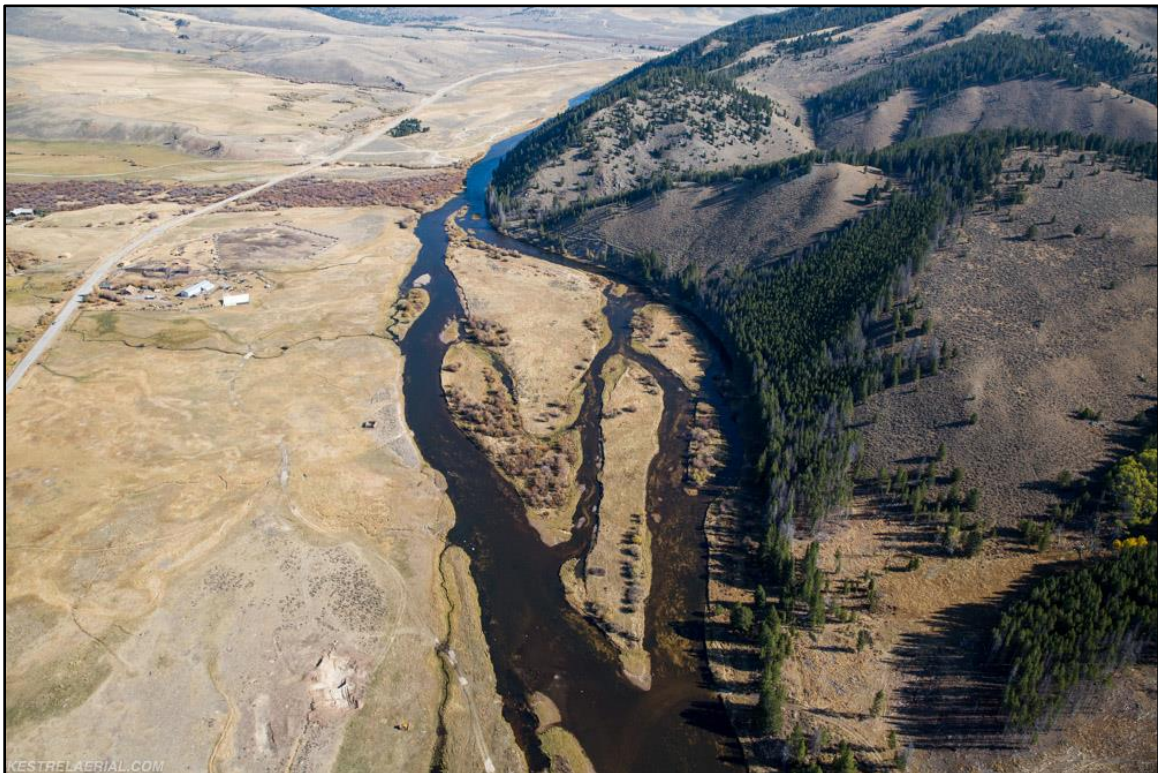
Figure 43. View downstream of Reach BH11 showing geomorphic diversity at islands. (Kestrel)

In general, Reach BH10 hosts a minimally deformable channel that is highly influenced by coarse sediment inputs from tributaries and valley walls. The greatest geomorphic diversity in the reach comes from island complexes that show a higher degree of reworking than the surrounding floodplain (Figure 43).

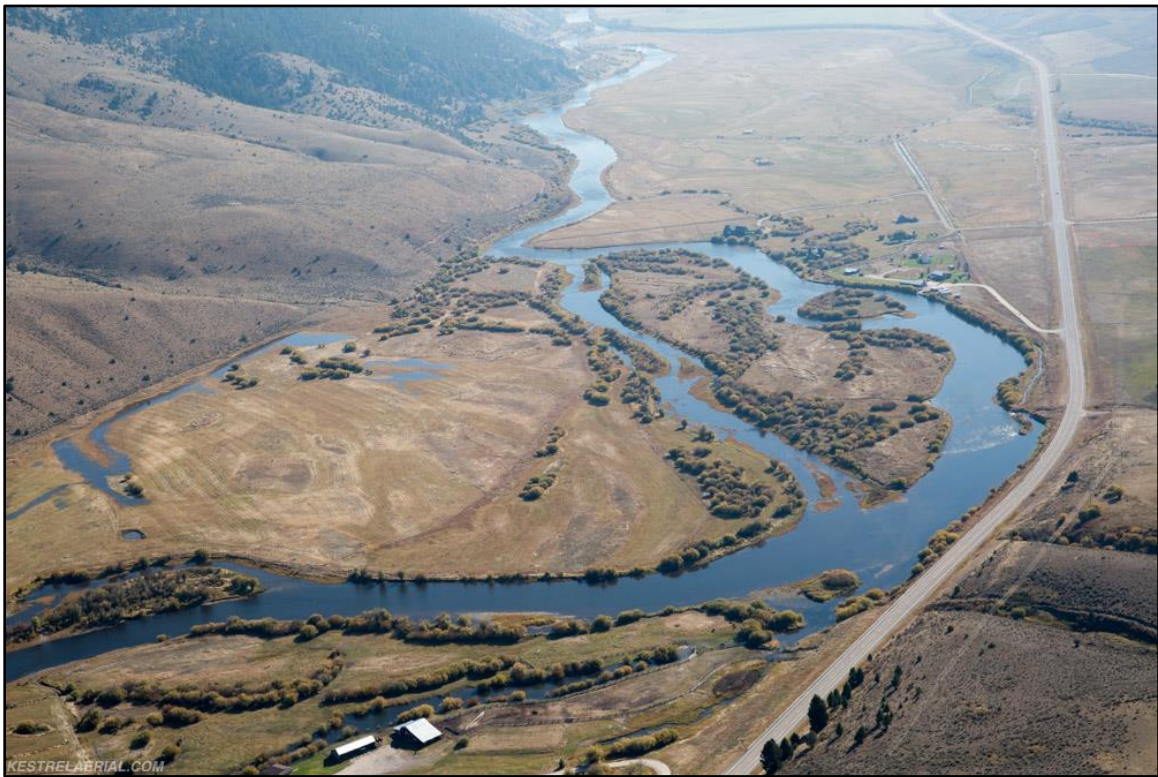
Figure 45. View downstream of Reach BH9 showing floodplain swales on left that form avulsion hazards. Wise River is just off photo in distance. (Kestrel)

Reach BH9 is an interesting section of river with respect to CMZ mapping, because although the mean migration rate is relatively low (0.6 ft/yr), there are complex floodplain features surfaces that show evidence of fluvial scour and potential channel occupation (Figure 45). As a result, Reach BH9 has numerous mapped Avulsion Hazard Areas as well as overflow paths. The Avulsion Hazard Areas were mapped where available data indicate continuous low swales that show evidence of a high level of fluvial connectivity, such as linear wetlands. Overflow paths were added to show other areas where historic swales are mappable such that they appear to provide continuous flow paths, however their level of connectivity is more uncertain.

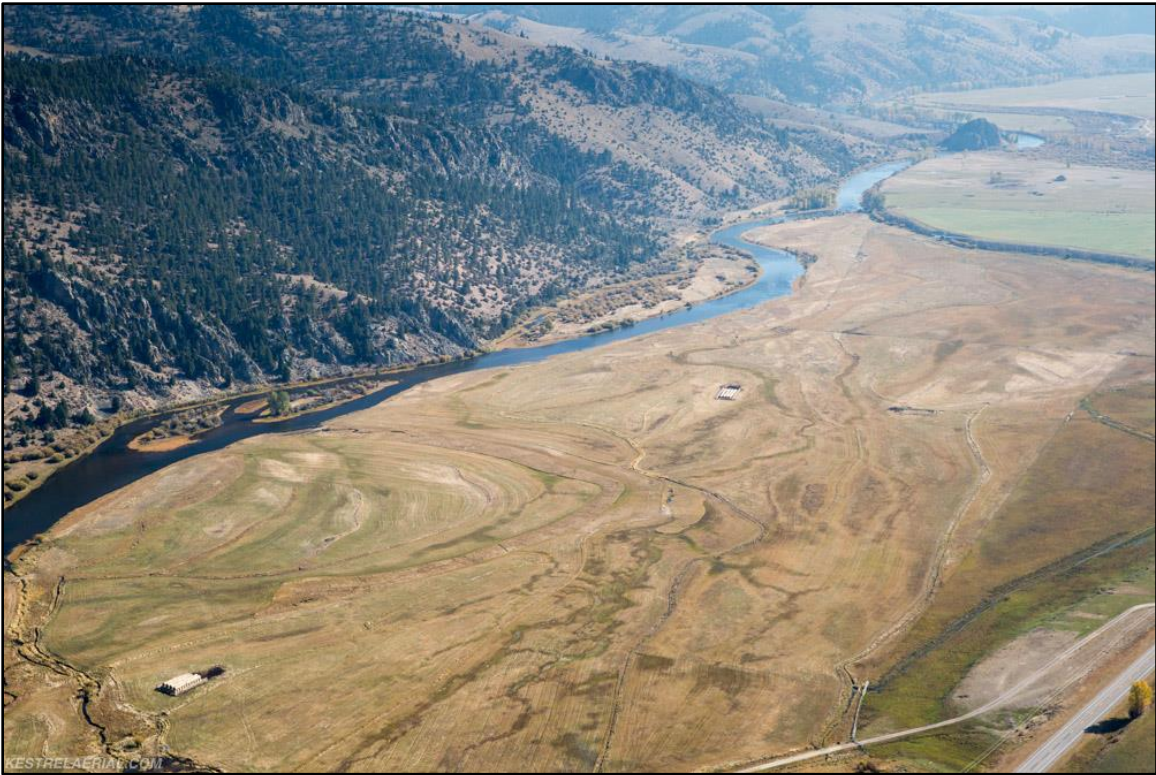
Figure 46. View downstream of Reach BH9 showing overflow paths on 100-year floodplain, RM 65.0. (Kestrel)

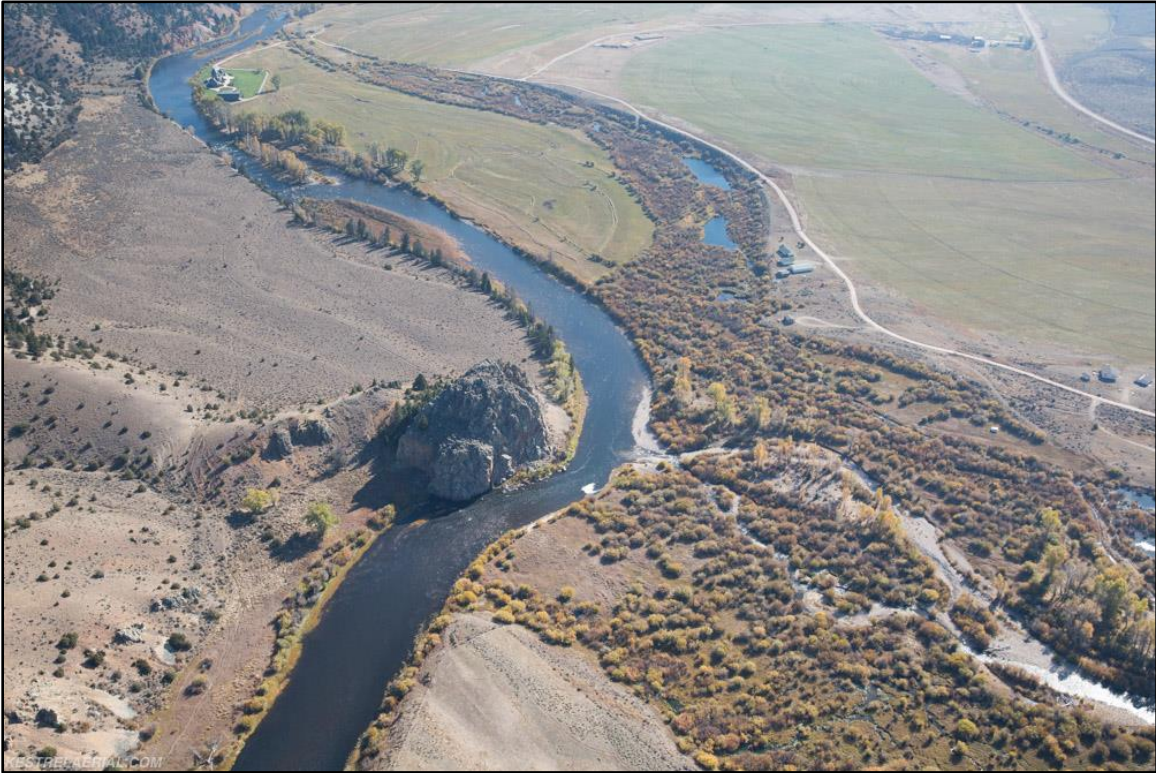
Figure 47. View downstream of Reach BH9 past mouth of Wise River showing avulsion path that extends behind residence. (Kestrel)

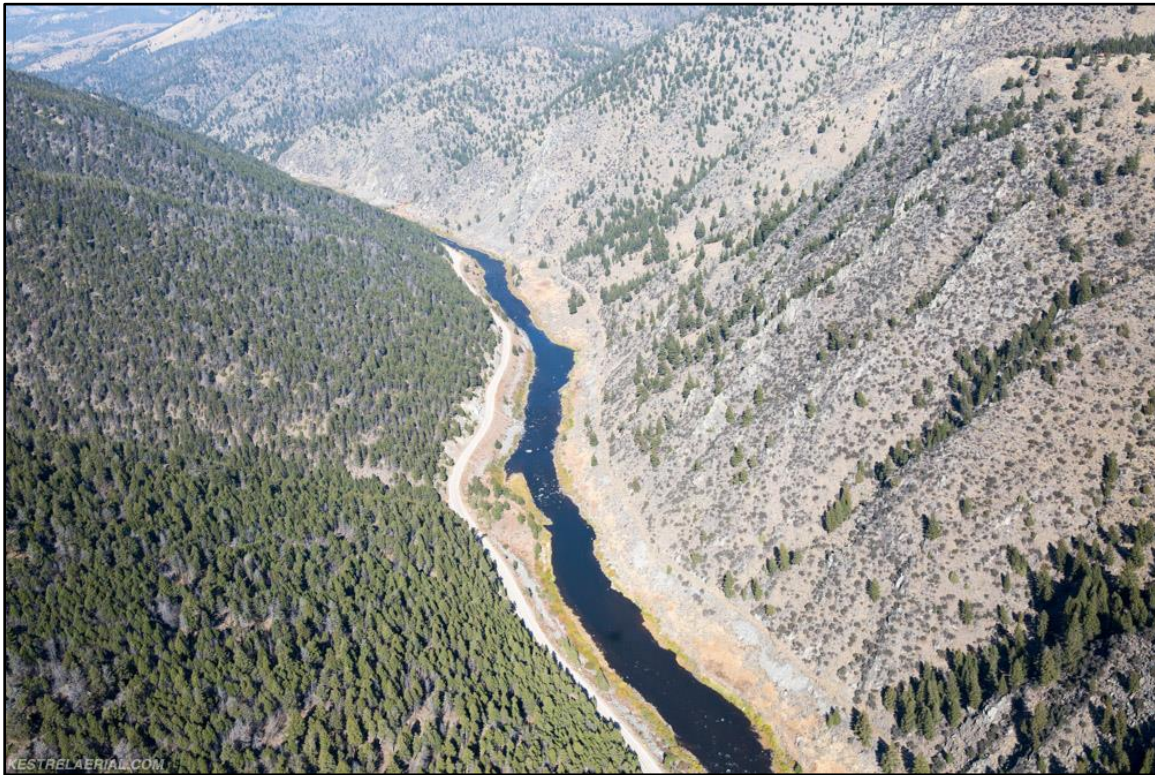
Figure 48. View upstream of Reach BH8 showing narrow canyon segment. (Kestrel)

Approximately ½ mile downstream of Dewey, the Big Hole River flows into a granitic canyon that is four miles long. The canyon is steep walled, and Highway 43 follows the south valley wall (Figure 48). Although a mean migration rate of 1.2 feet per year was developed for the reach, this rate is based on only seven measurements

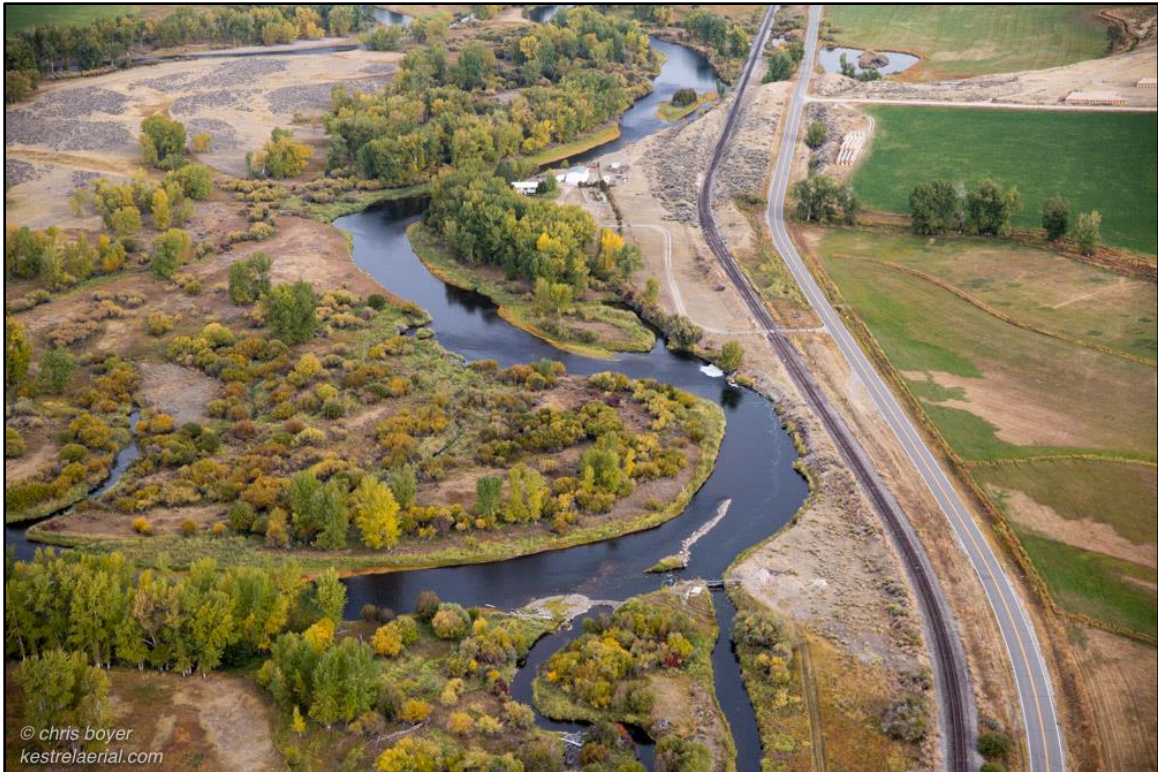
Figure 53. View upstream showing channel migration towards the railroad grade near Melrose, RM 37.3.

The rail line follows parallel to the stream corridor, bisecting the ancestral river valley and forming an artificial margin on the east side of the CMZ. At several locations in Reach BH5, the river has migrated into the transportation embankment; at RM 37.3, for example, the riverbank is less than 30 feet from the railroad tracks (Figure 53).

Reach BH5 has seen substantial river corridor development, some of which has been on islands. Large islands at Meriwether Ranch (RM 40.5), and near Melrose (RM 38.5) have bridge access to residences (Figure 54). All of these structures are within the Big Hole River Channel Migration Zone. Numerous other structures adjacent to the river are within the CMZ as well, most of which are in the 155-ft wide Erosion Hazard Area. An example structure in the Erosion Hazard Area (EHA) can be seen in Figure 53.

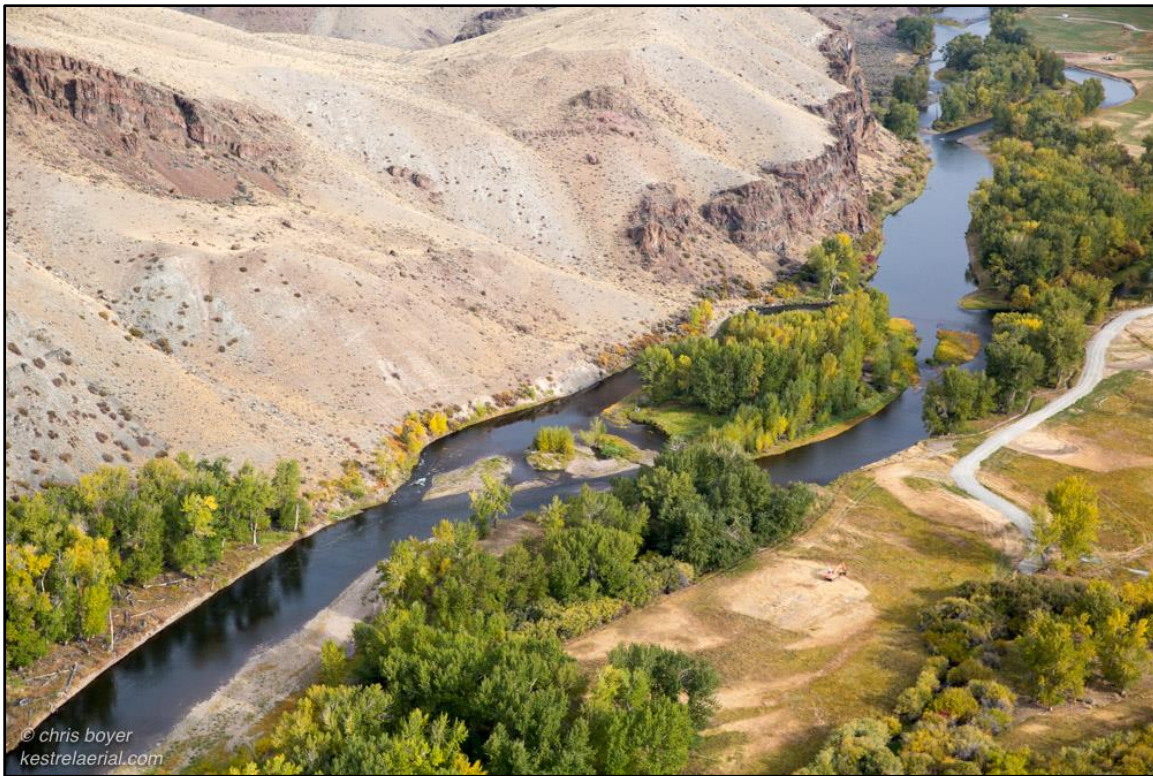
Figure 55. View upstream of Reach BH4 showing volcanic bluffline on western edge of CMZ and cottonwood succession on enlarging island in center of photo. (Kestrel)

Migration rates are relatively high in this reach with a mean rate of 2.0 feet per year and a 100-year buffer width of 201 feet. In several locations the river is flowing along a bedrock bluff on the west side of the valley, and that bluffline has been clipped from the CMZ (Figure 55). Most of the migration in the reach has been eastward away from the bluffline and at RM 33.0, the river has eroded to within 200 feet of the railroad tracks. Much of the left bank in Reach BH4 has been armored where it approaches the railroad (Figure 56). Channel migration in Reach BH4, although laterally constrained, has been active enough to promote cottonwood succession on channel margins and islands, with recent deposits supporting young age classes relative to older geomorphic features (Figure 55).

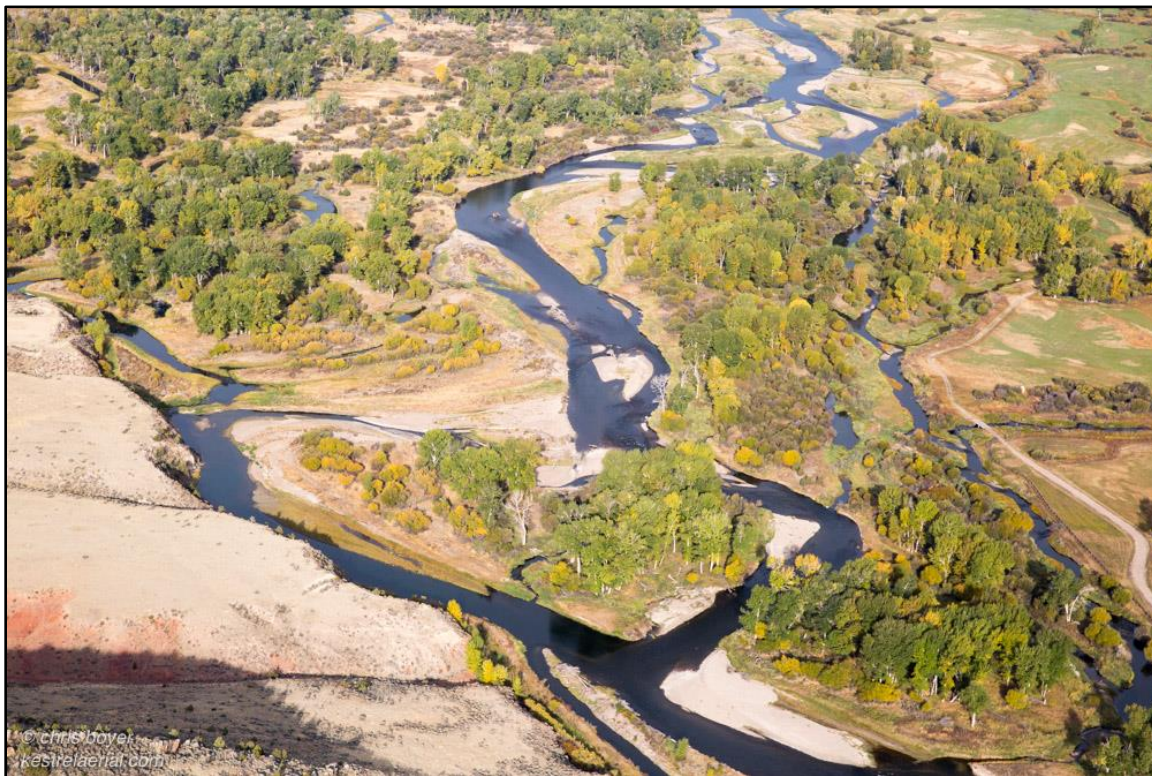
Figure 57. View upstream of Reach BH3 showing anabranching channel form. (Kestrel)

Area buffer width is 277 feet. Within this reach the Big Hole River takes on an anabranching form, meaning it supports multiple active channel threads that are separated by forested islands (Figure 57). One of the most recently dynamic sections is at Glen, where the river is progressively abandoning a historic meander near town that cut off prior to 1979 when the river avulsed (Figure 58 and Figure 59). Six avulsions occurred in the reach between 1955 and 2015, and in the lower end of the reach just above Notch Bottom, the CMZ is almost a mile wide.

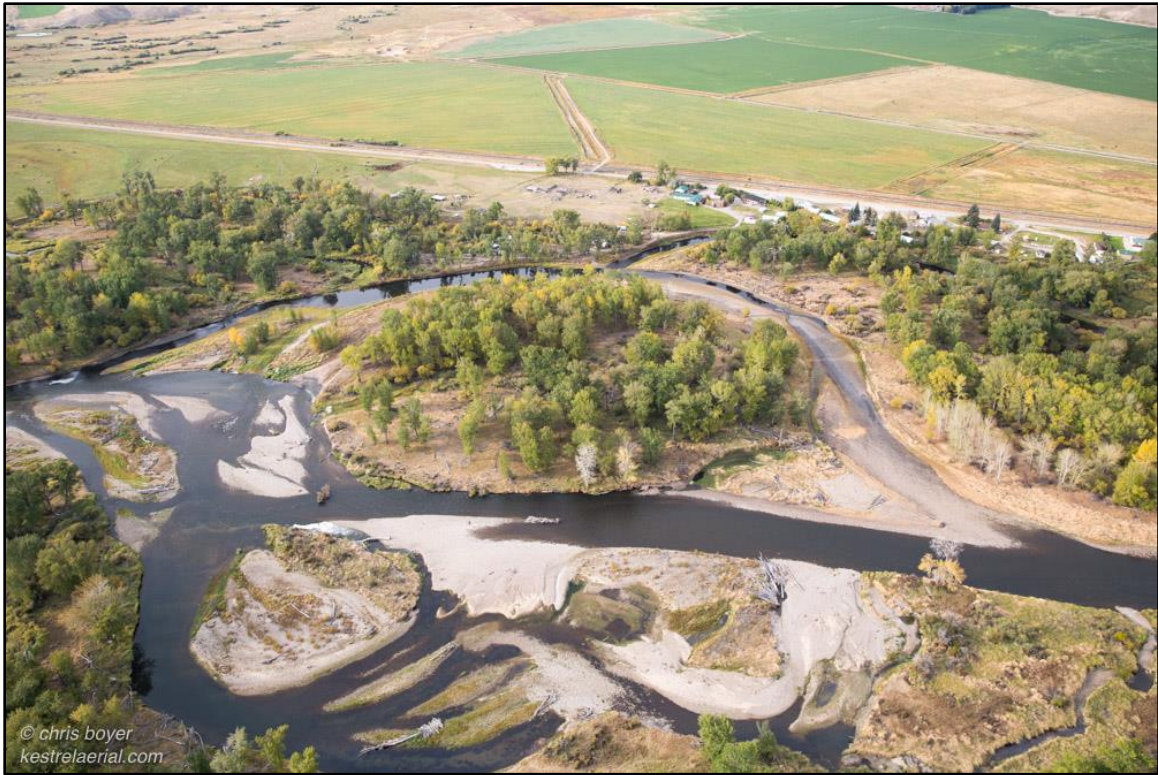
Figure 59. View west of Reach BH3 towards Glen showing avulsed channel in foreground. (Kestrel)

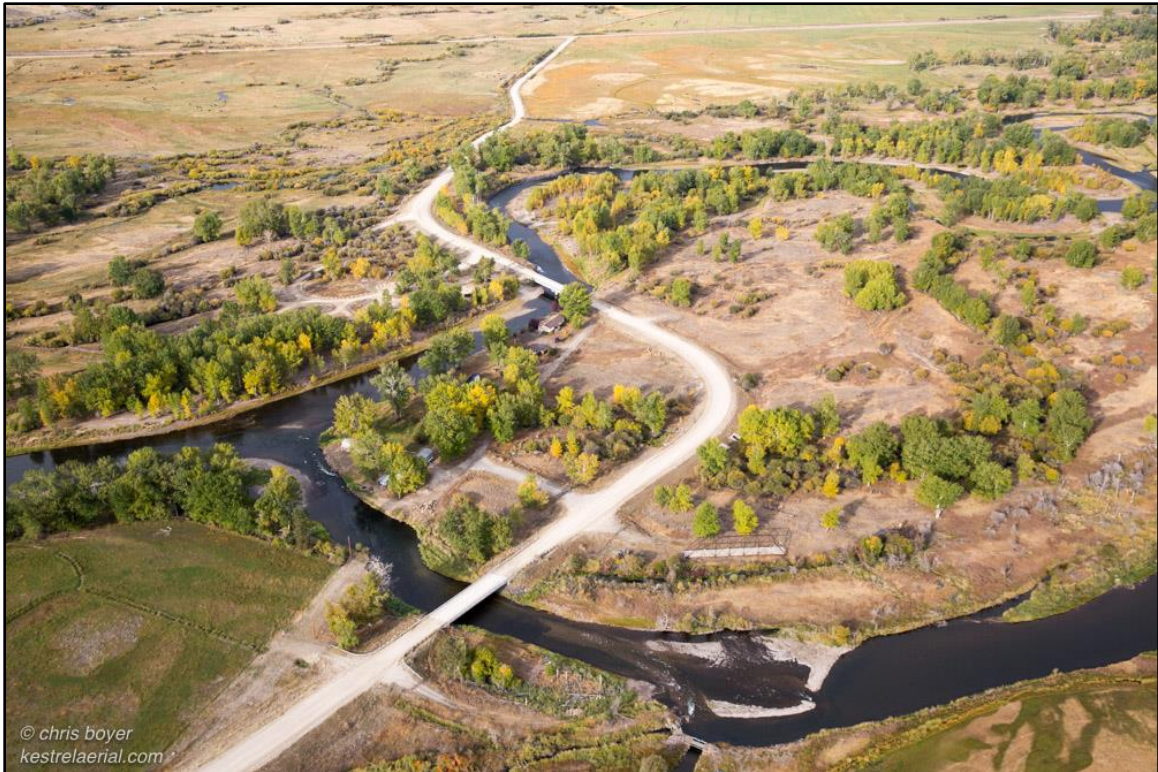
Figure 61. View west showing two Burma Road Bridges; far bridge approach angle has decayed with time and road is increasingly threatened. (Kestrel)

Burma Road crosses the Big Hole River at RM 24.8, and as it crosses an island, the road requires two bridges (Figure 60 and Figure 61). Although the east bridge has had a relatively stable planform and channel approach angle to the bridge structure since the 1950s, the west bridge has experienced over 200 feet of migration that has progressively impacted the approach angle, creating a “dogleg” pattern of approach that will eventually

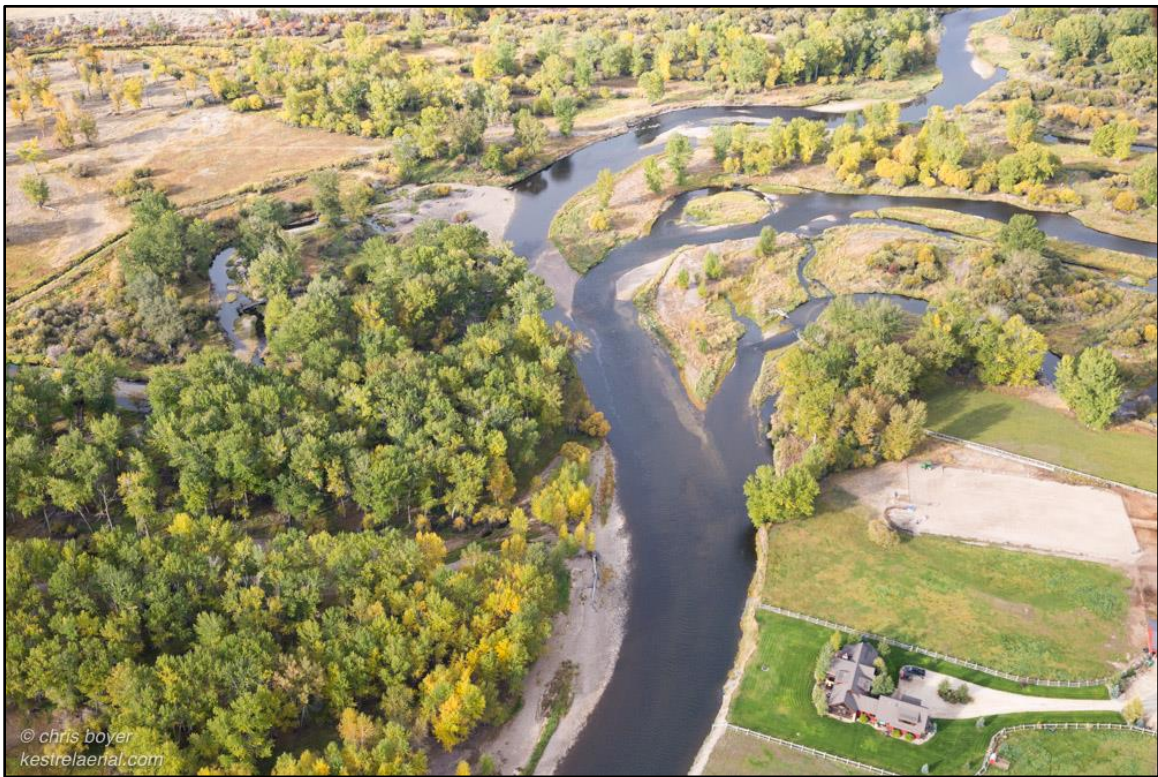
Figure 62. View upstream showing river corridor development, Reach BH3. (Kestrel)

require substantial maintenance to protect the integrity of both the road and the bridge. In addition to bridges, Reach BH3 supports some residential development within the Channel Migration Zone (Figure 62). Most of the armor mapped in Reach BH3 is protecting residential structures, many of which have little to no riparian buffer on adjacent streambanks.
