Big Hole River Channel Migration Mapping

Abstract

This report contains the results of a Channel Migration Zone (CMZ) mapping effort for approximately 111 miles of the Big Hole River from the town of Wisdom in the Big Hole Valley to its confluence with the Beaverhead River at Twin Bridges, Montana. This is a part of a larger effort to map approximately 425 miles of rivers in the Missouri River Headwaters watershed.

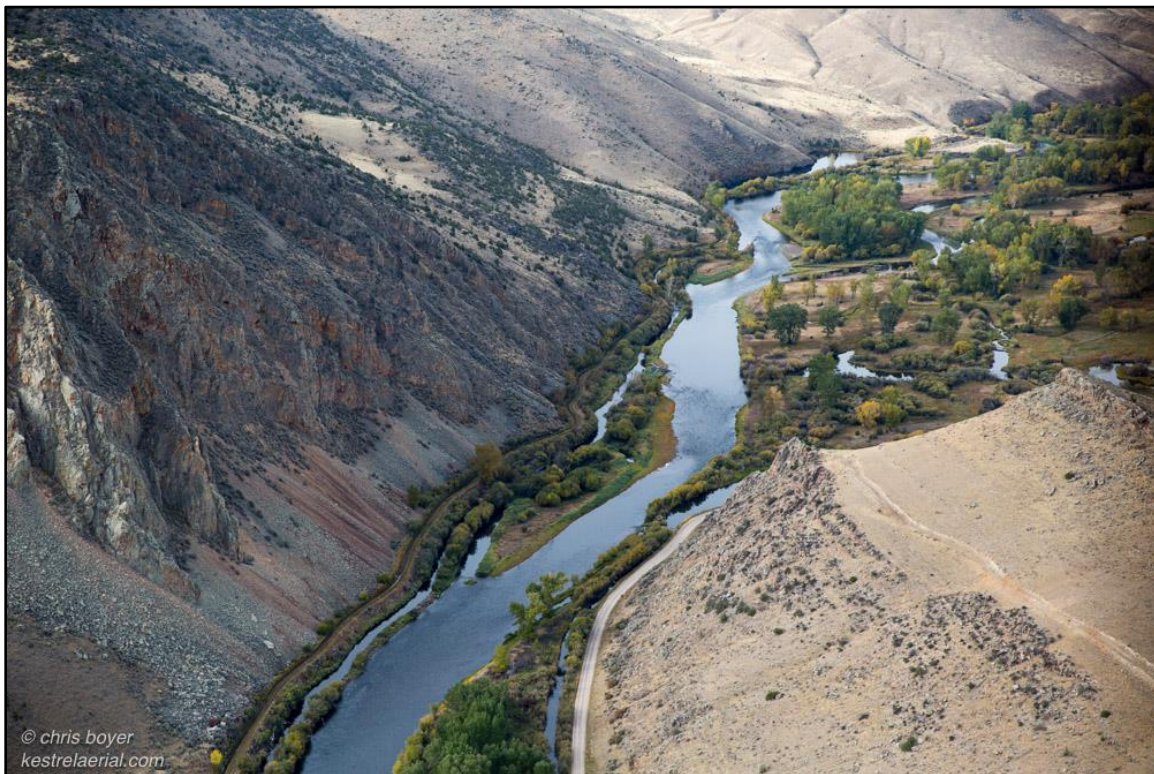
Figure 63. View upstream showing entrance to Reach BH2, with dark quartzite constriction at Notch Bottom. (Kestrel)

Reach BH2 extends from Notch Bottom 7.6 miles downstream. Notch Bottom is also known as “The Hogback”, which is a “conspicuous dark ridge that extends several miles south from McCartney Mountain (Alt and Hyndman, 1986). The Hogback is a tight anticlinal fold formed in quartzite that creates a north-south trending ridge that crosses the Big Hole River at RM 18.0 (Figure 63). The Hogback creates a narrow corridor constriction that marks a distinct reach break. For several miles downstream of Notch Bottom, the width of the river valley hourglasses into narrow constrictions two more times, once at RM 15.0 and again at RM 10.5 (Figure 64). These constrictions create similar geologic controls on valley form and, although less severely confining than the Hogback, still affect channel dynamics and the form of the CMZ. Between these constrictions, the river valley widens out and migration rates increase along with overall geomorphic complexity Figure 65.

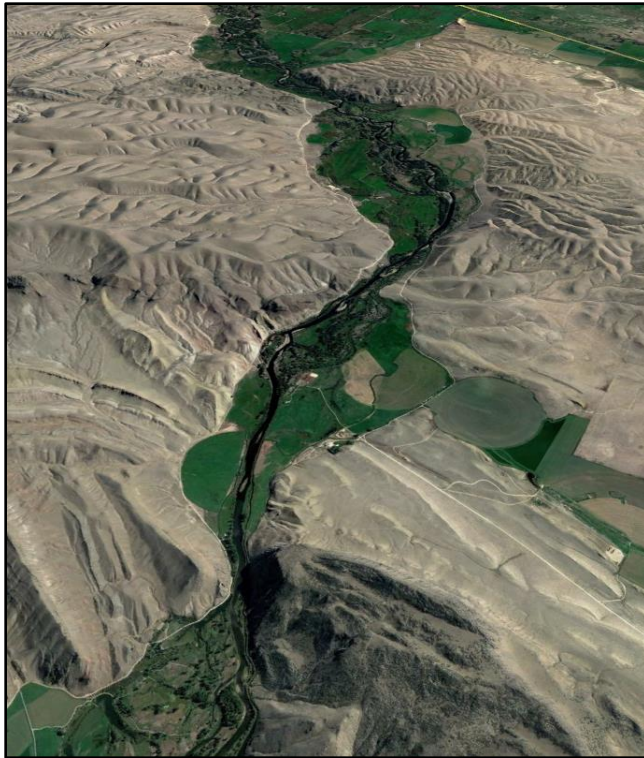
Figure 64. View downstream of Reach BH2 showing three geologic constrictions; Notch Bottom is in foreground (Google Earth).

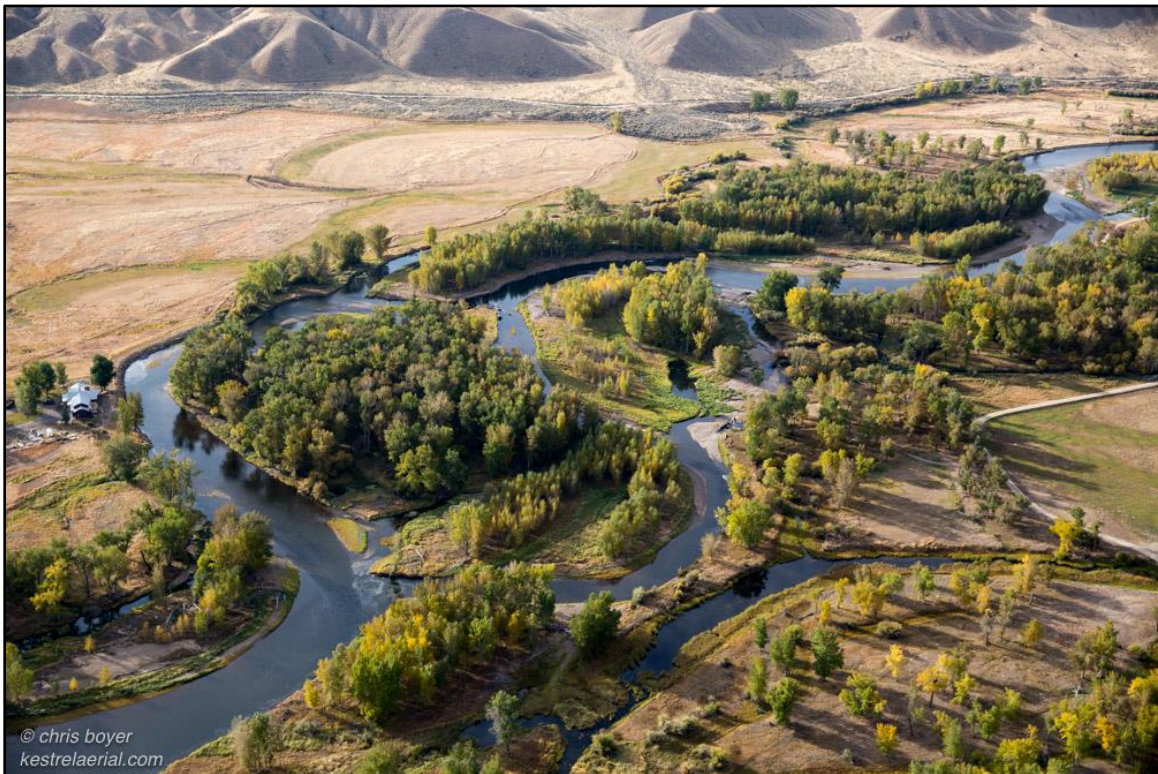
Figure 65. View upstream of Reach BH2 showing geomorphic complexity at RM 13.5.

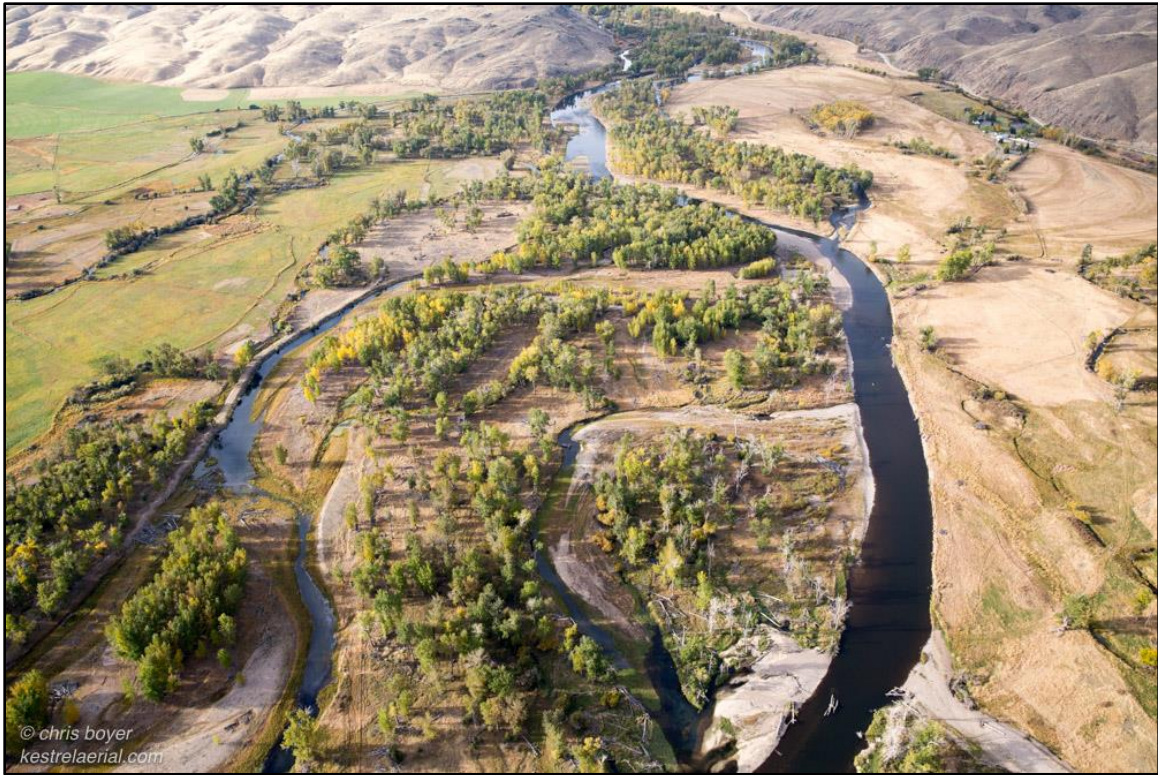
Figure 66. View upstream of avulsion site in Reach BH1; the decaying 1979 channel is to left.

Reach BH1 has one of the largest avulsions identified in the project reach; just above Pennington Bridge the river flanked left bank armor at RM 9.6 and subsequently carved a new channel several hundred feet to the west of its 1979 location (Figure 66 and Figure 67). The upper mile of the avulsion is entirely new channel and the lower 0.6 miles is a captured side channel. The avulsion has been followed by progressive abandonment of the 1979 channel and progressive morphologic evolution of the new thread. This evolution is evident in the 2011 imagery; high flows that year caused expansive flooding along the avulsion route due to the lack of floodwater capacity in the new channel at that time (Figure 68).

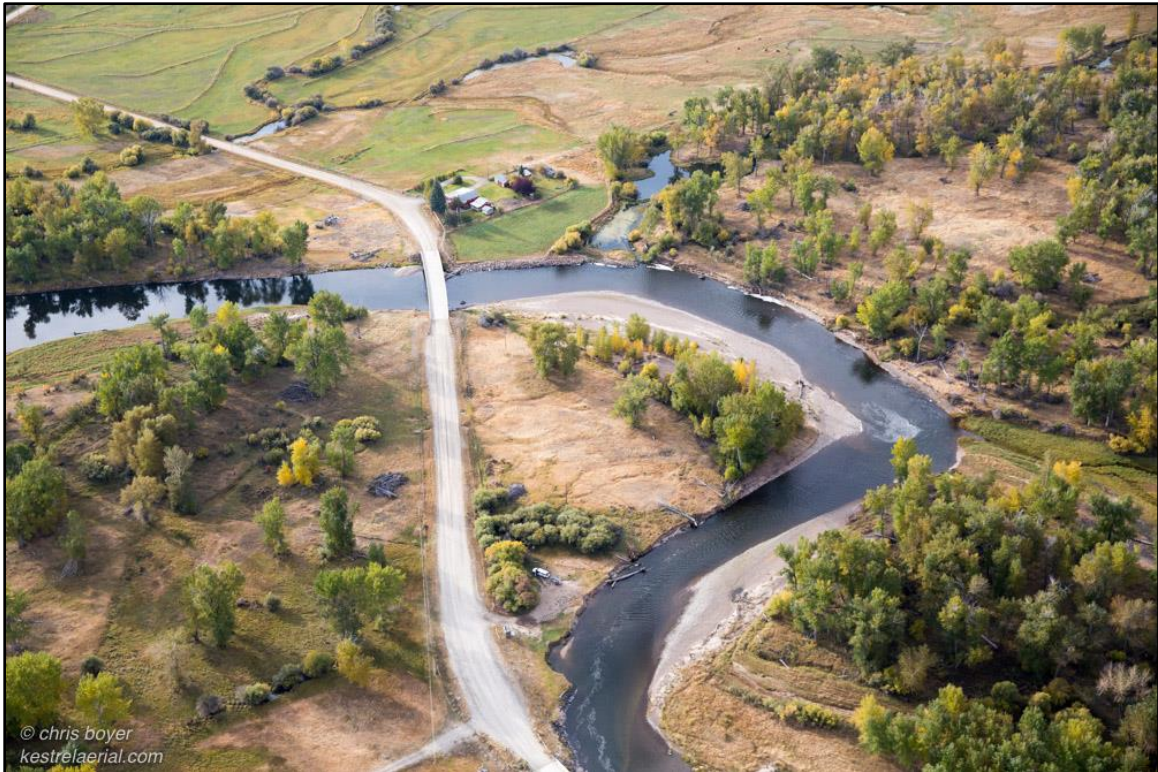
Figure 70. View west of main channel at Pennington Bridge; flow direction is to the left.

Pennington Bridge is similar to the Burma Road bridge in that it consists of two bridge spans over an island. This site has caused concern with regard to channel migration due to active erosion and poor channel alignments towards the bridge (Figure 69 and Figure 70).

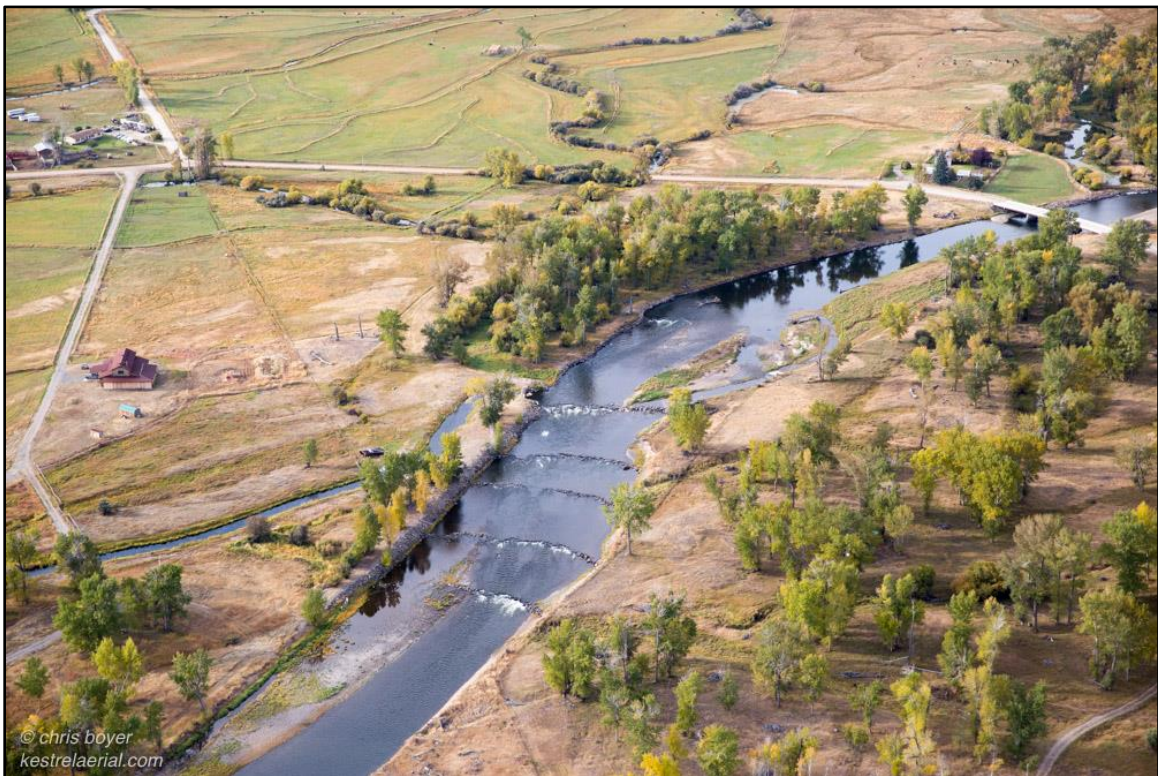
Figure 71. View upstream of rock grade controls at diversion structure just below Pennington Bridge.

In several locations on the river, constant changes in river conditions have created challenges in maintaining access to water at irrigation diversions. These challenges are commonly caused by a change in river location, as lateral channel movement can completely abandon a diversion structure. On the Big Hole River, however, diversion structures appear to be well-placed with respect to lateral channel movement, such that they remain functional with minimal intervention. However, it is also important to note that the dynamics of channel migration cause vertical changes in bed elevation. The bed profile of the lower Big Hole River is in constant flux with continual change in channel length through both migration and avulsion. Figure 71 shows an example of a series of grade controls designed to maintain bed elevations at a diversion just below Pennington Bridge.

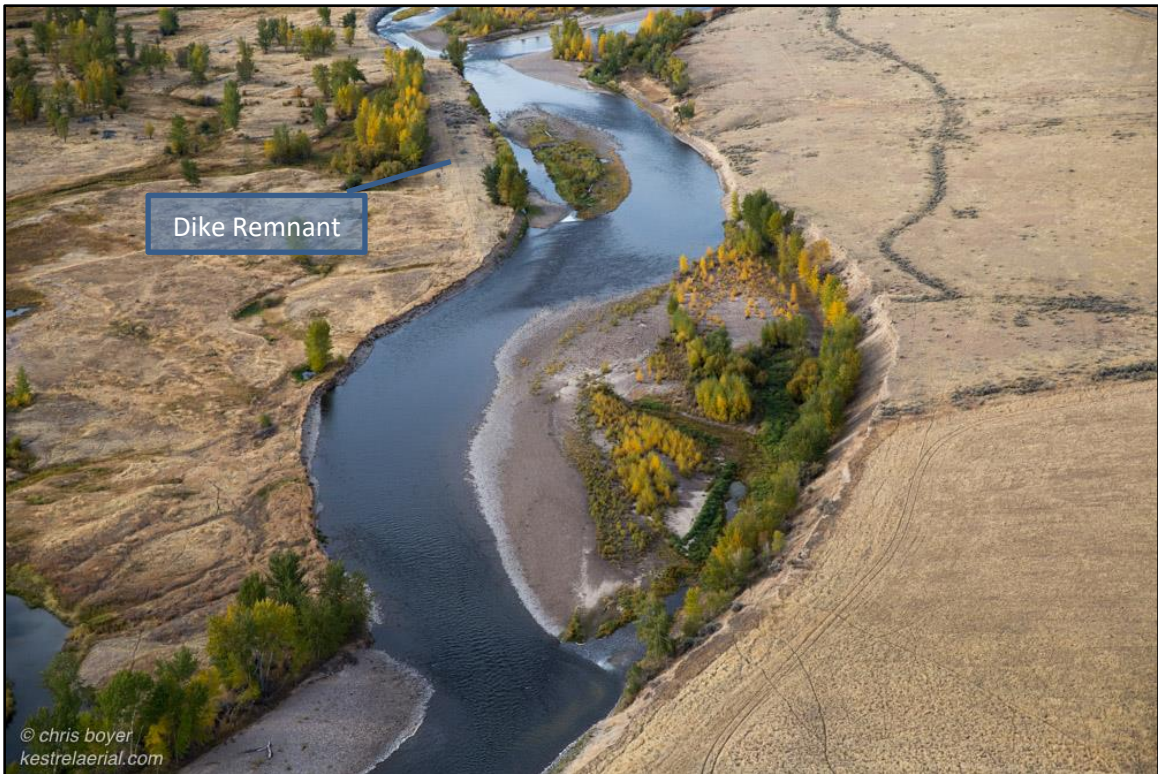
Figure 72. View upstream of high left bank terrace above High Bridge; note breached dike remnant on right bank.

Further downstream near High Bridge the river flows against a high terrace of outwash gravels (Figure 72). Although this unit appears to mark the boundary of the CMZ, it is clearly erodible as evidenced by arcuate erosional scars in the terrace margin. At one location at RM 2.6 which is about 0.7 miles upstream of the High Bridge, the river eroded out an 80-ft wide section of the high terrace that protruded into the stream corridor in 1955. This high terrace erosion highlights the fact that high surfaces that are well above the floodplain are not necessarily immune to river erosion.

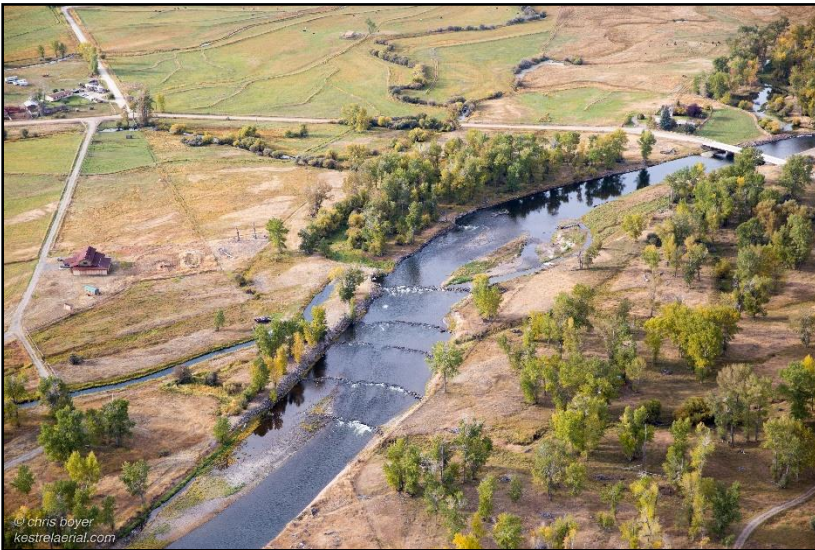
Figure 74. Grade control, September 30, 2017 (Kestrel).

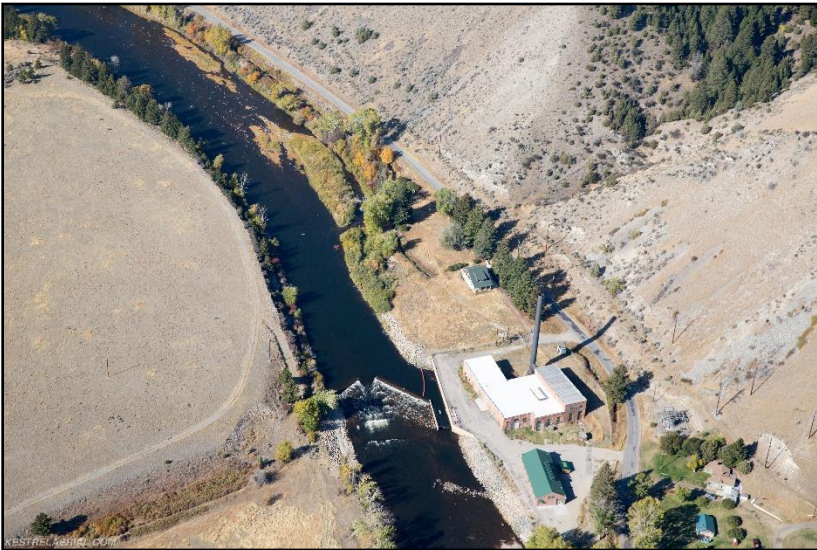
Figure 86. Pump house diversion, October 6, 2017 (Kestrel).
