Final Report
January 25, 2016

Deep Creek Channel Migration Zone Mapping

Prepared for:

Broadwater Conservation District
415 South Front street
Townsend, MT 59644

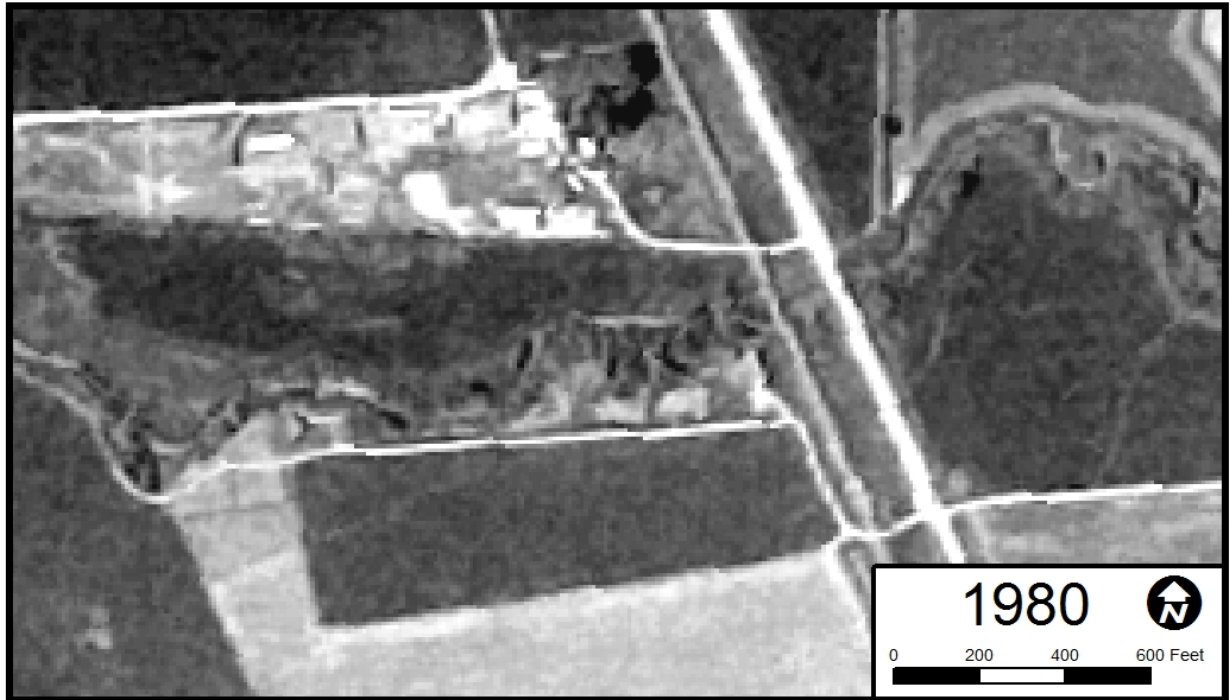
Figure 2-2. Example 1980 imagery, Deep Creek CMZ development (Hwy 287, Reach 1-2 boundary).

Table 1 lists imagery used for this project from the USGS and archives of current GIS data sets. The rows in green are the image sets primarily used in the analysis. Examples of the imagery used in the analysis are shown in Figure 2-1 through Figure 2-4.

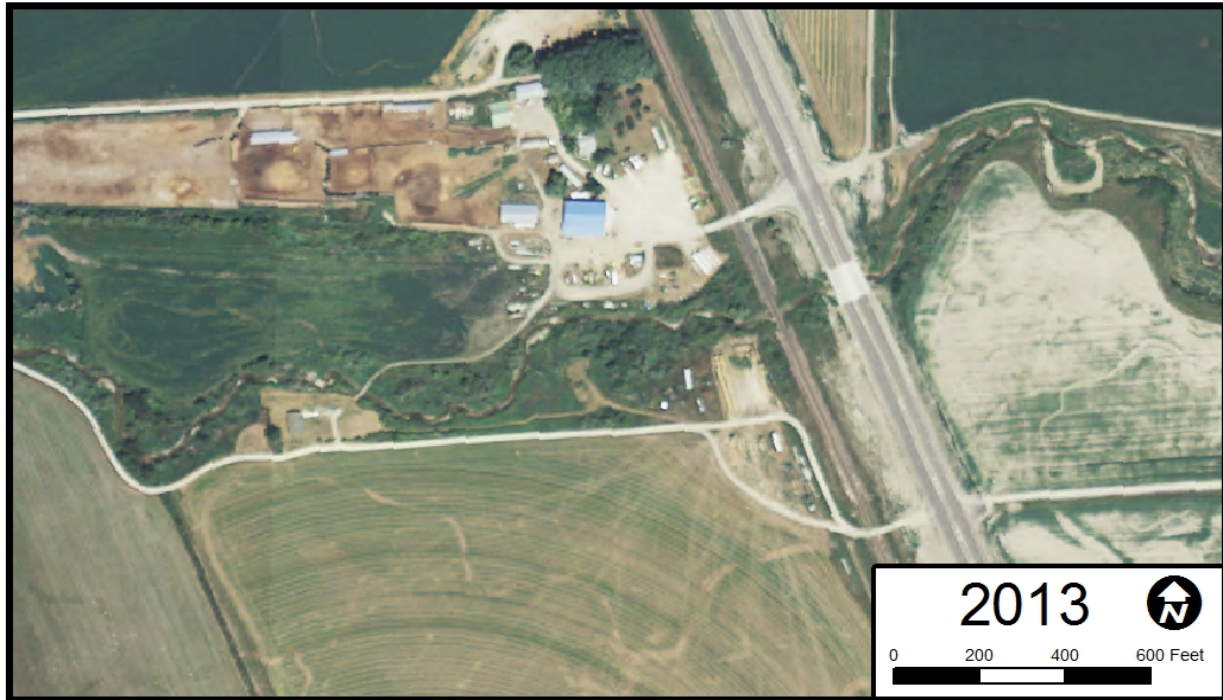
Figure 2-4. Example 2013 imagery, Deep Creek CMZ development (Hwy 287, Reach 1-2 boundary).

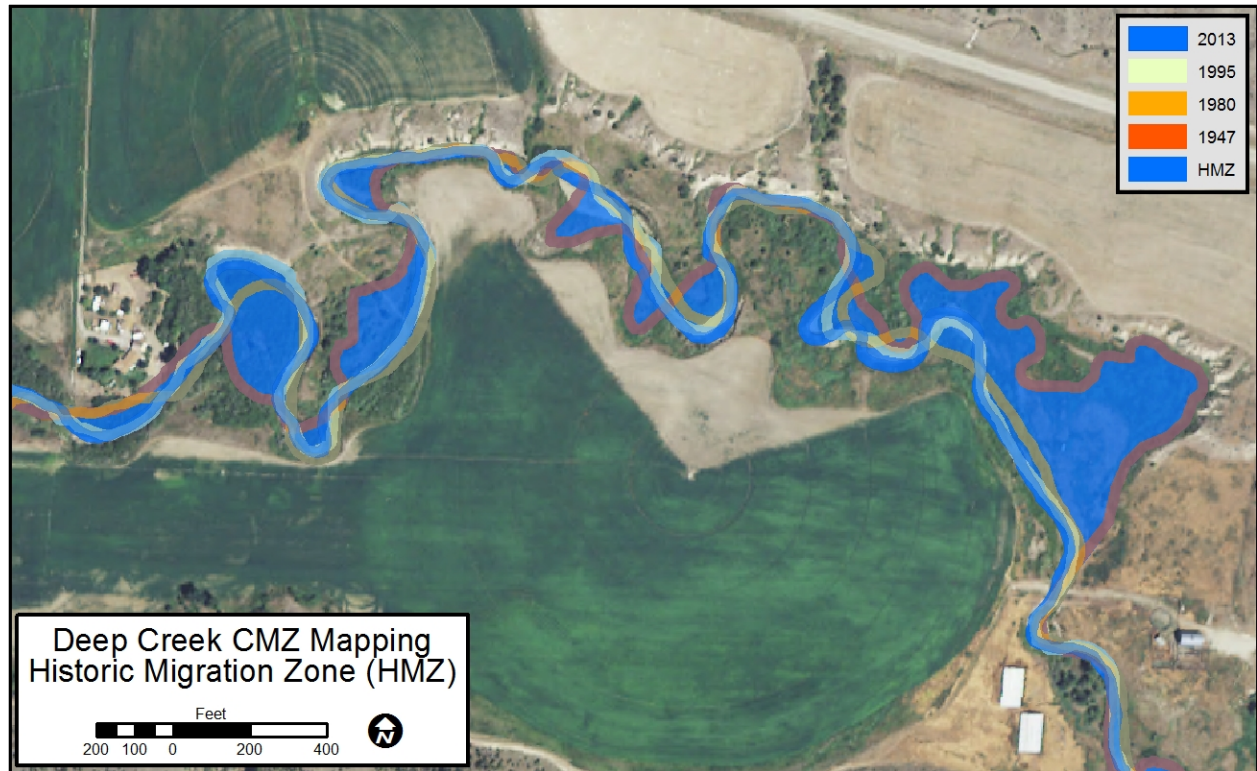
Figure 2-7. Example of mapped channel courses and composite Historic Migration Zone (HMZ).

The Historic Migration Zone is the overall footprint that the creek occupied in 1947, 1980, 1995, and 2013 (Figure 2-7). The method for delineating the HMZ is to overlay the digitized polygons for the channel for each time series, and union those polygons into a single HMZ polygon. All islands are included with the merged HMZ polygon.

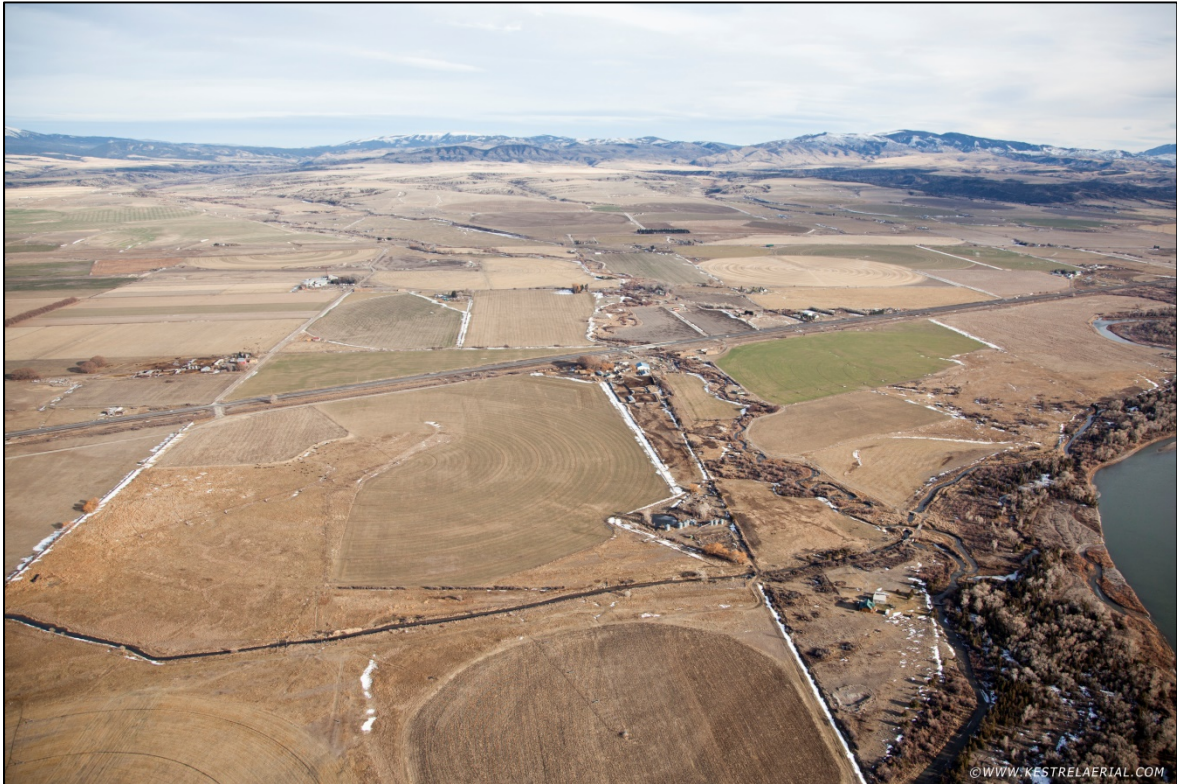
Figure 4-1. View east showing lower reaches of Deep Creek in foreground (Kestrel Aerial Services).

Reach 1 is located in lowermost Deep Creek, where it parallels the Missouri River between the river and Montana Ditch (Figure 4-1 and Figure 4-2). Bank migration rates are low in this reach and the CMZ is narrow as a result. The Erosion Hazard Area buffer in Reach 1 is 57 feet wide. Reach 1 appears to have been channelized sometime prior to 1947 and the creek has remained essentially straight for at least 66 years. LiDAR data suggest that the lowermost half mile of Deep Creek is an historic side channel of the Missouri River. The Management Corridor closely follows the edge of the CMZ. Inundation modeling was not available for Reach 1.

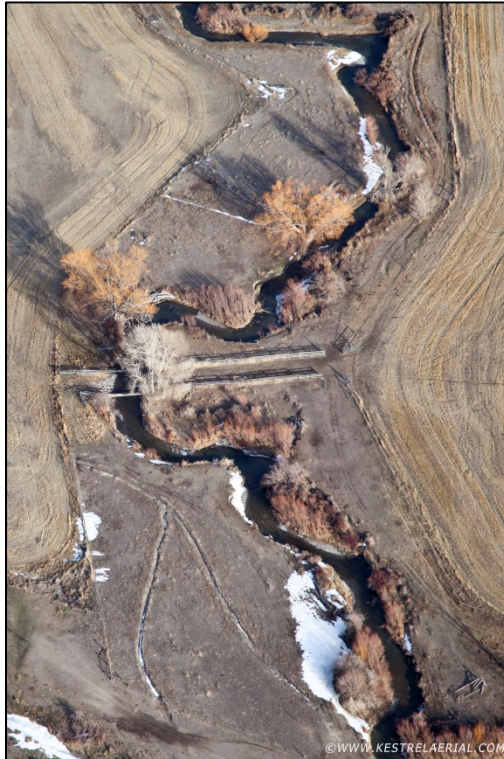
Figure 4-6. View upstream at RM 3.5 showing agricultural fields adjacent to the Deep Creek corridor; the management corridor is about 200-250 feet wide in this area and closely follows the field edges (Kestrel Aerial Services).

Reach 4 is bordered by extensive irrigated lands, with multiple pivots reaching to the edge of the stream corridor. The CMZ is relatively narrow in this reach, with an EHA buffer width of 83 feet (Figure 4-5). The proposed Management Corridor tends to closely follow the field margins through much of Reach 4 (Figure 4-6); however in some areas such as at RM 4.4, development extends into the active stream corridor (Figure 4-7). In the lower portion of the reach, around RM 3.0, the Management Corridor excludes part of the Historic Migration Zone, where the 1947 channel was channelized and the historic channel area developed for irrigation on the north side of the creek (Figure 4-5 and Figure 4-8).

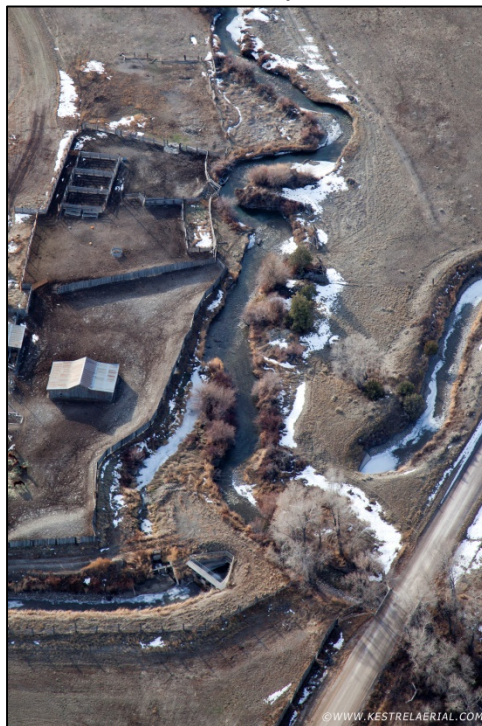
Figure 4-7. View downstream of uppermost portion of Reach 4 (RM 4.4) showing encroachment of corrals into the stream corridor; about one half of the corral area is within the proposed management corridor boundary.

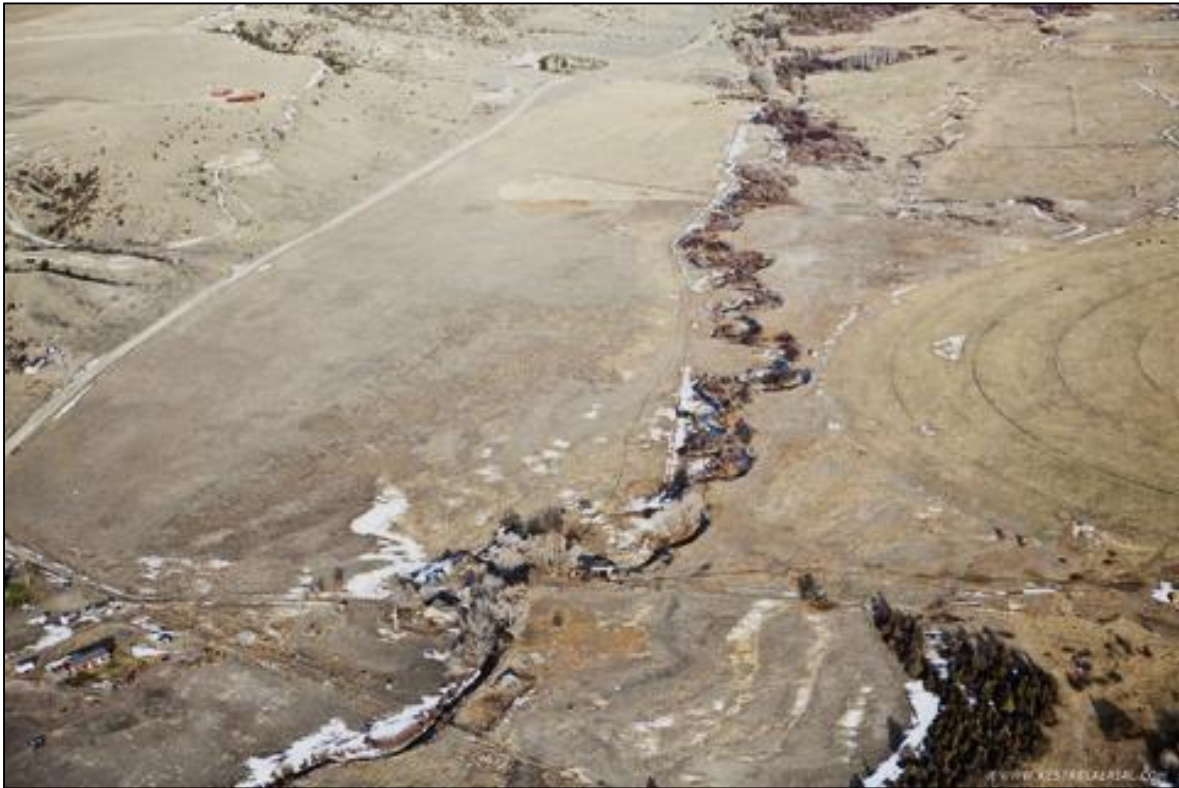
Figure 4-12. View upstream of Reach 6 showing narrow stream corridor with floodplain channels dissecting pivot ground in upper right portion of photo.

Reach 6 is about 1.3 miles long, and similar to other reaches in lower Deep Creek, it is a narrow stream corridor with substantial riparian clearing and pivot irrigation development on the floodplain (Figure 4-12 and Figure 4-13). Similar to Reach 5 downstream, there are relic channels on the south floodplain area, some of which cross pivot fields (Figure 4-14 and Figure 4-12). These areas were mapped as having some risk of avulsion, indicating the potential for activation during flood events or in response to any blockage on the main channel. Since the risk of such an event is relatively low, these areas were not included in the proposed management corridor.

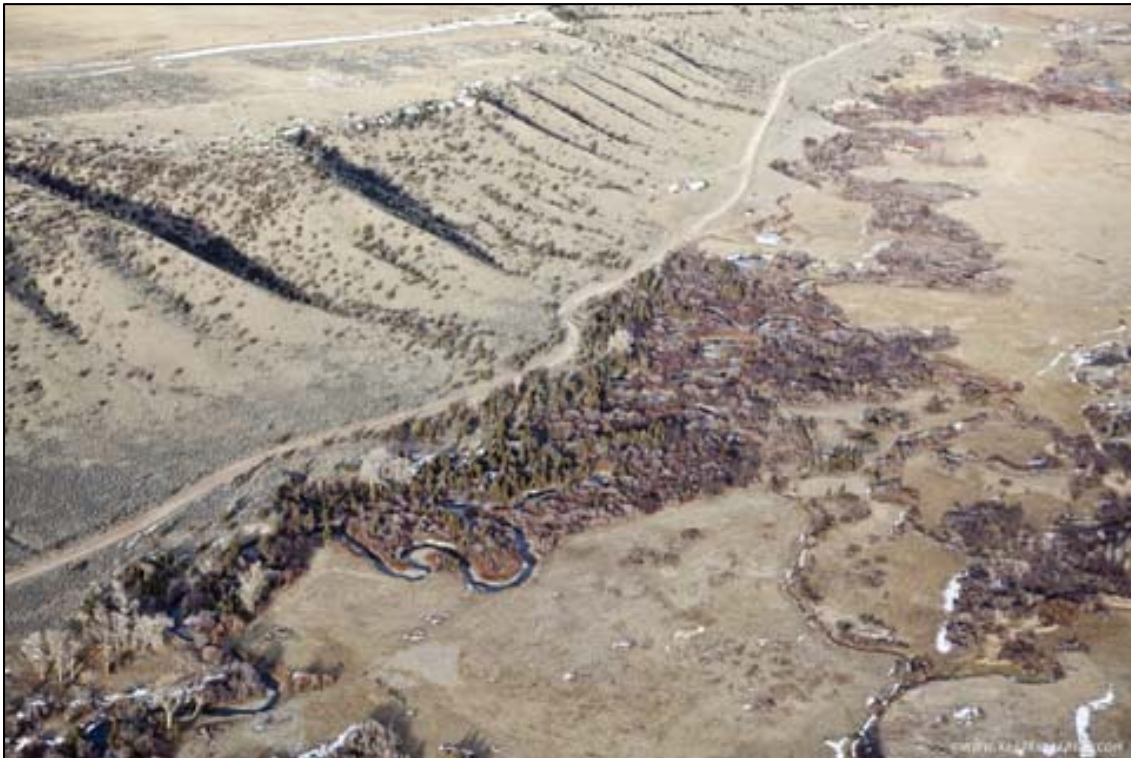
Figure 4-15. View upstream of Reach 7 showing wide riparian corridor and sinuous channel.

Reach 7 marks a distinct change in the Deep Creek corridor relative to downstream reaches. The reach is sinuous, and supports a relatively robust riparian corridor (Figure 4-15). The Erosion Hazard Area buffer width is 69 feet, indicating moderate rates of channel migration relative to other reaches (Figure 4-16). The inundation modeling results show that in the upstream-most portion of the reach, the historic channel area has been diked on the south side of the river at RM 8.6 (Figure 4-17). The air photos show that this happened before 1947 and as a result this area is not within the mapped Historic Migration Zone. Although the proposed management corridor does not include this remnant floodplain feature, it could provide excellent opportunity for floodplain/wetland restoration.

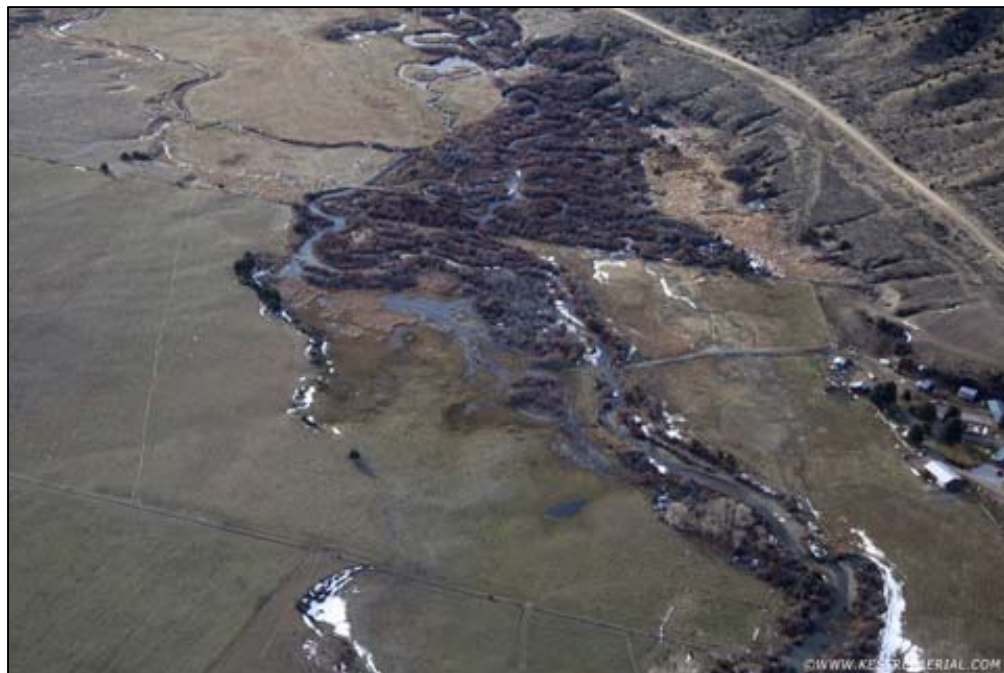
Figure 4-21. View downstream of Reach 8 showing a transition from the leveed section bounded by low floodplain to an open floodplain downstream.

Figure 4-21 and Figure 4-22 show the leveed reach as photographed obliquely from the air. There is evidence of active deposition within the stream channel, and saturated floodplain ground landward of the levees. This reflects the most striking issue in the reach, which is the perching of the creek above the adjacent floodplain. Figure 4-23 shows that Deep Creek is perched above both the north and south floodplain by two to four feet. This channel perching has created the highest avulsion risk within the entire project area. Avulsion out of the perched, leveed segment should be considered imminent should the levee overtop or fail.

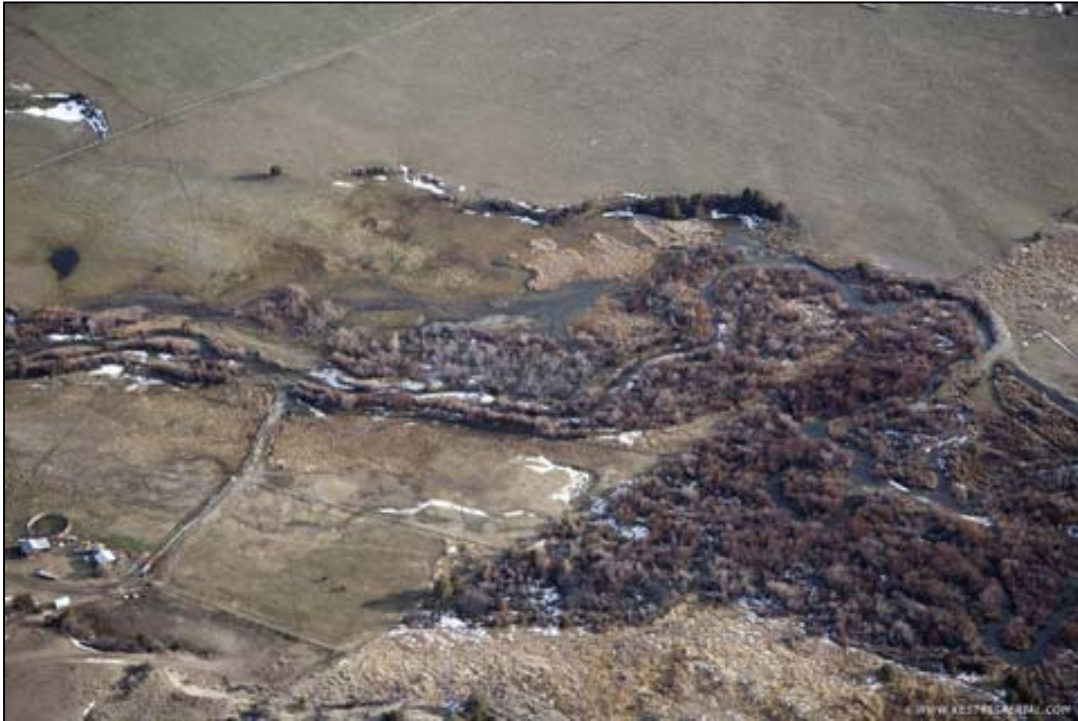
Figure 4-22. View south of leveed and perched section of Deep Creek (left portion of photo).

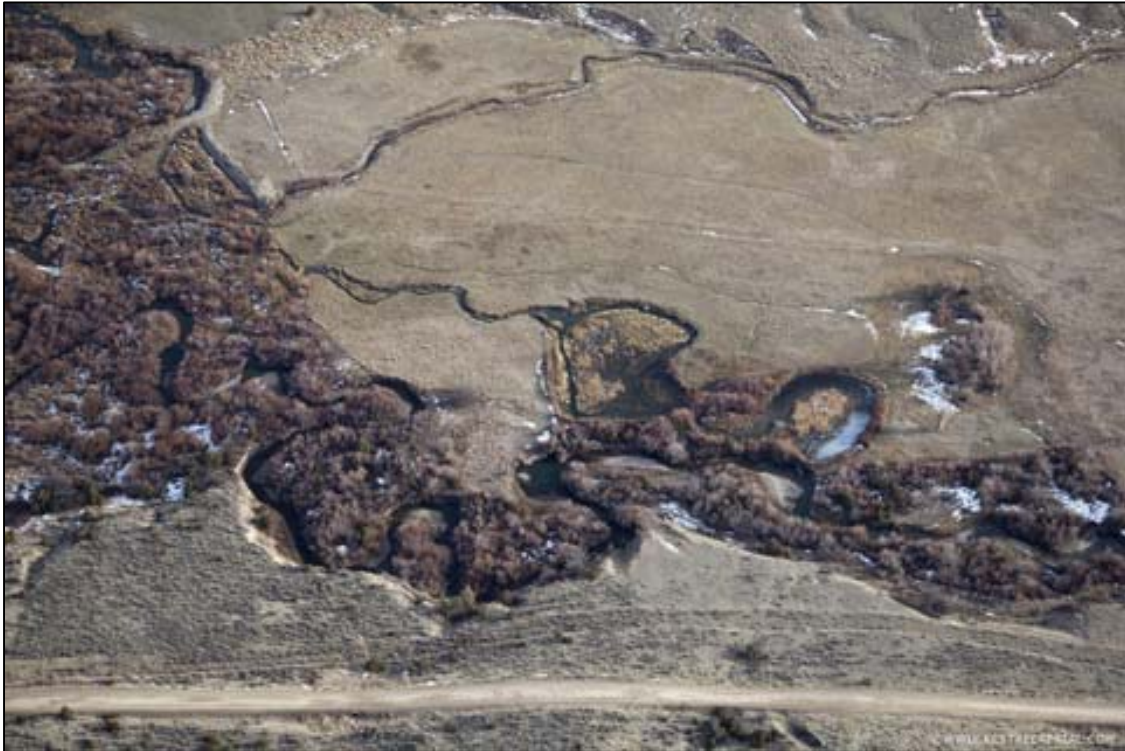
Figure 4-25. View south of lower Reach 8 showing abandoned, moderately perched meanders that were active channels in 1947.

In the lower portion of Reach 8, the grade increases, as evidenced by both the channel profile, as well as the perching of meanders that were active channel in 1947 (Figure 4-25).

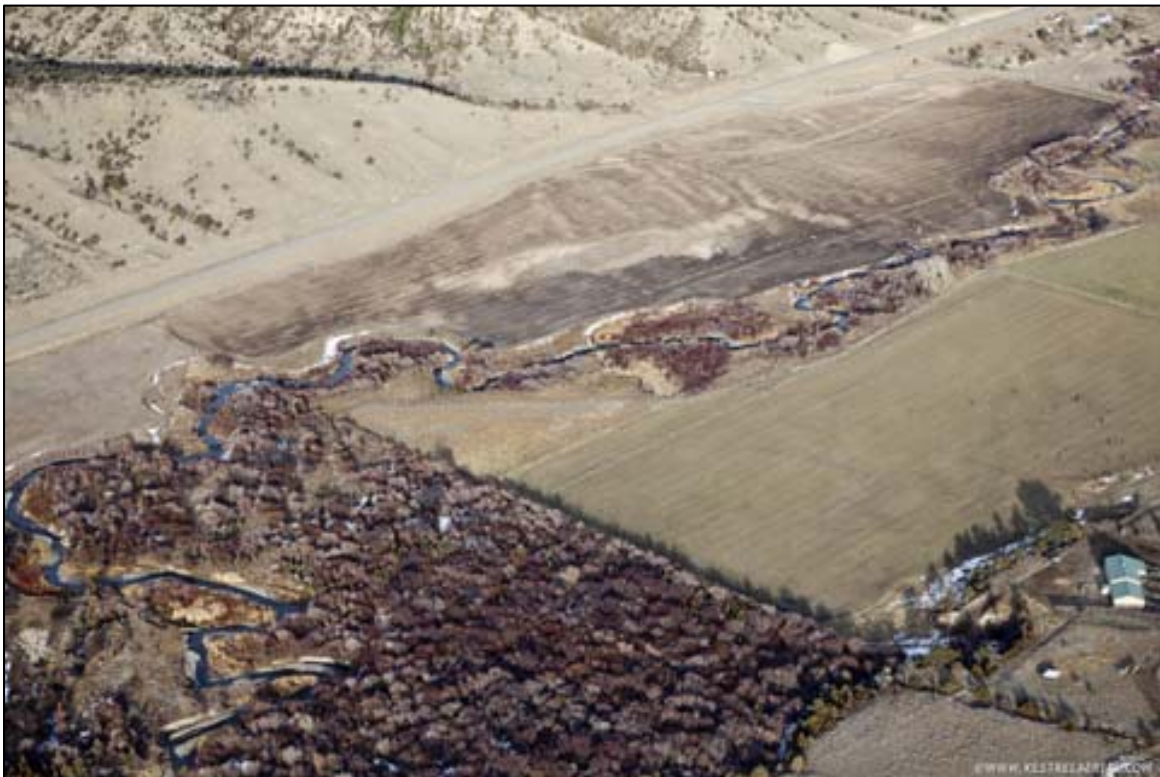
Figure 4-29. Abrupt land use boundary showing riparian clearing and likely historic riparian extent.

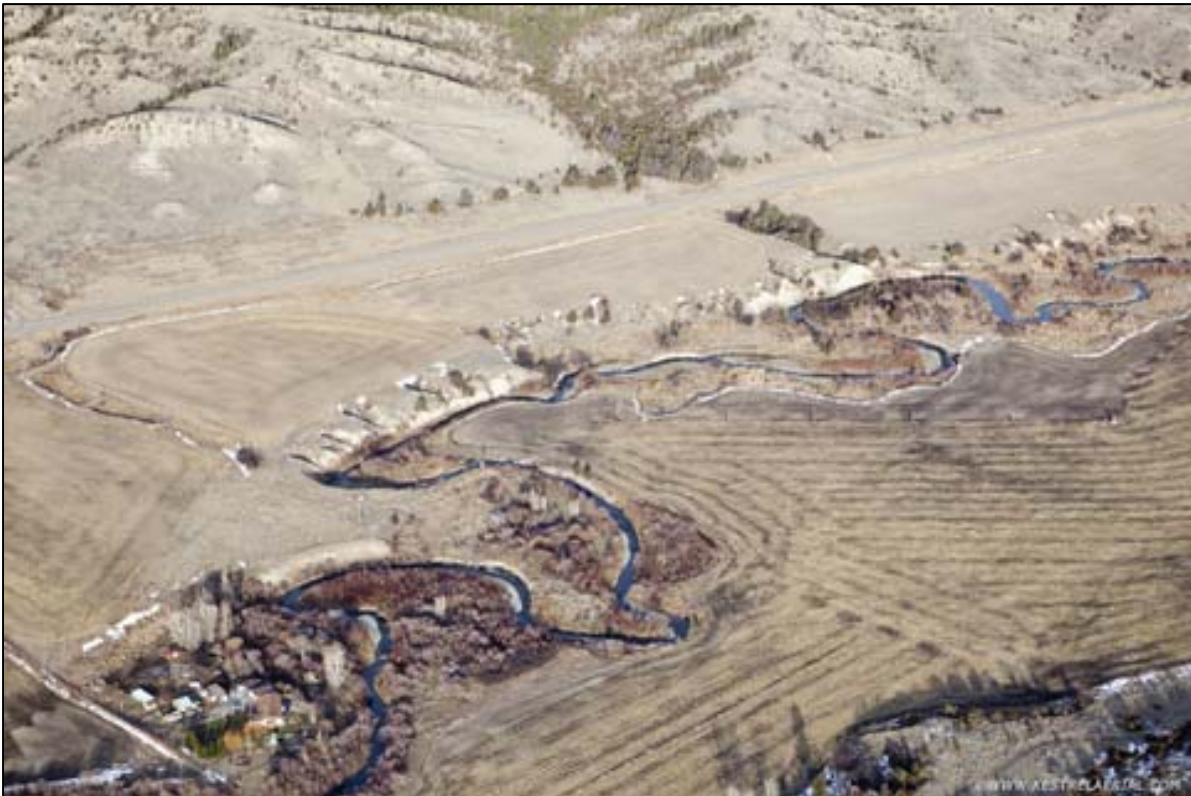
Figure 4-35. View to north over a portion of Reach 12 showing intensive cultivation of the floodplain and erosion of Deep Creek into alluvial terraces on the north side of the valley.

Reach 12 is characterized most notably by a prominent bluff line north of the river where the channel has eroded into alluvial terraces that are prone to gullying (Figure 4-35). Extensive riparian clearing in the reach has limited the woody vegetation thread to the near stream environment, mostly meander tabs. Similar to Reach 11 downstream, migration rates are relatively high in Reach 12, which has an Erosion Hazard Area buffer width of 135 feet (Figure 4-36). Reach 12 is relatively sinuous, with numerous large meanders that will become increasingly prone to cutoff with time (Figure 4-37). The Historic Migration Zone has a relatively large footprint which reflects historic patterns of meander lengthening and cutoff. According to the Skidmore Watershed Restoration Plan, Reach 12 has gained almost 500 feet of channel lengths since 1995. The Plan also documents almost 1,900 feet of bank armor in the reach, about half of which is rock riprap. There is about 500 feet of rock riprap protecting the right bank both above and below the bridge at RM 15.65.

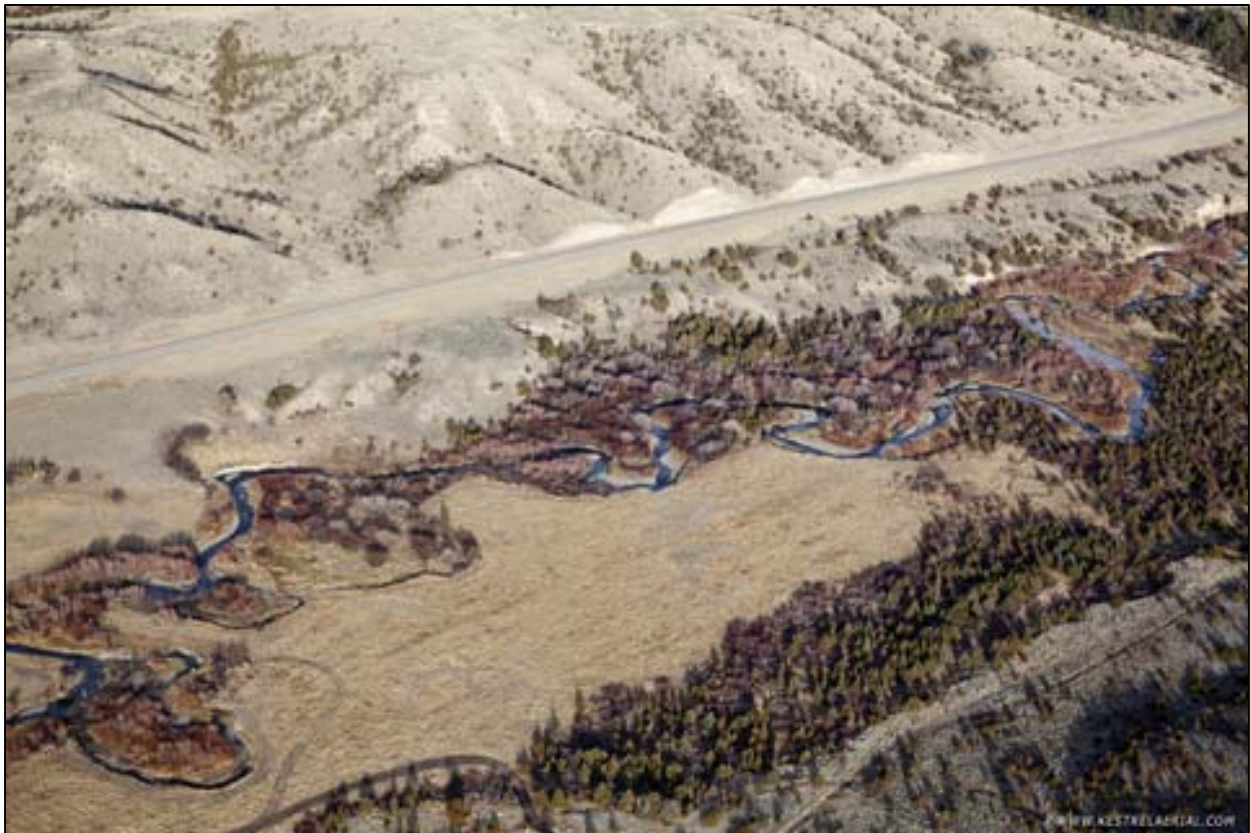
Figure 4-38. View upstream of Reach 13 showing main channel on north side of valley and avulsion risk to right of fields.

In Reach 13, Deep Creek is a highly sinuous channel that has distinct meanders and meander cutoff remnants (Figure 4-38). The reach has experienced at least four meander cutoffs since 1995, and the Skidmore Watershed Restoration Plan reports that between 2009 and 2011, the reach lost 973 feet of length. Within this reach, Deep Creek has fairly high rates of bank migration which results in an Erosion Hazard Area buffer width of 114 feet (Figure 4-39). Inundation modeling shows that in the middle of the reach, there is a large channel that flows along the south valley wall (Figure 4-40). A LiDAR-derived cross section of the valley at this location shows that due south of the creek at RM16.7, the floodplain channel is much larger and about six feet lower than Deep Creek water surface. This channel does create a moderate avulsion hazard for Reach 13, which is mapped in the CMZ. It is not included in the proposed Management Corridor due to its distance from the main channel.

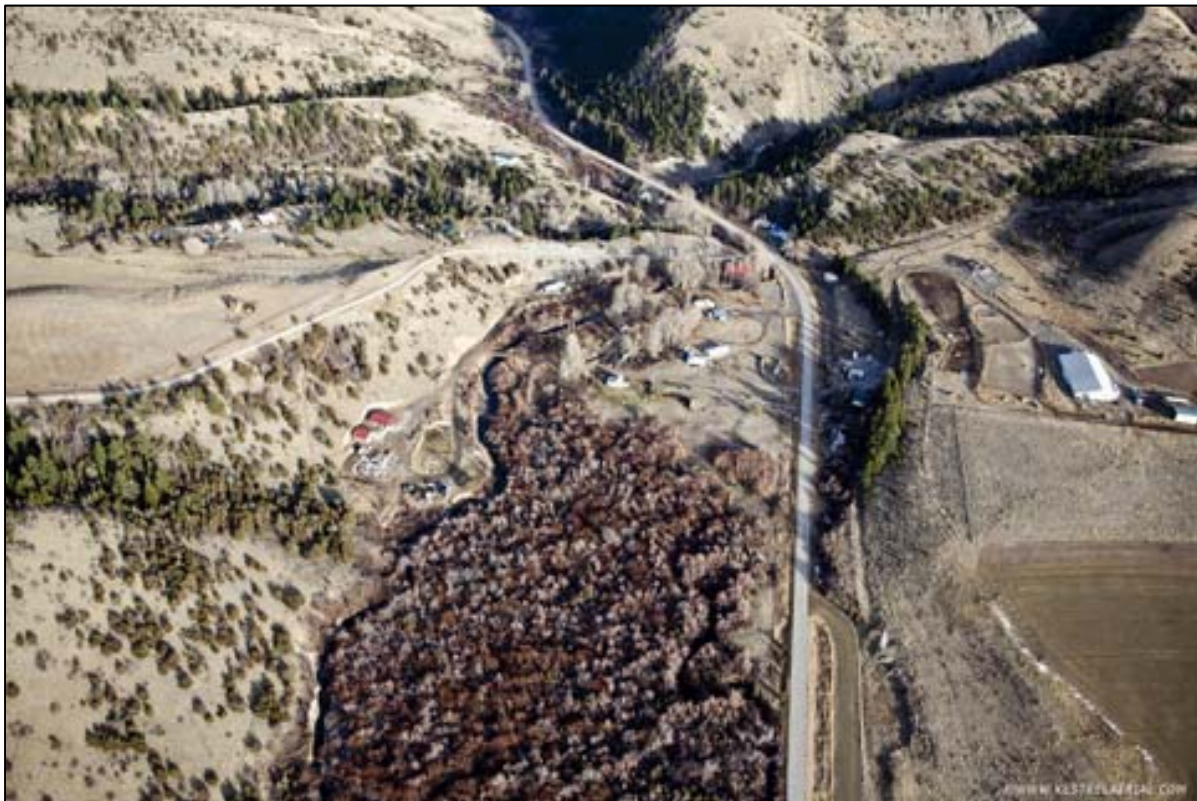
Figure 4-45. View upstream of Reach 15 showing broad riparian zone and moderate avulsion risk area to right (south) of main channel in foreground.

Reach 15 is located just upstream of the Highway 12 Bridge and consists of a relatively short section of channel at the mouth of Deep Creek Canyon that supports a wide riparian corridor. The upper portion of the reach also has substantial residential development (Figure 4-45). Reach 15 has the widest Historic Migration Zone in the project area, because in 1947 the channel was about 500 feet south of its current location (Figure 4-46). Older channels to the south that are evident on the inundation modeling map are included as moderate risk avulsion hazard areas (Figure 4-47). The proposed Management Corridor contains the HMZ only.
