CERTIFIED CORNER RECORDATION

T. 33N., R. 6W., P.M.M. **GLACIER** County Corner 1/4 SEC.COR.SECS.17&18

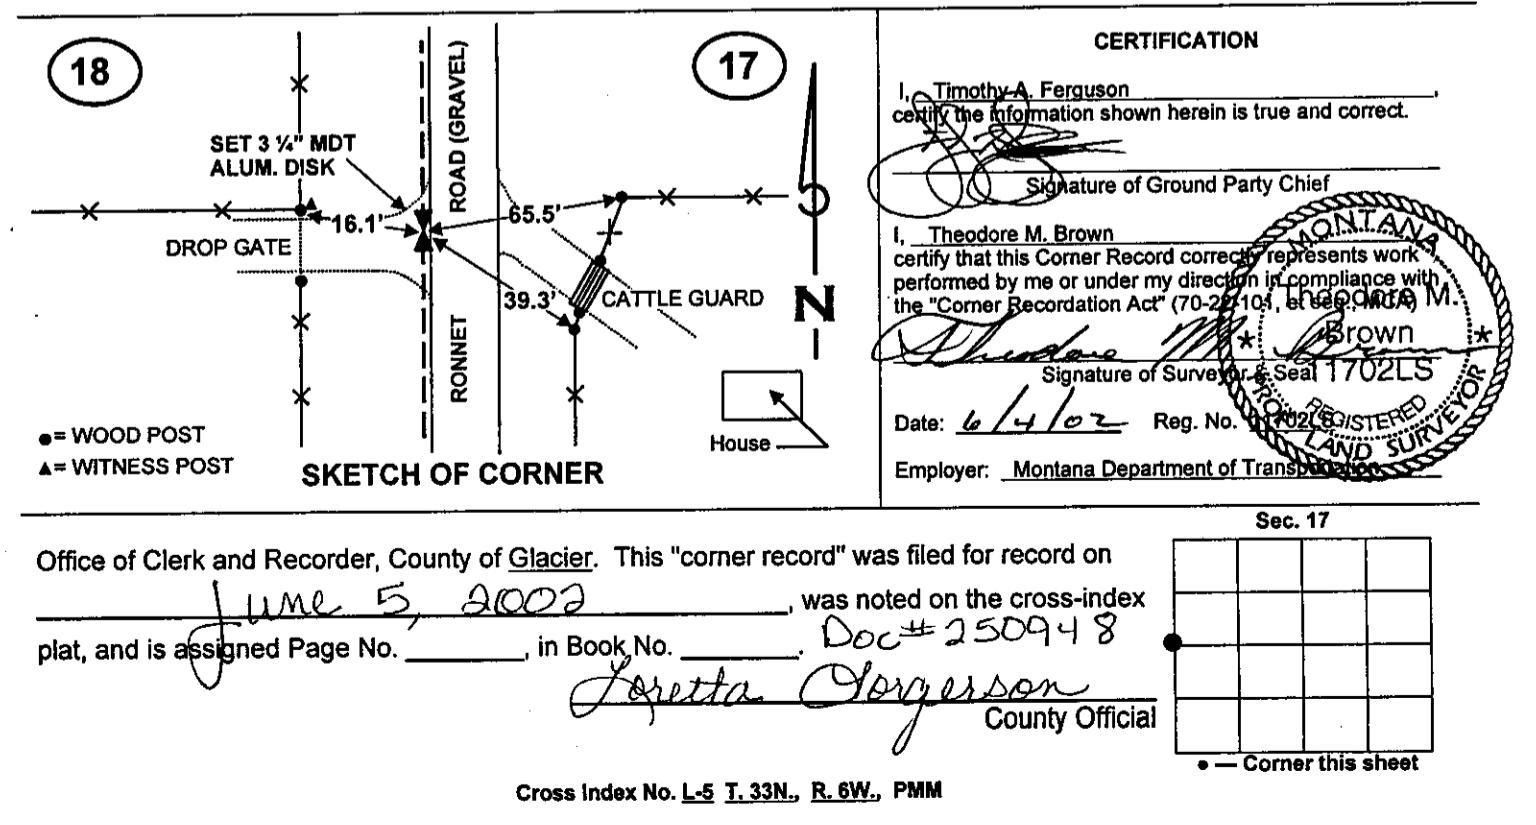
No evidence of the 1/4 section corner or allotment pipe found. This position was established by Single-Proportion between the S1/16 corner of Sections 17 & 18, T33N, R6W and the NW corner of Section 17, T33N, R6W.

Set an MDT 3 ¼ " aluminum disk on a 3" diameter aluminum pipe, 30" long, 36" in the ground for 1/4 corner of Sections 17 & 18. Point falls along the West shoulder of Ronnet Rd. in an approach to the West.

Set a witness post with MDT decal 16.1' NW of monument at East face of fence intersection running North, South & West.
