CORNER RECORD (Survey of Record Index) See Instructions

T <u>9S</u> R <u>14E</u> P.M.M. SEC <u>25</u> COUNTY Park **MONTANA**

Replaced monument at alley corner in Block 7 SE corner Lot 32 - also being SE corner of Lot A, SD 384, which was destroyed in water line construction

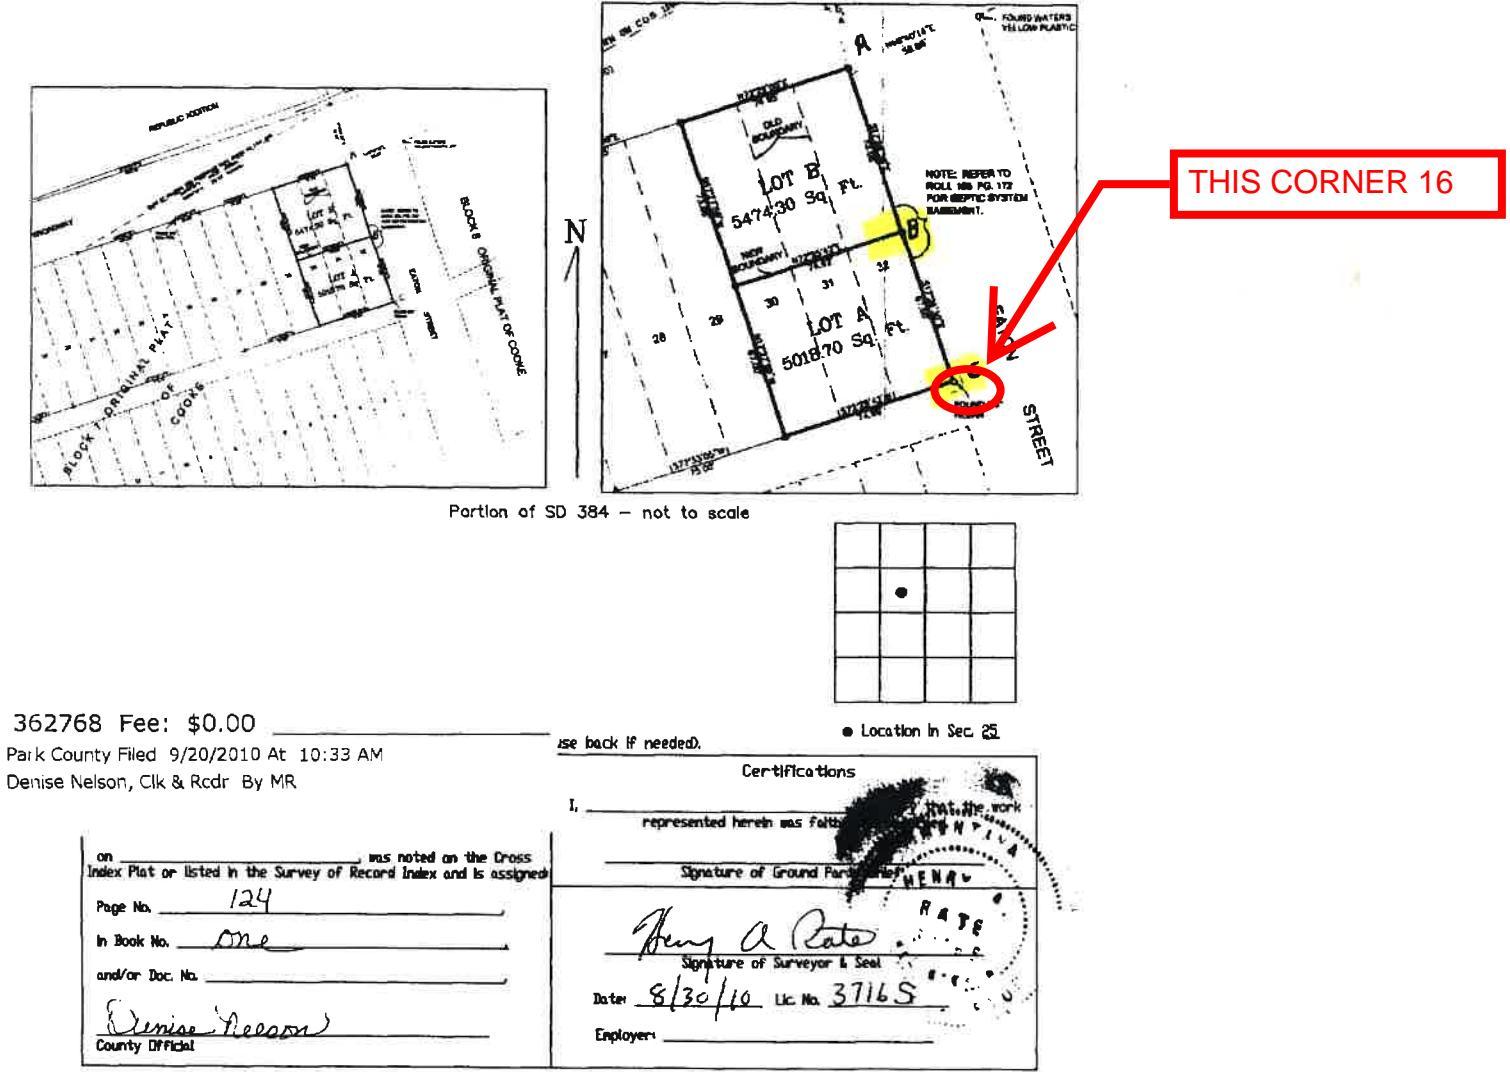
Exhibit below is a portion of SD 384. Found "A" — 1/2 in. pipe 7 ins. down. Found "B" — yellow plastic capped rebar 6 ins. down under new fill.

Set "C" at record distance from "B" on southerly projection of line "A"—"B". Set a 1 1/2 in. Surv Kap 2 ins. down. Found mangled rebar 10 ins. down in general location. Surv Kap is 4 ft. south of building comer and 4.5 ft. west of water box.
