PLSS CORNER RECORD

1/4 Corner_SECTION 23 T. 9S R. 8E P.M.M. PARK County

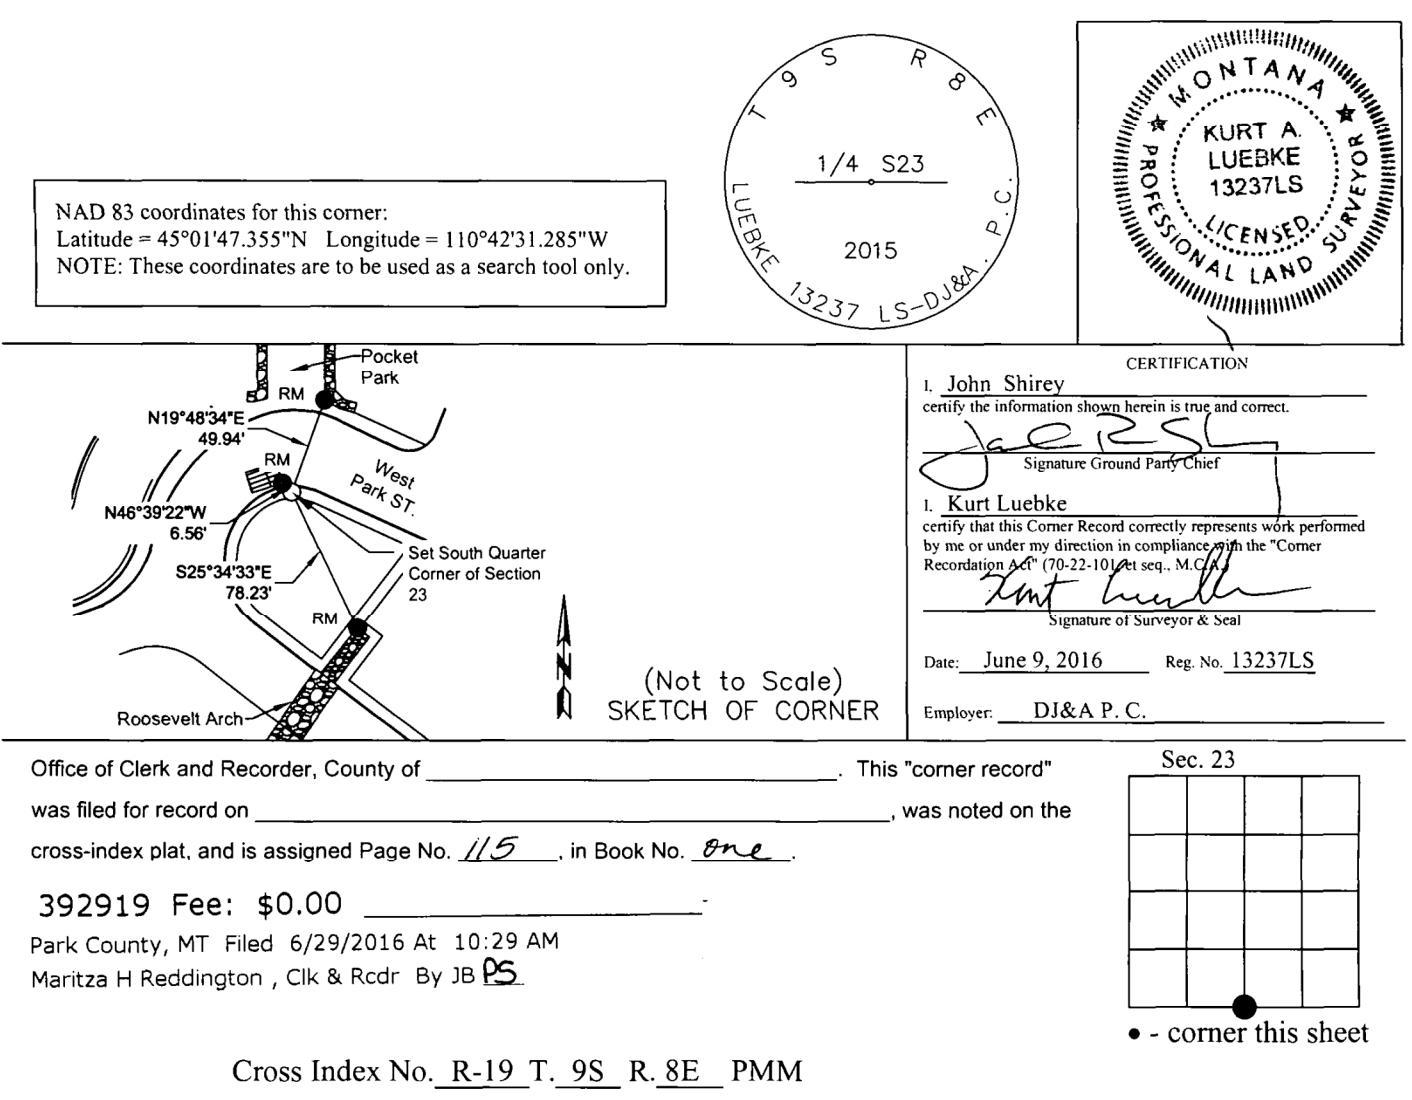
PERPETUATION: As a replacement to the existing survey monument placed by 287ES in 1983 due to construction; Set a 3/4" diameter x 30" long rebar monument, set 8" below the lid of an aluminum monument can set in concrete, with 3 1/2" aluminum cap marked as shown below

Reference Monument, N19°48'34"E, 49.94 feet to Southwest corner of stone pillar.

Reference Monument, N46°39'22"E, 6.56 feet to Southeast corner of storm grate.

Reference Monument, S25°34'33"E, 78.23 feet to Northwest corner of stone column on Roosevelt arch.
