## PLSS Corner Collection System Data Sheet

Meridian: PMN	<u>M</u> Tier:	<u>30N</u> Range	e: <u>39E</u>	Section(s): <u>8, 9, 16, 17</u>	County: Valley
GCDB Point ID:	<u>M T 2 0 0</u>	300N03	<u>90E0</u>	300500

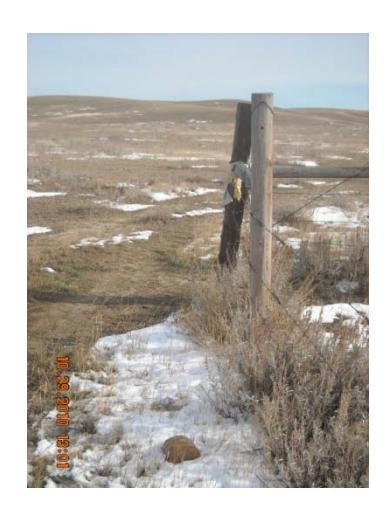
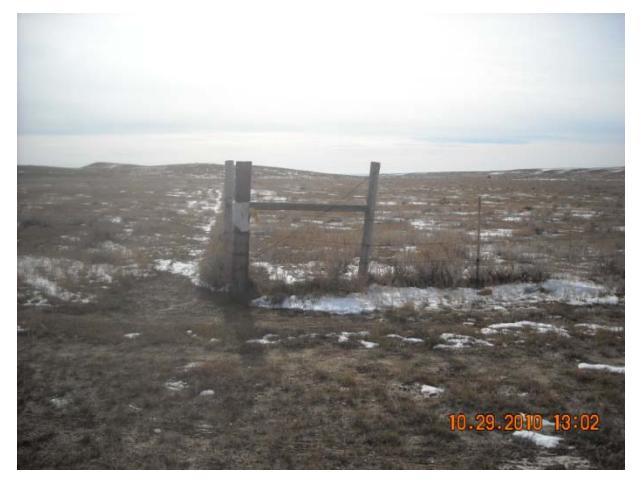
Found: <u>Granite stone lying loose ±10' west of railroad tie fence corner post. 4 notches on top and side. Stone is</u> broken. Tied fence corner as corner. Fences run south and west.
