CERTIFIED CORNER RECORDATION

1/4 Corner Sections 22 & 27 T. 5 N. R. 12 W. P.M.M. <u>Deer Lodge County</u>

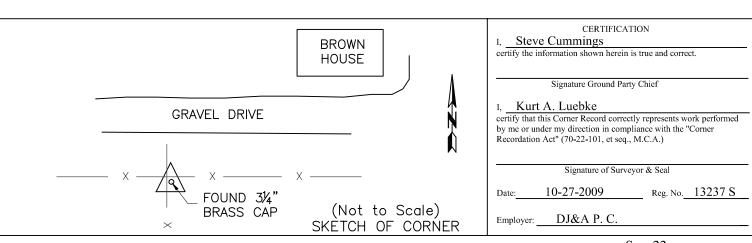
EVIDENCE FOUND: Found 3¼" Brass Cap, 0.75' above ground, from which:

A wood 2x4, 2.5' above ground bears north, 2.5 feet dist. A $\frac{5}{8}$ " rebar, 3.8' above ground bears southwest, 0.4 feet dist. A 4 way fence corner bears bears north 2.0 feet dist.

PERPETUATION: Left monument as found.

Located approx. 75 feet south of private driveway, behind storage sheds, approx. 25 feet up gradual north facing

slope.
