CERTIFIED CORNER RECORDATION

1/4 Corner Sections 19 & 20 T. 5 N. R. 13 W. P.M.M. <u>Deer Lodge County</u>

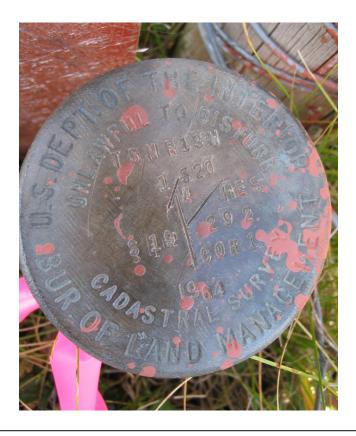
EVIDENCE FOUND: Found 3¼" Brass Cap, marked as shown below, 0.6' above ground with carsonite post alongside, from which:

A house with a red roof bears N46°E

PERPETUATION: Left monument as found.
