## CERTIFIED CORNER RECORDATION

Corner Sections 7, 8, 18 & 17 T. 7 N. R. 14 W. P.M.M. <u>Granite</u> County

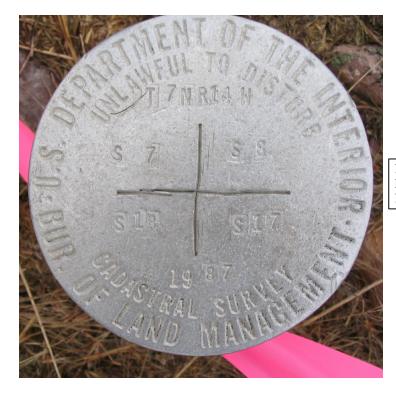
HIGHWAY 348 FOUND 31/4' (Not to Scale) A SKETCH OF CORNER ALUMINUM CAF 5.3' Employer: CERTIFICATION

Found 3 ¼" Aluminum Cap, 0.4' above ground in mound of stone, 5.3 feet west of fence line. **EVIDENCE FOUND:**

PERPETUATION: Left monument as found.
