CERTIFIED CORNER RECORDATION

P.M.M. <u>Lake</u>County Corner Sections 1, 2, 11 & 12 T. 25 N. R. 19 W.

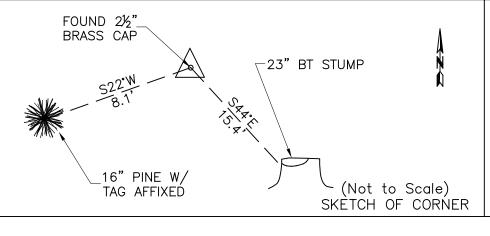
EVIDENCE FOUND: Found 2½" brass cap, 1.2' above ground on northerly facing gentle slope.

A 23" Ponderosa pine stump bears S44°E, a distance of 15.4 ft., scribing visible.

PERPETUATION: A 16" pine bears S22°W, a distance of 8.1 ft., affixed BT tag.
